VERMONT AGENCY OF TRANSPORTATION

Materials & Research Section
Research Report

CARGILL SAFELANE® HDX OVERLAY

Report 2014 – 04

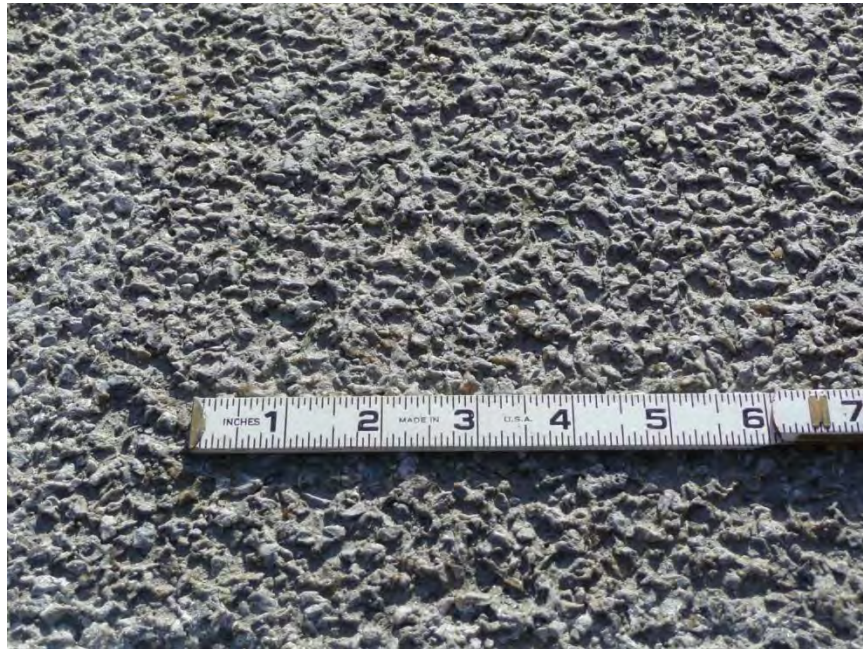
Figure 11 The texture of the SafeLane overlay after a year of service.

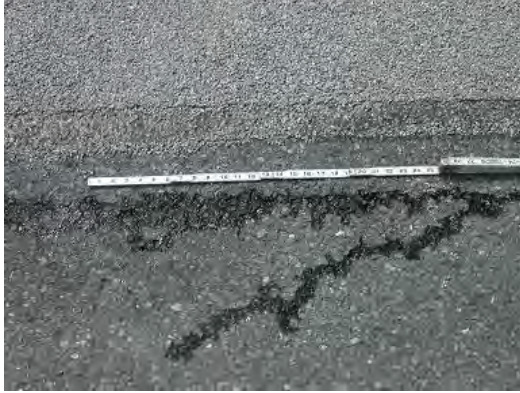
On the second day of the installation, water seepage along the centerline joint was noted in the travel lane and was attributed to the heavy rainstorms the night before. Table 6 summarizes the water seepage locations. The water seeped through the first lift of the overlay as can be seen in Figures 10 and 11 below.

Figure 12: Water leaking from the centerline joint

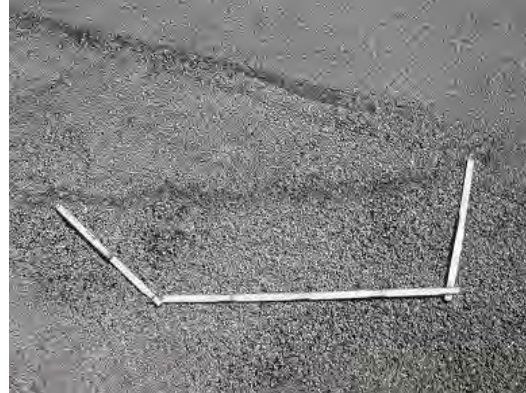
Approximately four months following installation, these areas began exhibiting distress in the form of “pop-outs” where presumably the hydrostatic pressure of the groundwater within the steep incline caused the portions of the treated area to essentially lift from the layers below resulting in “pop-out” or pothole areas. In most cases, these uplifted areas were not merely the overlay but portions of the underlying pavement as well. These areas are summarized in Table 7. Some of the pop-out or pothole areas are near the water seepage locations noted during the application. Figure 12 shows one of the potholes. As such, many pop-outs were failures of the underlying pavement and not the overly itself.

Figure 13: Water seeping through 1st lift of overlay

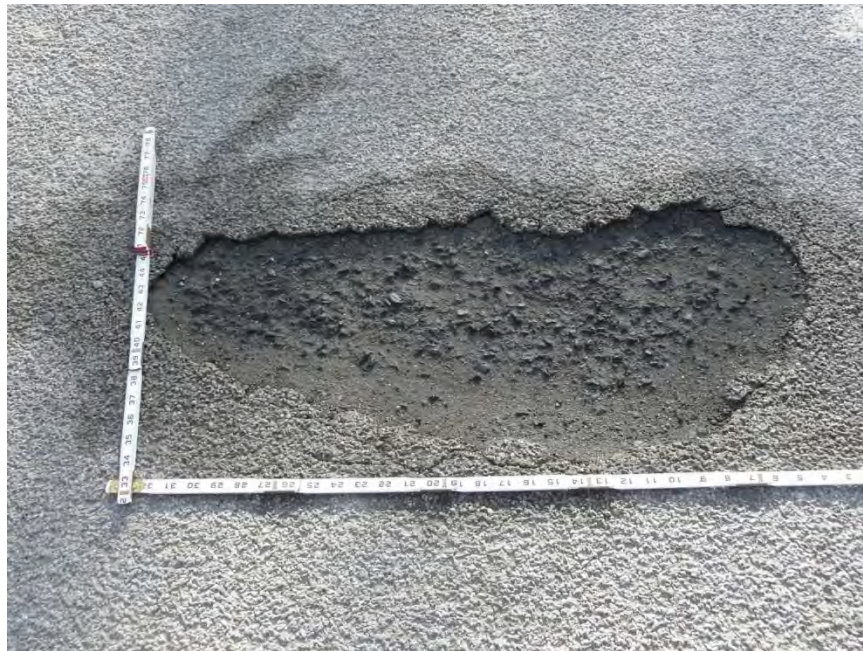
Figure 14 An example of a pothole. The underlying pavement was lifted out with the overlay.

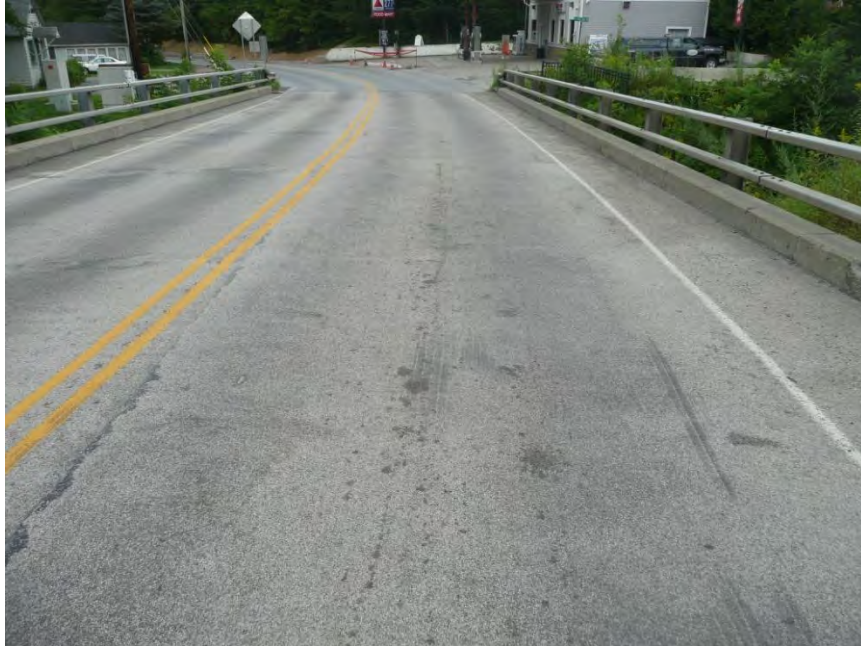
noted that the wheelpaths of the overlay were slippery. The surface was damp due to precipitation during morning hours. Upon furtherer examination, it was noted that within the wheelpaths, little aggregate remained on the surface of the experimental overlay. Instead, as shown in Figure 18, exposed epoxy was present in the majority of the surface of the overlay.

Cargill representatives were contacted and an onsite meeting to collect material and determine possible causes was conducted in September 2010. Attending were representatives from District 5, Cargill, and Materials and Research personnel. Ten cores of the overlay material were extracted to examine the current condition of the overlay and probable causes. Cargill personnel examined the cores at their central laboratory. They believed the loss of aggregate was due to studded tires. An earlier hypothesis was that the epoxy set up too quickly which did not allow enough time for the aggregate to bond properly to the epoxy. The analysis rebutted the earlier hypothesis. See Figure 19.

Figure 18 The darken wheel paths show where the aggregate has been stripped, exposing the underlying epoxy (2010).

Because of the premature failure in the wheelpaths, Cargill agreed to repair the overlay with a harder aggregate, which was projected to resist the wear of studded tire use more effectively. Due to time and weather constraints, the repair did not take place until August 2nd and 3rd, 2011. Research, District 5, Cargill, and Parent Construction representatives were onsite.

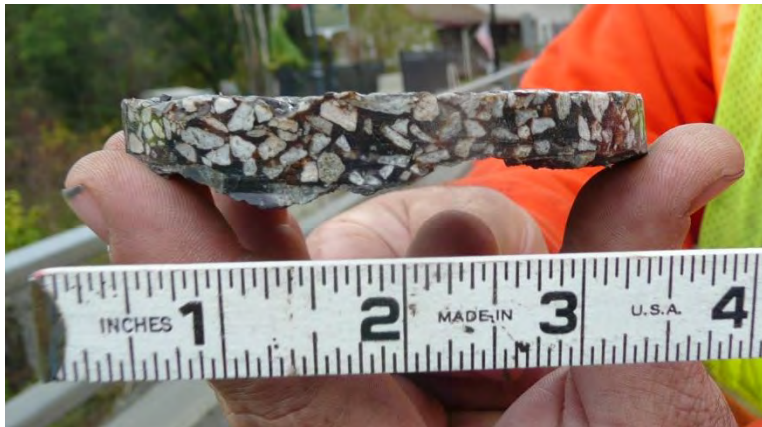
Figure 19 Core of the overlay.

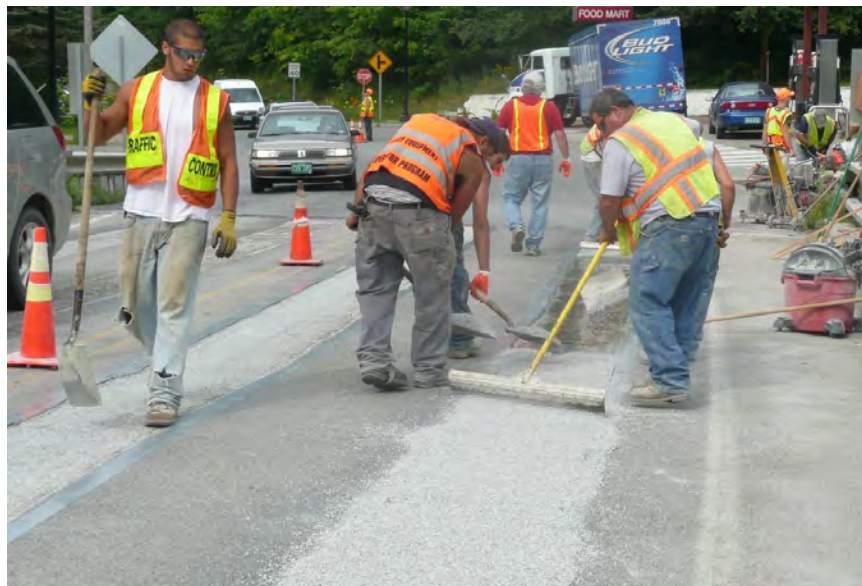
Figure 20 Repairing the wheel paths.

To prepare the surface the wheelpaths were milled to remove any remaining epoxy or aggregate from the original overlay. One lift of the epoxy and aggregate was then placed. Once cured, traffic was switched to the other side and the wheelpaths in the other lane were completed. As of the summer of 2012 the overlay appeared to be in good condition with no reports of crashes or incidents at the location.

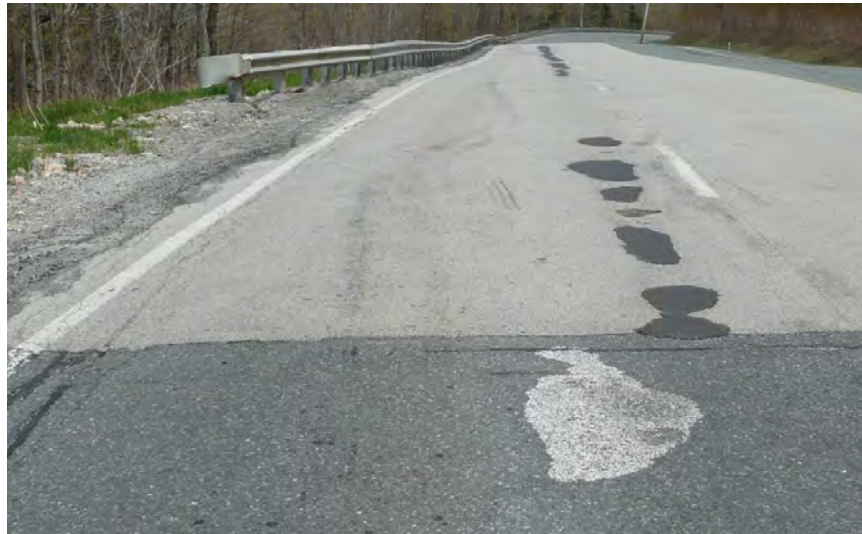
Figure 21 Pothole repair less than a year after application.
