Agency of Transportation

Report on Spring 2006 Evaluation of Detectable Warning products installed 2003- 2005

July 12, 2006

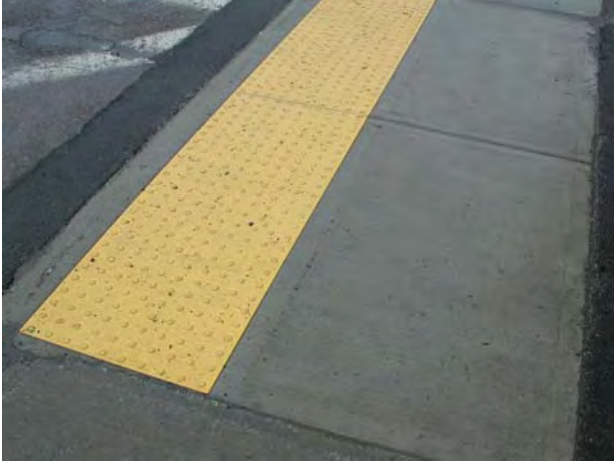
Overall condition of this product is good. There is some damage to the panels. No evidence of separation from underlying concrete.

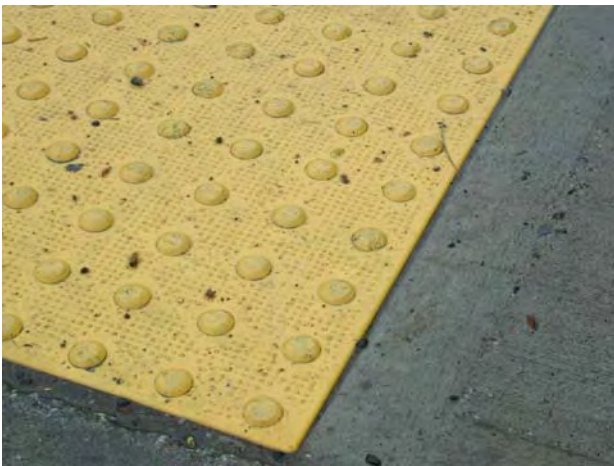
A few full domes are missing. The tops of quite a few domes have been scraped off.

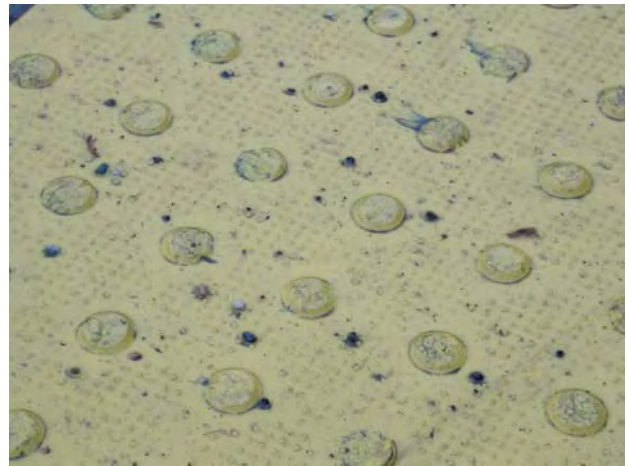
Individual domes are chipped and broken. It is likely that many domes no longer meet the ADA standards for dome height.

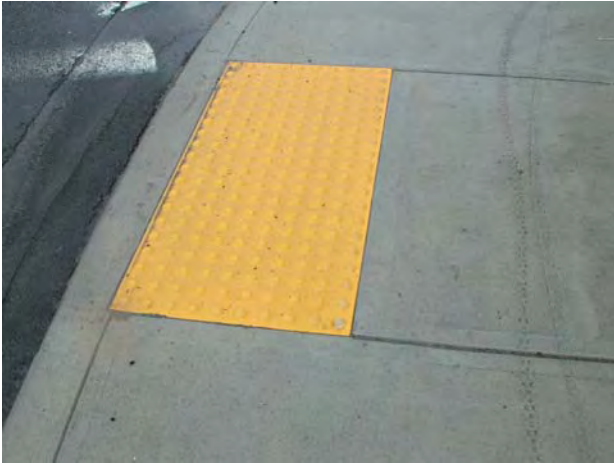
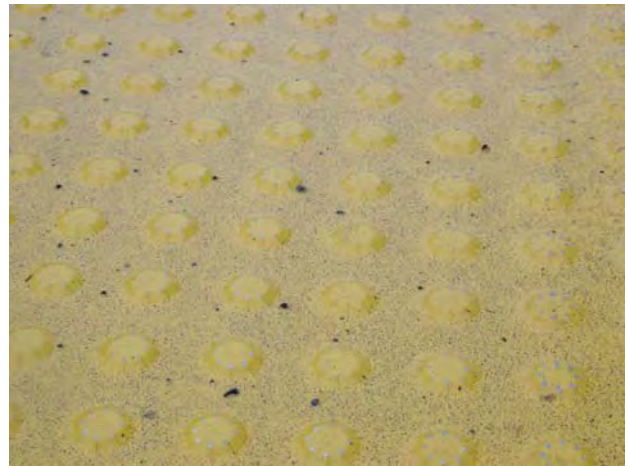
The integrity of the dome field was very good.

The overall durability of this product is very good. An early installation showed problems with the coating that is adhered to the stainless steel panel. The product in place incorporates a new coating process and small ridges on the domes that are intended to cause any plow blades to ride above the normal dome top.

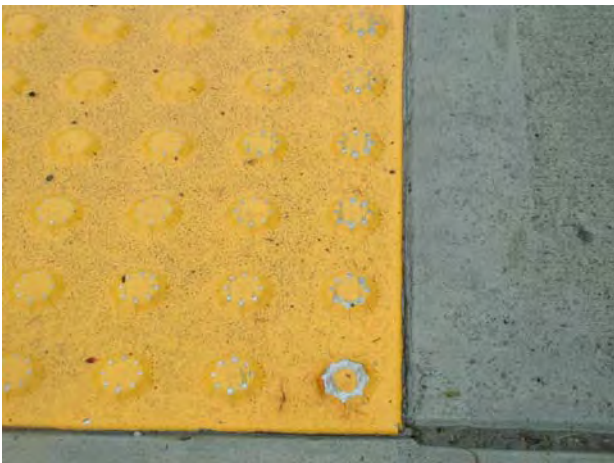
Some of the small ridges had been removed by the plow and there are signs of complete removal of the coating, exposing the underlying stainless steel. One dome on a leading edge of the panel was partially crushed.

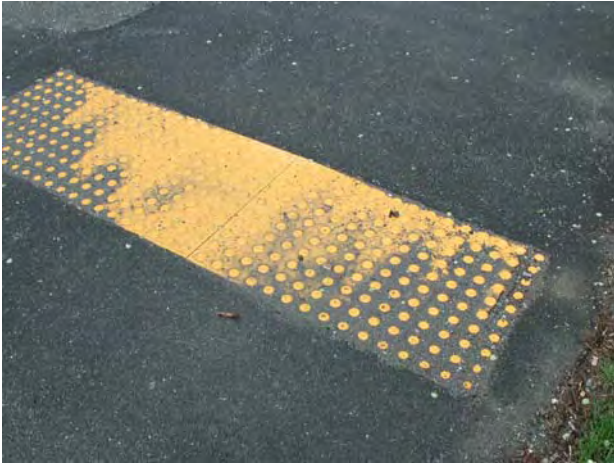
Sand and gravel from the adjacent road and winter maintenance had accumulated between the domes on portions of the panels. The panels were in very good shape overall.

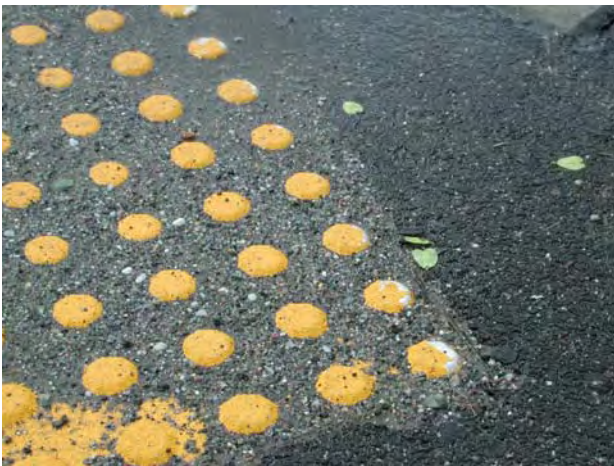
As with almost all products evaluated, the leading edge of the panel is where the majority of damage was observed.

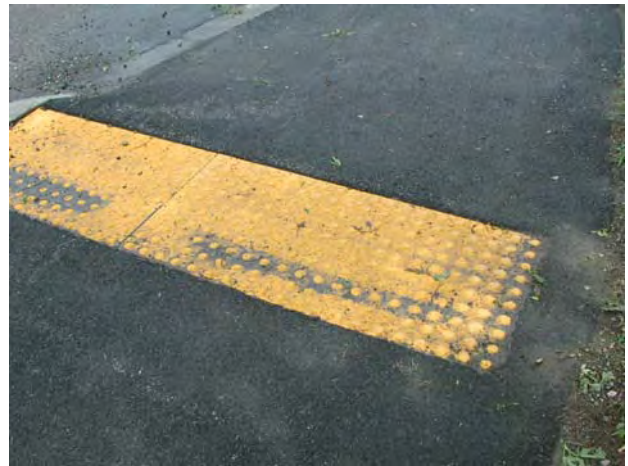
It was noted on one of the panel installations that a void had formed under the panel, allowing it to deflect when stepped on. Installation of these panels on asphalt must be done carefully to avoid such voids. Continued deflection may cause the panel to crack over time.

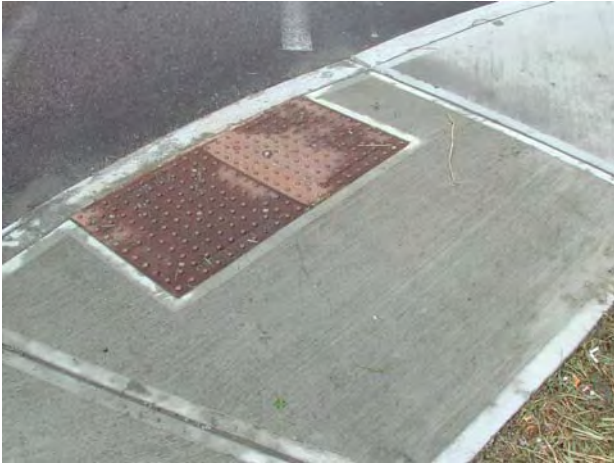
The natural rust color of these panels appears to provide adequate contrast to the surrounding concrete, even when the concrete is wet.

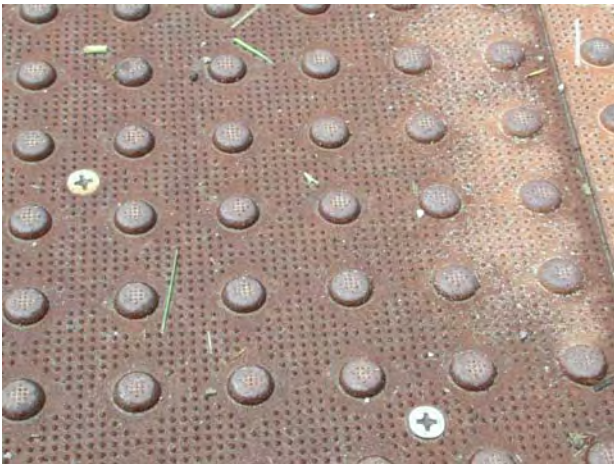
This product showed virtually no damage from snow plows. All domes were intact.

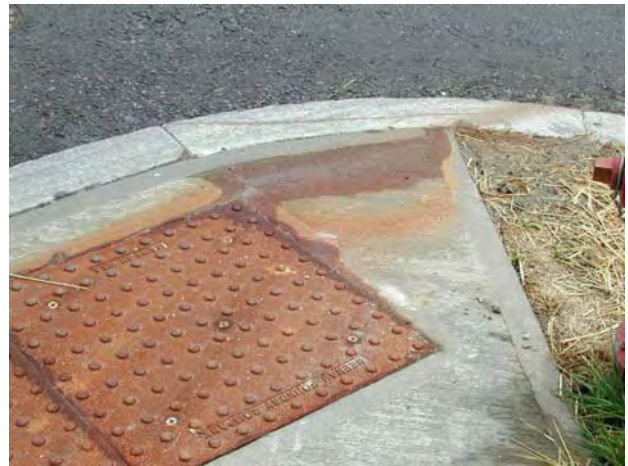
The one feature of this product that will need to be monitored is the extent to which the rust “bleeds” onto adjoining surfaces. Some bleeding was observed on this ramp, but generally was very limited.

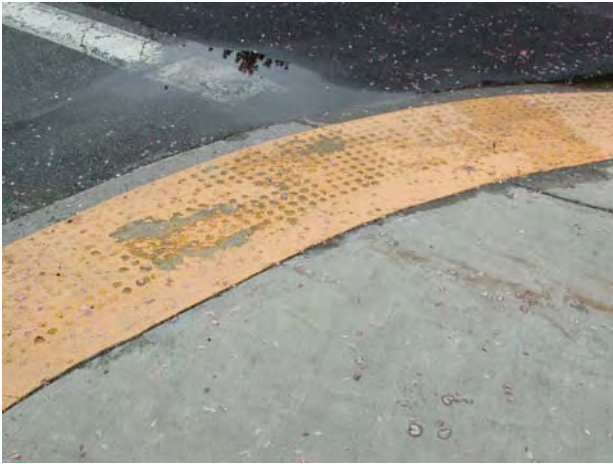
Large sections of the coating have been completely removed from the ramp surface.

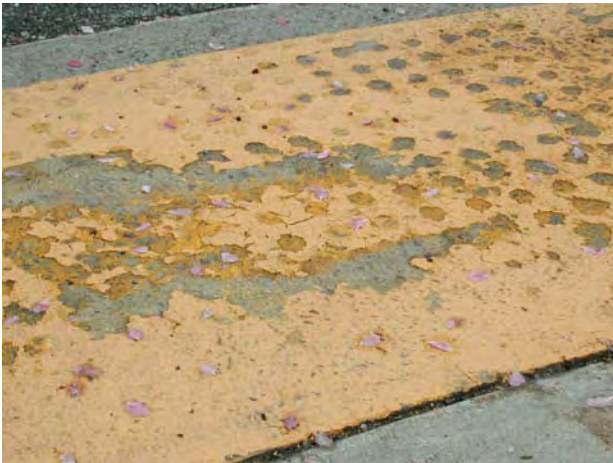
In addition to entirely missing sections, many individual domes have been removed.

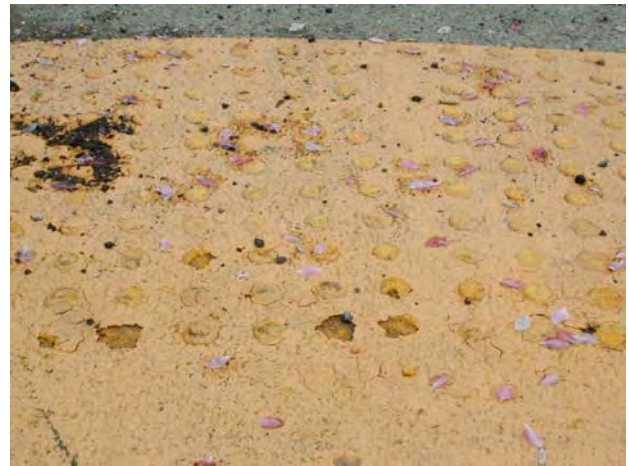
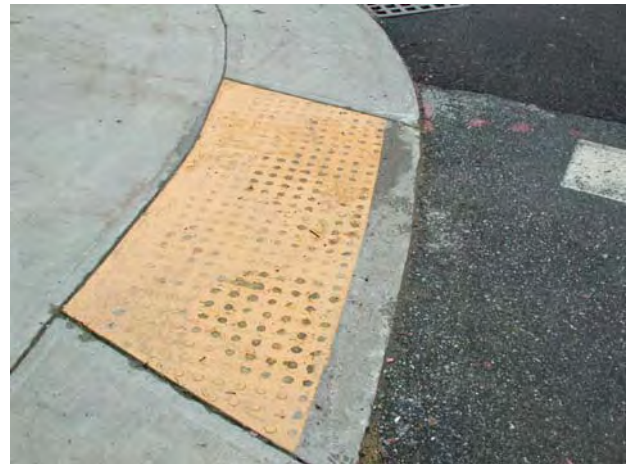
Overall assessment of this product is that it has failed.

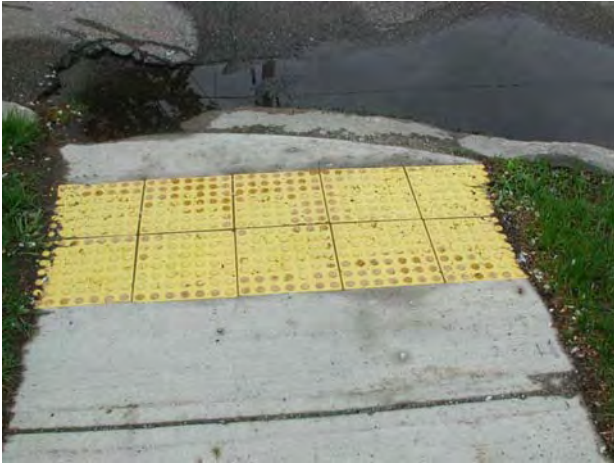
At least 50% of the domes have been lost or severely damaged. The overall condition is fair to poor. The tiles are intact and have not separated from the surrounding concrete.

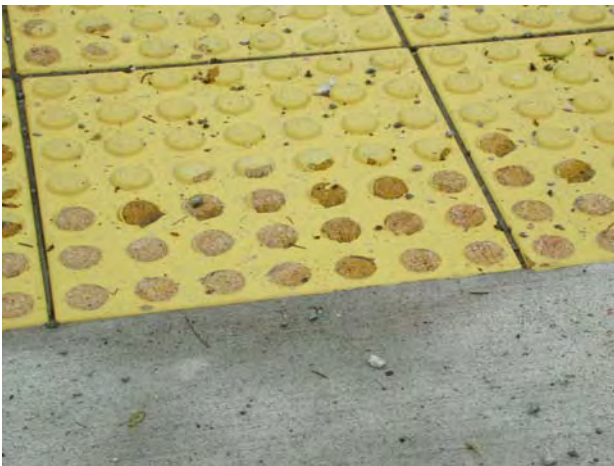
Based on the continued damage that this product has sustained each winter, it is considered to be a failed product.

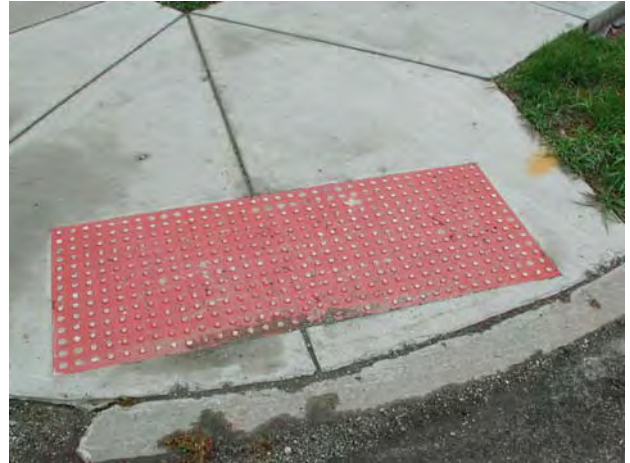
The panel is adhered well in the surrounding concrete. However, at least 50% of the domes have been lost or severely damaged.

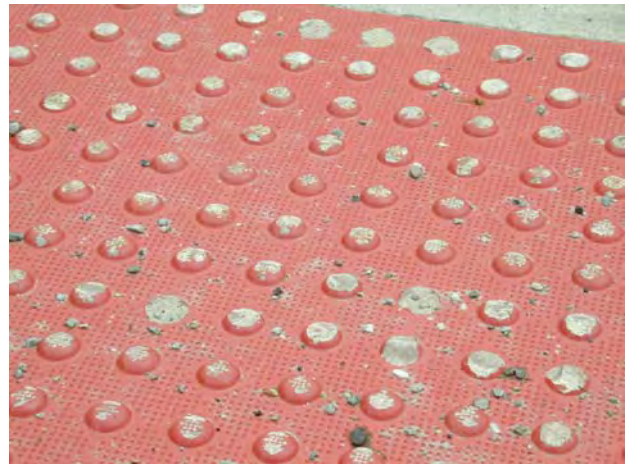
Based on the continued damage observed with this product each winter, it is considered to have failed. A three year life span for these materials is not acceptable.

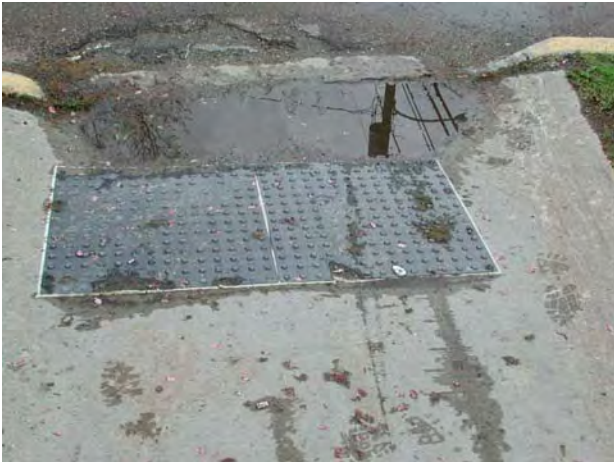
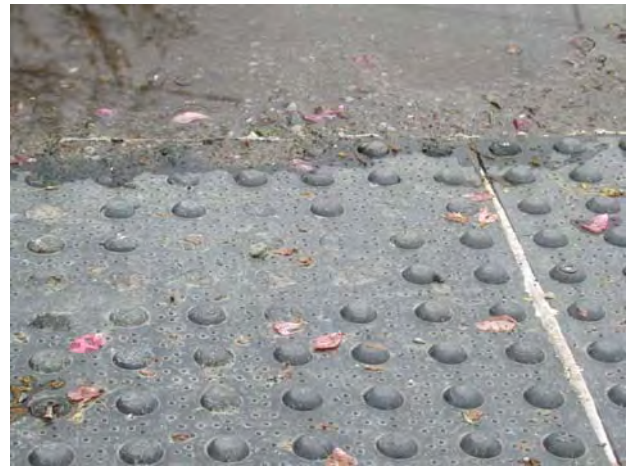
A number of domes have been completely removed. Based on the overall condition of this product only 3 years after installation, it will be recommended to remove it from the Approved Products list.

The overall condition of these panels is fair to good with some continued damage being evident.

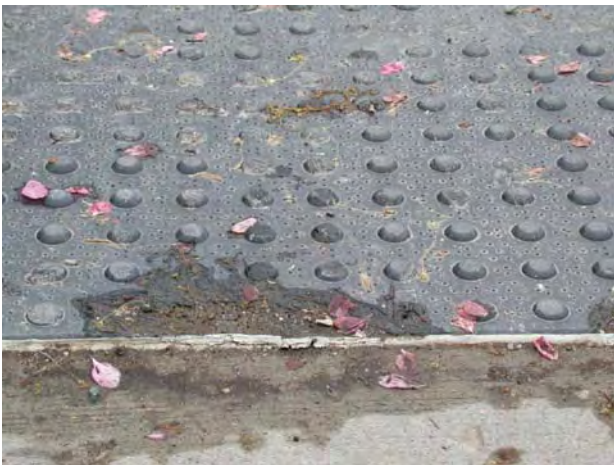
Some small sections of panel have been completely removed and. Many dome show signs of scraping.

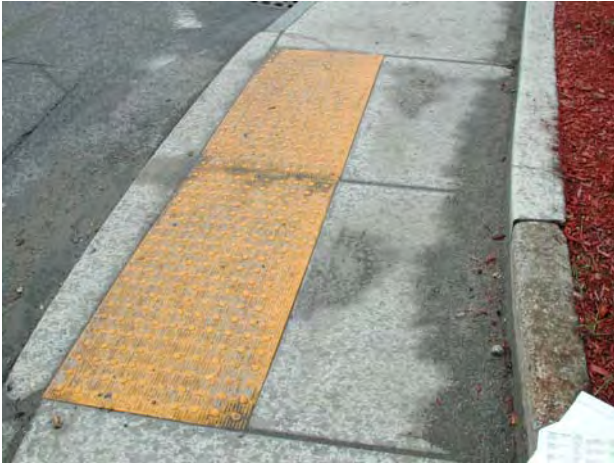
In general this product is showing minimal damage, although it has only been in place for one winter.

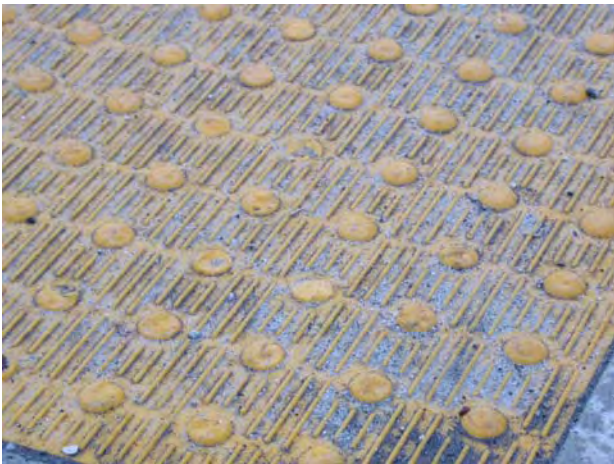
A few domes have been chipped or fully removed. This product will have to be monitored for one or two winters to see how well it holds up. It is expected to show continued wear like other plastic compound products.

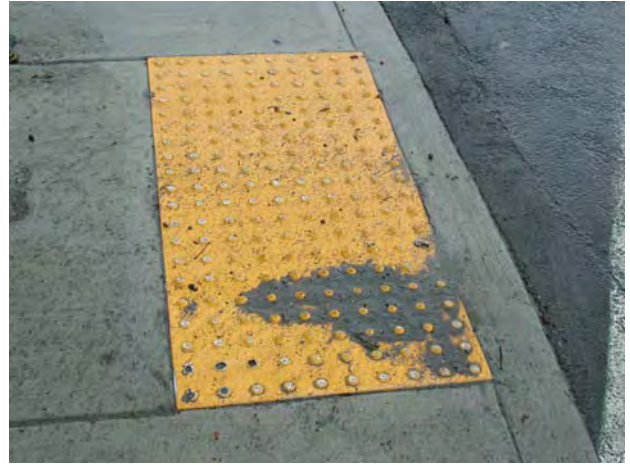
The overall condition of the panel is good, yet it is showing signs of wear after one winter season.

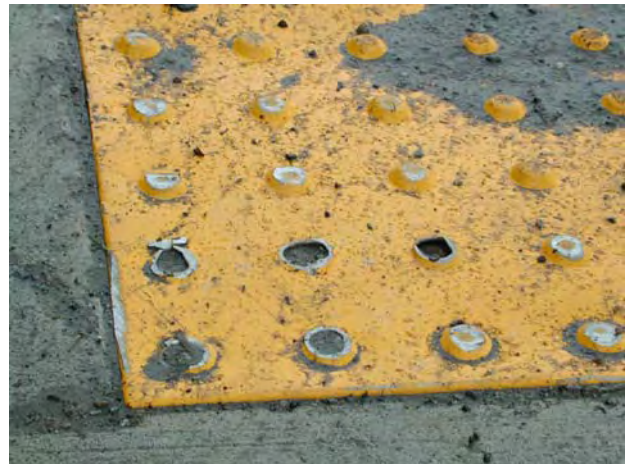
Of most concern with this product is that where complete domes have been removed, a hole in the panel surface has resulted. This will allow water to accumulate under the panel surface and may cause problems when subjected to the freeze-thaw cycle. It is likely that this product will not be recommended for use on Agency projects.

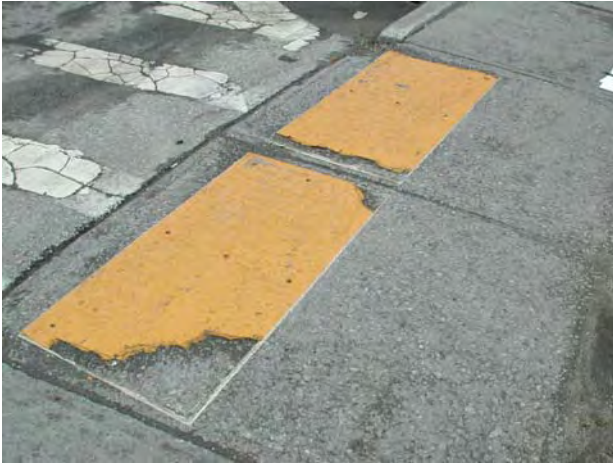
After one winter, the product is showing considerable signs of wear and exhibits a poor bonding to the substrate.

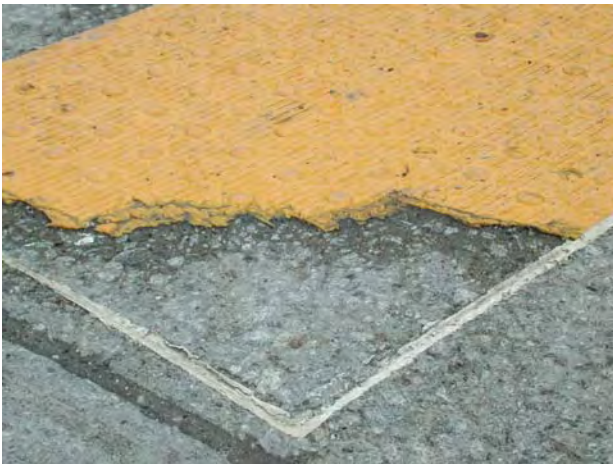
It appears that the sidewalk plow blade lifted one corner of this semi-rigid panel and broke the piece of panel off.

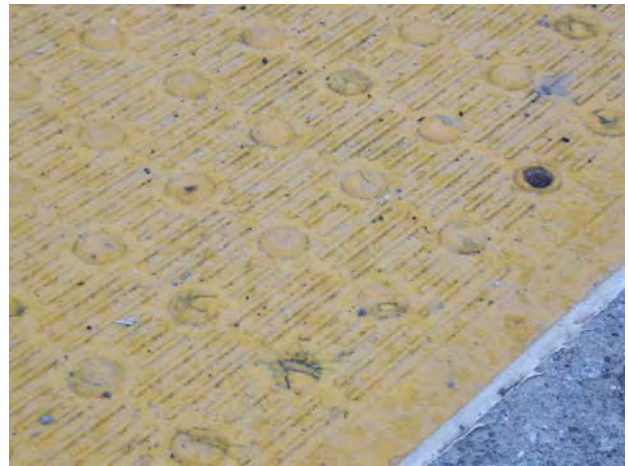
In addition to the wholesale removal of sections of this product, individual domes were crushed and sheared off. This product is considered to have failed.

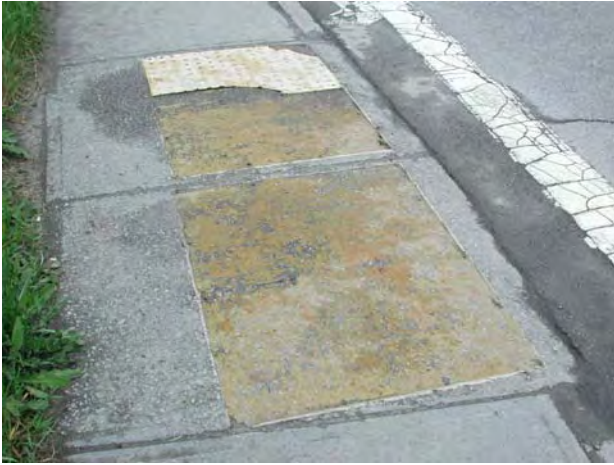
This flexible product experienced almost complete removal after being exposed to one winter of sidewalk plowing, demonstrating a poor bonding to the underlying concrete.

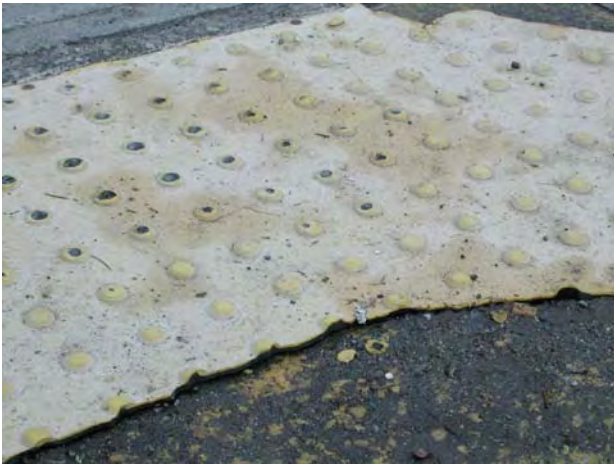
The remaining portion of this product showed extreme fading of the color and damage to domes. This product failed.

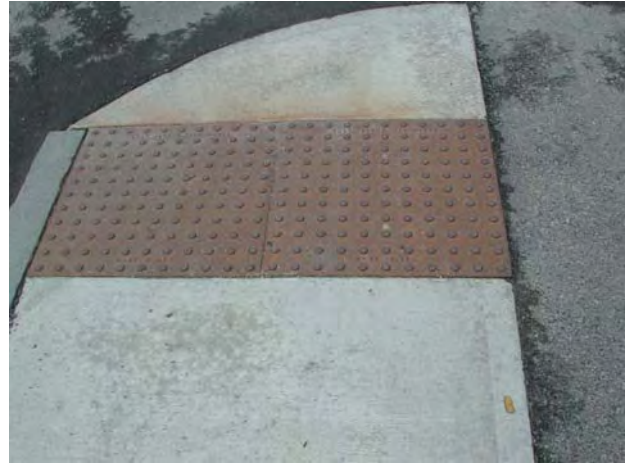
These panels showed virtually no damage and all domes were intact. There was good color contrast to the surrounding concrete. Some minor bleeding of rust onto the adjacent concrete was observed.

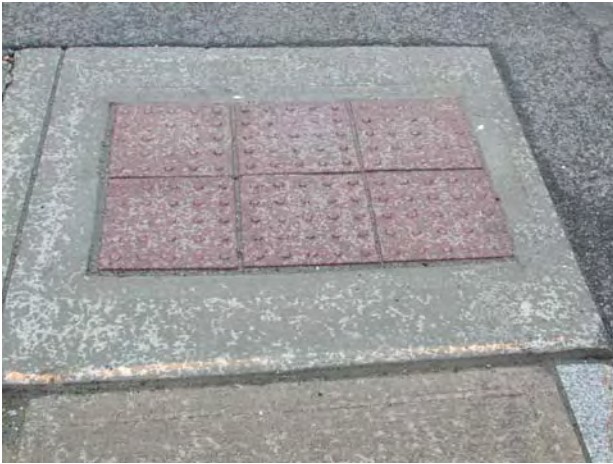
Overall, this product is in fair to good shape. The color contrast to the adjacent concrete is fair but diminishes when wet.

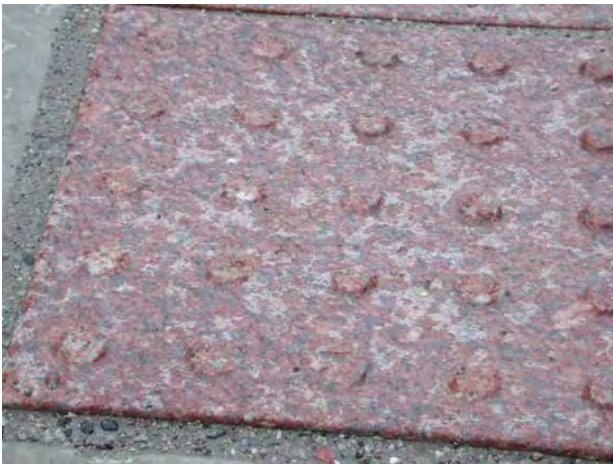
Approximately 25% of the domes show signs of chipping or crushing as a result of winter maintenance. It is expected that continued deterioration would take place with this product.

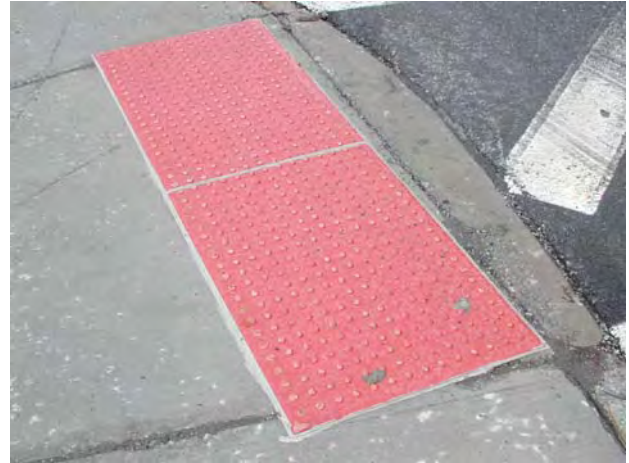
The overall condition and appearance of this product is very good. Color has not significantly faded since its original installation. Joint seams are intact.

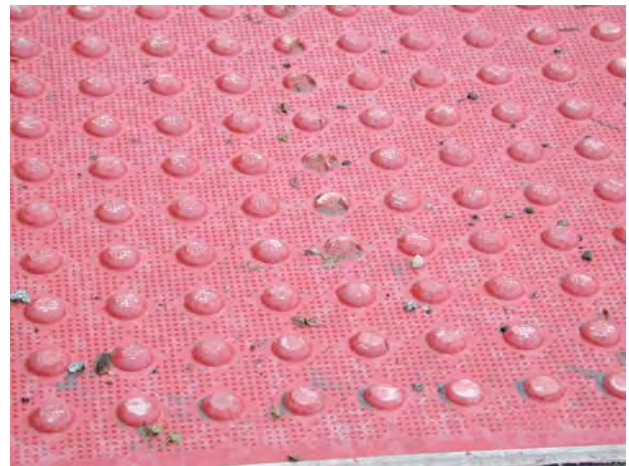
There are a few missing domes and some scraping of dome tops is evident, especially on the leading edge of the panels.

Although some continuing damage has been observed, this product is holding up well.

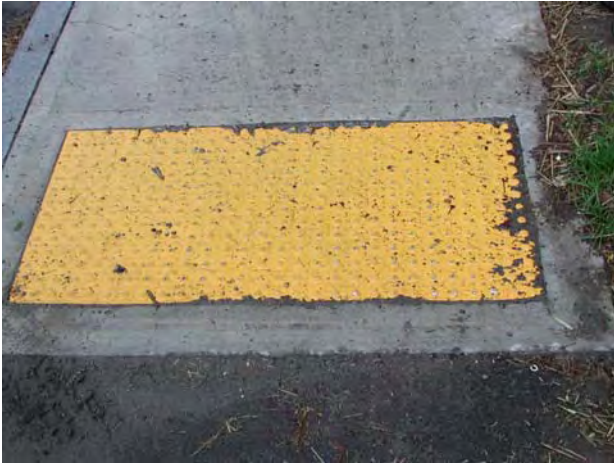
The overall condition and color fastness of this product is very good.

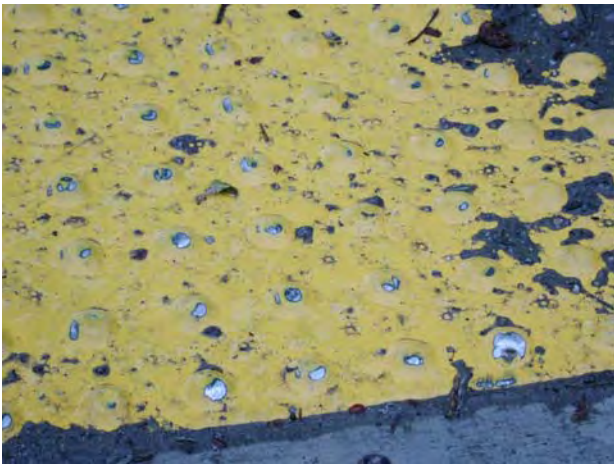
The panel surface is showing the impact of one winter of sidewalk plowing in that some of the coating has been removed from the panel, exposing the underlying stainless steel. Some minor dome damage was present.

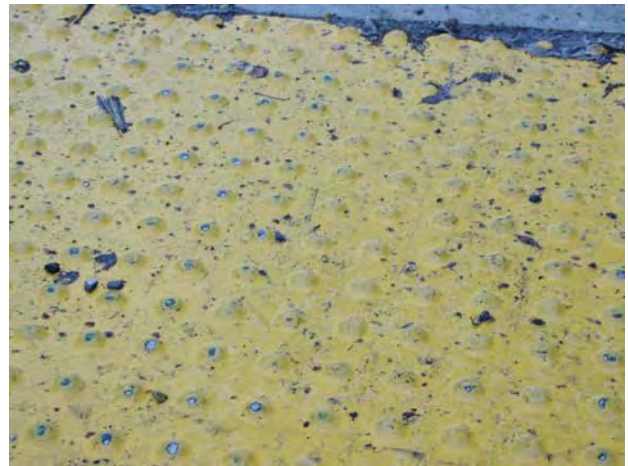
The removal of surface coating was noted on some internal domes, not just the leading edge.
