Reinforced Earth[®]
Mechanically Stabilized Earth Abutment Walls
Initial Report 1998-3
April, 1998

Reporting on Work Plan 94-S-21

State of Vermont
Agency of Transportation
Materials and Research

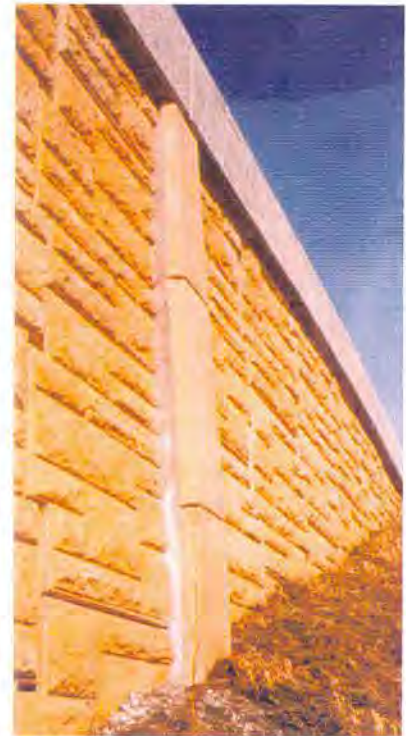
Figure 8. Repaired Slip Joint Wingwall 4

While constructing Wingwall 4, the panels developed a slight outward bow. Although the backfill was contained at the slip joint by geotextile fabric and the wall was in no risk of failure, the bow made it impossible for the slip joint covers to fit flush with the joint. Attempts were made to relieve pressure on the fabric by placing large aggregate in the gap; but the appearance of the repair gave the false impression that aggregate was actually coming out of the joint. In response, the joint was filled with mortar after all anticipated movement had subsided (Figure 8).

The exact cause of the movement is unknown, but it has been speculated that the wall shifted when the temporary sheet pilings, just six feet away, were vibrated for removal. This was aggravated by the fact that the area between the wing wall and abutment is very narrow. As previously noted, the reinforcing strips were attached directly to opposing panels to compensate for the lack of volume, but until sufficient layers of panels could be placed, the structure was susceptible to movement. As of the date of this report, the joint has experienced no further distress.

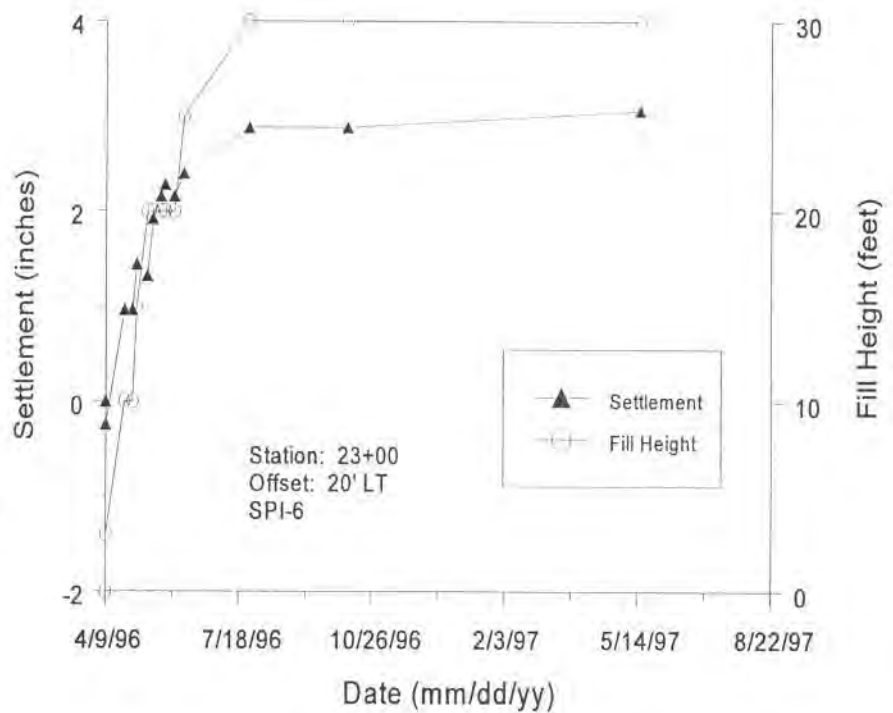
Figure 10. Typical Type I Settlement Platform Results

The results of the measurements at each instrument location were plotted against time and fill height. A typical graph of the data taken on Type 1 stand pipe settlement platform, SPI-6, is shown in Figure 10. Using equations proposed by Cheney¹, predicted settlements were calculated using soil data from standard penetration borings, field density tests, and the embankment geometry at the completion of construction. These results are presented in Table 2. In general, correlation of the calculated settlement with measured values from the Type 1 platforms is considered quite good.

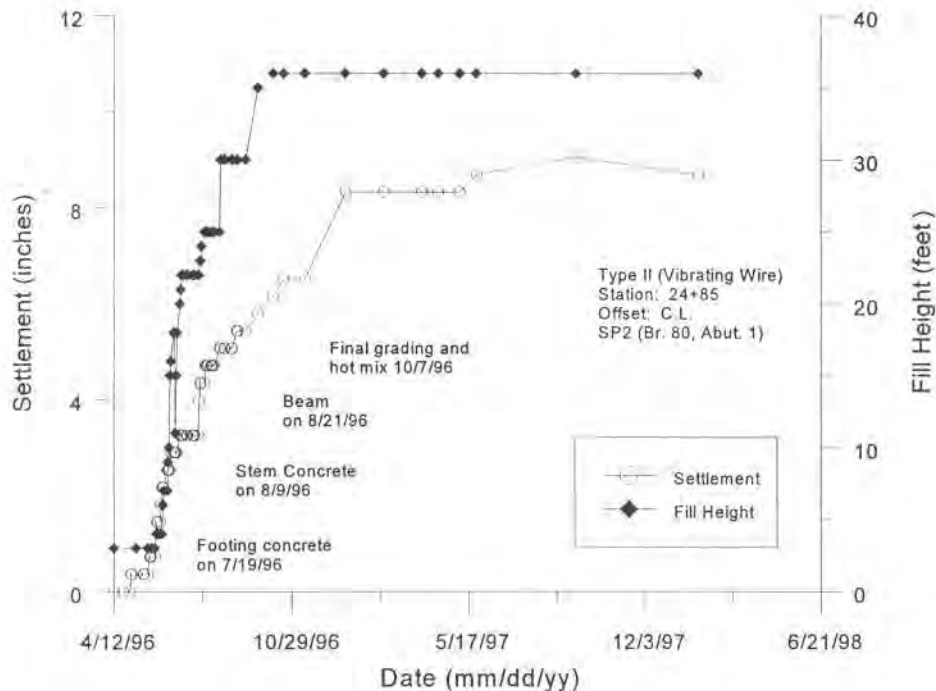
Figure 11. Typical Vibrating Wire Settlement Platform Results

In areas where the Type I settlement platforms would interfere with traffic or the placement of the concrete made it difficult to maintain the standpipes, vibrating wire settlement platforms supplied by Geokon Incorporated were installed to monitor elevation changes remotely. Vibrating wire pressure transducers lowered into boreholes were attached to reservoirs and settlement plates at the ground surface via fluid filled tubes. As the settlement plates move with the ground surface around them during construction, the transducers sense the change in fluid head in the tubes and provide a measure of the difference in the elevation between the reservoir and the sensor. Via an electric cable running from the sensor to a remote readout location, the vibrating wire settlement platforms were monitored periodically with a Model GK-401 Readout Box and the data plotted against time and fill height as shown in Figure 11.

Results of measured values taken from the vibrating wire settlement platforms also correlated quite well with predictions made using the methods proposed by Cheney as shown in Table 2.

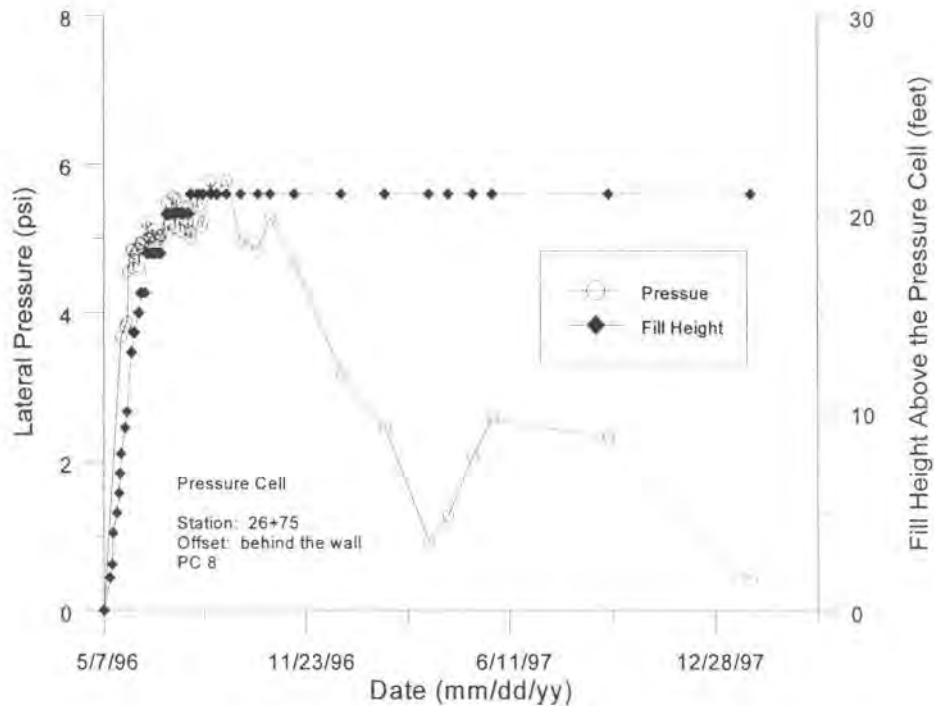
Figure 13. Typical Horizontal Earth Pressure Cell Results

Lateral pressure readings tended to be much more erratic than the vertical measurements and generally dropped off after several months of monitoring. It is not known if this is due to a gradual failure of the instrument, a bridging effect in the soil or a general loss of soil to cell contact due to panel movement. A typical example of this tendency is shown in the plot in Figure 13.

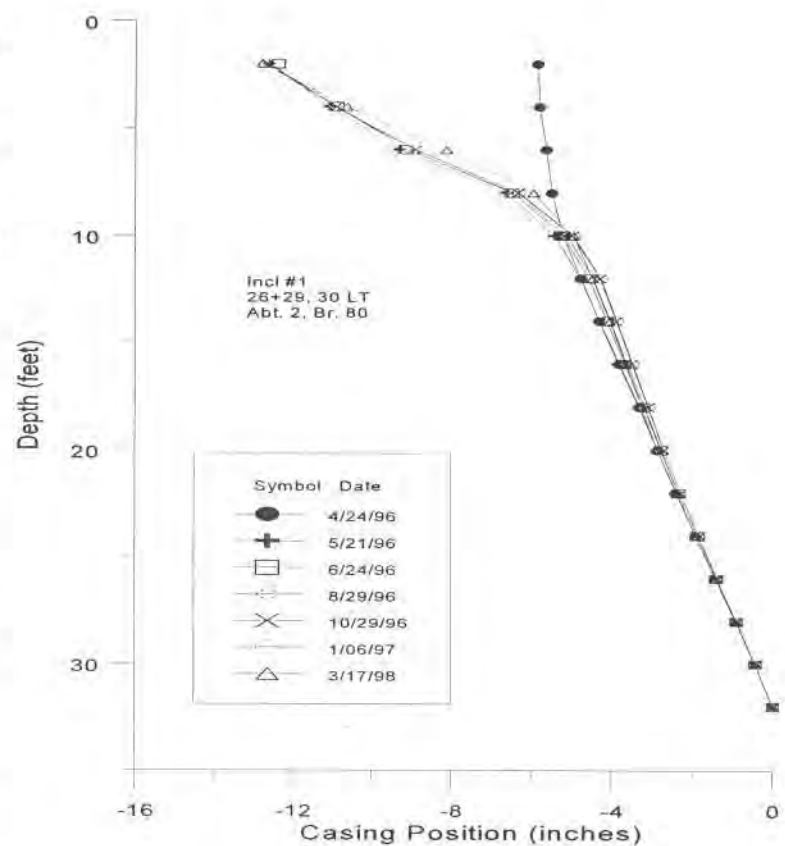
Figure 14. Inclinometer Results at Base of Wingwall 3

Graphs depicting the deviation of the casing with depth were updated as the data became available. Shown in Figure 14 is a plot of the cumulative deviation in the casing installed at the base of wingwall number three referenced to a fixed point at the bottom of the casing. The initial readings taken on April 25, 1996 indicate the casing was out of plumb by approximately five inches. Prior to construction of the leveling pad, the upper five feet of the casing was left unsupported which accounts for the large lateral movement to that depth between the first two sets of readings. Following the May 21, 1996 set of readings, no appreciable movement was detected at the base of the wall.

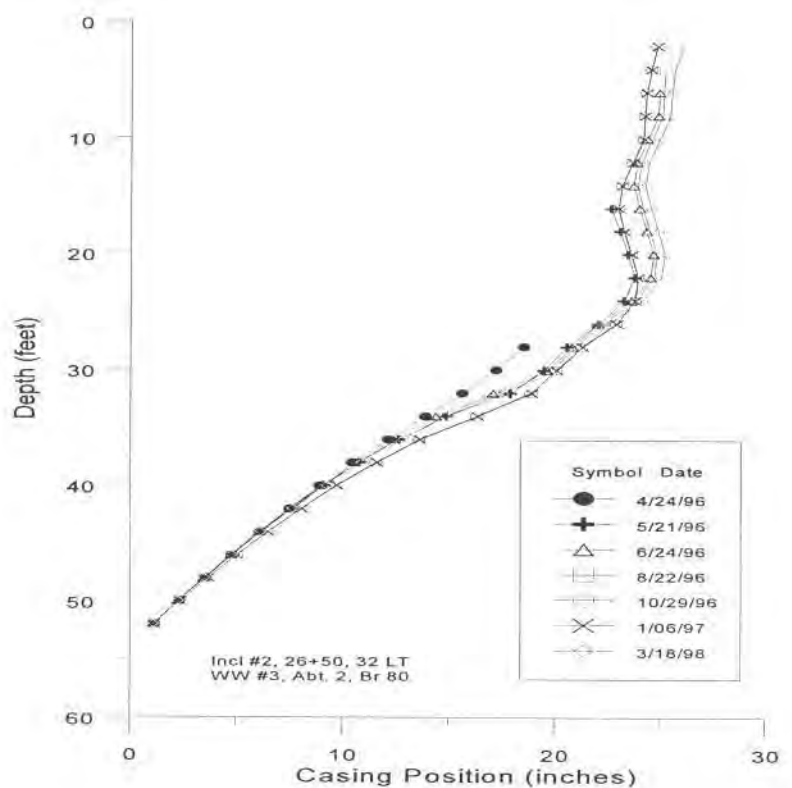
Figure 15. Inclinometer Results Behind Panels in Wingwall 3

As the MSE wall was constructed, additional sections of inclinometer casing were attached and embedded in the select backfill behind the wall facing. Presented in Figure 15 are the results of readings taken at Inclinometer 2 (Incl-2) as the fill was placed. This inclinometer was installed approximately 20 inches out of plumb. The two inches of displacement recorded at the top of the casing between the initial set of readings taken on April 4, 1996 and the next set on May 21, 1997, were due to the compaction of the initial fill placement next to the casing. Further monitoring of the instrument indicates the top casing rotated out approximately 1.5 inches relative to the base of the wall or about 0.25 degrees.

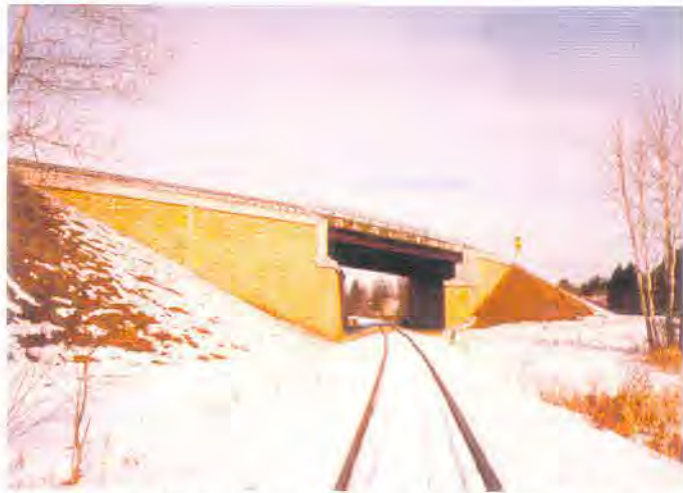
Figure 16. Completed MSE Abutment Walls

At present, the MSE abutment walls constructed on the Wallingford project are performing as expected and according to plans. The structure has been stable and no adverse distress has been found. If subsequent inspections show any significant findings, these will be reported in update reports.
