FINAL FIELD REPORT

U2017 - 07

Assessment of Super-Slab, a Precast Concrete Slab in a Bridge Approach Application

Bridge 8 Site Visit – VT 103, Chester VT

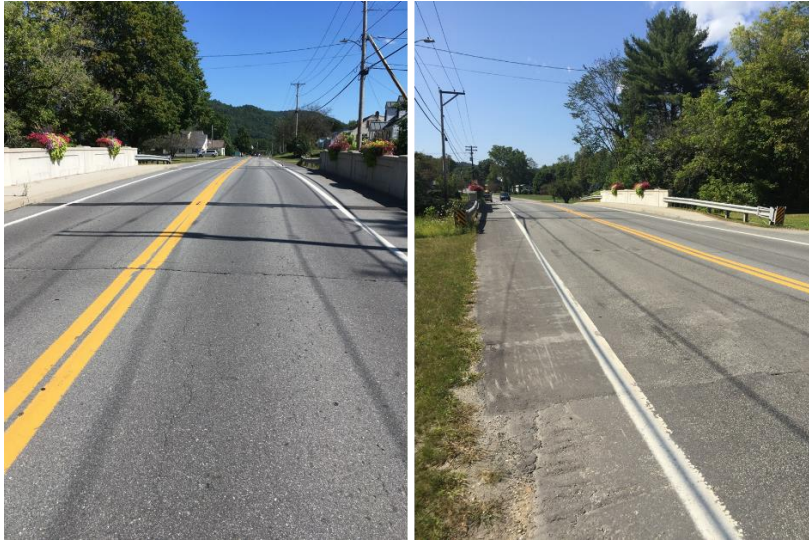
Overall views of Bridge 8 on VT 103, Chester VT. The left photo shows the west end of Bridge 8 looking towards the east, while the right photo shows the east end of the bridge looking towards the west.

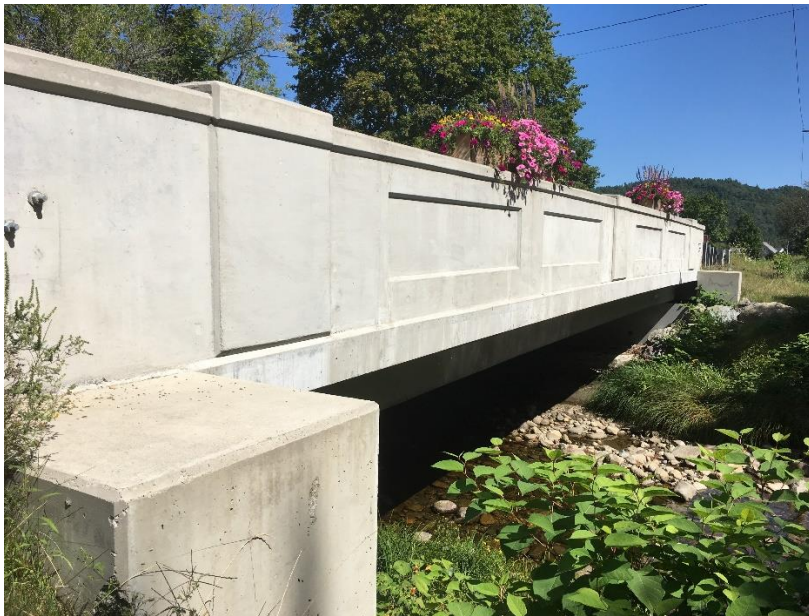
Side view of Bridge 8 from the west end looking to the east.

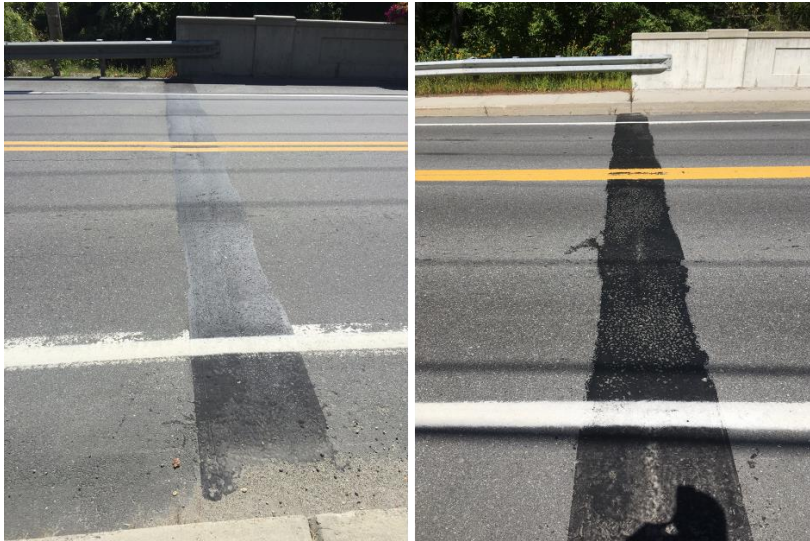
The photo on the left shows the bridge joint on the east end of the bridge, while the photo on the right shows the bridge joint on the west end of the bridge. The bridge joints were in good condition.

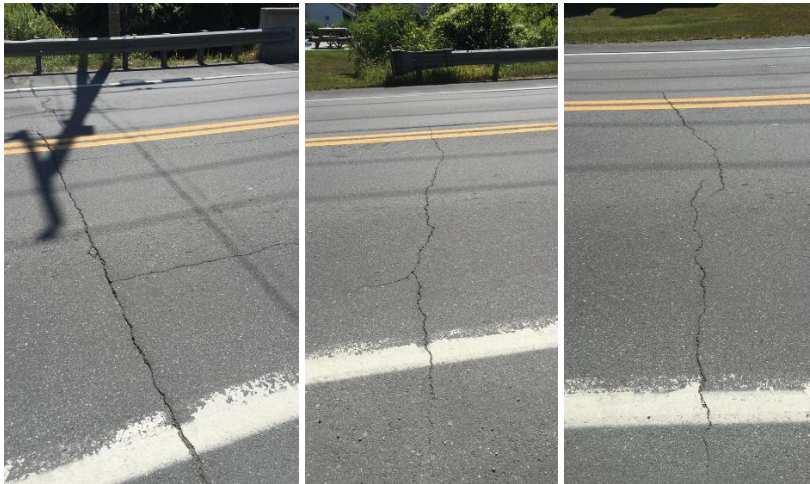
East end approach cracking. From left to right; 1st transverse crack (approximately 19ft from the east end bridge joint), 2nd transverse crack (approximately 39ft from the east end bridge joint) and 3rd transverse crack (approximately 59ft from the east end bridge joint). Two longitudinal wheelpath cracks (one for each wheelpath) were observed emanating from the 1st transverse crack on the westbound lane. A longitudinal crack was also noted emanating from the 1st transverse crack on the left wheelpath within the eastbound lane. No wheelpath cracking was noted on the eastbound lane near the 2nd and 3rd transverse cracks, but a small 2ft wheelpath crack was found on the westbound side near the 3rd transverse crack. It should also be noted that differences in the pavement (color) was evident approximately 60ft from the east end bridge joint.

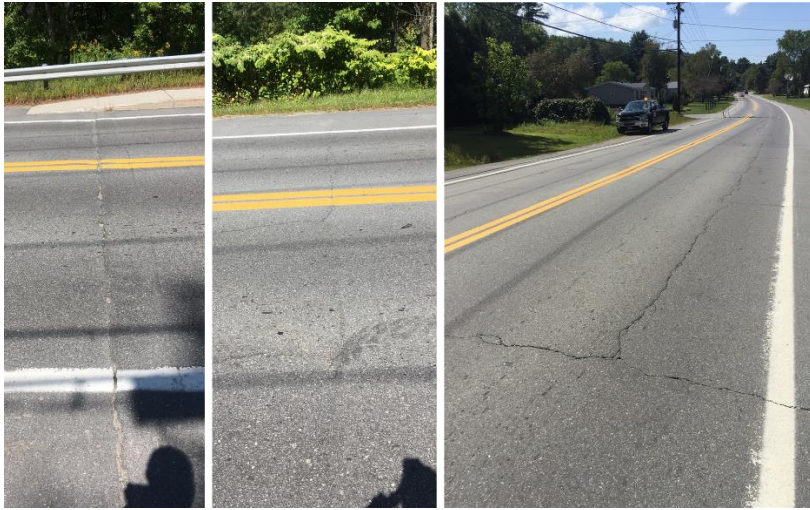
West end approach cracking. From left to right; 1st transverse crack (approximately 20ft from the west end bridge joint), 2nd transverse crack (Eastbound side) and 2nd transverse crack (Westbound side), both approximately 55ft from the west end bridge joint. On the eastbound side a 20ft longitudinal crack between the wheelpaths was noted connecting the west bridge joint with the 1st transverse crack along with small wheelpath cracking. Two wheelpath cracks that extended 8ft on the eastbound side (one on each wheelpath) near the 2nd transverse crack were also observed and can slightly be seen in the middle photo. An extensive wheelpath crack was also noted on the westbound lane near the 2nd transverse crack, seen in the far right photo.

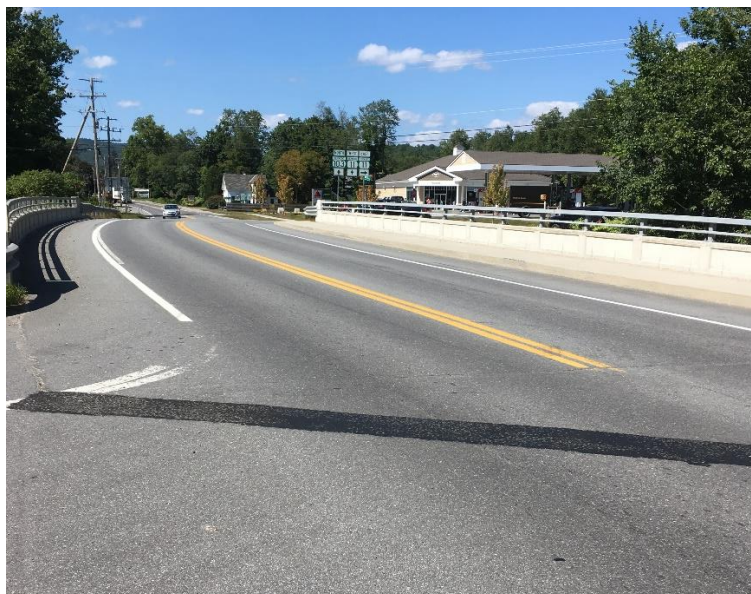
Overall view of Bridge 9 from the east end looking west on VT 103, Chester VT.

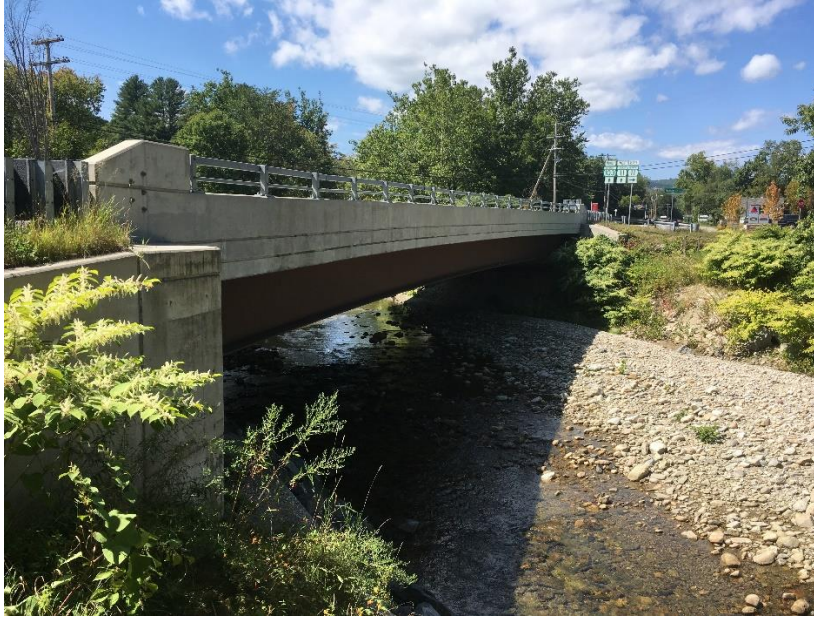
Side view of Bridge 9 on VT 103, from the east end looking to the west.

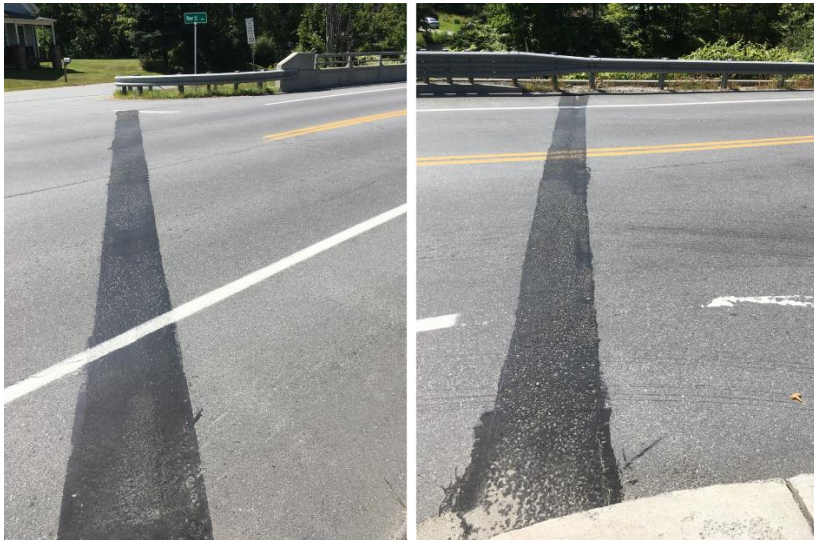
The photo on the left shows the bridge joint on the east end of the bridge while the photo on the right shows the bridge joint on the west end of the bridge. The bridge joints were in good condition.

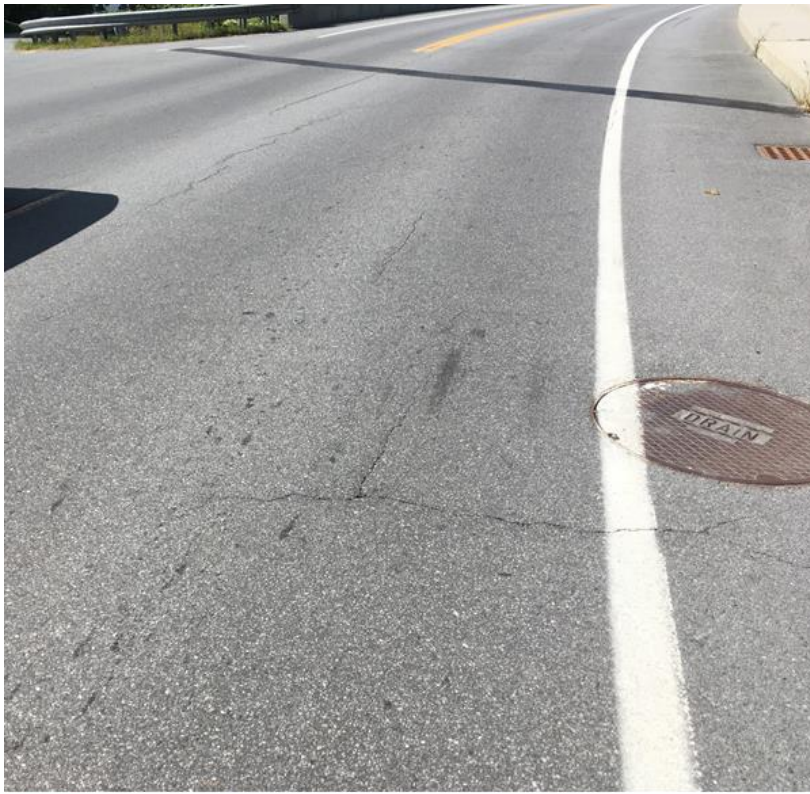
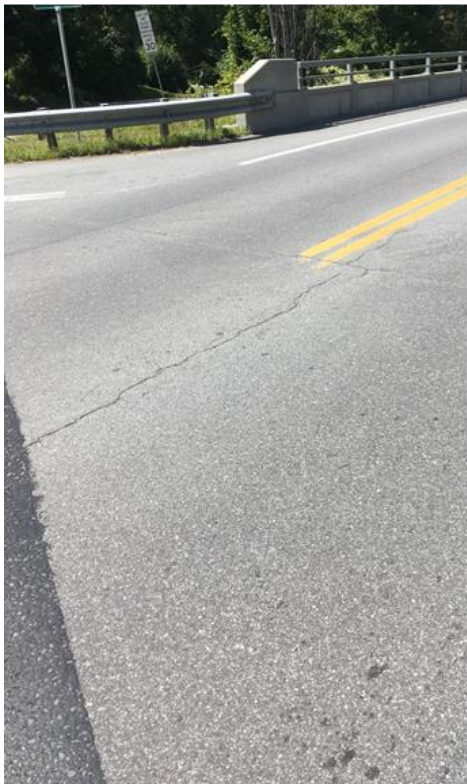
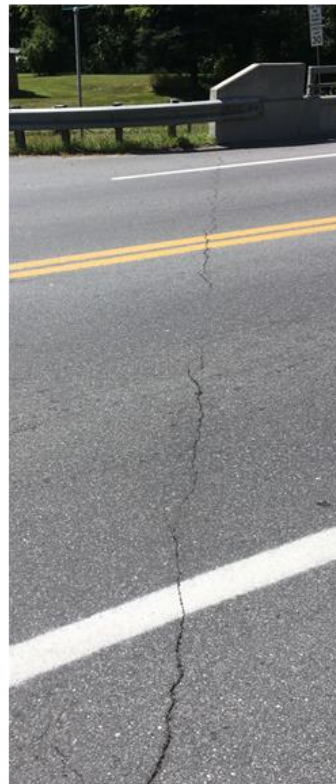
Bridge 9 east end approach cracking. The top photo shows both longitudinal and transverse cracking within the westbound wheelpath. The bottom left photo shows a 26 foot centerline longitudinal crack emanating from the east end bridge joint, while the bottom right photo shows a transverse crack across the width of the bridge approximately 19ft west of the east end bridge joint. A few wheelpath cracks were also observed on the westbound lane. Two of them were 4 – 5ft in length and one was 18ft in length. A 14 foot eastbound wheelpath crack emanating from the east end bridge joint was also noted. No other cracking was observed or noted on the bridge deck.

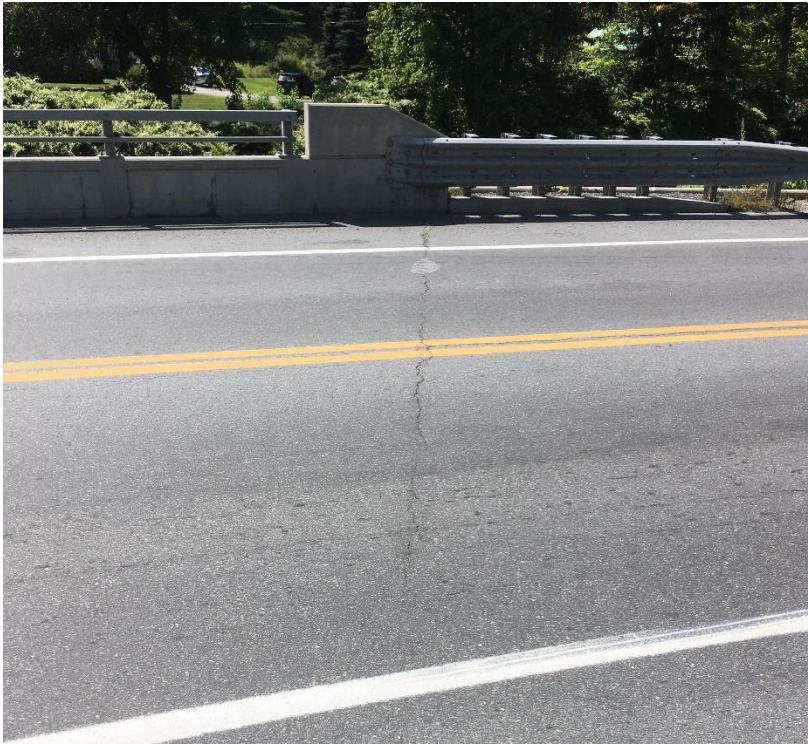
West end approach transverse cracking across the width of the bridge, 18ft east of the west end bridge joint. Wheelpath cracking, approximately 18 – 24 feet in length was observed extending from the west end bridge joint on the westbound lane. Smaller right wheelpath cracking was also noted on the westbound lane turning onto Pleasant Street. A Close-up can be seen below. No wheelpath cracks were found on the eastbound lane.

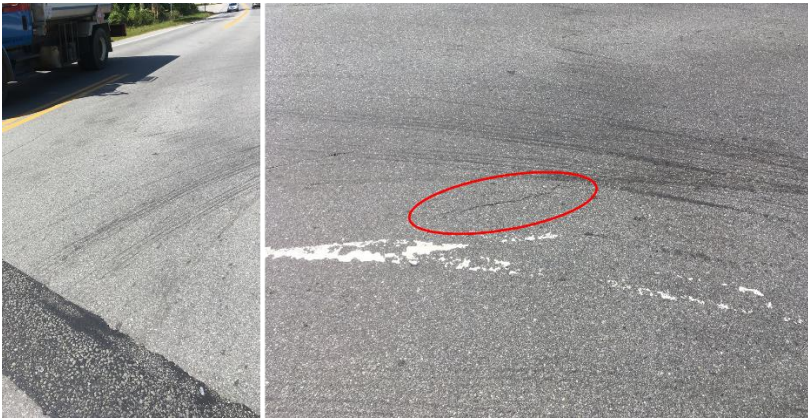
Close-up of west end approach cracking and wear within the wheelpath turning onto Pleasant Street. Three cracks were approximately 4ft in length and one was 11ft in length.
