**FINAL FIELD REPORT**

**U2017 - 09**

## **Assessment of Fiber Reinforced Polymer (FRP) Strips for Bridge Rehabilitation**

### **FRP Strips Site Visit – Bridge 98 on I-89, Swanton VT**

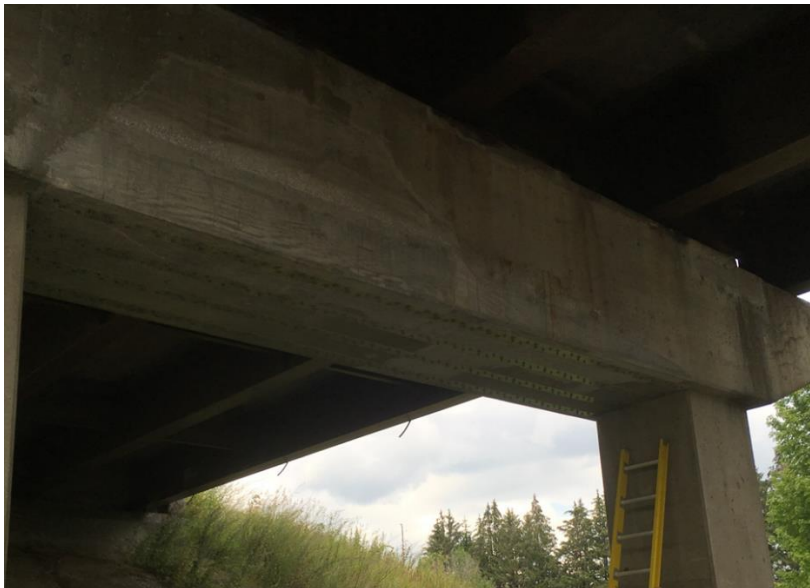
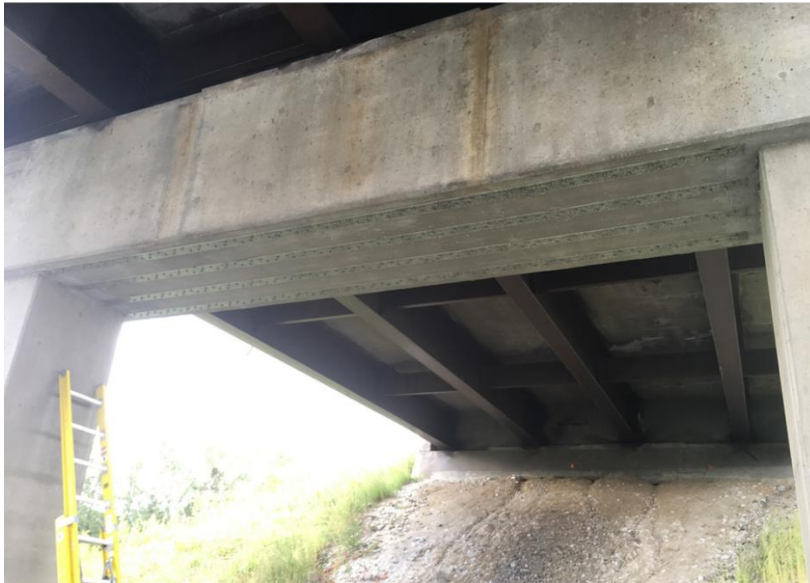
The top photo shows the overall view of the North end bent of the northbound lane of Bridge 98 on I-89 in the town of Swanton. The bottom photo shows the overall view of the South end bent of the northbound lane of Bridge 98. Four 4" wide x 1/8" thick FRP strips on the undersides of the bents can be seen in both photos.

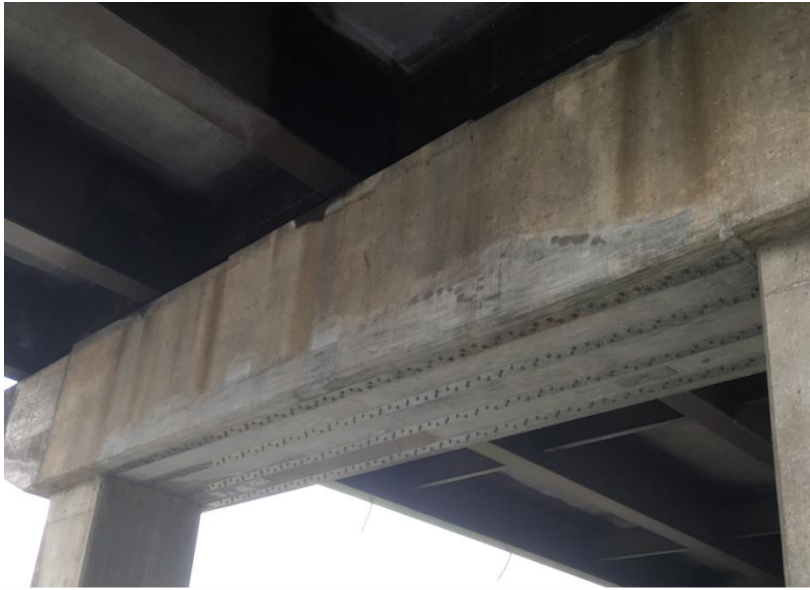
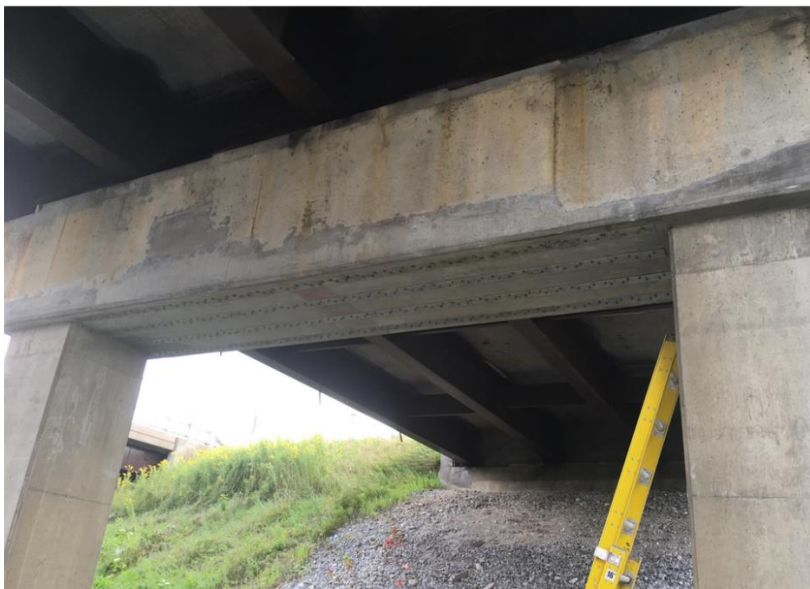
The top photo shows the overall view of the North end bent of the southbound lane of Bridge 98 on I-89 in the town of Swanton. The bottom photo shows the overall view of the South end bent of the southbound lane of Bridge 98. Four 4" wide x 1/8" thick FRP strips on the undersides of the bents can be seen in both photos.

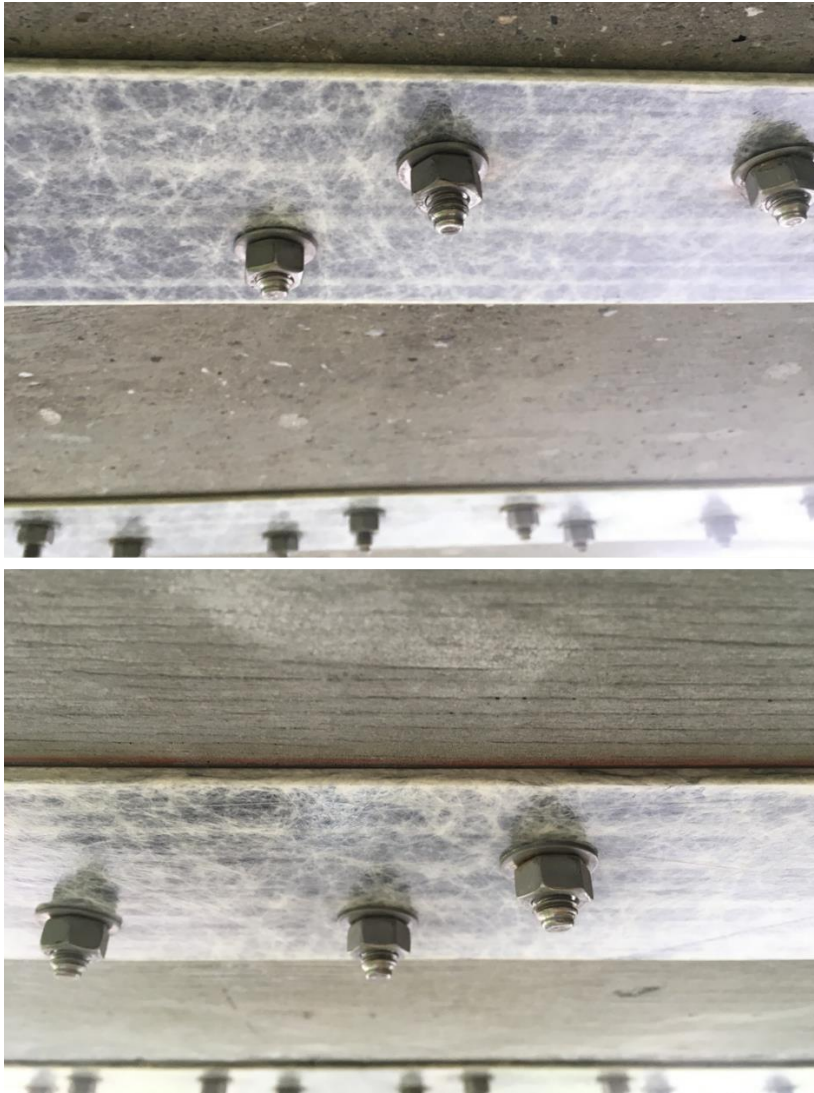
The top photo shows the close-up view of the East side of the South end bent on the southbound lane of Bridge 98. The bottom photo shows the close-up view of the East side of the South end bent of the northbound lane of Bridge 98. The photos show that there was no gaps between the FRP strips and the concrete. It should also be noted that no gaps were found at any of the 24 FRP strips on Bridge 98. The torque of randomly selected swedge bolts were tested to determine if vibrations or dynamic loading from bridge traffic had loosened the bolts. Eight bolts were selected at random per bent, four from each the west and east sides of the bridge bent. Bolts at the mid-span of each bent could not be reached due to not having a high enough ladder. The mid-span theoretically should be experiencing little to no movement or bending compared to the ends.

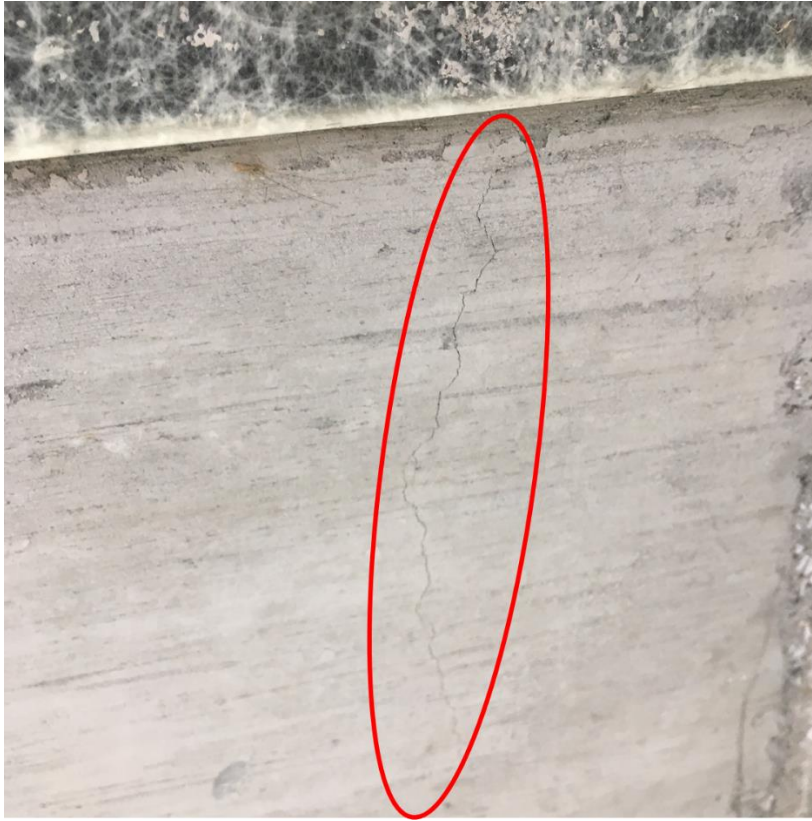
Close-up of a hairline crack near the East side of the North end bent on the southbound lane of Bridge 98. The crack was spotted between two FRP strips on the underside of the bent.

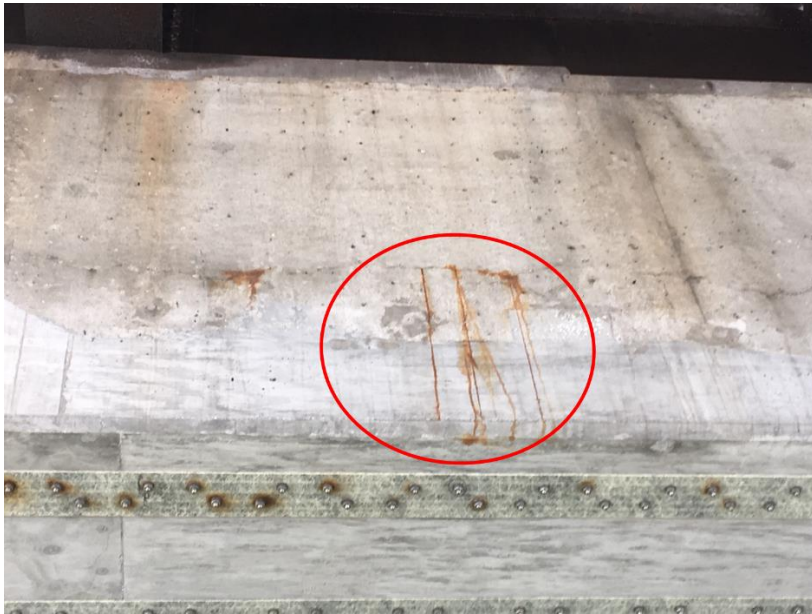
Close-up of a crack on the front face of the horizontal member near the mid-span of the North end bent on the southbound lane of Bridge 98. What looks like rust can be seen dripping out of the crack (seen within the red circle), which means that moisture has entered the crack and has started corroding the reinforcing steel within the concrete bent.
