POLICY, PLANNING, & INTERMODAL DEVELOPMENT DIVISION

FIELD REPORT

U2017 - 03

**Assessment of Bridge Deck Membrane (BDM) System
Bridge 165 VT 100, Warren VT**

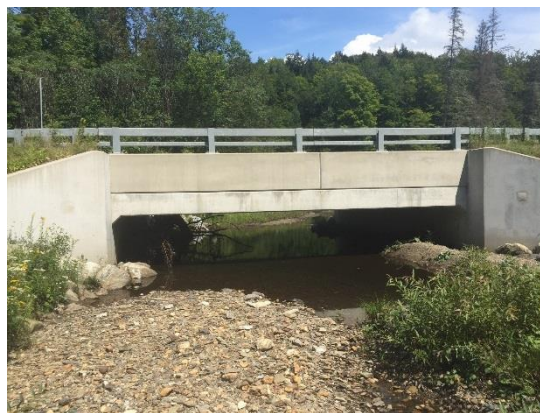
After the initial inspection of the surface pavement on bridge 165, a subsequent inspection of the underside of bridge was done. There was no evidence of the white material seeping through the bridge deck joints and cracks that was observed and noted during the [2016 site visit](#). The current inspection revealed no new cracks or leaking of the underside of the concrete bridge. The inspection did yield evidence of wood debris on the north side of the bridge, which can be seen in Figures 1 & 8.

**Figure 1: Overall View of Bridge 165 on VT 100, Warren VT.
Right side of the bridge**

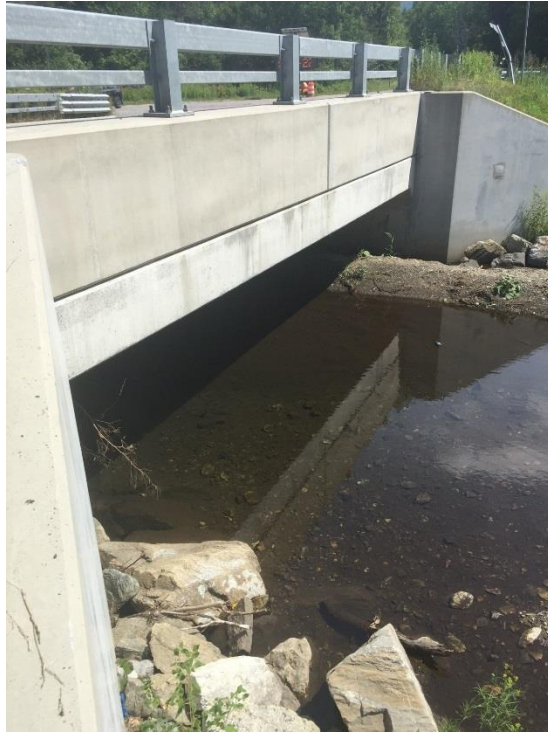
**Figure 2: Overall View of Bridge 165 on VT 100, Warren VT.
Right side of bridge facing south**

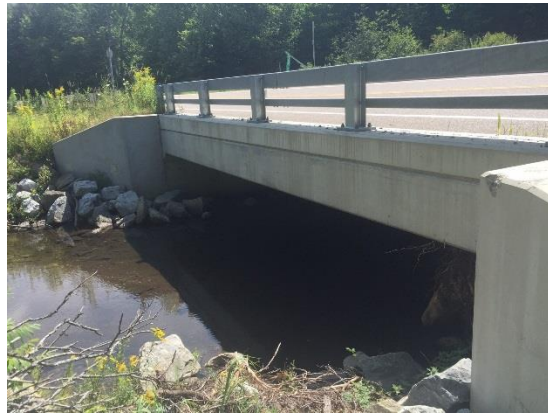
**Figure 3: Overall View of Bridge 165 on VT 100, Warren VT.
Left side of bridge facing north**

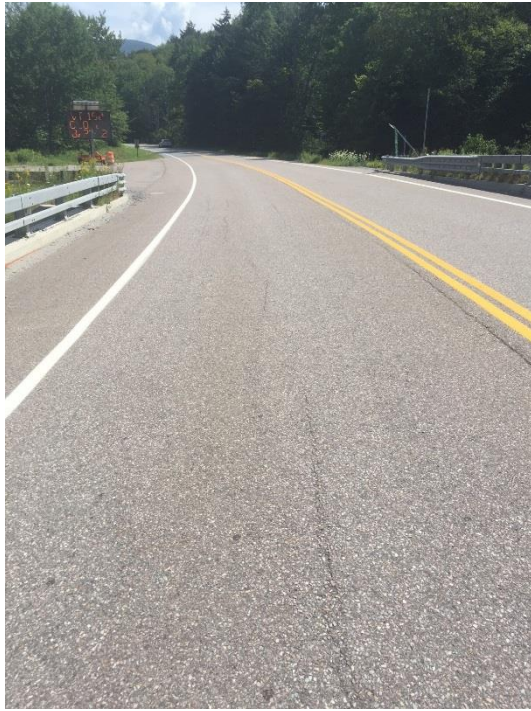
Figures 4 - 6 show longitudinal cracking on the bridge overlay. From the visual inspection and photographic evidence, the BDM has been working properly. The only signs of deterioration are several longitudinal cracks on the pavement surface. As previously stated in the 2016 field report, I observed and monitored the longitudinal cracking occurring in the surrounding asphalt overlay, again emphasizing the fact that the cracking could be attributed to the material properties of the asphalt overlay and not the bridge deck membrane. This year’s site visit showed the single

Figure 4: Overall view of bridge overlay. Side view looking south.

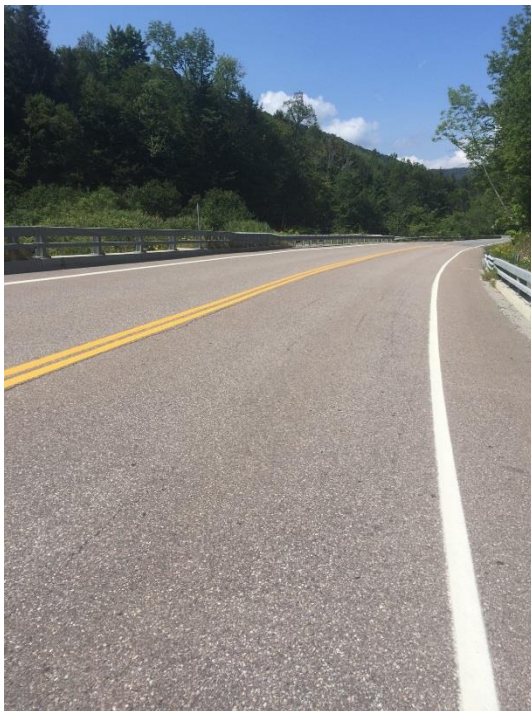
Figure 5: Bridge Overlay, looking north.

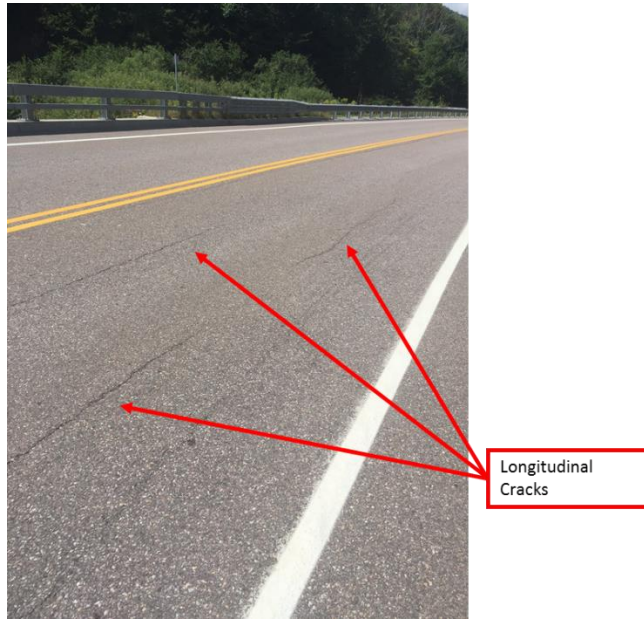
longitudinal crack on the southbound lane and eight longitudinal cracks on the northbound lane. The crack on the southbound side was located on the south end of the bridge, in the center of the wheel path, and was approximately 12ft long. On the northbound lane there were; two cracks in the wheel path and one between the wheel path on the southern end of the bridge that were approximately 2 – 3ft long, three cracks near the mid-span of the bridge within the wheel path that were approximately 9, 12 and 15ft long and two cracks on the north end of the bridge in the center of the wheel path that were 6 and 12ft long. The centerline crack that runs the whole length of the bridge was again evident and can be seen in Figure 4. To be certain that the membrane was in good condition and is not contributing to the surface cracking, core samples through the surface overlay and into the concrete deck, full deck ground penetrating radar (GPR) scans or an overlay replacement would have to be conducted. The annual site visits have shown photographic evidence of the BDM (Figure 7) and the progression of the longitudinal cracks on the pavement surface (Figure 6).

Figure 6: Longitudinal cracks on northbound lane

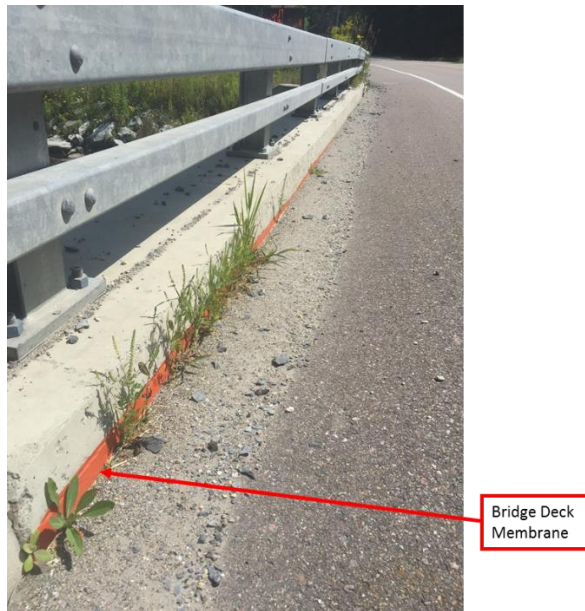
Figure 7: Bridge deck membrane

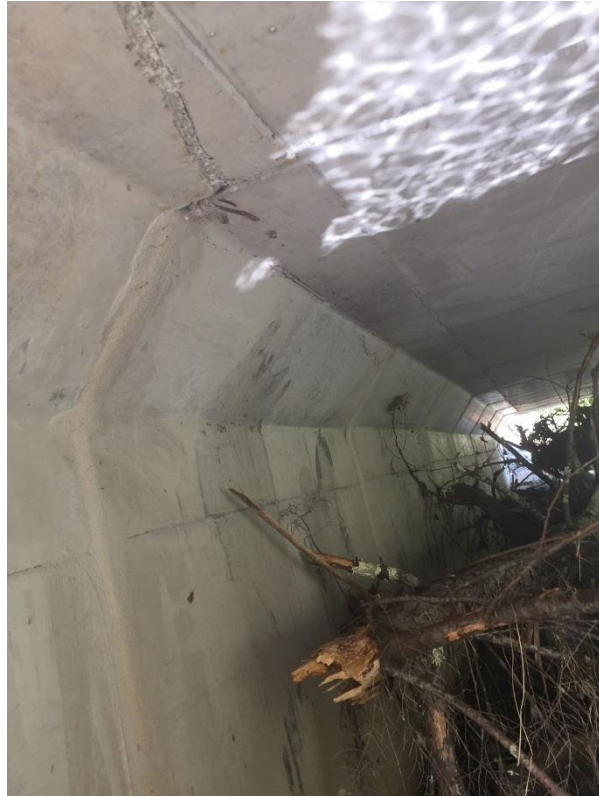
Figure 8: Bridge underside with debris
