REDUCING REPEAT DAMAGE OF VERMONT'S ROADS & STRUCTURES

MAP-21 Part 667 (National Highway System)

*Submitted to FHWA November 19, 2018
Minor revisions December 13, 2019*

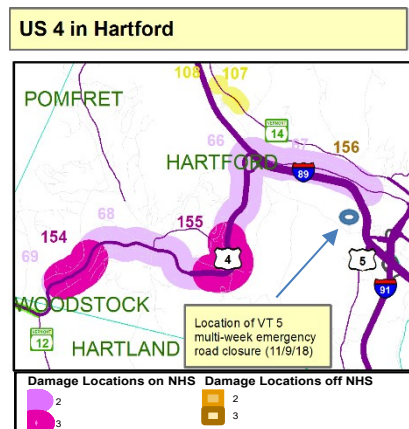
Location 1: US 4 in Hartford

There are only two locations on the Vermont NHS that have been damaged in three different emergencies. These two locations (shown in dark purple), plus others with two DDIRs, are on an approximately 10-mile section of US 4 that is mainly in Hartford but also Woodstock and Hartland. This section also includes a highly vulnerable section of road. A current event that may be of interest is the nearby closure of US 5 for culvert failure. There are also nearby overlapping DDIRs off the NHS on VT 14 (shown in yellow).

District agrees with the assessment of US 4. Some permanent repairs were made to the damaged locations. Many of the US 4 problems are due to the steep slope on the highway. There are locations on US 4 that could become problematic in the future. These have not been funded.

- Further review DDIRs and district needs
- Gain understanding of what has been done and what is planned
- Monitor and maintain asset until a project is programmed to make a lasting permanent repair. Make temporary repairs to the extent financially possible for the District's funds (band aids). Most of these are already identified on corridor needs map. Capture the ones not identified.

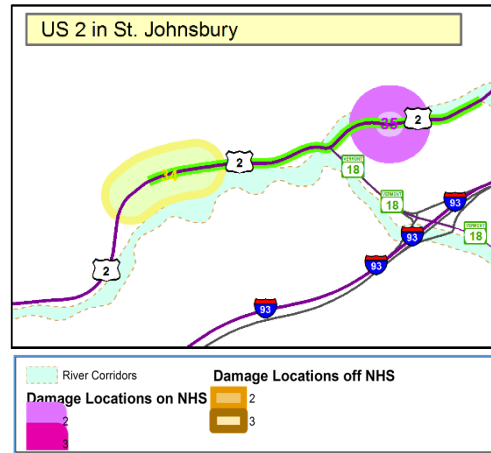
Location 2: US 2 in St. Johnsbury

There are two overlapping DDIRs on the eastern NHS part of VT 2. Less than a mile away there are also two DDIRs on the non-NHS western part of VT 2 (shown in yellow). The NHS section of VT 2 has relatively high use (close to 5,000 AADT) and is important for its location near the interchange with I-93.

This location is a continued issue whether there is a storm event or not. Mid-winter and spring thaws cause slope failure and plugs the drainage infrastructure within this section of US 2. District 7 continues to inspect and maintain drainage throughout the year. This section of US 2 has been on our District Needs list and is a high priority.

On the non-NHS side, the retaining wall on the side of the road away from the river was recognized as deteriorated years ago. Fixing it would take funds but not be difficult. There are likely similar problems now on the eastern (NHS) side. Design has previously been explored but not completed due to other priorities for the funding available. There are issues on the upslope and probably also river side of the road. Implications downstream should be considered in work in this location.

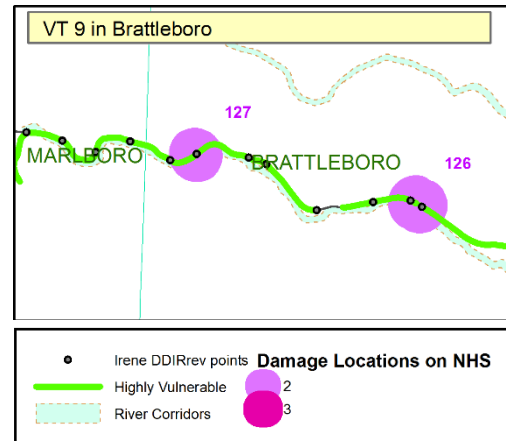
Location 3: VT 9 in Brattleboro

Analysis identified two locations on this corridor each with two DDIRs. Further research clarified that the damages were all from the Tropical Storm Irene event. This remains a corridor of concern with 12 DDIRs (available) from that storm within approximately 2 miles. The issues are primarily vulnerable road embankments although there are also moderately vulnerable culverts and bridges based on analysis for a FEMA Pre-Disaster Mitigation (PDM) grant application underway for submittal by January 4, 2019.

This stretch of corridor has had repeated damage both which has qualified for federal relief, and smaller state funded response. Some location in this corridor have been addressed, but this stretch of highway needs to be looked at as a larger project. The geometry of the road generates conflict with the adjacent Whetstone Brooke. These areas need to be addressed or failures will continue.

District notes there is a range of potential fixes ranging from small slope repair to creating resilient infrastructure to full scale road realignment and/or stream relocation.

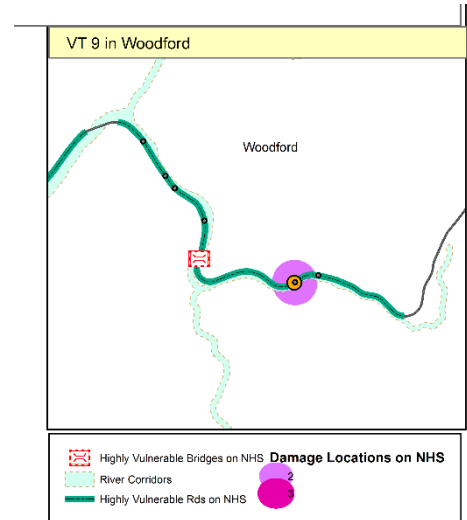
Location 4: VT 9 in Woodford

There are two overlapping DDIRs and approximately a mile away is a highly vulnerable bridge. There are six additional single DDIRs in approximately two miles of the location. River corridors come together in this vicinity and the district notes 60' cliffs with rocks falling from them.

Generally, a difficult and vulnerable corridor, but need to explore if the specific location of one of the DDIRs was remedied. The biggest repair work in this area is around the larger bridges at the bottom of the hill.

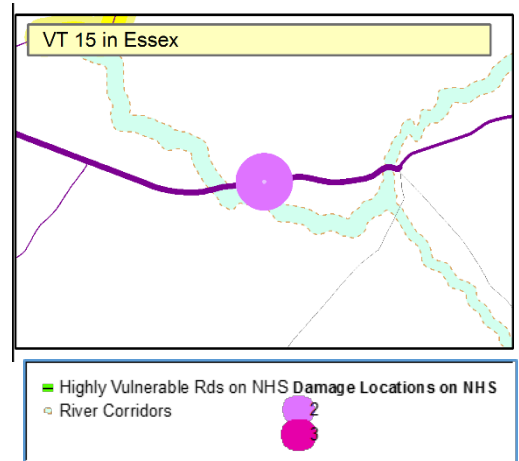
This is Unique ID 39 in analysis. The buffers for the two DDIRs only overlap slightly. Another set of DDIRs was showing just to the east (ID 40) but seems to have been a messy data issue. There is a lot of surface water and a stream corridor connecting VT 15 and the non-NHS VT 128 sections to the north where there have been multiple DDIRs. This may be a lower-priority location than others.

This area was damaged in 2011 and 2013. Explore if there is a problem with slope pipe installed as raised by district staff.

Fixing the small area with two slightly overlapping DDIRs should be coordinated with surrounding single DDIRs and the stream corridor to avoid future damages.

- Explore district comments about potential nearby repair that didn't hold up
- Review road with stream corridor and surface water layers

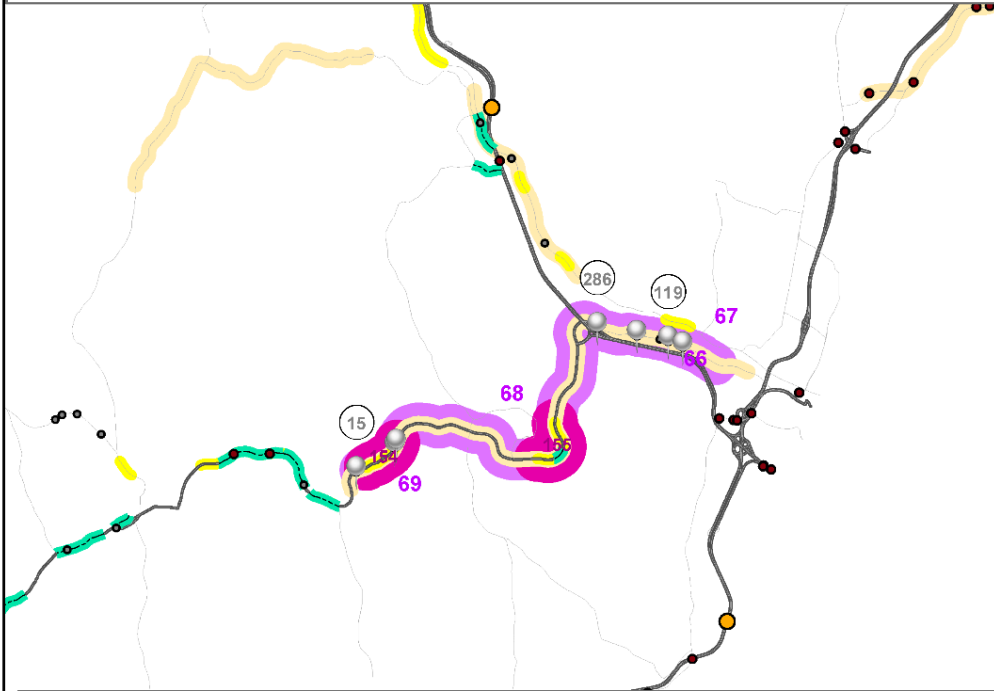
Review Areas 66, 67, 68, 69, 154, 155 with District Needs

FID	BeginMM	IssueCateg	IssueDescr	EstimatedC	WorkType	FailurePro	FailureImp	RemainingS	AssetID	LastEditDa	Completion	OBJECTID	Top2Prior
15	0.4378	Culvert	pavement edge, slope, culvert issues. very deep old stone culverts drainage failed bottomed out. these issues run the stretch of tafsville to white river junction	0					31504			40	0
119	0	Culvert	70' Deep stone box culvert - stones missing from roof of culvert - beginning to fail	500000						2016-12-16		280	0
253	0	Culvert	3 stone box culverts caving in/outlet failed	1000000	Capital Project					2016-12-29		585	0
286	6.51	Pavement	bump in road from trucks, what can we do to prevent this, has been fixed once	25000						2016-12-28		659	0
423	0	Slope	2 failed stone retaining wall - remove wall, slope bank back and install stone on slope	36000	District Forces					2016-12-29		990	0
1358	0	Culvert	Sinkhole in shoulder	0	District Forces	Very High	Very High	0-1 years		2017-04-28	2017-11-30	39530	0

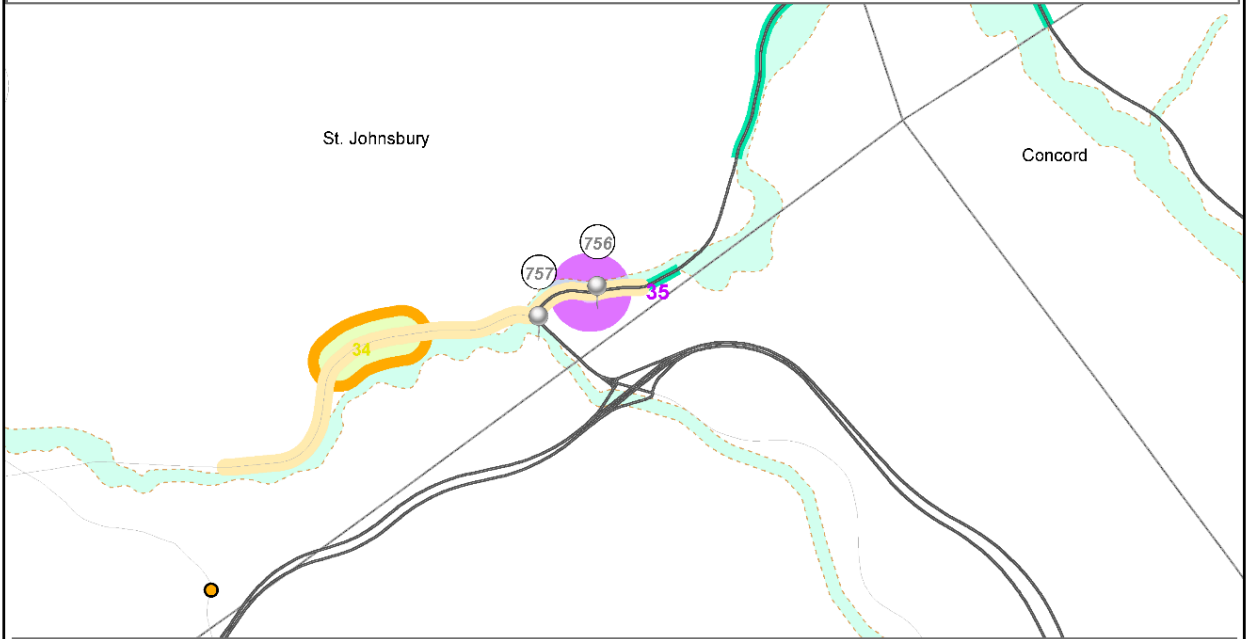
District 7 US 2 Area in St. Johnsbury Review Area 35 with District Needs

FID	Route	BeginMM	EndMM	ProjectLen	Owner	IssueCateg	IssueDescr	Action'sTak	ActionsNee	EstimatedC	Source	Top2Priori	last_edt_1
756	U002	6.7	7.1	211	HVY MCB Maintenance Lunenburg	Slope	Failed slope, retaining walls, and poor drainage. Drainage gets filled in with sediment from slope and above field constant maintenance issue, ice and sediment. Moose River is located adjacent to route 2 and slope.	Phase 1 - There were plans drawn for this section of wall that were not completed.	Area is not a viable district project, contract out.	3000000	Alex Nicholson 02/01/17	0	2017-07-19
757	V018	0.2259	0.2259	713	HVY MCB Maintenance Lunenburg	Slope	Retaining wall replace part of corridor need ID 44.	None	Issue could be combined into a all encompassing St. J. slope rehabilitation project. Replace 713' of retaining wall and associated under rail grade as necessary.	0	Alex Nicholson 02/07/17	2	2017-07-19

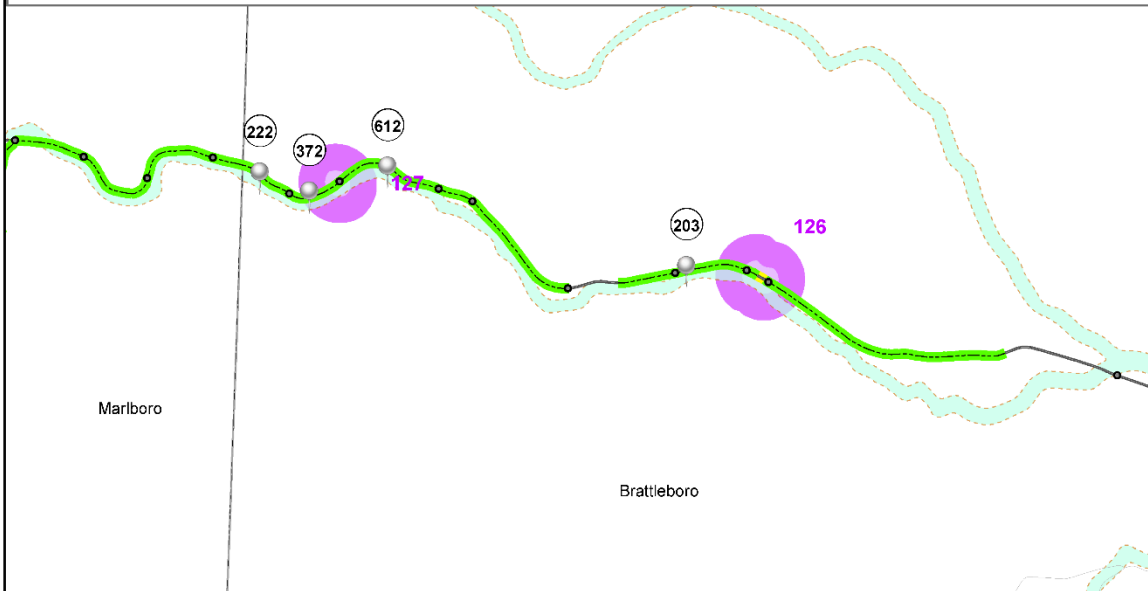
District 1/2 Area VT 9 Area in Brattleboro Review Areas 126 and 127 with District Needs

FID	BeginMM	District	Owner	IssueCateg	IssueDescr	ActionsNee	EstimatedC	WorkType	FailurePro	FailureImp	RemainingS	LastEditDa	OBJECTID
203	1.809	1	HWY MOB Maintenance Wilmington	Culvert	Place new culvert and new DI	Place new culvert and new DI	0	District Forces	Low	Low	5-10 years	2016-07-21	464
222	0.09	1	HWY MOB Maintenance Wilmington	Slope	Irene Site never repaired (river work)	river work	0					2016-07-21	519
372	0.281	1	HWY MOB Maintenance Wilmington	Ledge			0						870
612	0.6	1	HWY MOB Maintenance Wilmington	Other	Stream Bed armory	Stream Bed armory	30,000		Med	Med		2016-07-21	1405

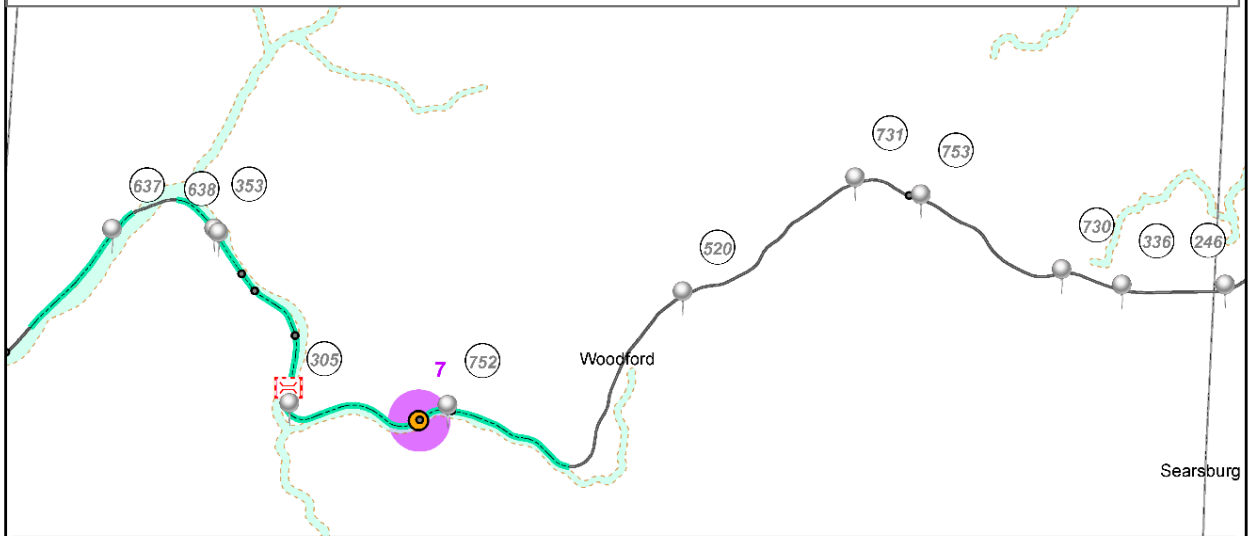
District 1 VT 9 Area in Woodford Review Areas 7 with District Needs

FID	Route	BeginMM	EndMM	Owner	IssueCateg	IssueDescr	ActionsTak	ActionsNee	EstimatedC	FailurePro	FailureImp	RemainingS	LastEditDa	Completion	OBJECTID
305	V009	2.86	2.95	HWY MOB Maintenance Bennington	Ledge	60ft cliff, rocks failing		secure cliff ledge	300,000	Med	High	3-5 years	2016-07-20		715
353	V009	1.74	0	HWY MOB Maintenance Bennington	Slope	Unstable slope, erosion		stabilize slope	0	Low	Med	5-10 years	2016-07-20		815
637	V009	0.975	0	HWY MOB Maintenance Bennington	Culvert	PID 10007 - 18' Metal culvert in critical condition		new culvert	5,000	Very High	Low	0-1 years	2017-03-27	2015-09-30	5442
638	V009	1.789	0	HWY MOB Maintenance Bennington	Culvert	PID 10013 - 30' metal culvert in critical condition		replace culvert	10,000				2017-03-27	2016-10-03	5443
752	V009	3.878	0	HWY MOB Maintenance Bennington	Culvert	PID 10049 - 24' metal pipe - Critical at barrel and outlet	Full replacement. 24" HDPE with underdrain		15,000				2017-06-07	2017-06-02	5446

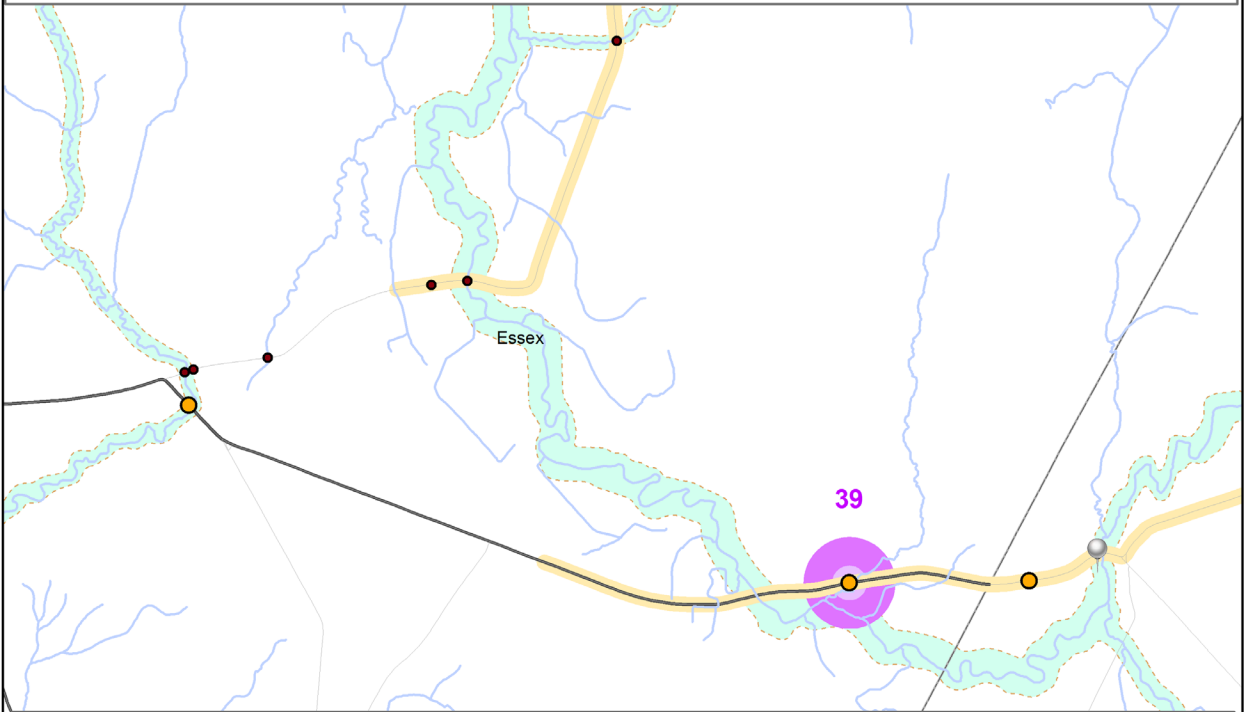
District 5 VT 15 Area in Essex/Jericho Review Areas 39 with District Needs

FID	Route	BeginMM	Owner	IssueCateg	IssueDescr	ActionsTak	EstimatedC	WorkType	FailurePro	FailureImp	Remainings	Detour	AssetID	OBJECTID	last_edt_1
1082	V015	0.3905	HWY MOB Maintenance Colchester	Culvert	Culvert PID 1836. Culvert is located between two Dis cannot see through culvert but there is a drop within the pipe.	None	20,000	Capital Project	Med	Med	1-3 years	20-30 miles	1836	917	2017-12-06
