PAVEMENT MARKING COMPARISON STUDY – US ROUTE 302 BIKE LANE MARKINGS

Ian Anderson, Research Engineer
Vermont Agency of Transportation
Research Section

November 2018

Final Report 2018-03

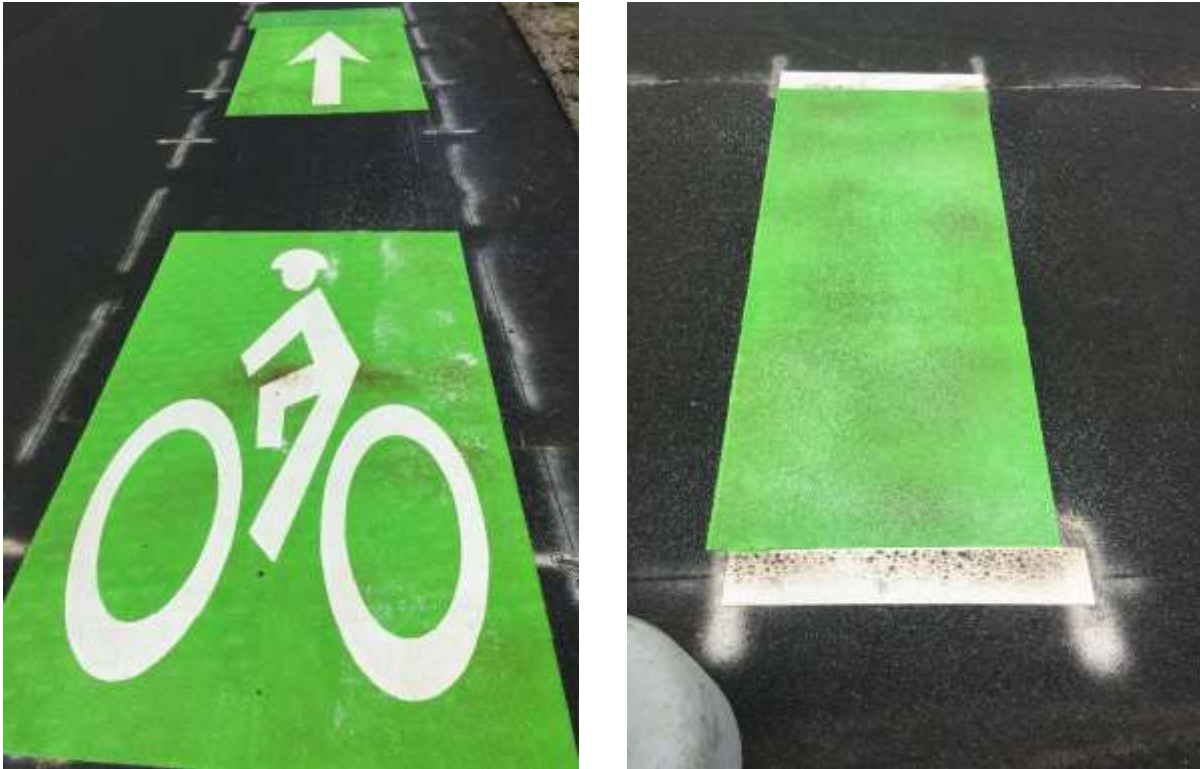
Figure 4: Burned PreMark

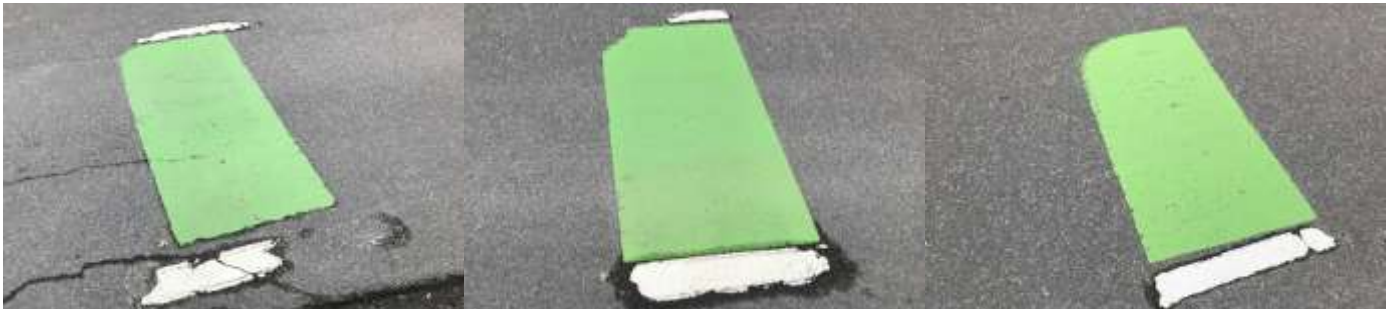
Figure 11: Location 1 PreMark in Good Condition

The first 8 skip marks and the first block are performing well and observed to be in good condition. Wear is occurring on the outside edge (nearest the traffic lane) but maintain nearly full shape. The leading edge of each is worn down, but none are chipping.

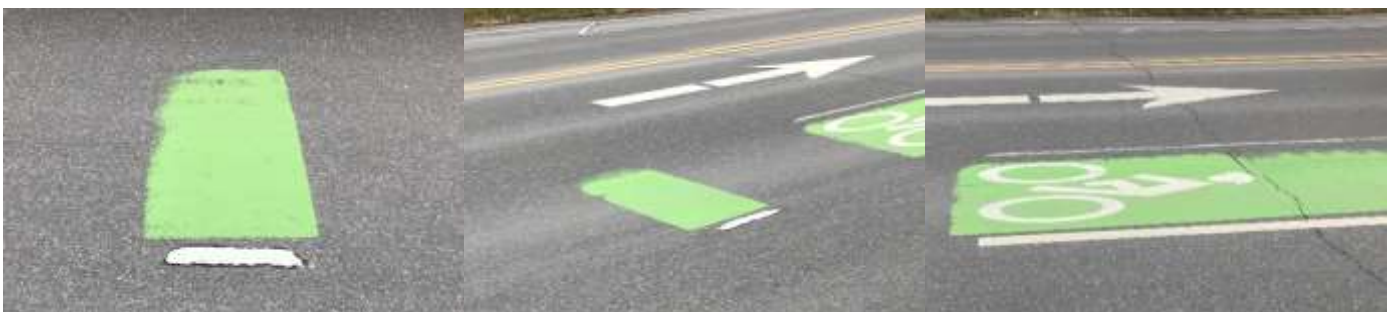
Figure 12: Location 1 PreMark in Fair Condition

The 9th through 12th, and 16th through 22nd skip marks are observed to be in fair condition, as is the beginning of the large block. Traffic wear has begun to affect the markings, with some spots of nearly full wear. No chipping is occurring, and the PreMark is well bonded to the pavement.

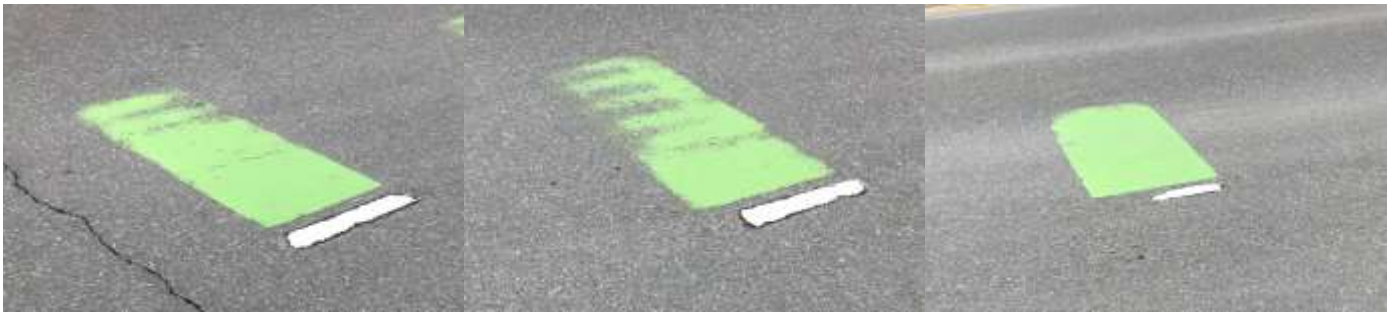
Figure 13: Location 1 PreMark in Poor Condition

The 13th through 15th skip marks are in poor condition. They have lost some coverage area, have worn fully through, and do not clearly define the bike lane. No chipping is occurring, all damage is from traffic wear.

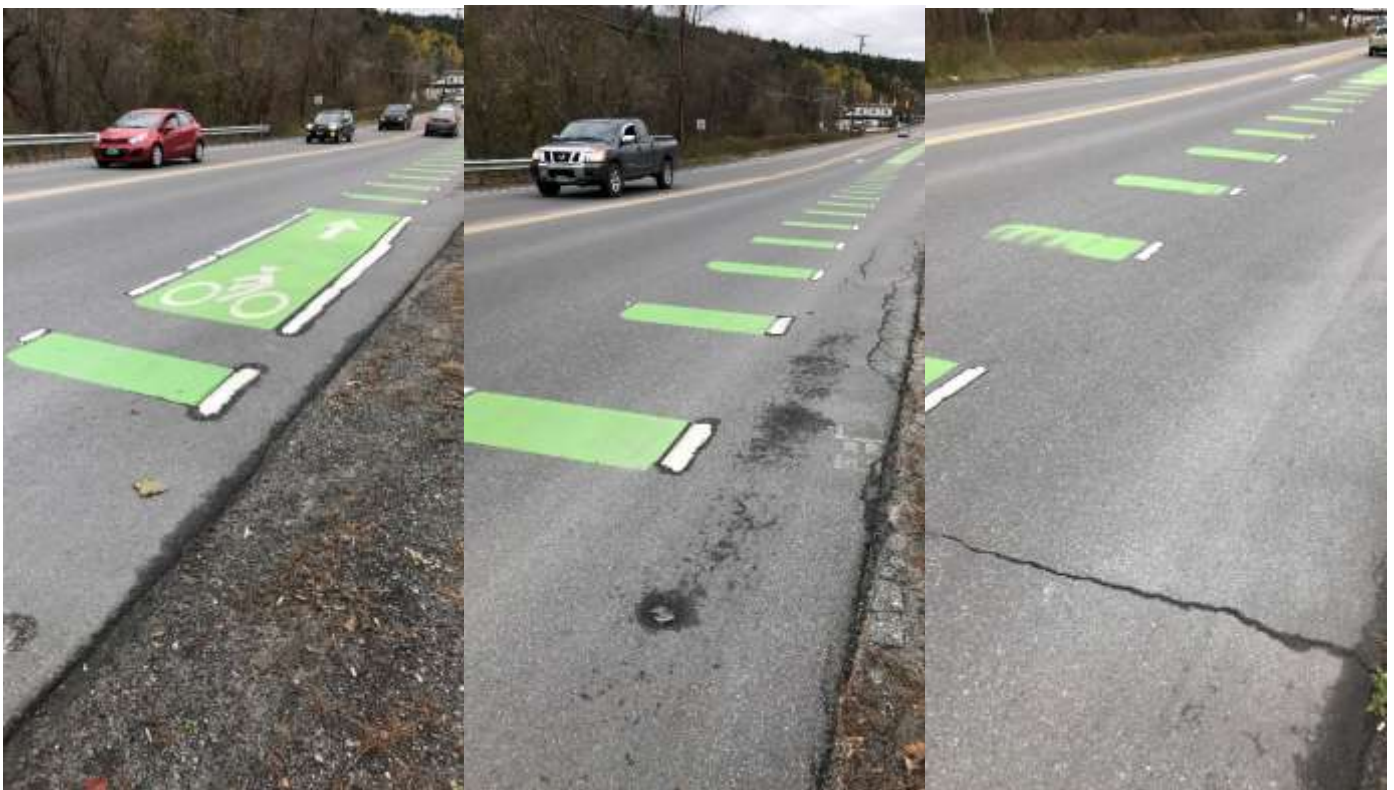
Figure 14: PreMark Condition Location 1

A broader view of the first PreMark section can be seen in below. Overall, the first PreMark site is performing well, with some wear at the places with the highest cross-over traffic. The PreMark is well bonded to the pavement, and seems to have no issue with differential expansion that may result in premature failure.

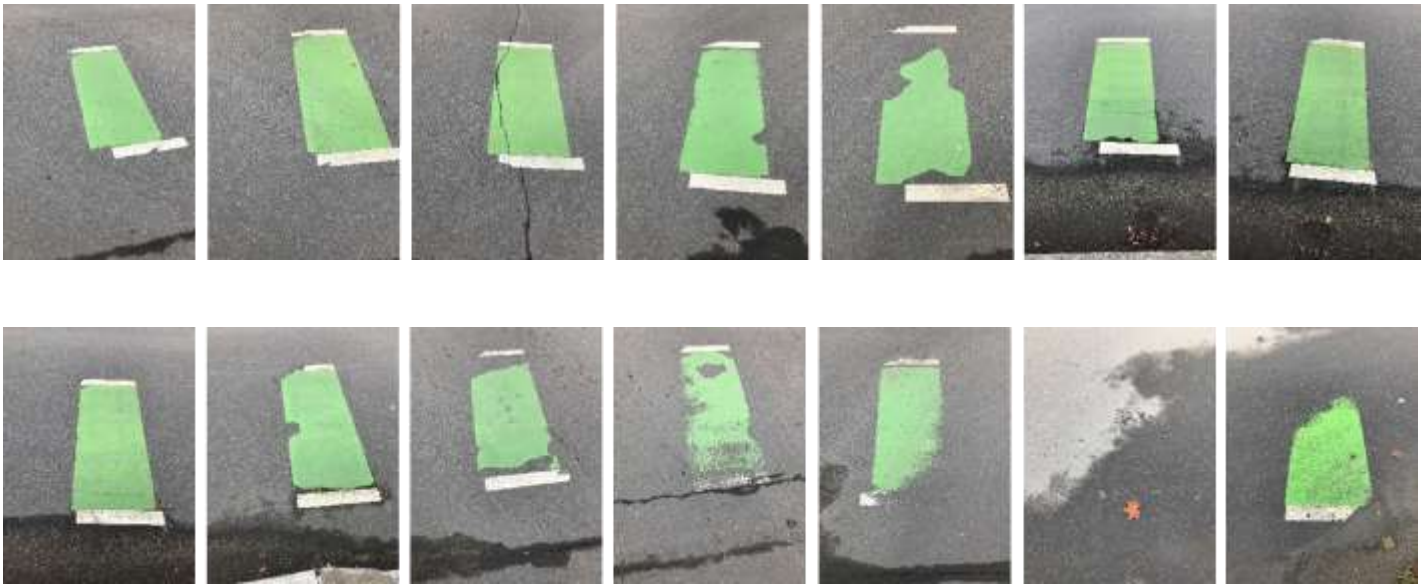
Figure 15: PreMark Condition Location 2

The second installation of PreMark can be seen in Figure 15. Of the 14 skip blocks, 6 are in Good Condition (1, 2, 3, 6, 7, 8), 2 are in Fair Condition (4, 9), 5 are in Poor Condition (5, 10, 11, 12, 14), and block 13 is Missing.

Several of the blocks are chipping, cracking, and delaminating, likely due to differential expansion with the pavement, and are easily removed. Several blocks show heavy wear, mainly blocks 11-14, which are located at the exit of the McDonalds, including block 13 which has been complete worn away. Overall, the PreMark installations in the second location are performing worse than the first location, and are the worst green markings in the study. Cracking and delamination are likely to rapidly deteriorate several of the blocks this winter, shown close up in Figure 16 below. The presence of moisture is indicative of a delaminating element, as the moisture in the voids is the last to evaporate post precipitation event, and further degrade the marking as freeze-thaw takes effect in the winter months.

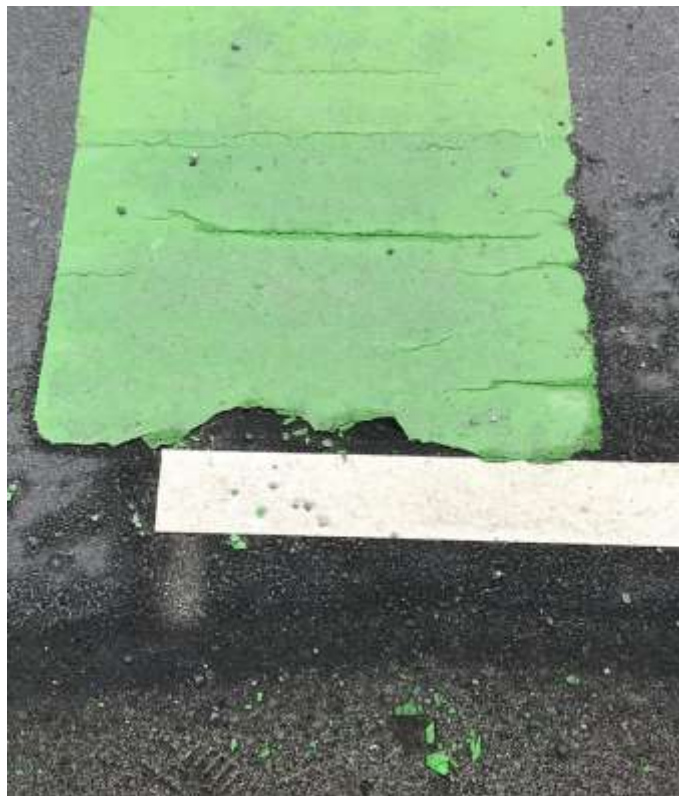
Figure 16: PreMark Delamination

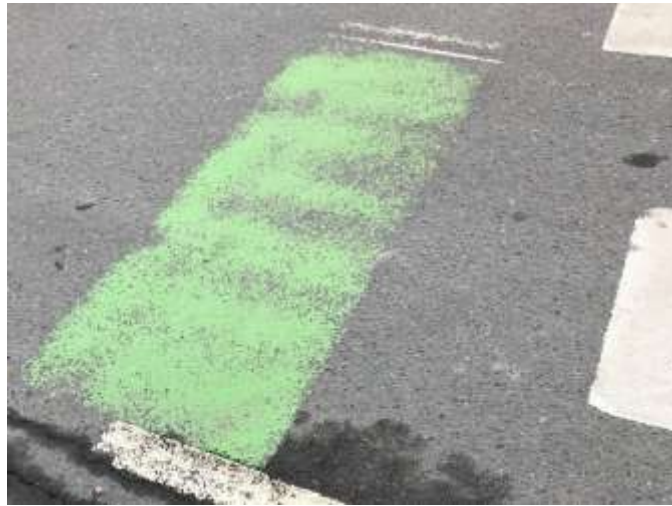
Figure 17: PreMark Condition Location 3

The third PreMark site, the lone skip on the opposite side of this road from the second, is performing poorly, as shown in Figure 17. The marking is very worn over its entire area, as a result of heavy turning traffic from those exiting to the right.

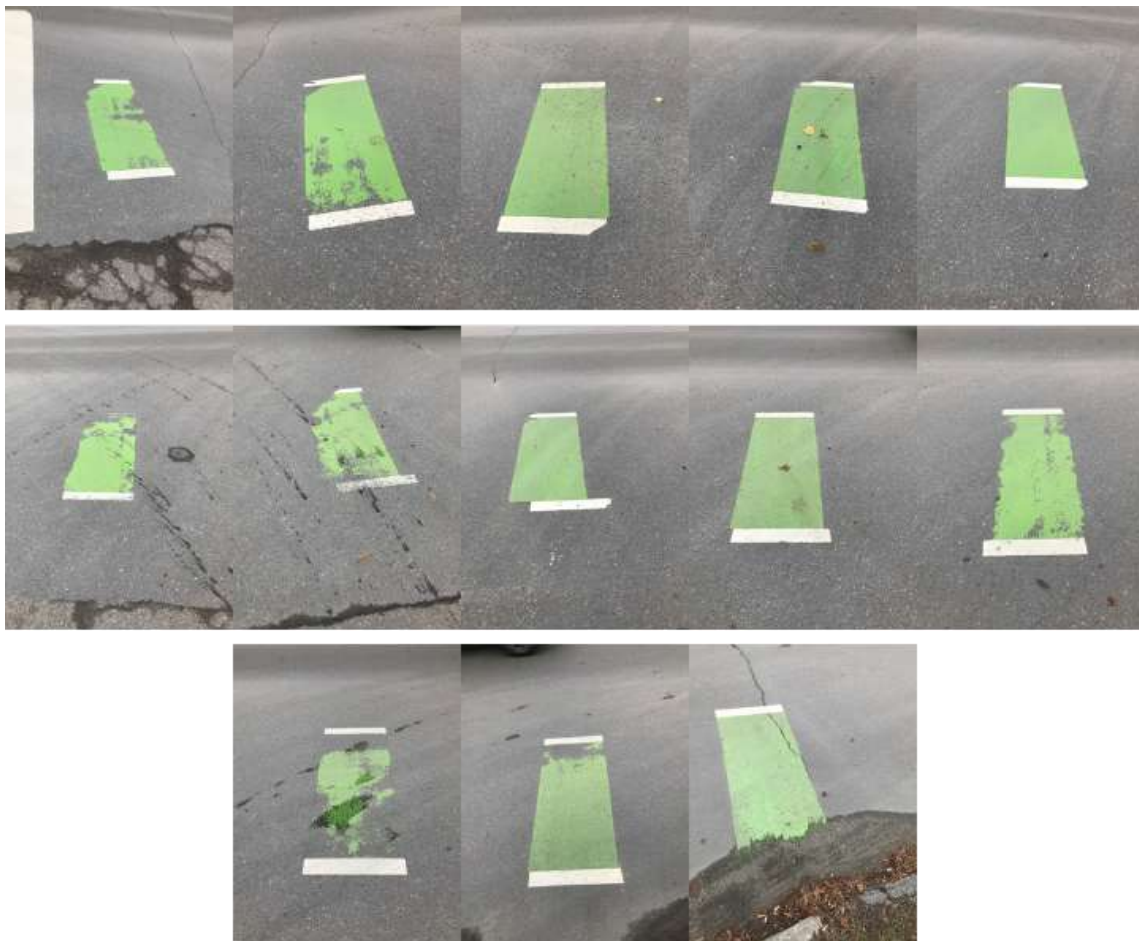
Figure 18: CycleGripMMAX Condition Location 1

The first installation of CycleGripMMAX, located at the Vermont Shopping Center contains 13 skip marks. Condition observations for CycleGripMMAX include six skips in Good (3, 4, 5, 8, 9, 13), five in Fair (1, 2, 6, 10, 12), two in Poor condition (7 and 11), and none missing. Photo observation can be seen in Figure 18 below. The most worn marks, numbers 7 and 11 are located in the turn tracks of cars entering and exiting the shopping center. The damage appears to be from wear, and there is no evidence of cracking, chipping, or delamination. Overall, the markings at location 1 are in a fair condition, showing wear and reduction in covered area, but maintaining functionality on most skips.

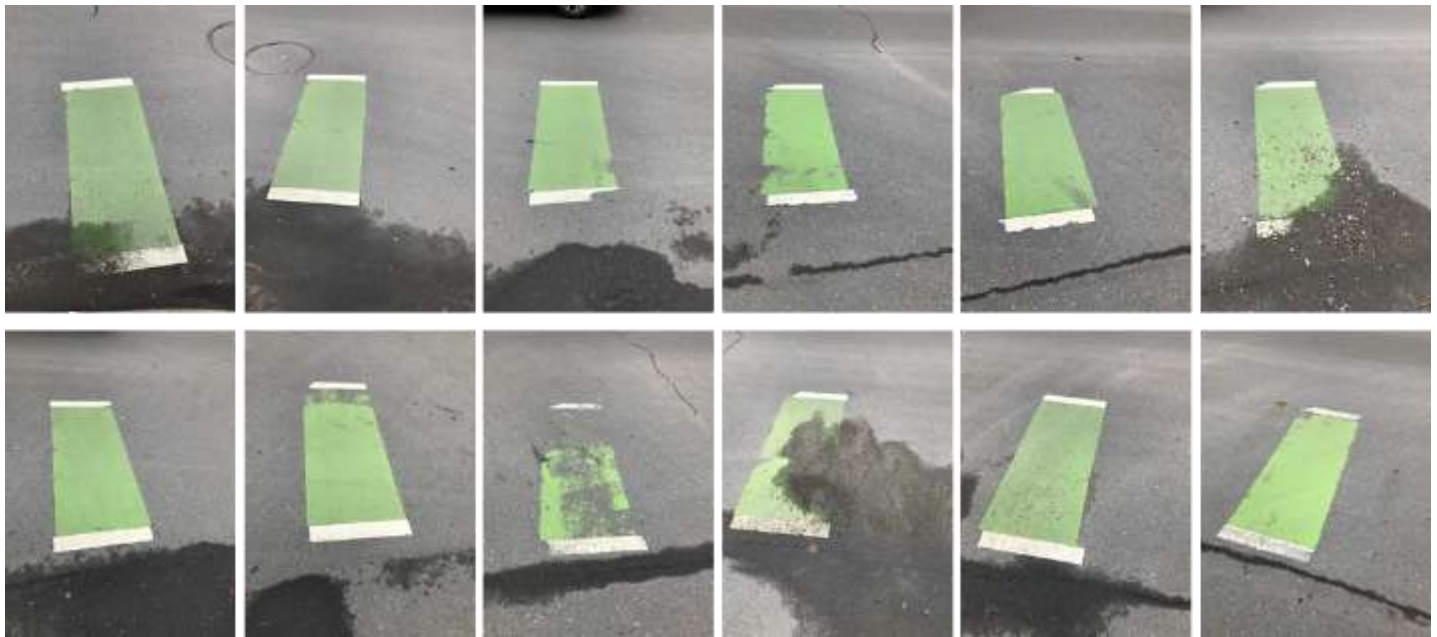
Figure 19: CycleGripMMAX Condition Location 2

CycleGripMMAX in the second location, crossing the driveway for the medical offices and Burger King, can be seen in Figure 19. Field observations show that the skip mark conditions are: seven Good (1, 2, 3, 6, 7, 8, 11), four Fair (4, 5, 10, 12), one Poor (9), and none missing. The minor damage is all from wearing, with no chipping, cracking, or delamination. The 13th skip in this location is PreMark, and performing poorly as described and shown above. Overall the CycleGripMMAX in location 2 is in Good condition, showing its durability and quality.

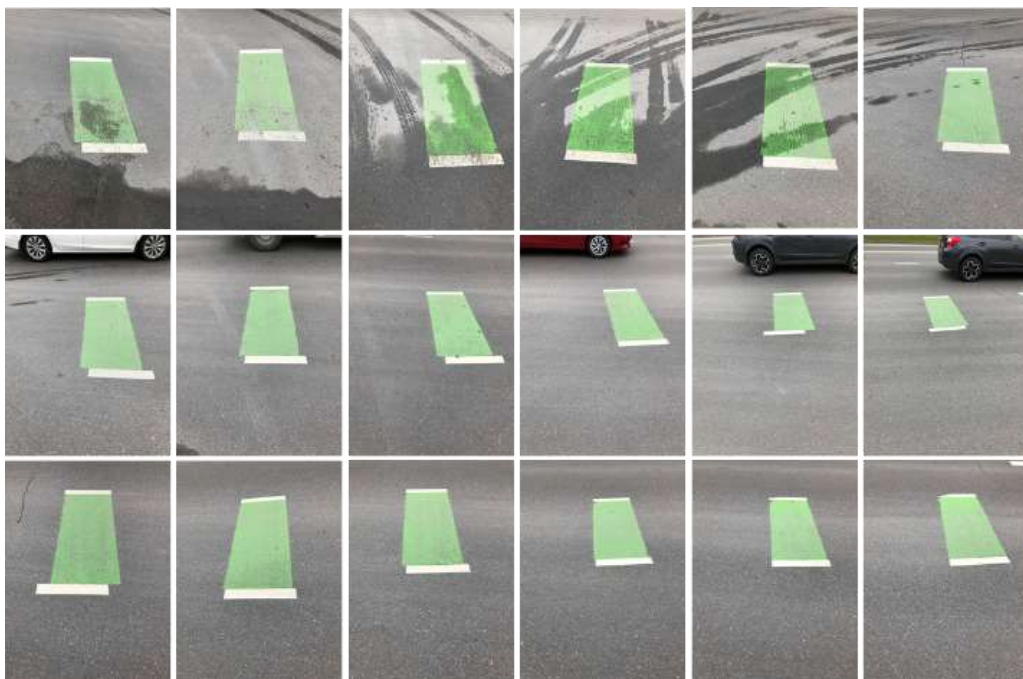
Figure 20: Color-Safe Condition Location 1

Color-Safe was used in two locations, the first utilizing 18 skip marks and a large box in front of CVS. All 18 of the skip boxes are in Good condition, as seen below in Figure 20. The large block is in good condition, with some minor wear under tire tracks, as vehicles ride the markings line, an example shown in Figure 20.

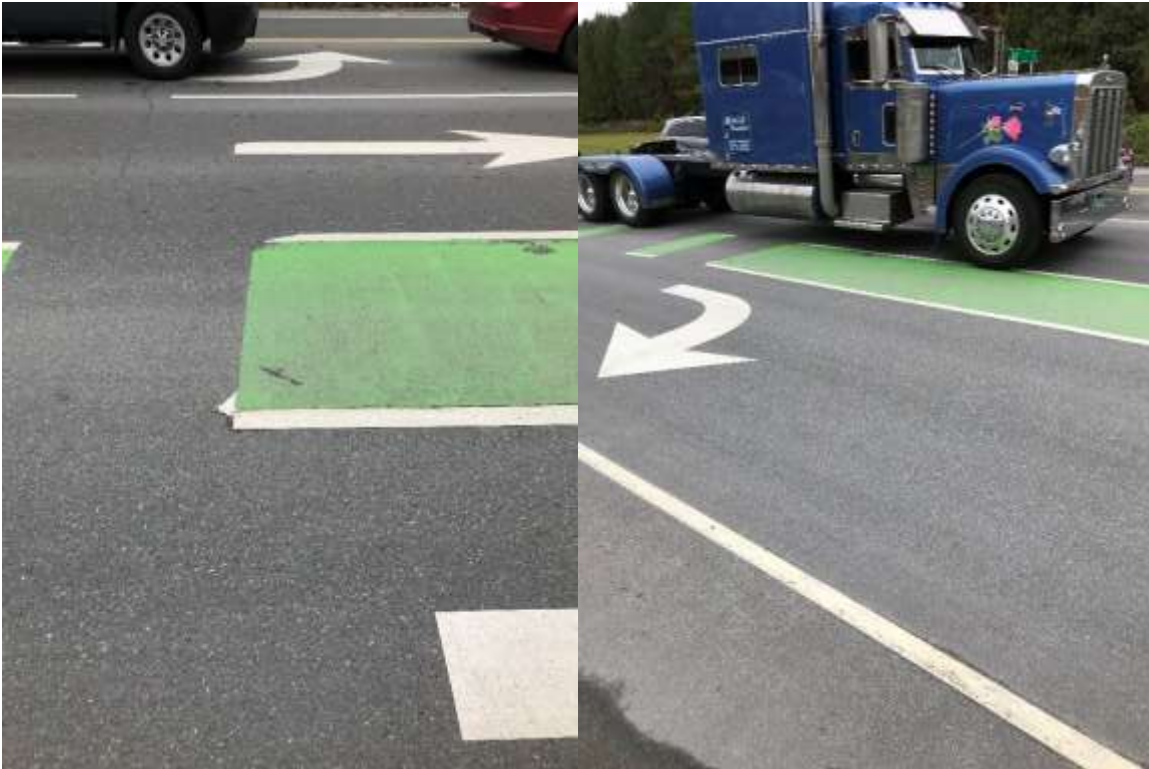
Figure 21: Color-Safe Block

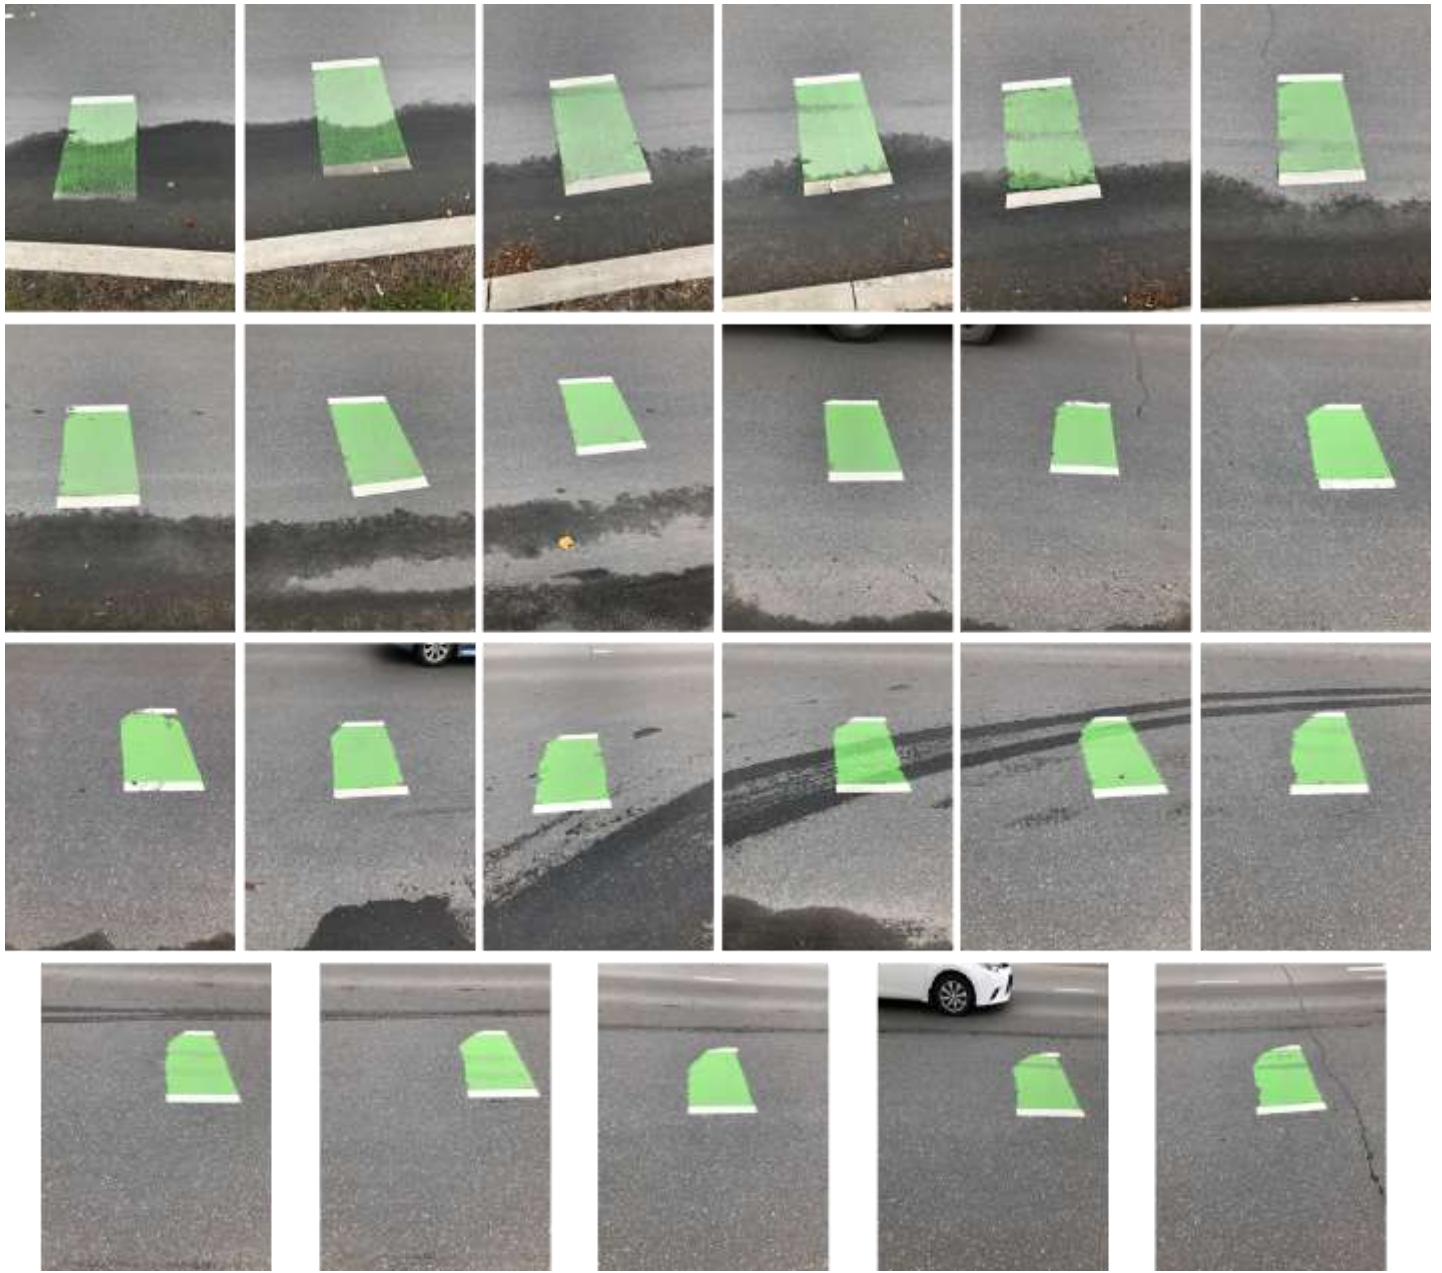
Figure 22: Color-Safe Condition Location 2

The second site of Color-Safe is between the straight and turn lane approaching Berlin State Hwy, and contains 23 skip boxes. Observation shows the skip mark conditions to be: ten Good (1, 2, 3, 4, 7, 8, 9, 10, 11), with the remaining 13 in Fair condition, and can be seen in Figure 22. The Color-Safe in location 2 is performing well, and is in good and fair condition. The wear present is from heavy traffic, likely the highest of all test sites, as Berlin State Hwy leads to Interstate 89.
