ASSESSMENT OF THE 40" WIDE PAVING SKID BOX FOR PREVENTATIVE MAINTENANCE

Ian Anderson, Research Engineer
Vermont Agency of Transportation
Research Section

Experimental Feature
Reporting on Work Plan 2012-R-03

Final Report 2018-06

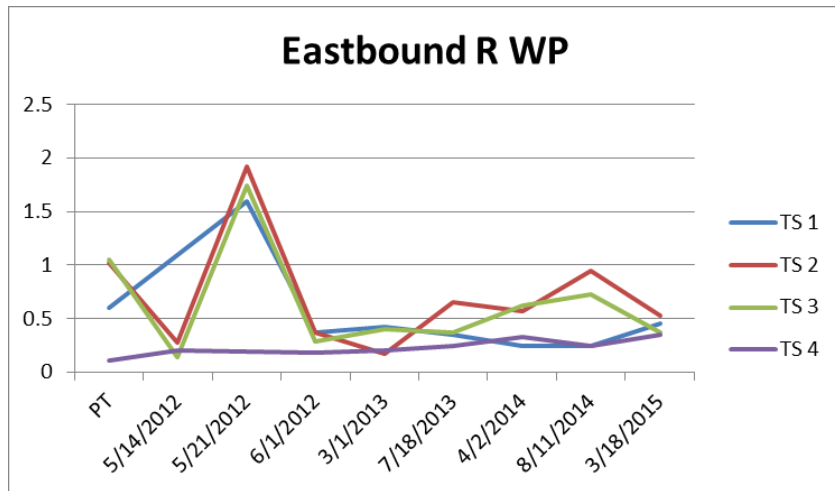
Figure 3: Eastbound right wheel path rutting

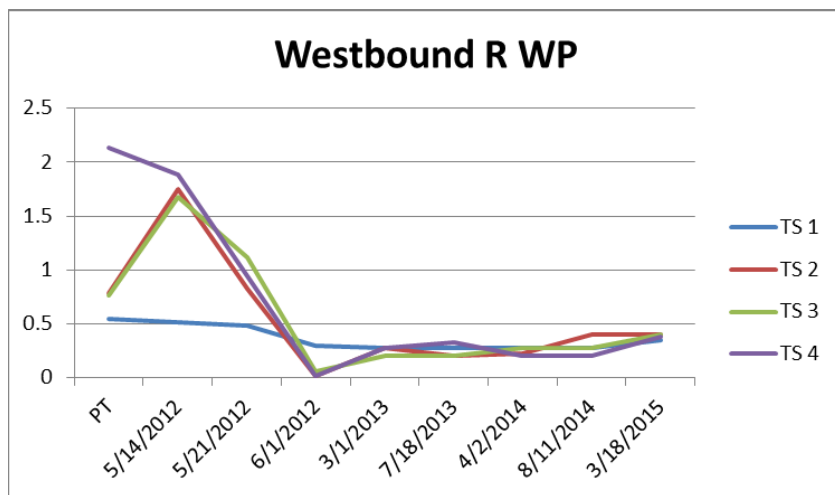
Figure 4: Westbound right wheel path rutting
