ASSESSMENT OF SUPER-SLAB, A PRECAST CONCRETE BRIDGE APPROACH SLAB

Ian Anderson, Research Engineer
Vermont Agency of Transportation
Research Section

December 2018

Final Report 2018-07

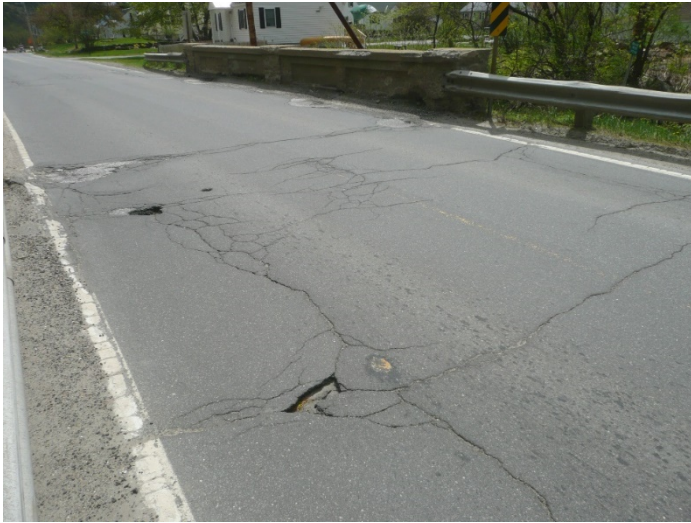
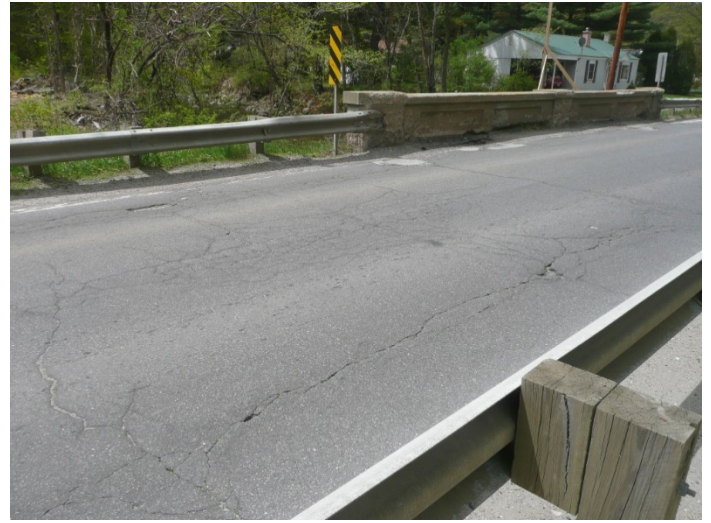
Approaches to Bridge 8 at pre-construction showed significant signs of pavement distress, including fatigue, thermal, and alligator cracking, accompanied by formation of potholes (see Figure 2). Approaches to Bridge 9 showed less signs of distress than Bridge 8, revealing thermal cracking and some fatigue cracking (see Figure 3).

Figure 2: Approaches to Bridge 8, preconstruction

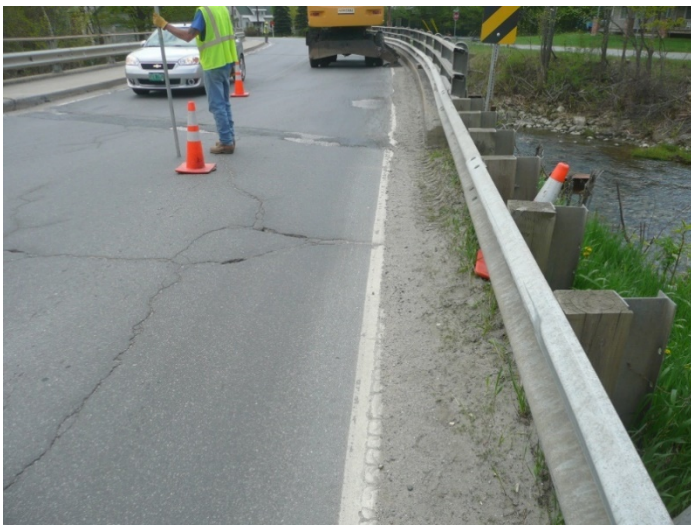
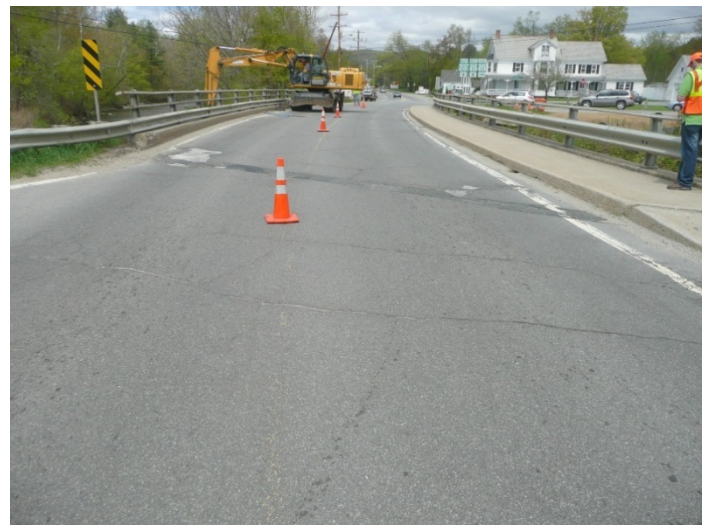
Figure 3: Approaches to Bridge 9, preconstruction

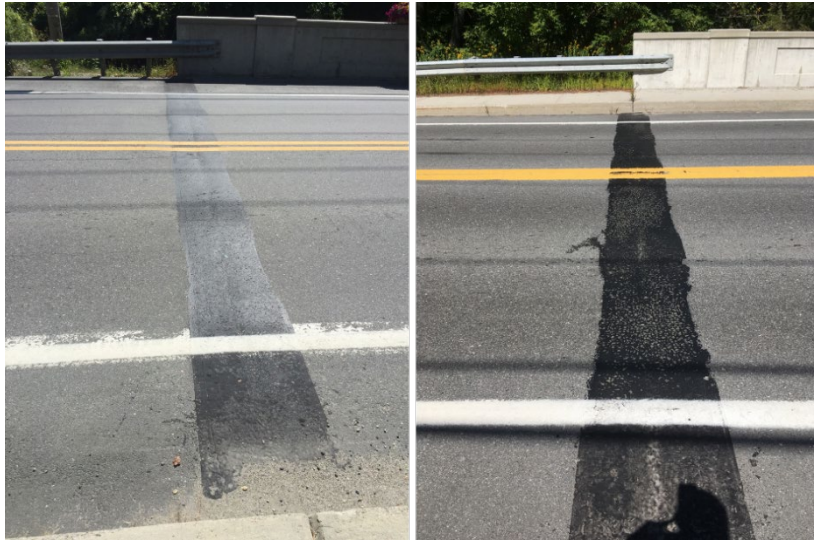
Figure 4: Bridge 8 joints, east and west ends respectively, appearing to be in good condition

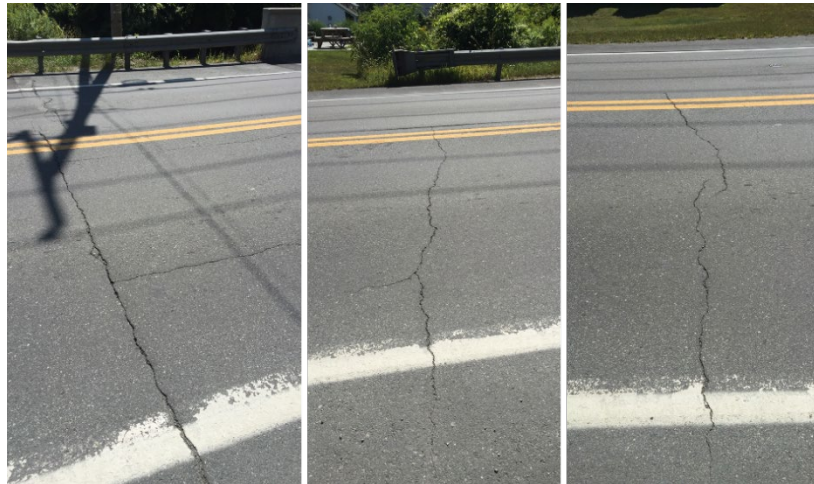
A site visit to Bridge 8 and 9 in Chester, August 30 of 2017, was conducted to close the project. Observations and photos on the performance and appearance of the Super-Slab System after installation were collected. Figure 4 shows the bridge joints of Bridge 8. Figures 5 and 6 shows cracking in the Bridge 8 approach slabs. The eastern approach of Bridge 8 showed a transverse crack approximately 19ft from the east end bridge joint, a second transverse crack approximately 39ft from the east end bridge joint, and a third transverse crack approximately 59ft from the east end bridge joint (figure 5). Two longitudinal wheelpath cracks (one for each wheelpath) were observed emanating from the 1st transverse crack on the westbound lane (figure 5). A longitudinal crack was also noted emanating from the first transverse crack on the left wheelpath within the eastbound lane. No wheelpath cracking was noted on the eastbound lane near the second and third transverse cracks, but a small 2-foot wheelpath crack was found on the westbound side near the third transverse crack.

Figure 5: Cracking at eastern approach of Bridge 8

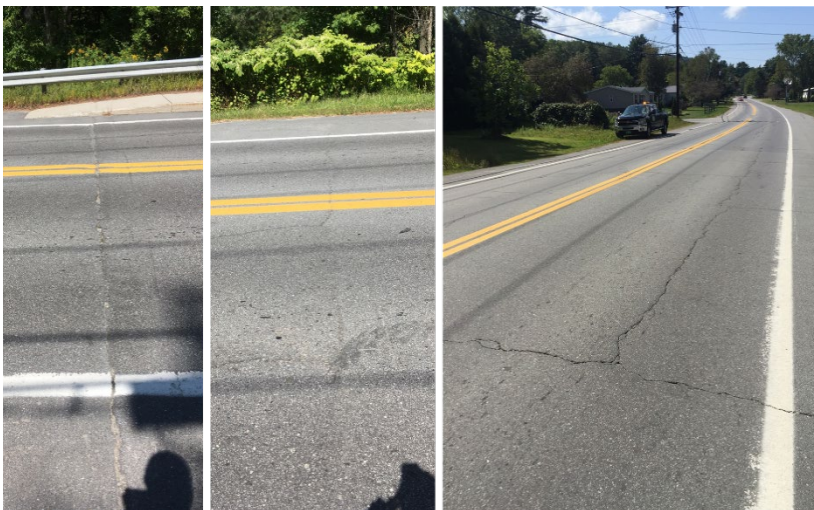
The western end approach to Bridge 8 showed a transverse crack approximately 20ft from the west end bridge joint, a second transverse crack (Eastbound side) and third transverse crack (Westbound side) both approximately 55-feet from the west end bridge joint (figure 6). On the eastbound side a 20-foot longitudinal crack between the wheelpaths was noted connecting the west bridge joint with the first transverse crack along with small wheelpath cracking (figure 6). Two wheelpath cracks that extended 8ft on the eastbound side (one on each wheelpath) near the second transverse crack were also observed and can slightly be seen in the middle photo (figure 6). An extensive wheelpath crack was also noted on the westbound lane near the second transverse crack (figure 6).

Figure 6: Cracking at western approach of Bridge 8

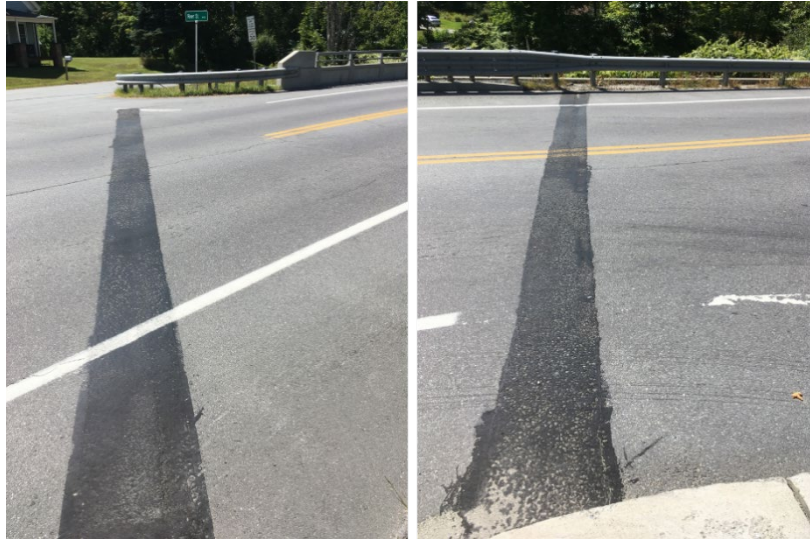
Figure 7: Joints at Bridge 9, appearing to be in good condition

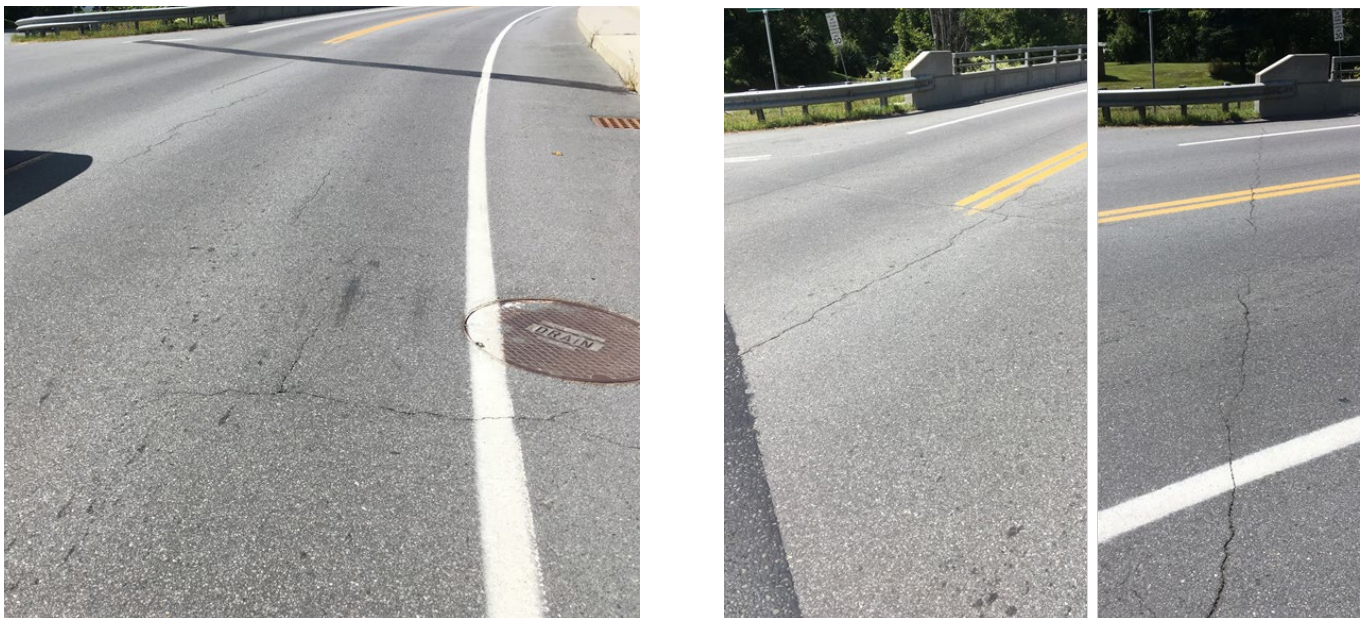
Bridge 9 bridge joints can be seen in Figure 7, and the cracking can be seen in Figures 8 and 9. The eastern approach of Bridge 9 shows both longitudinal and transverse cracking (figure 8) within the westbound wheelpath. There is a 26-foot centerline longitudinal crack emanating from the east end bridge joint, and a transverse crack across the width of the bridge approximately 19 feet west of the east end bridge joint (figure 8). A few wheelpath cracks were also observed on the westbound lane. Two of them were four to five feet in length and one was 18 feet in length. A 14-foot eastbound wheelpath crack emanating from the east end bridge joint was also noted. No other cracking was observed or noted on the bridge deck.

Figure 8: Cracking at eastern approach of Bridge 9

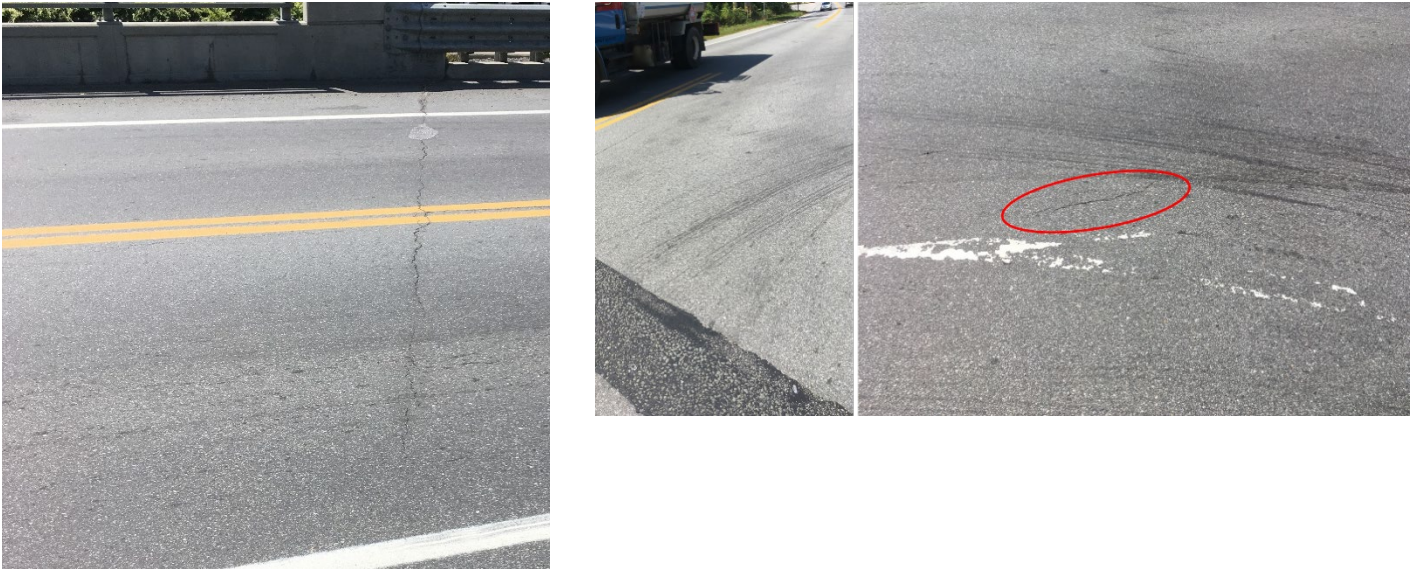
Transverse cracking across the width of Bridge 9 western approach was seen 18 feet east of the west end bridge joint. Wheelpath cracking, approximately 18 to 24 feet in length was observed extending from the western bridge joint on the westbound lane (figure 9). Smaller right wheelpath cracking was also noted on the westbound lane turning onto Pleasant Street (figure 9). No wheelpath cracks were found on the eastbound lane.

Figure 9: Cracking at the western approach of Bridge 9
