ASSESSMENT OF JAHN PERMEABLE MORTAR SYSTEM IN A HISTORIC BRIDGE ABUTMENT APPLICATION

Ian Anderson, Research Engineer
Vermont Agency of Transportation
Research Section

January 2019

Final Report 2019-01

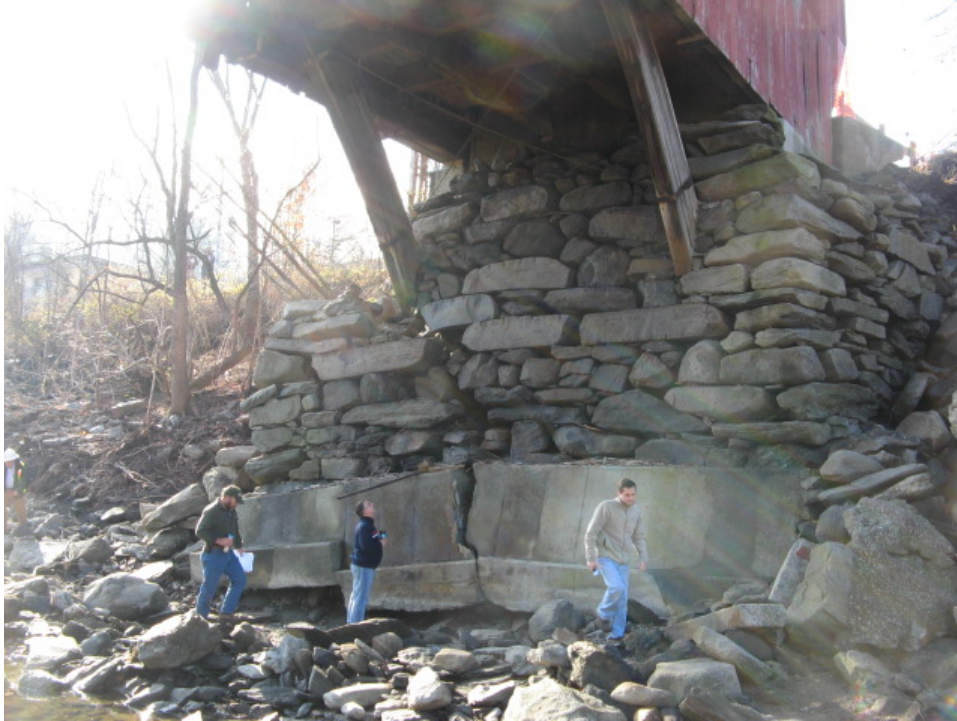
On August 28, 2011, Tropical Storm Irene caused significant damage to the crossing. The western abutment was undermined and partially collapsed (Figure 9), causing damage to the timber structure of both spans of the bridge. Though the bridge remained standing, the western abutment continued to break apart in the months after the storm. That winter, the western span was removed except for the arches (Figure 10). The timber was carefully removed, labeled and stockpiled at the town garage for later use in the rehabilitation project. For nearly two years, the surviving components of the structure lay dormant. In late 2012, construction began on the bridge and on September 7, 2013 the bridge was reopened after extensive \$2.5 million reconstruction was completed.

Figure 9: Western abutment partially collapsed

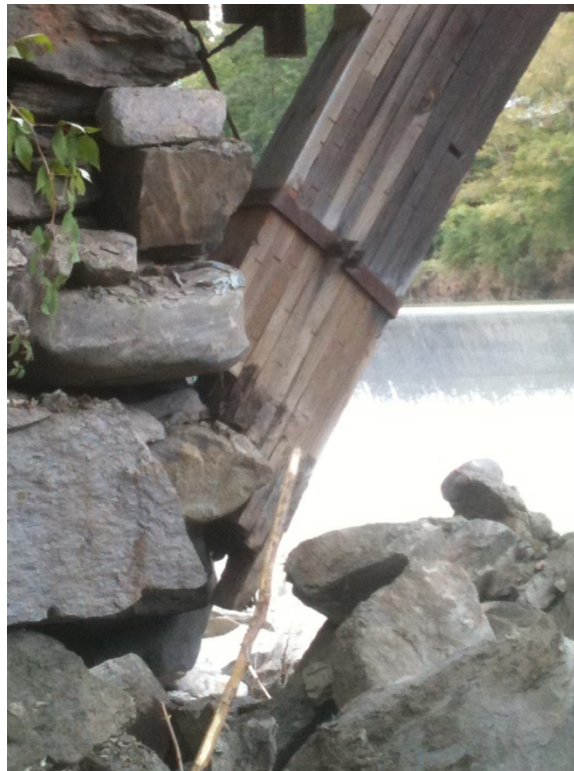
The flooding eventually undermined the western abutment at the downstream end. The abutment fractured, resulting in the downstream western arch to pull out of the stone socket securing it in place (Figure 11). In turn, the western span twisted, causing damage at connections throughout both spans. The covered bridge was scheduled for a nearly \$3 million National Covered Bridge rehabilitation project that was scheduled to begin in September 2012. Much of the work that was planned for that project was incorporated in the project resulting from the storm activities.

Figure 11: Downstream western arch dislodged from abutment

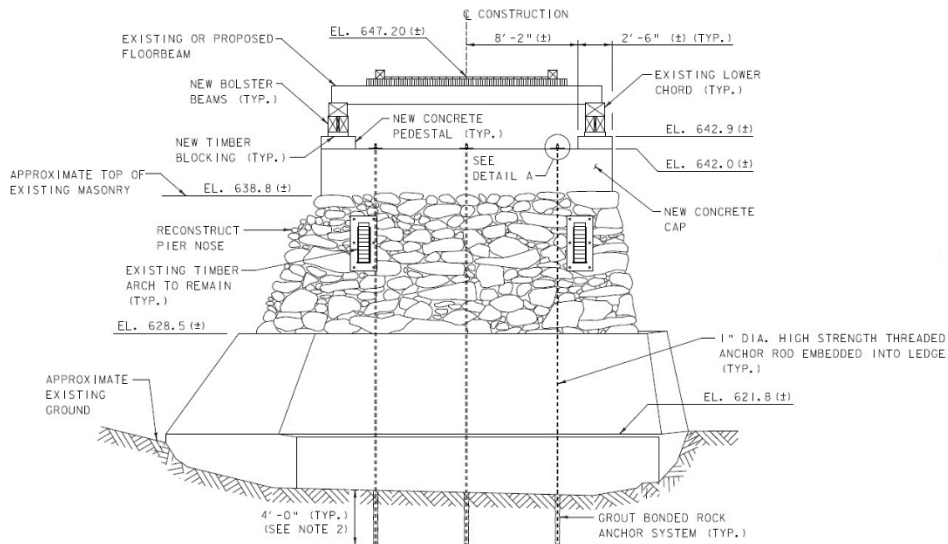
Figure 13: Details of the Bridge Pier

Alpine constructed an enclosure around the pier (Figure 13) and on February 5, 2013, the stonemasons began initial application of the Jahn Pointing Mortar on the western face of the pier. The purpose of this initial activity was for testing and training on how to prepare the dry-laid stone for the mortar, mix the mortar to the right consistency and apply to it. Cathedral Stone Products was onsite to oversee the testing and to train the stonemasons. The contractor provided heat in the enclosure to bring the atmospheric and stone temperatures up to the specified level for stone pointing and grouting. Initial observations indicated that the mortar mix had to be adjusted initially to obtain the consistency required for pointing stones.

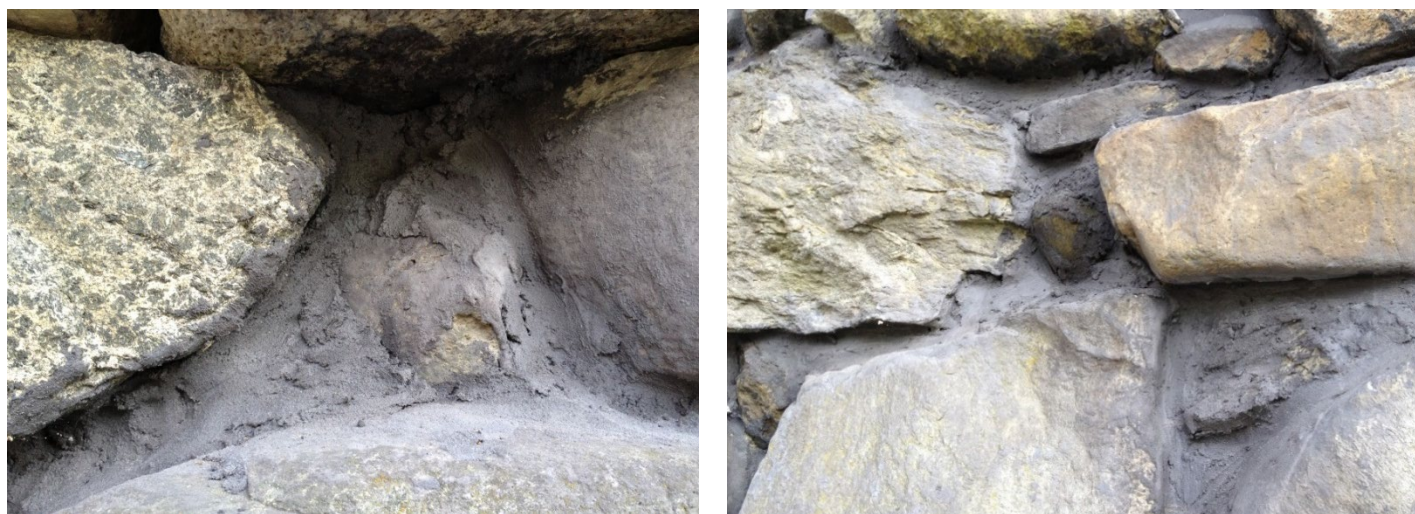
Figure 14: Up-close view of stone pointing and mortar work

The stonemason used a narrow pointed mason's trowel to pry out small loose stones and debris from the dry-laid stone joints. Using a brush or their hands, the stonemason would remove dust and dirt from within the joints. The crew had access to an air compressor, which they used to clean fines out of the joints. It was determined that a power washer would be the best option to conduct the final cleaning of the stones. Where there were gaps, the stonemason would size up a stone provided on the rigging, and fit it into the opening, carefully matching the shape of the stone to the shape of the gap. In places, several stones were required. Smaller stones were worked deep into the larger gaps (Figure 14). The stones for this work came from the collapsed western abutment that was being excavated. The larger stones were broken apart to make smaller stones for chinking.

Once the stone pointing and cleaning was complete, the stonemasons would mix a portion of the Jahn Pointing Mortar. The grout was given a blackish color to give the appearance of a void, to simulate the open joints of dry-laid stone. When cured, the color would become more of a dark gray. The stonemasons would work the mortar deep into the stone joints.

Repeated application would continue until the mortar either could no longer be worked into the joint or the stonemason felt the joints were sealed. The mortar was then worked into a smooth concave surface using a joint filler tool allowing the original stones to protrude out to maintain their original appearance.

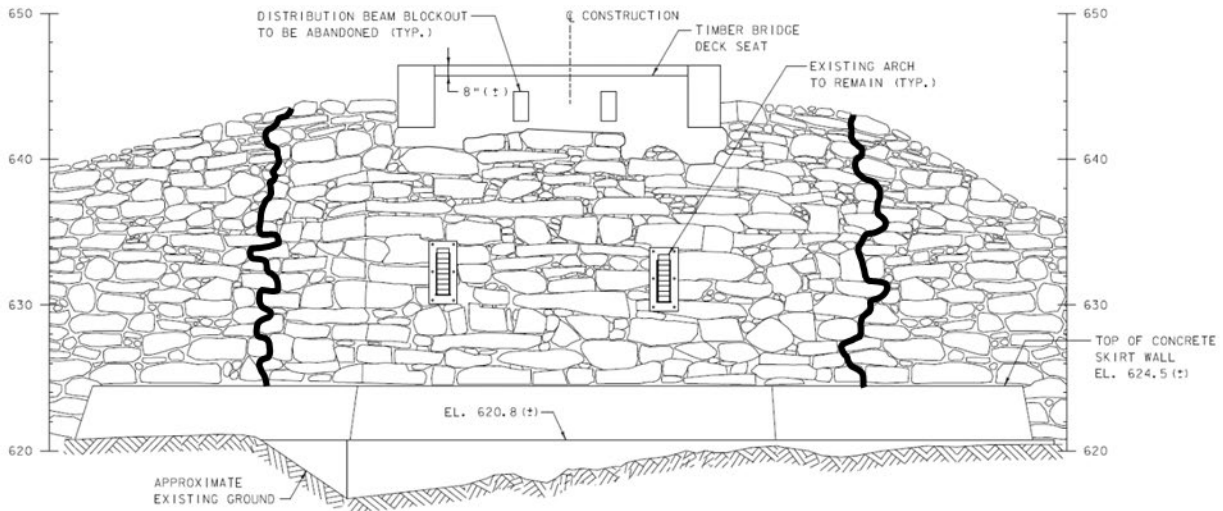
Figure 15: Details of the Eastern Abutment (dark lines shows extent of pointing)

With the experience level adequate for the job, the mortaring process continued on the pier on all faces. Since the work was being accomplished in February, the stones and surroundings in the enclosure needed to be warm enough to meet the specifications of a 50°F minimum. This was done by indirectly heated air blowing into the enclosure. By February 22, the stone pointing was complete. On February 26, the enclosures were made ready to begin pointing stones on the eastern abutment (Figure 15). This work was done directly below the superstructure. The stonemasons began pointing on February 28. By March 1, the pointing was complete with the exception of the bottom two feet, as that was outside the heated enclosure. This would be completed later in May.

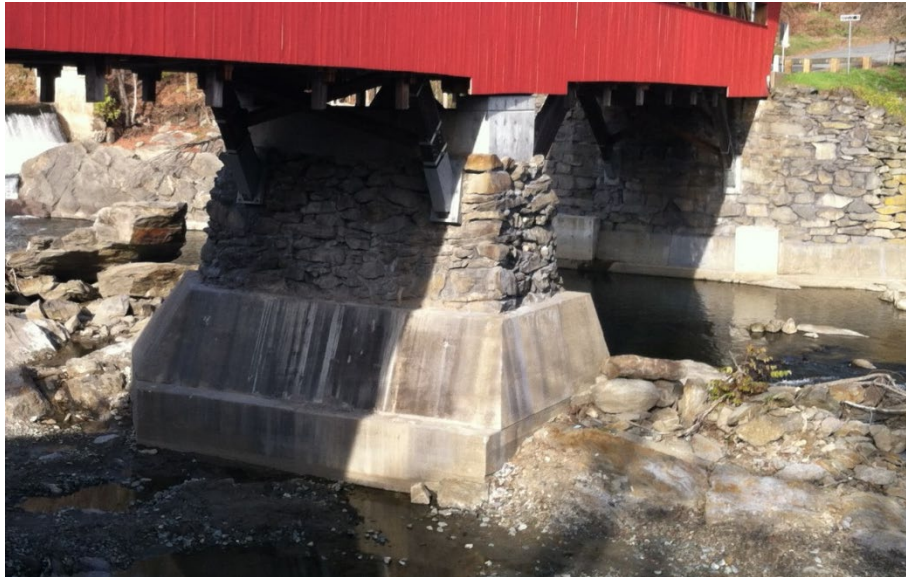
Figure 16: Completed pier showing the concrete cap and abutment

The final work on the pier was placing a new 3-foot high reinforced concrete cap (Figure 16) for the midspan of the bridge span to rest on and to distribute the vertical loads from the bridge into the pier. The cap was affixed to the stone pier by 28 anchor rods that were drilled and grouted into the stone. Six shafts in a 3-by-2 grid were drilled through the concrete cap and on through the grouted stone mass ending 4 feet into the existing riverbed ledge below the pier. 1-inch diameter high-strength threaded steel anchor rods were inserted into the shafts and embedded into the ledge using grout. The rods were bolted and tightened to a specified tension. Grout was then placed in the shaft. The tensioned rods provide bending resistance caused by lateral forces applied to the pier.

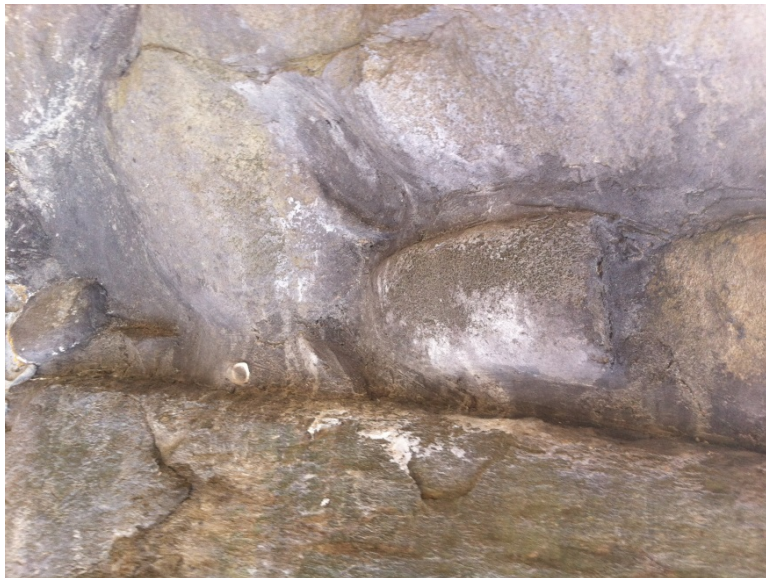
Research and Development has visited the project site once a year since the project was completed until 2017. In a discussion with the CEO of Cathedral Stone Products, Denis Rude, he said that as the salts leach out of the interior of the pier and abutment, a white powder like substance would appear on the surface of the grout. This powder would eventually blow off the surface with wind or be washed off by rain. There were concerns that the repairs to the pier and abutment would cause an efflorescence to form in places. The use of the Jahn products was intended to prevent such efflorescence from forming. Under observations from 2013-2017, the white powdery substance has been observed forming; however, it is not accumulating (Figure 17). There seems to be a consistent light dusting in places. Overall, the grout appears to be functioning as expected.

Figure 17: Up-close view of white powdery residue on mortar (2017)

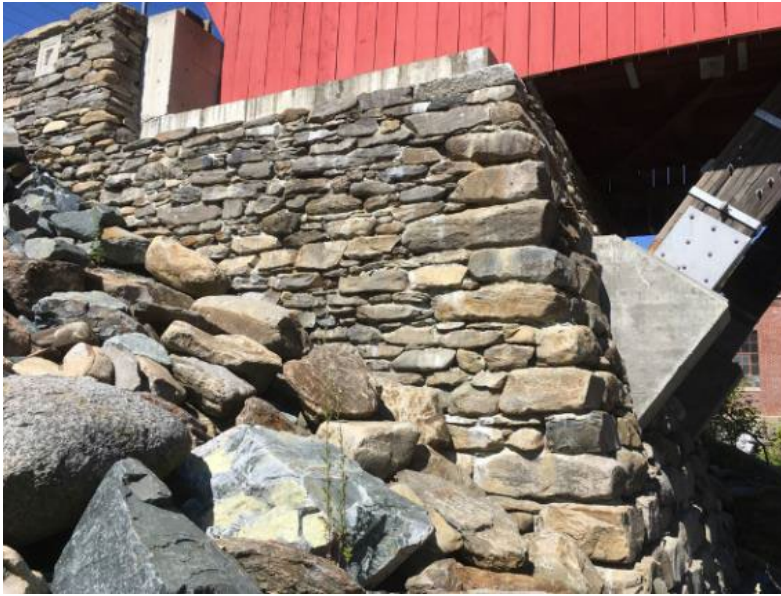
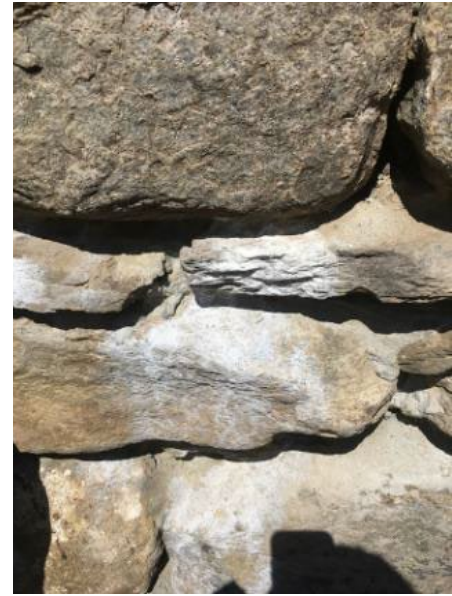
Figure 18 shows the overall view of the Southern wall of the west abutment and a close-up view of a powdery residue (most likely chlorides) leaching out of the mortar of the Southern wall of the west abutment. The observed residue stains consisted of two different colors, yellow/orange and white/gray. The yellow/orange stains might be indicating that the mortar is drawing out other minerals besides chlorides or that iron elements are deteriorating within the abutment.

Figure 18: Southern Abutment and closeup of mortar leachate (2017)

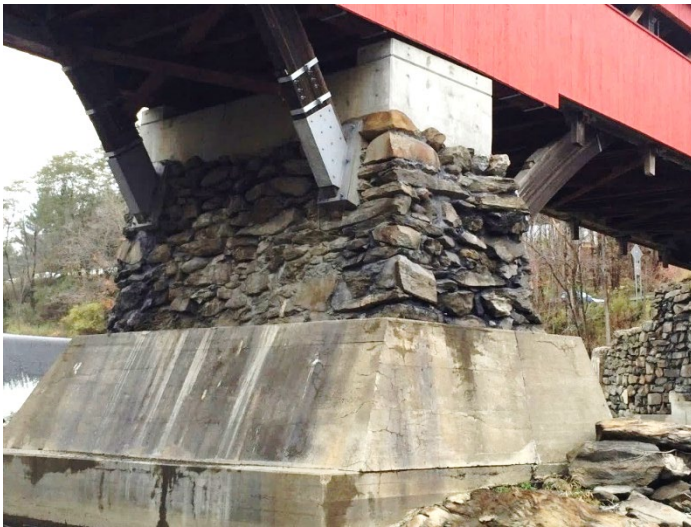
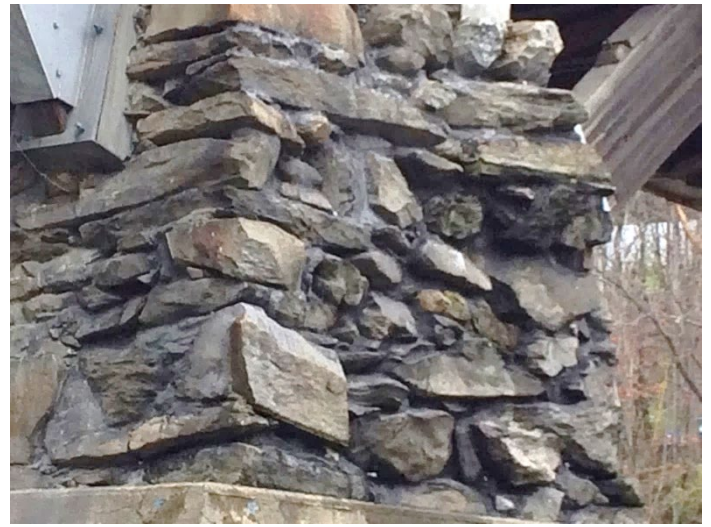
Another purpose of using the Jahn products was to strengthen the dry-laid stone pier and abutment to preserve the overall historic appearance of the bridge. Concerns were that the mortar would be obvious from a distance. Observations at various distances from the substructure units gave an appearance of dark joints between stone (Figure 19). The mortar and pointed stones were virtually invisible to the eye from afar. Even up close, the dark grey color of the mortar has aged in a way that it is not obvious in most places on each substructure unit. Places where the mortar is visible are where there were large gaps in the dry-laid stone (Figure 19).

Figure 19: Pier after Construction in 2014
