BIG-R-BRIDGE SUPER-COR BURIED METAL STRUCTURAL PLATE ARCH AND VIST-A-WALL MECHANICALLY STABILIZED EARTH RETAINING SYSTEM: CONSTRUCTION AND SETTLEMENT REPORT

May 2019

Experimental Feature
Reporting on Work Plan 2015-01

Initial Report 2019-11

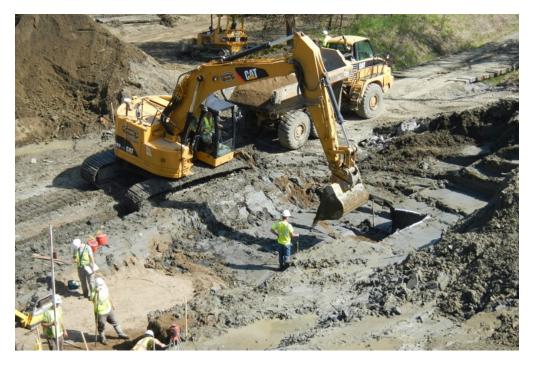
Figure 1: Excavating for the Arch Foundation

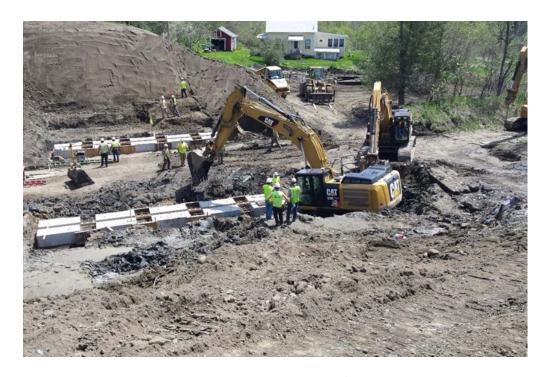
Figure 2: Arch Foundation Elements Ready for the Closure Pour

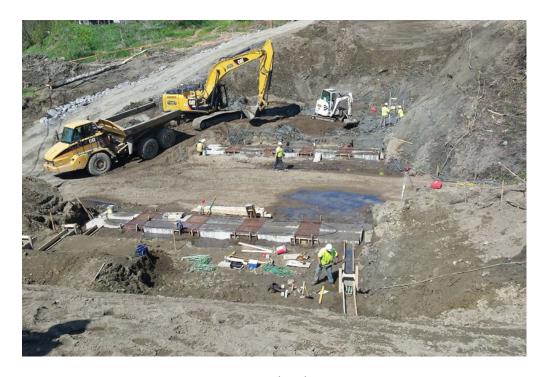
Figure 3: Curing the Closure Pour

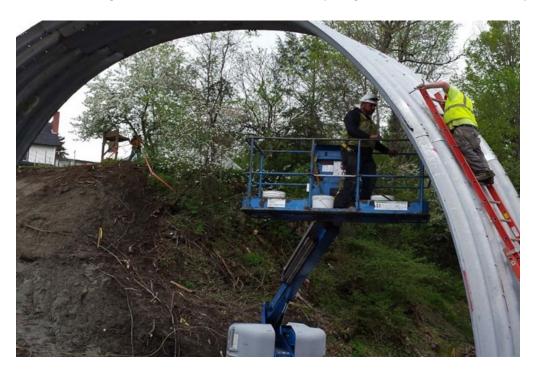
The contractor was supplied with 2" and 3" length bolts for assembly. However, in some connections where four plates were stacked, the contractor realized that 4" bolts would be necessary for assembly. Otherwise, there was not sufficient thread projecting through the multiple plate stack to attach the nut. The heads of the connection bolts were consistently placed on the outside face of the arch, although this was not a design specification. Bolt tensioning was performed from below for the sake of assembly convenience. The contractor decided to face the bolt threads inward, because they found it easier to tension from below. Figures 7 and 8 show the workers torqueing arch bolts and the arch fully assembled.

Figure 7: Contractors connecting panels with torqued arch bolts

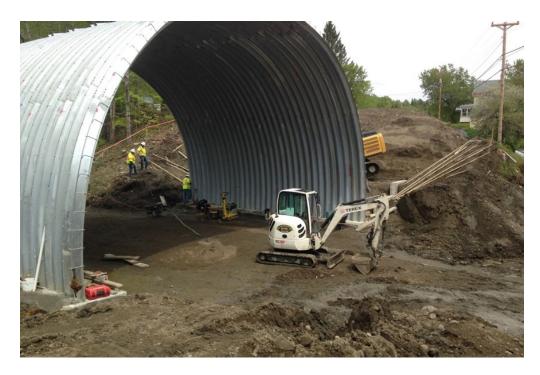
Figure 8: Fully assembled Arch

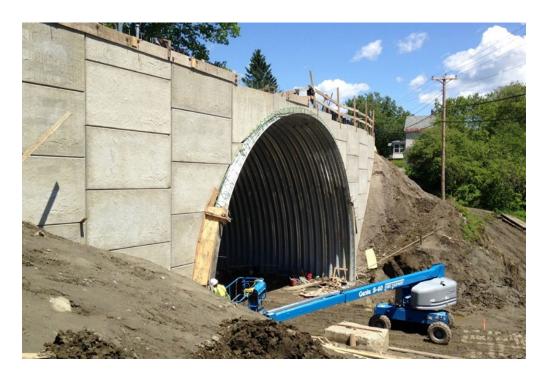
Figure 9: Arch Collar Formwork in Construction

The field construction of the architectural collar proved to be time-consuming and challenging to form, pour, and cure. The complex curve and skew of the arches complicated this issue, which is why they were not considered for precasting. The contractor did not meet the first of their two contractual re-opening dates (for the LVRT), partially due to issues constructing these collars. The original design did not specify pouring the collars in three sections (two legs and a center arch). This modification was approved in the field, but affected scheduling.

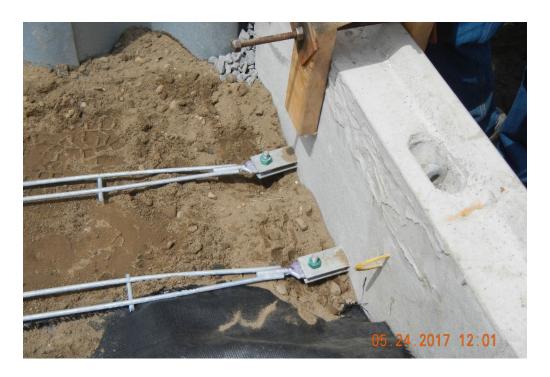
Figure 12: Reinforcing strips connected to the wall panels

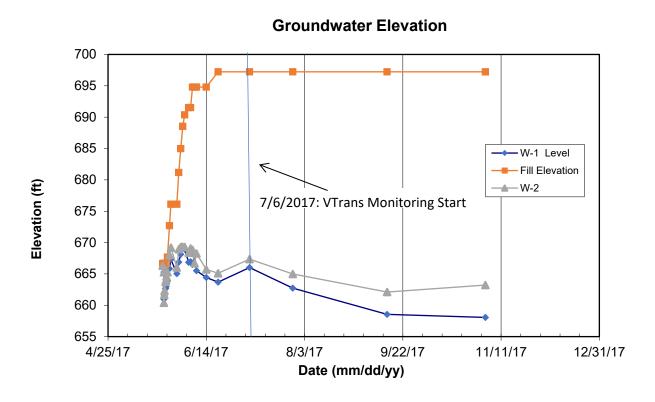
boring B-101 during drilling. The soils present at the western abutment location appeared significantly wetter than the eastern abutment. For this reason, a pair of two-inch diameter PVC groundwater observation wells and a pair of vibrating wire piezometers supplied by Geokon Inc. were installed to measure the groundwater levels. The purpose of the wells was to measure the effectiveness of the select backfill and drainage pipe in draining water during and after the end of construction in the fill behind the western abutment. The piezometers were installed at locations where monitoring wells would have interfered with traffic behind both abutments and were used to determine the effectiveness of the select backfill and drainage system on either side of the bridge. Once the final fill elevation was achieved, the water level decreased from the highest elevation by 5.6 feet and after approximately 5 months of observation, had decreased by an average of 4.5 feet. Results from the monitoring wells and piezometers can be seen in Figure 17 and Figure 18, respectively.

Figure 17: Monitoring well data

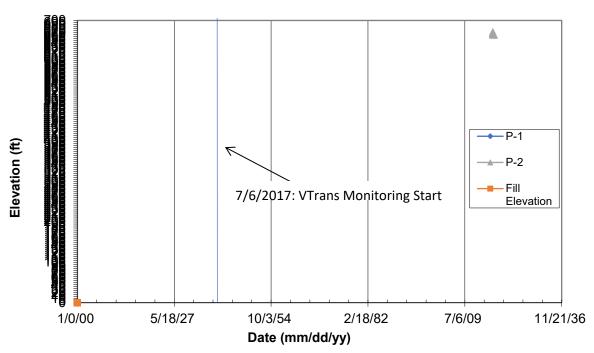
Figure 18: Piezometer data

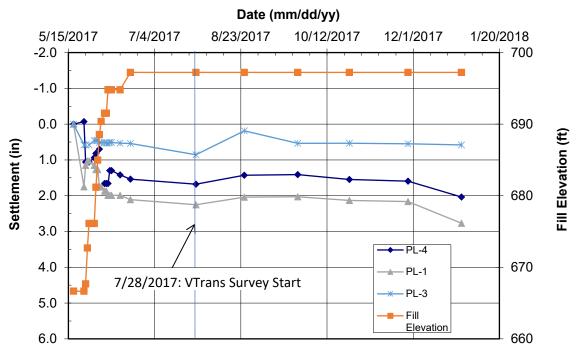
The data from the Type I settlement platforms was measured from the same survey point by both the contractor during construction, and VTrans personnel after construction. This data shows total settlement values of between 0.6 inches and 2.3 inches with the majority of the movement happening while the embankment fill was being placed. This amount of settlement was anticipated by the design which predicted settlements of up to 2 to 3 inches expected during construction.

Settlement platform PL-1 experienced the greatest amount of settlement and PL-3 experienced the least amount of settlement. This matches what was expected as PL-3 is located in the area of the previous pier and PL-1 is located in what was the previous embankment. The in-situ material in the location of PL-3 likely experienced greater pressures from the previous structure than PL-1 and more settlement likely occurred long before the settlement platforms were constructed.

Figure 19: Type I settlement platform data

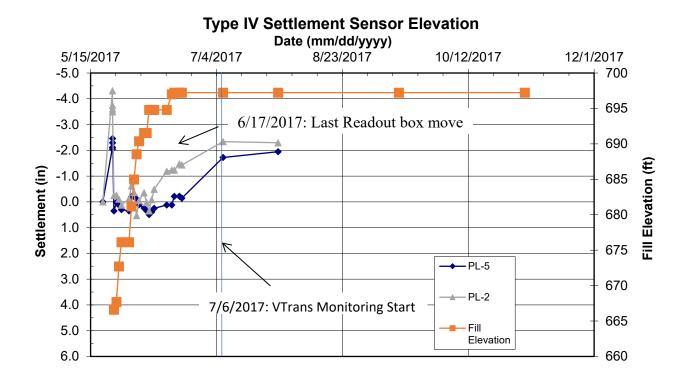
The readout box used to obtain the settlement measurements for the Type IV platforms as well as the fluid filled tubes were moved during construction multiple times. The tubes were protected from construction activity and covered with burlap fabric to reduce the effect of weather on them. However, as can be seen in the data, the readings fluctuate until the final fill height is established. At this point, the tubes were buried and the readout box location was moved for the last time. Although the data was calibrated, the final values show a negative settlement which is likely inaccurate. Looking at the trend of the data obtained, it shows that the majority of the movement occurred during construction and has leveled out afterward, which correlates to the data obtained from the Type I platforms. The data from the Type I platforms should be used to evaluate the performance of the wall system as it is likely more accurate.

Figure 20: Type IV settlement platform data

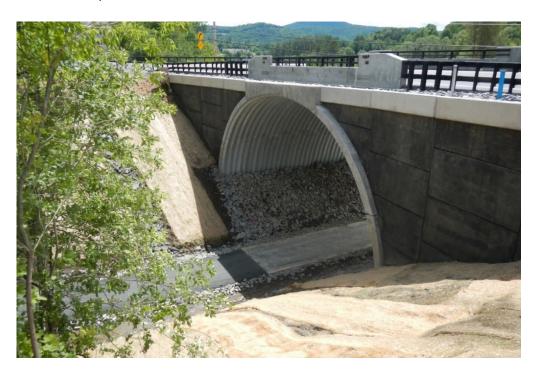
Figure 21: Completed Vist-A-Wall abutments and bridge

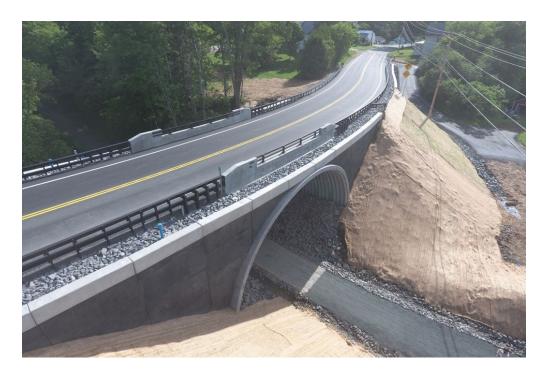
Figure 22: Completed Structure over the trail
