1. Report No.	2. Government Accession No.	3. Recipient's Catalog No.
4. Title and Subtitle Cost-Effective and Rapid Concrete Repair Techniques		5. Report Date February 8, 2016

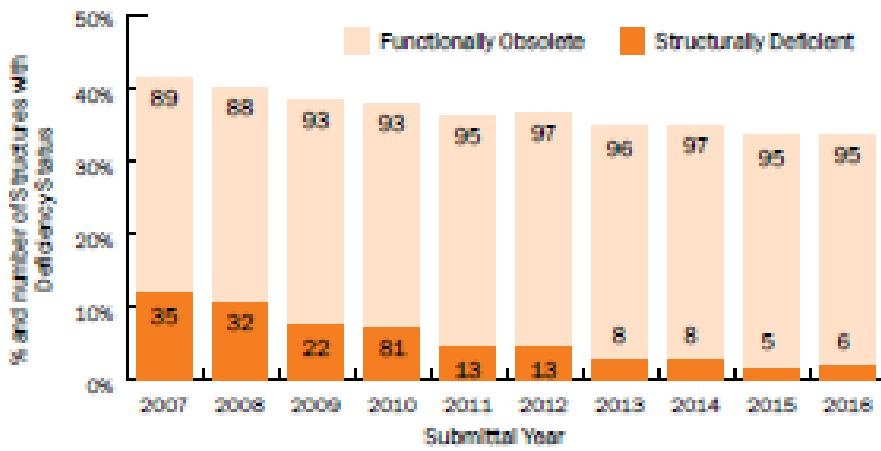
State Highway Structure Trends

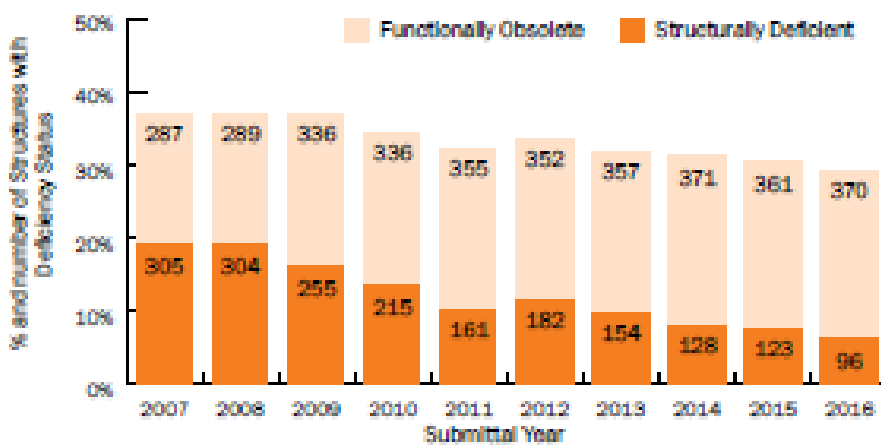
Figure 1.1 Downward trends of percent structurally deficient and functionally obsolete bridges in Vermont (VAOT 2017)

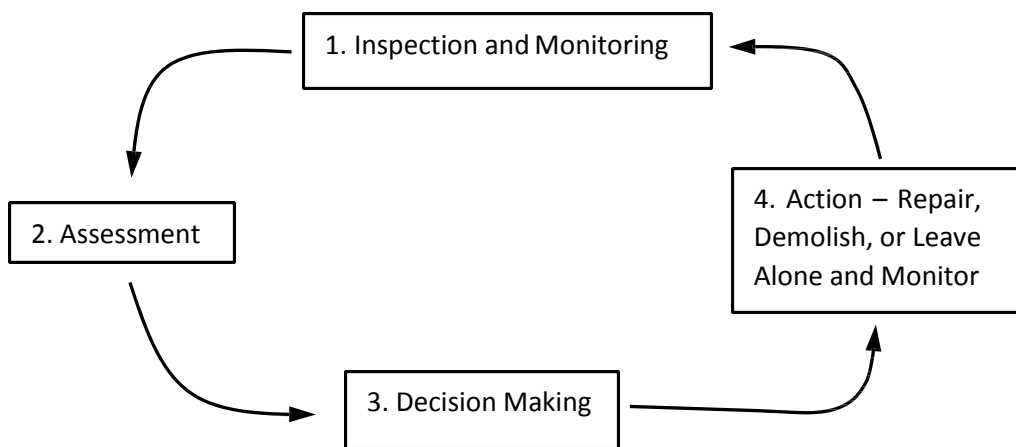
Figure 1.2 Cyclic nature of structural maintenance and repair

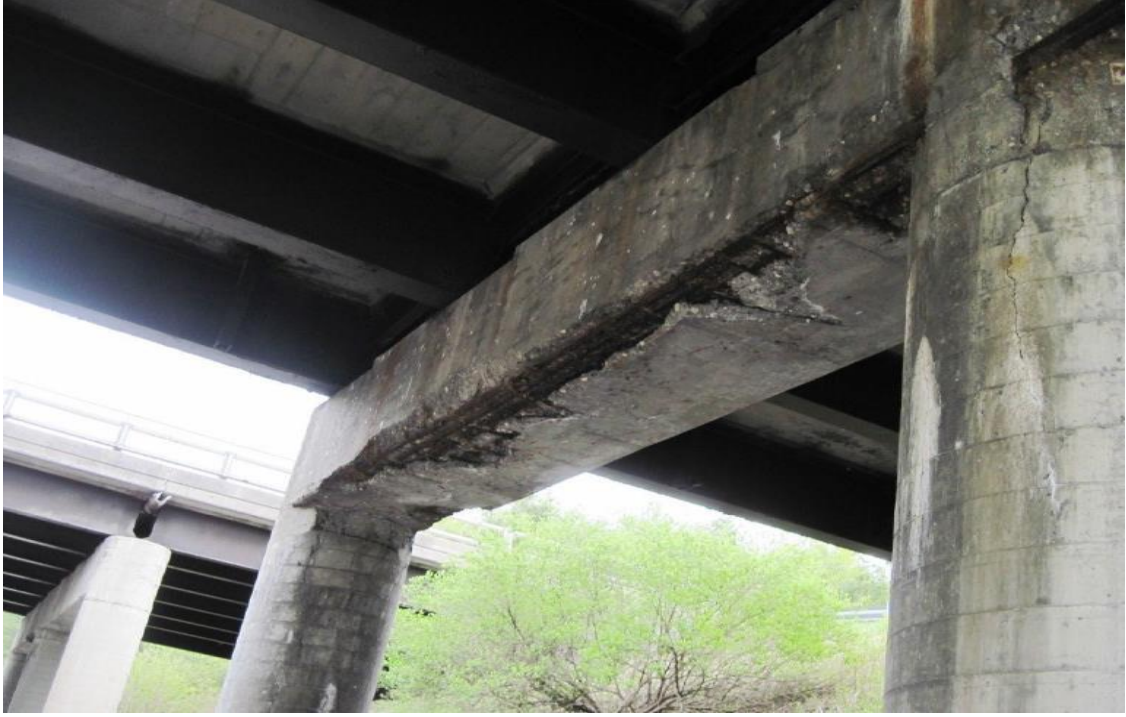
Many highway overpass bridges have expansion joints above piers and bearings. The flow of deicing salts and water onto the piers and bearings leads to corrosion damage to the pier caps, bearing seats and bearings. Figure 4.1 shows the I-89 Middlesex/Richmond Bridge #45 S with severe spalling damage to the pier caps. Figure 4.2 shows the bridge with repaired and strengthened pier along with some of the construction formwork.

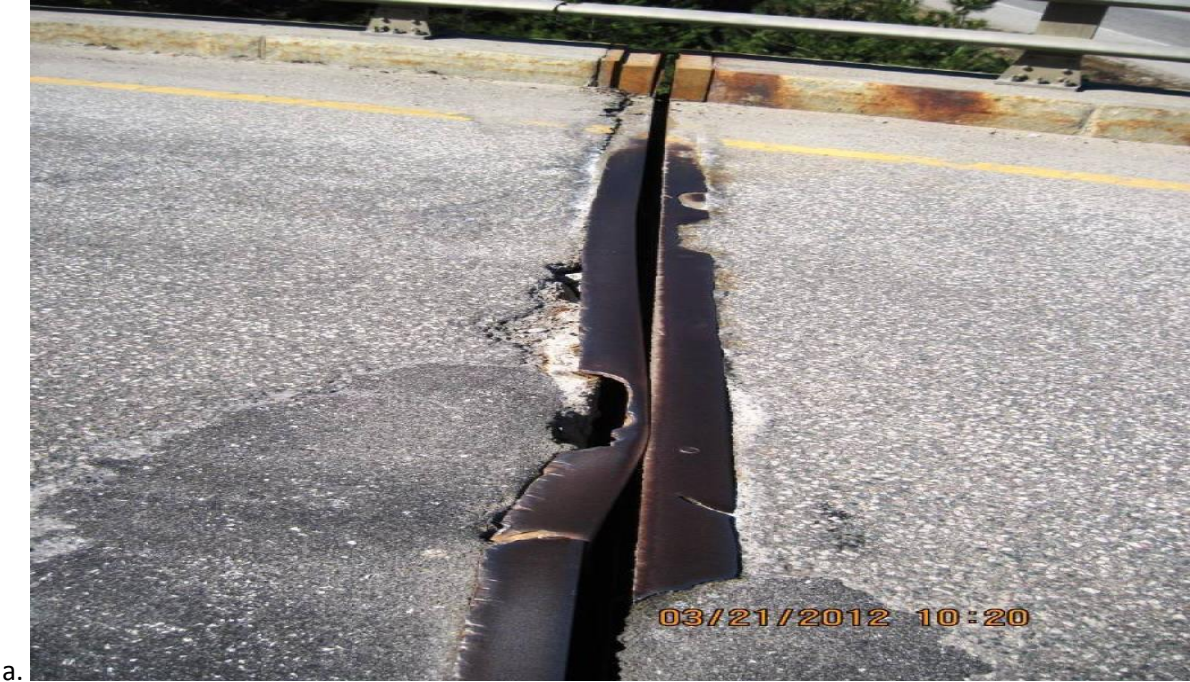
4.3 shows a damaged steel expansion joint and bearing for Vt. Rte. 903 Conn Berlin Br. #1. Figure 4.4 shows a replacement that eliminates the steel joint.

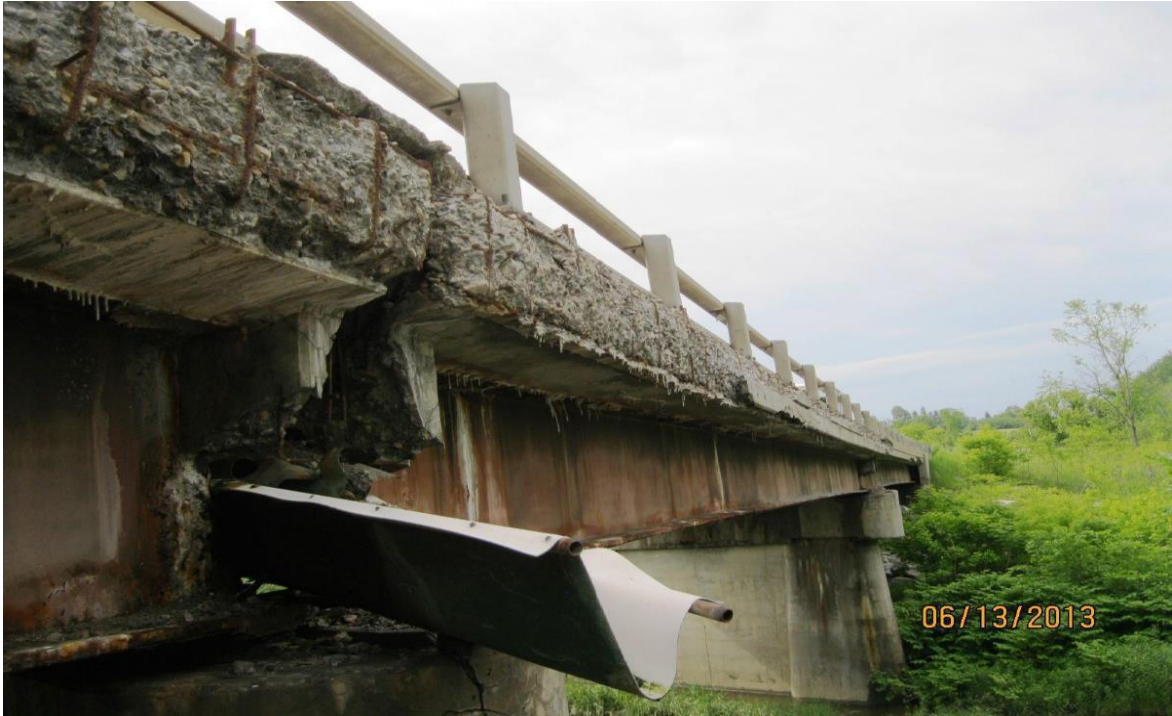
Vermont has multiple highway overpass bridges with severely distressed fascia. Spalling concrete is a safety issue for vehicles passing underneath. Many of the fascia have integrated guard rail systems and pose a safety risk if the rails fail to contain out of bounds vehicles. Figure 4.5 shows a severely damaged fascia on US 7 New Haven Br.#129. Figure 4.6 shows the reconstructed curb and fascia, along with new guard rail and fencing.

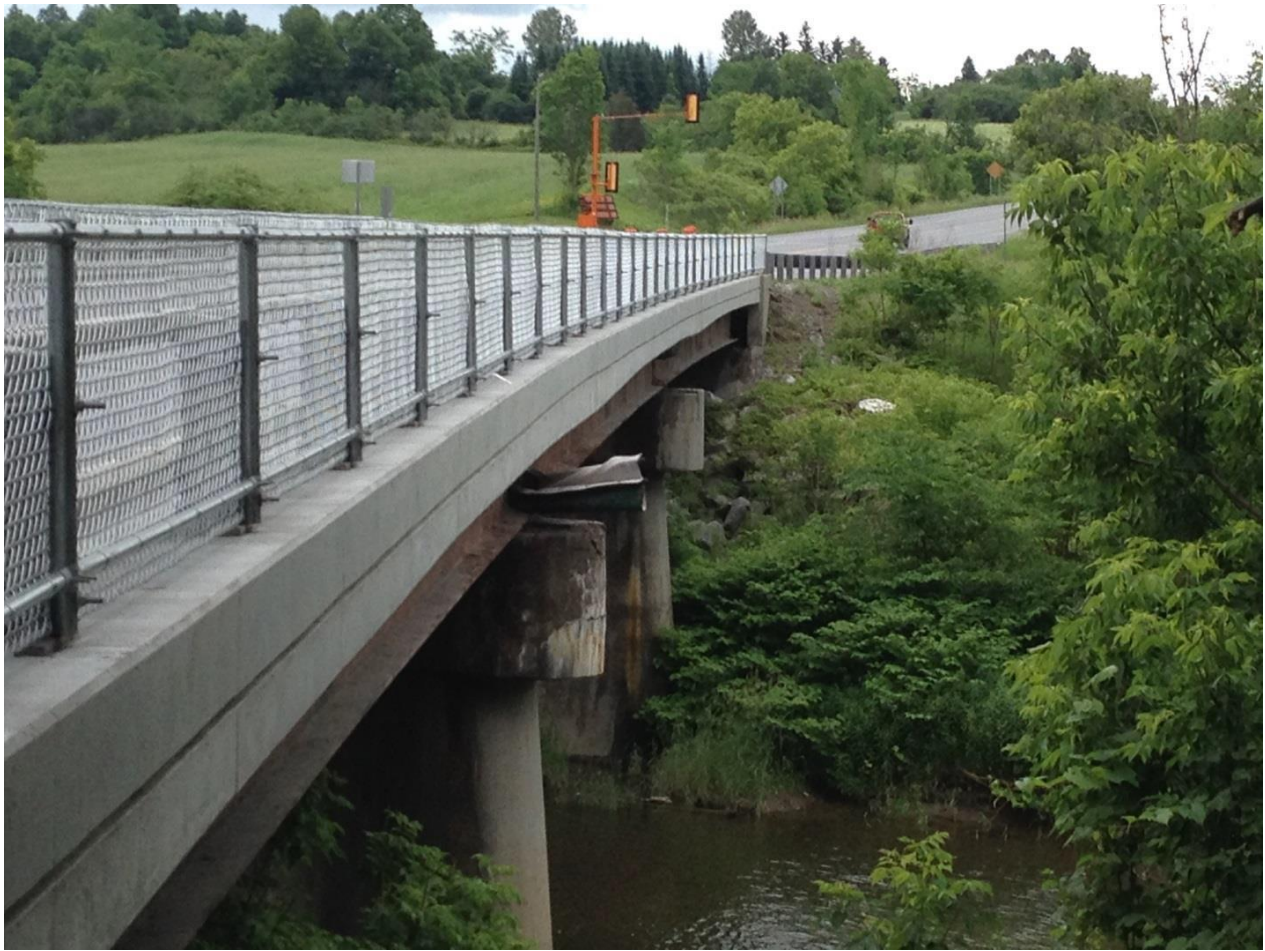
Figure 4.6 US 7 New Haven Br. #129 – REPAIRED Fascia/Curb Reconstruction, \$350,000

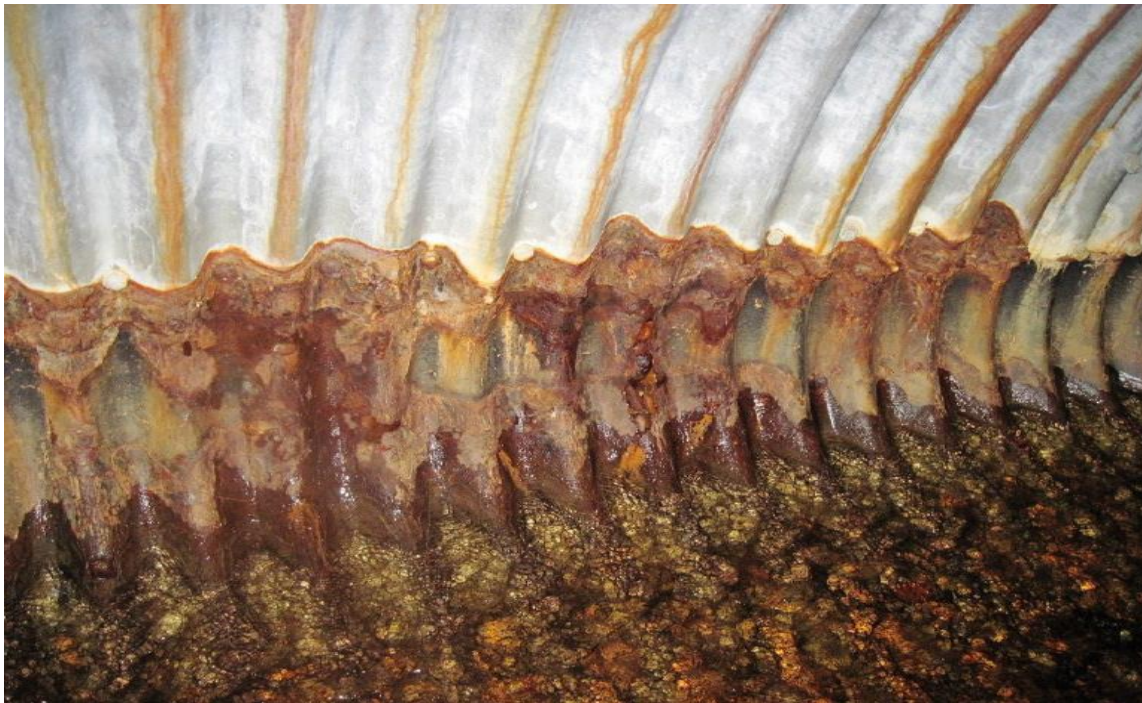
Bridges with integrated water flow structures, such as corrugated steel arches, can suffer damage at the water flow line due to corrosion and erosion. Figure 4.7 shows the Vt. Rte. 30 Winhall Br. #45 with a severely damaged corrugated steel flow line. Figure 4.8 shows a repair that replaced the flow line with concrete.

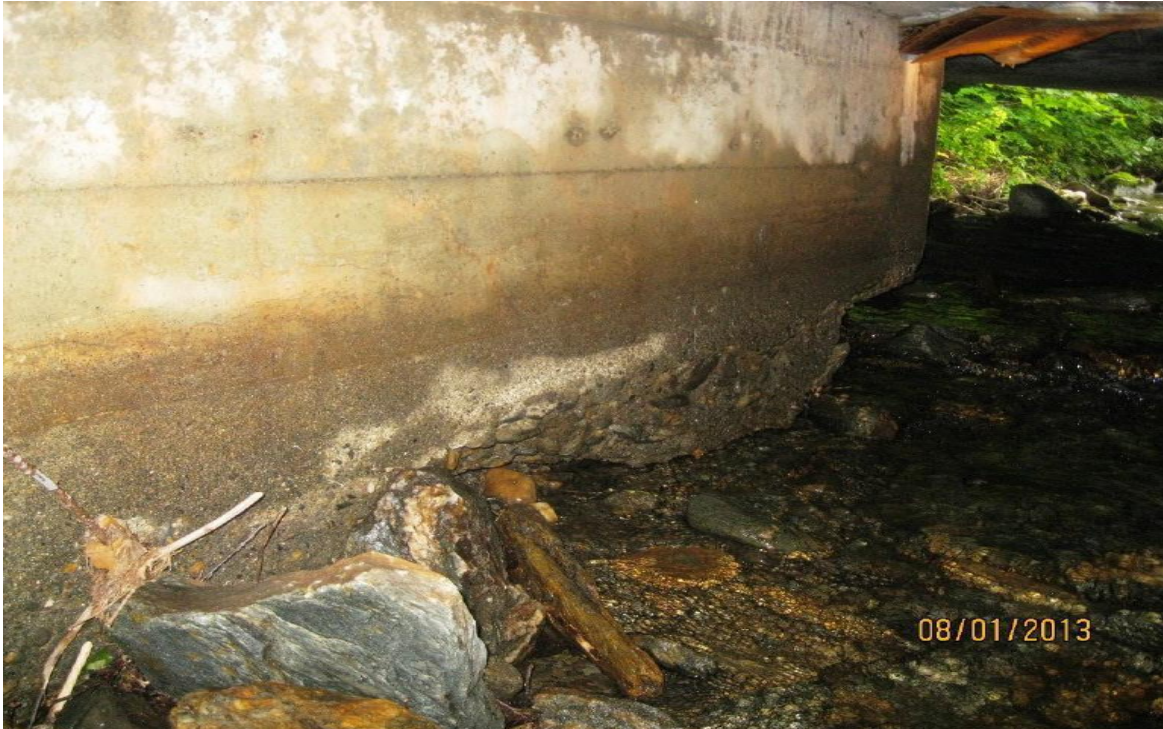
Concrete footings placed in stream flows are constantly subjected to hydraulic erosion effects. Figure 4.9 shows a footing on Vt.Rte.108 Stowe Br. #11 with erosion damage. Figure 4.10 shows a cast-in-place repair to the footing.

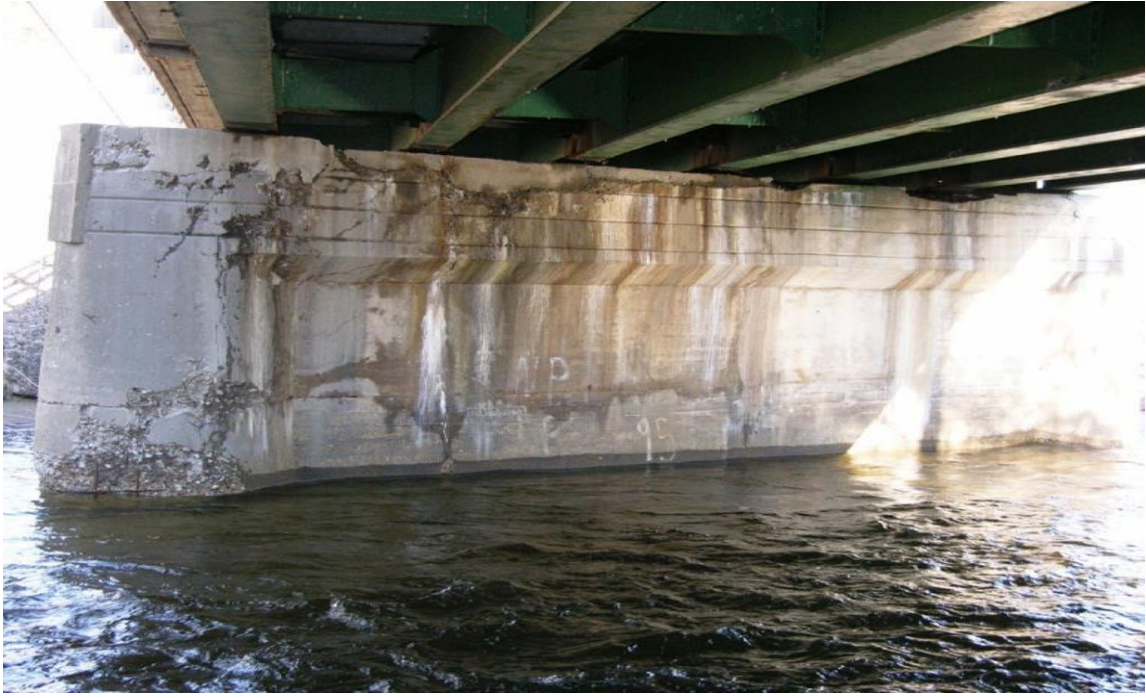
Figure 4.12 US4 Hartford Br. #65A – REPAIRED Pier/Pedestal Reconstruction, \$150,000

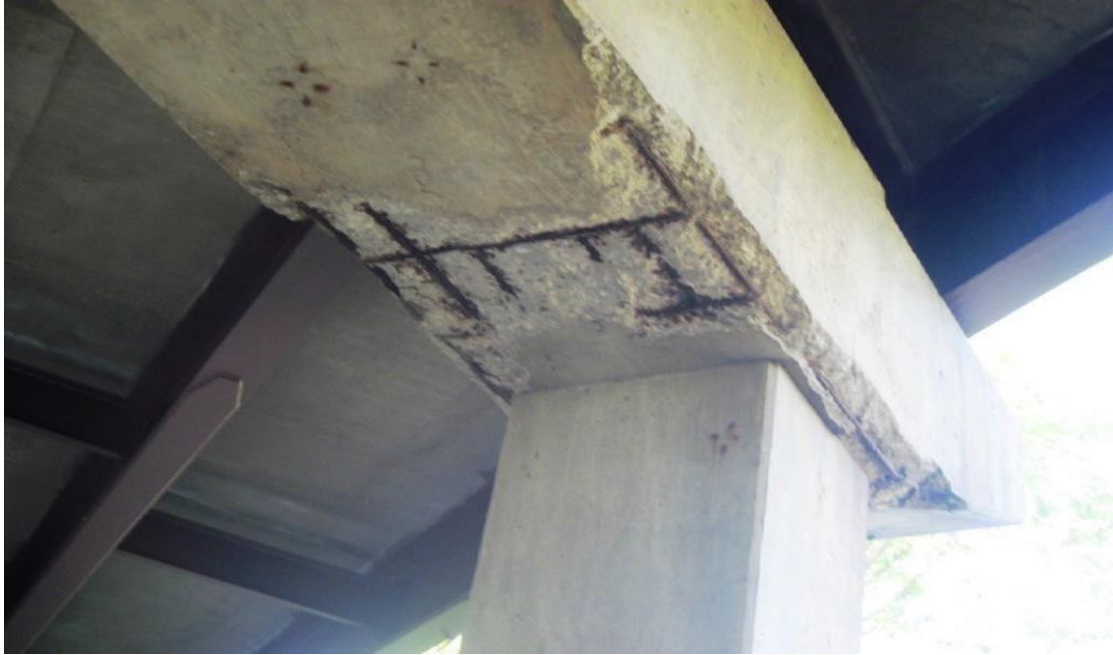
Figure 4.14 Vt. Rte. 11 Londonderry Br. #27 – REPAIRED Pier Repairs, \$120,000

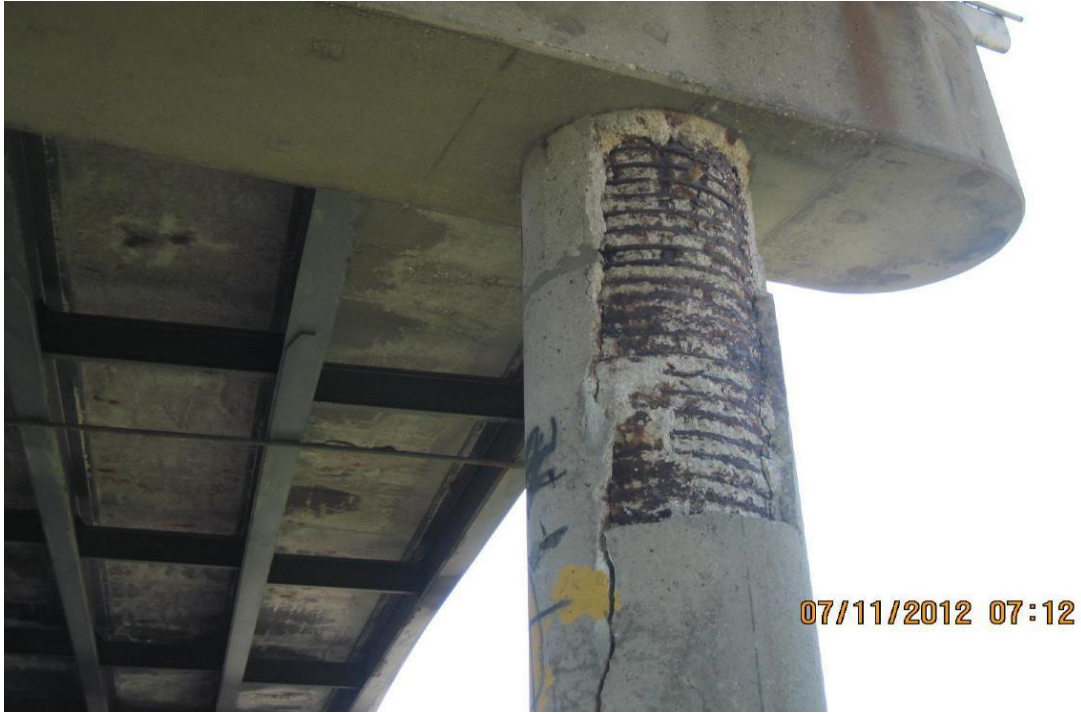
Figure 4.16 | 89 Richmond Br. #55 S – REPAIRED Bearing Seat/Pier repairs, \$150,000

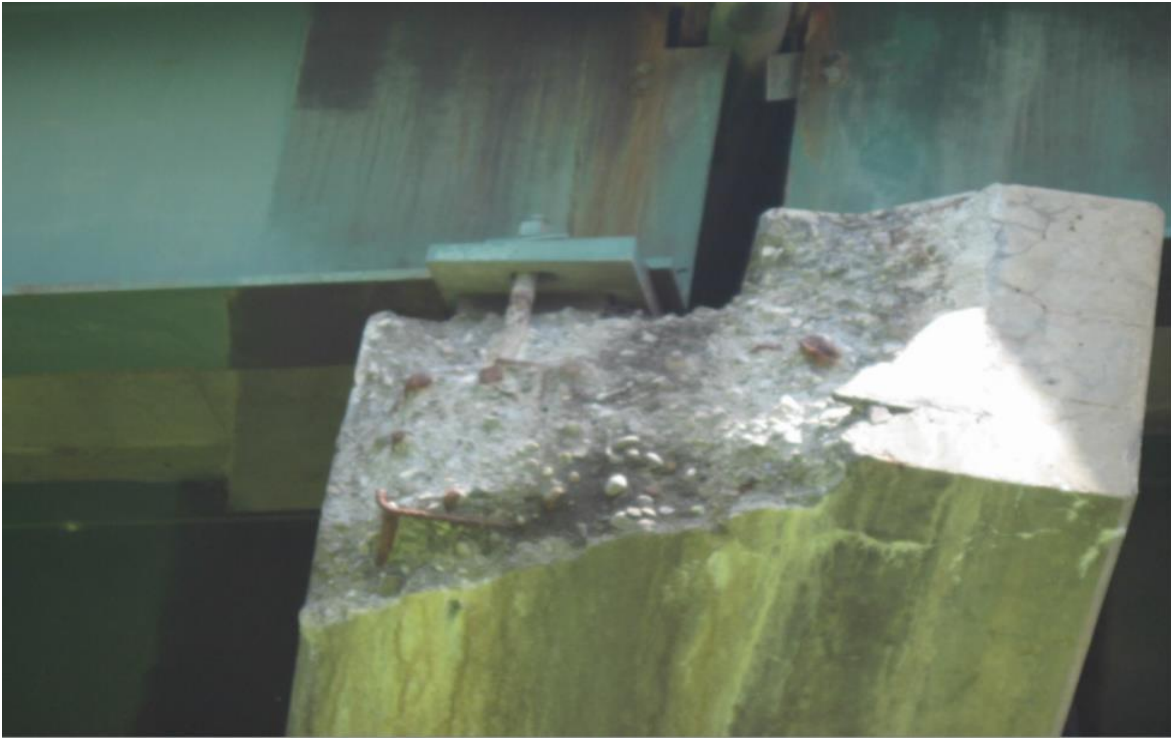
Figure 4.18 River Street Rutland City Br. #27 – REPAIRED

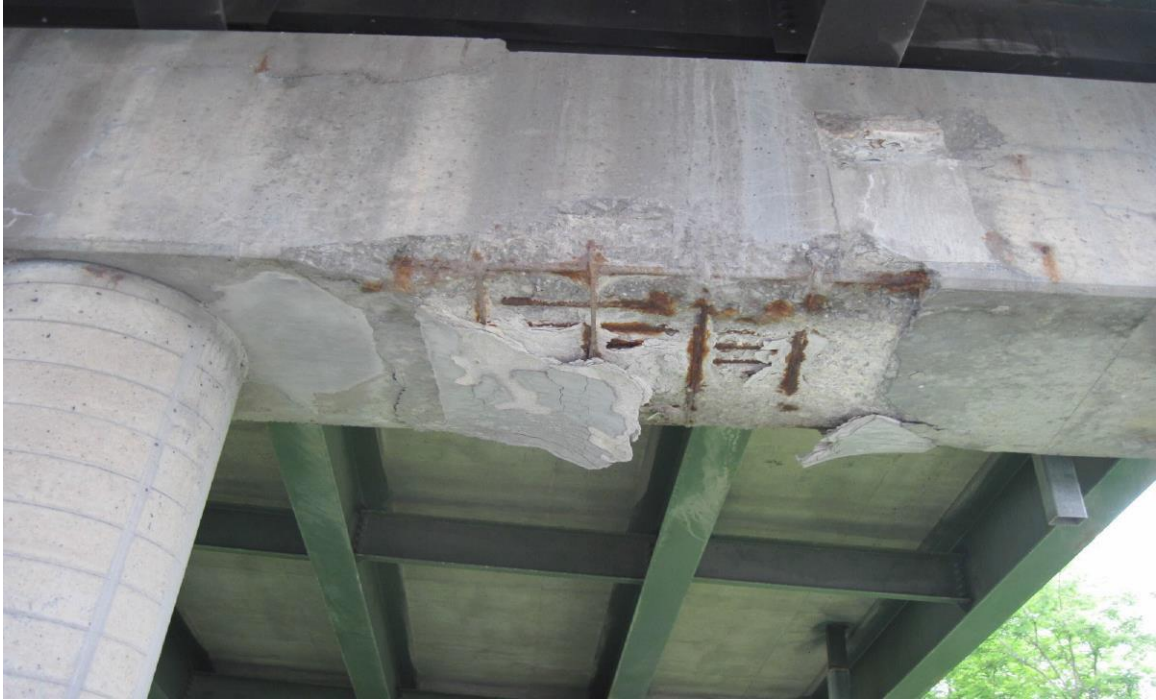
Figure 4.20 | 89 Williston Br. #60 – REPAIRED Pier Repairs, \$150,000

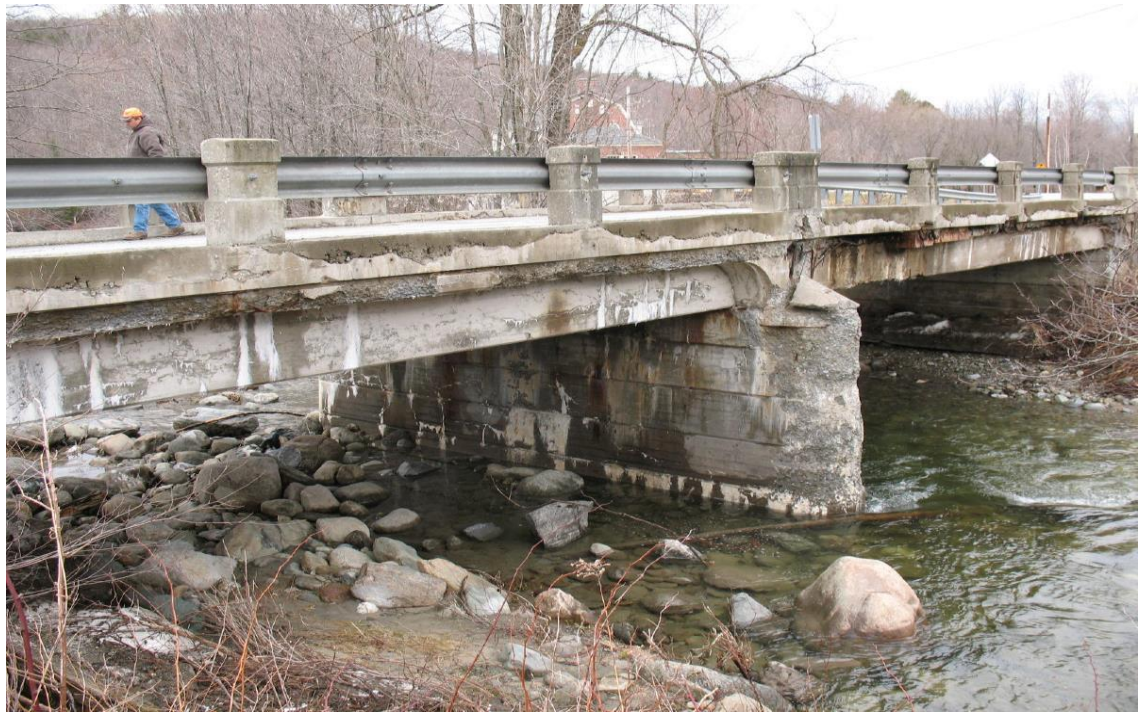
Many short span bridges in Vermont use combinations of integrated concrete beams and decks, with T-beam/deck combinations as common variants. The integration of concrete beams and decks produces an efficient structural form, but can result in combined damage to both the deck and beams, which leads to combined repairs. Figure 4.23 shows damage to both the deck and beams in Vt. Rte. 105A Richford Br. #2. Figure 4.24 shows a reconstruction repair. Figure 4.25 shows Vt. Rte. 12 Woodstock Br. #19 with considerable spalling from both the deck and the beam. Figure 4.26 shows the repaired bridge.

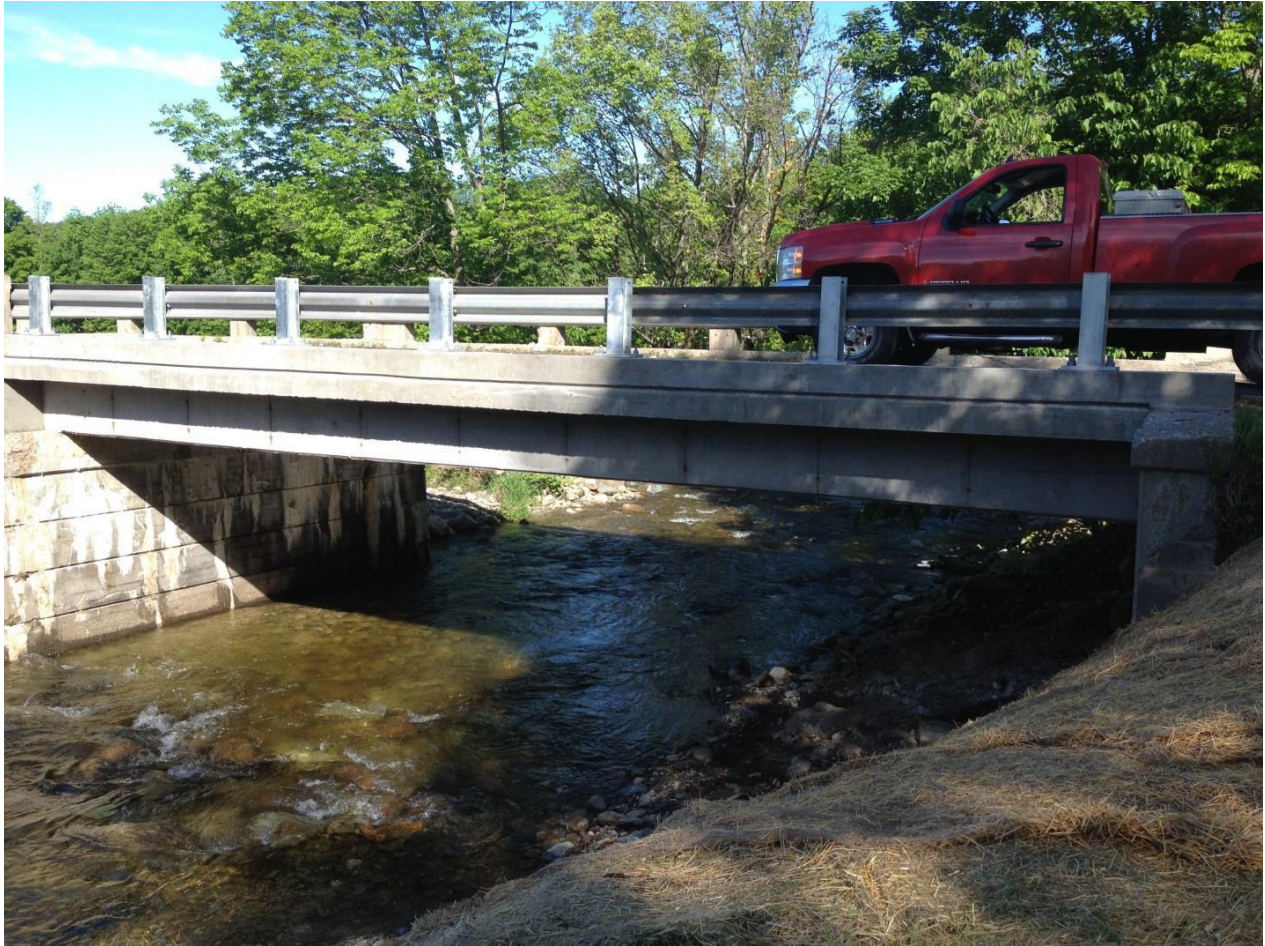
Figure 4.24 Vt. Rte. 105A Richford Br. #2 –REPAIRED T Beam/Deck Reconstruction \$150,000

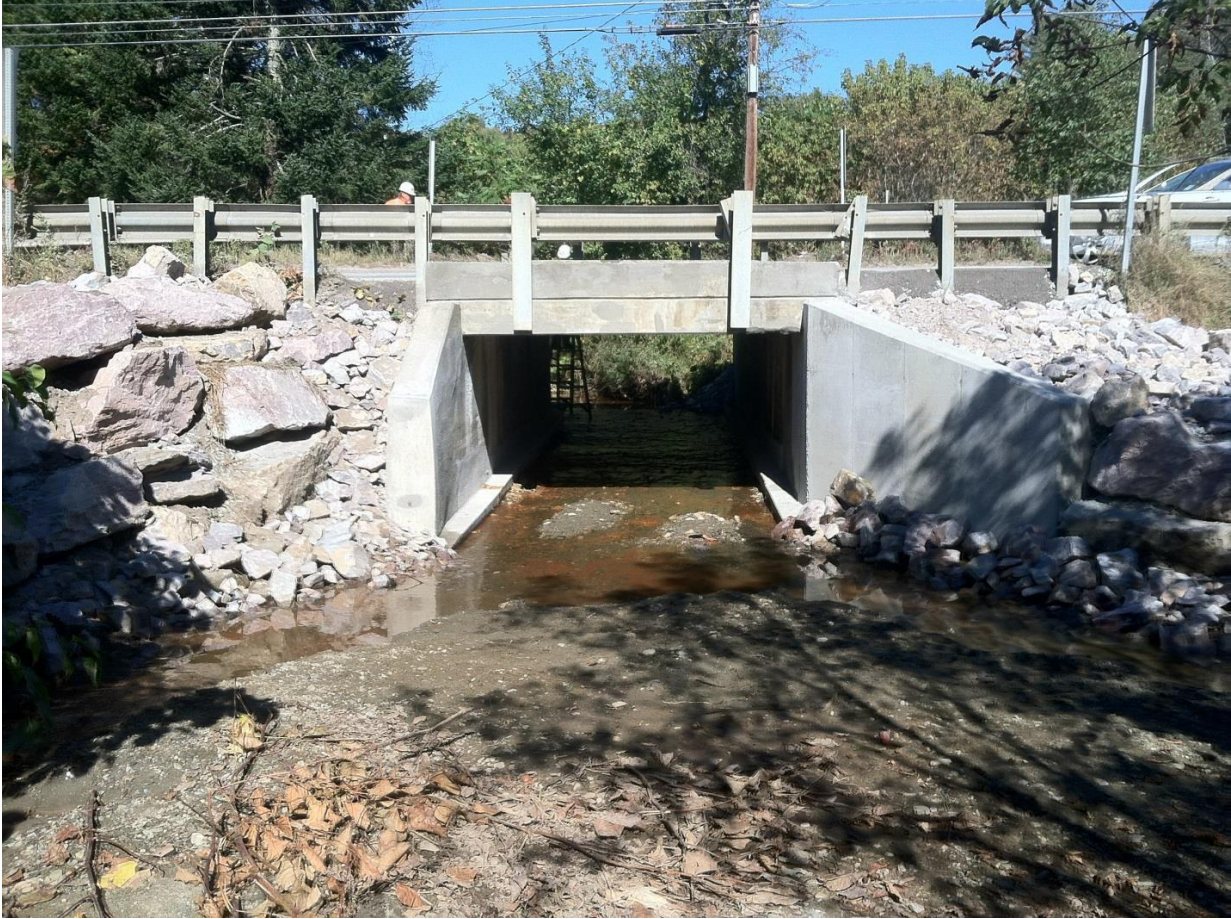
Figure 4.28 Vt. Rte. 12 Berlin Br. #70 - REPAIRED Head Wall/Wing Wall Reconstruction, \$150,000

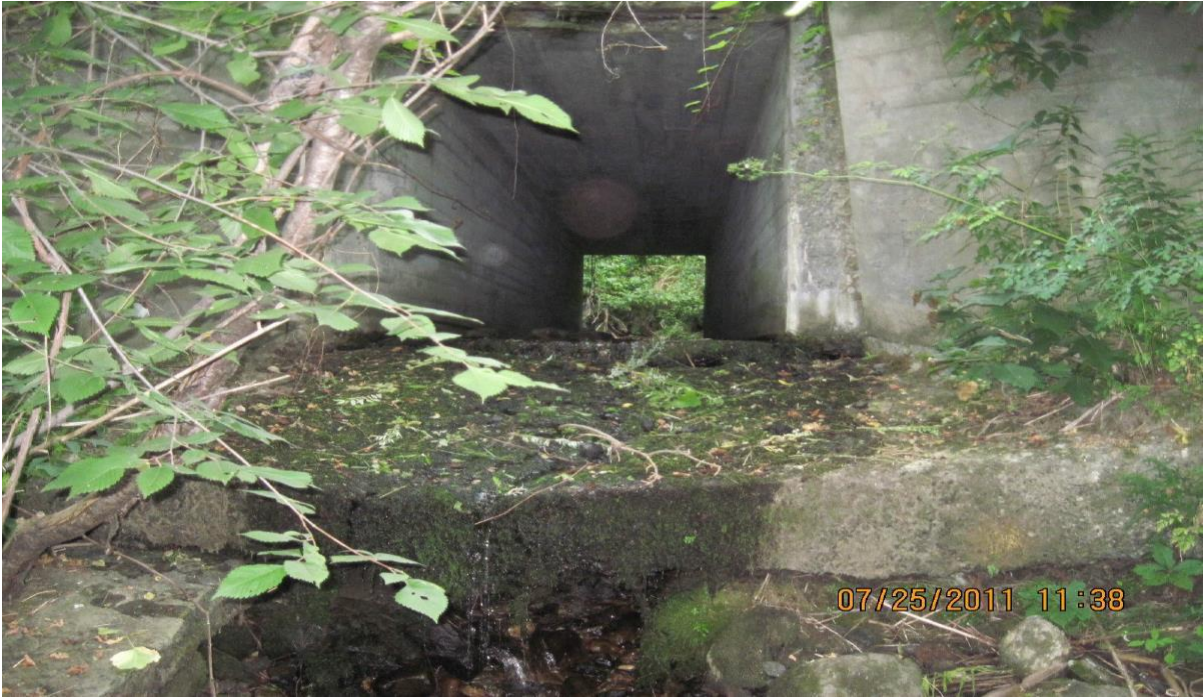
Figure 4.30 Vt. Rte. 12 Elmore Br. #95 - REPAIRED Wing Wall Encasement, \$100,000

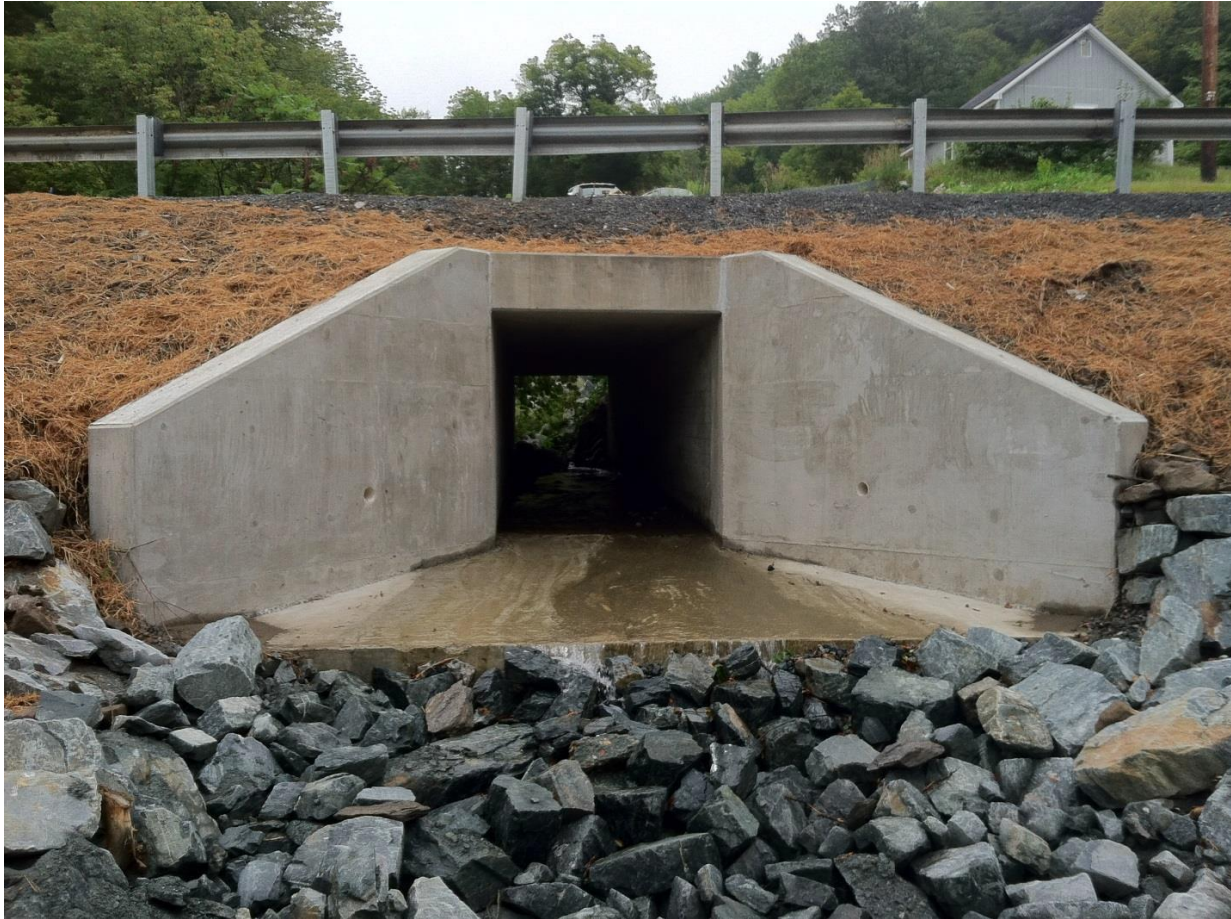
Figure 4.32 Vt.Rte.14 Hartford Br.#7 - REPAIRED Wing Wall/ Cut-off Wall Reconstruction \$180,000

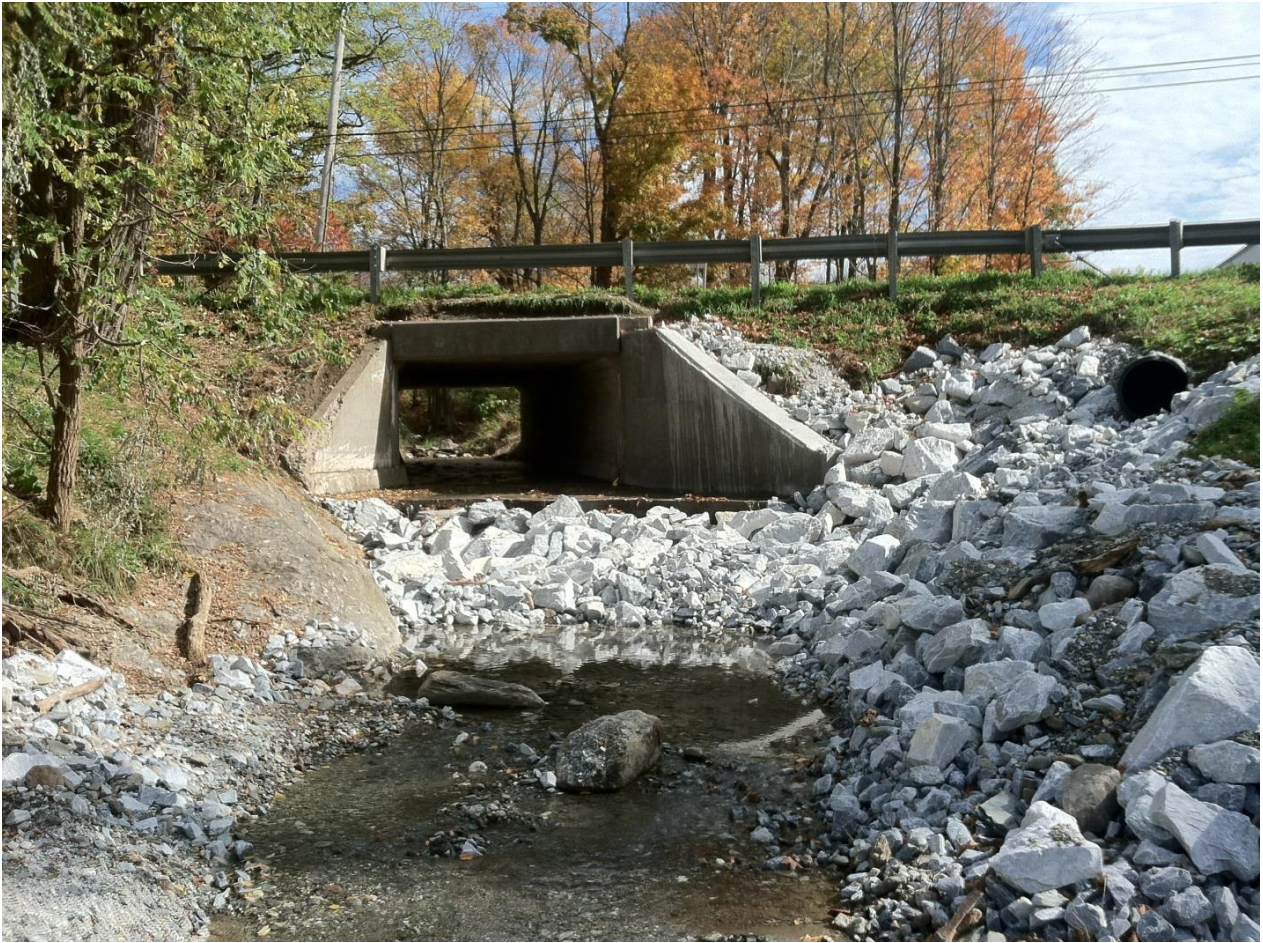
Figure 4.34 Vt. Rte. 30 Pawlet Br. #78 - REPAIRED Wing Wall reconstruction, \$80,000

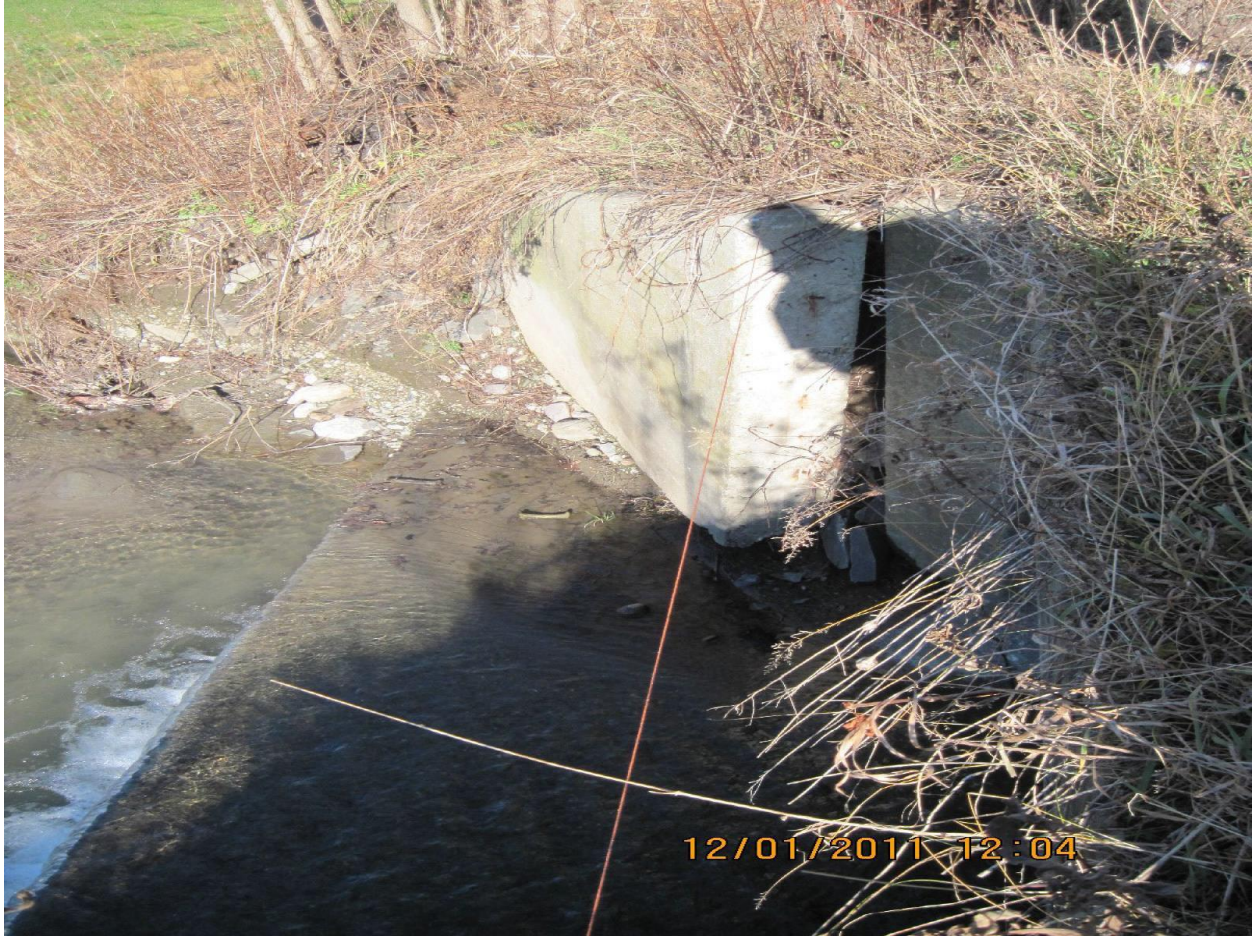
Figure 4.35 Vt. Rte. 30 Pawlet Br. #77

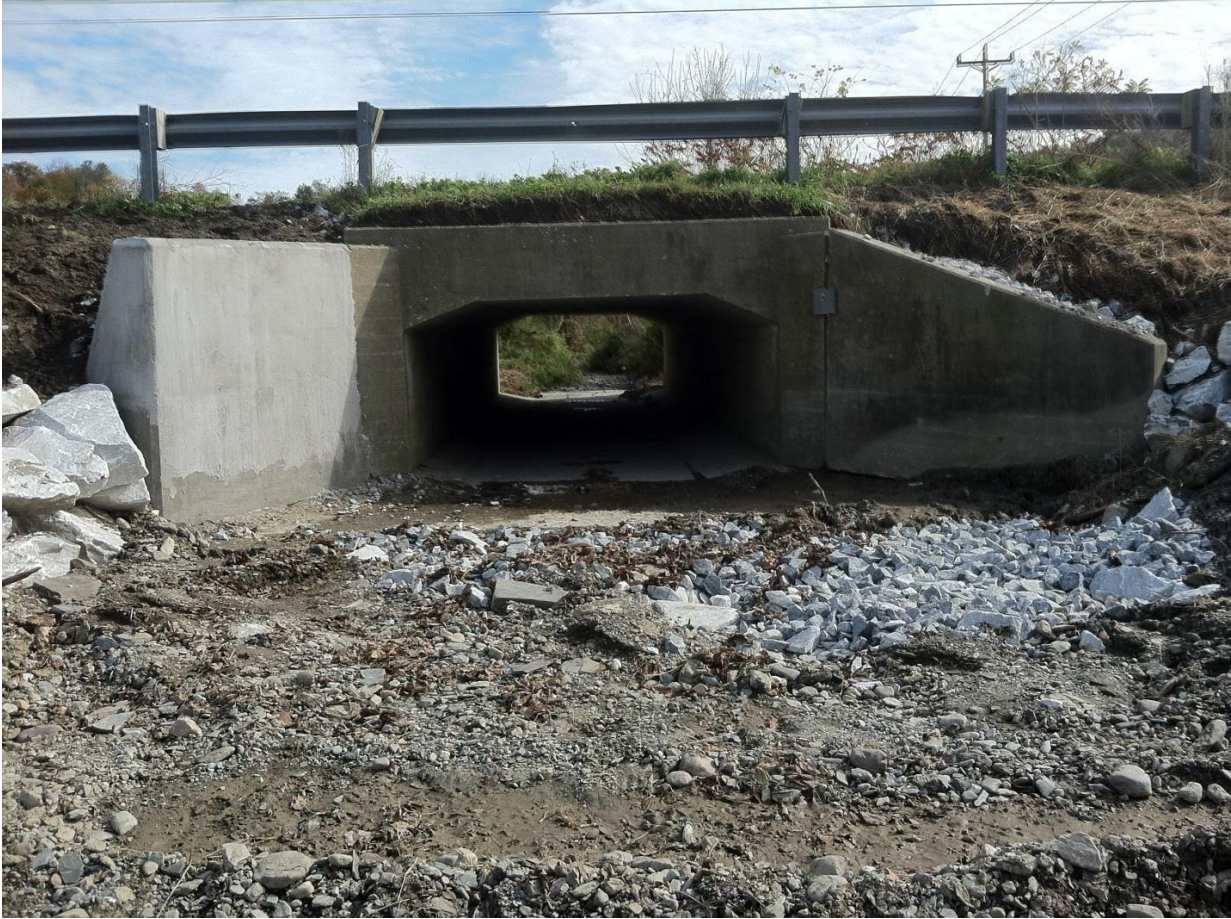
Figure 4.36 Vt. Rte. 30 Pawlet Br.#77 - REPAIRED Wing Wall/ Cut-off Wall Reconstruction \$100,000

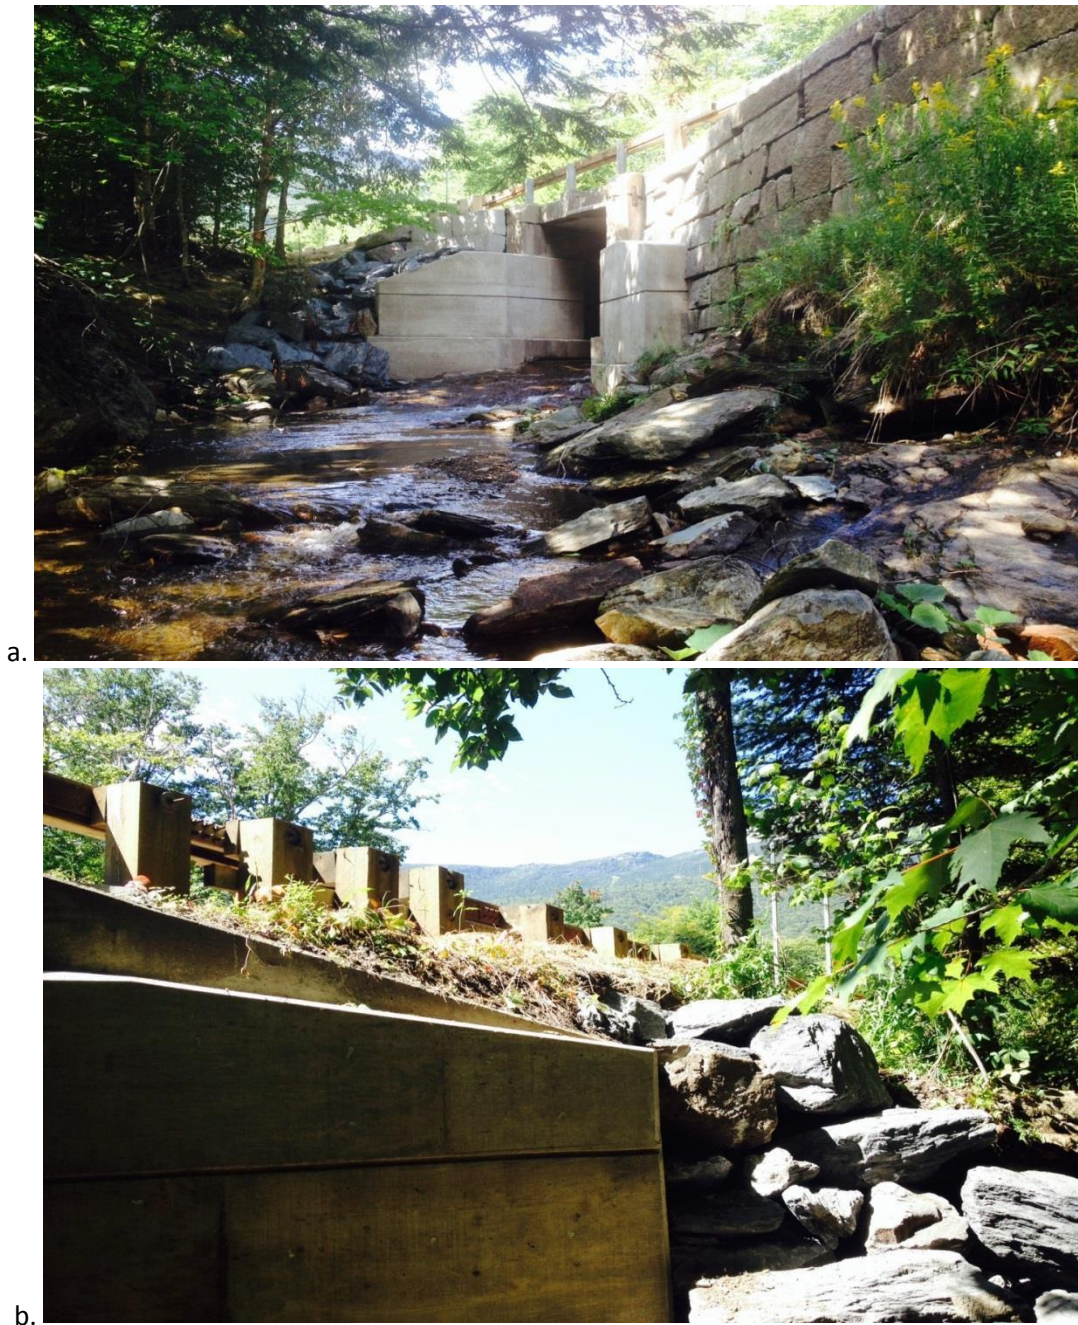
Figure 4.38 Vt. Rte. 108 Stowe Br. #10 – Repaired Wing Wall Encasement/ Other Repairs, \$200,000

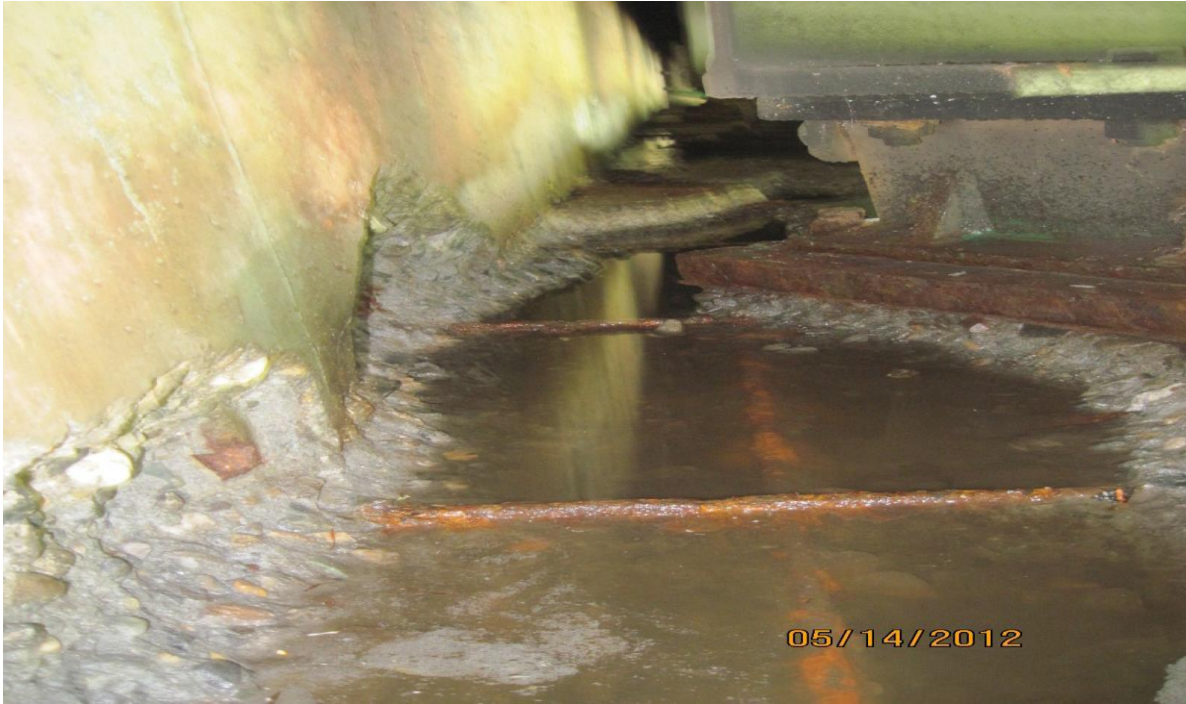
Some bridges suffer more than one type of damage. In these cases, it can be expeditious to perform multiple component repairs in one setting. Figure 4.39 I 91 Hartford Br. #42 N/S had damage to the abutments, piers and drainage system. Figure 4.40 shows the repairs. Figure 4.41 Vt. Rte. 113 Vershire Br. #11 had severe damage to both the deck and wingwalls. The repairs appear in Figure 4.42.

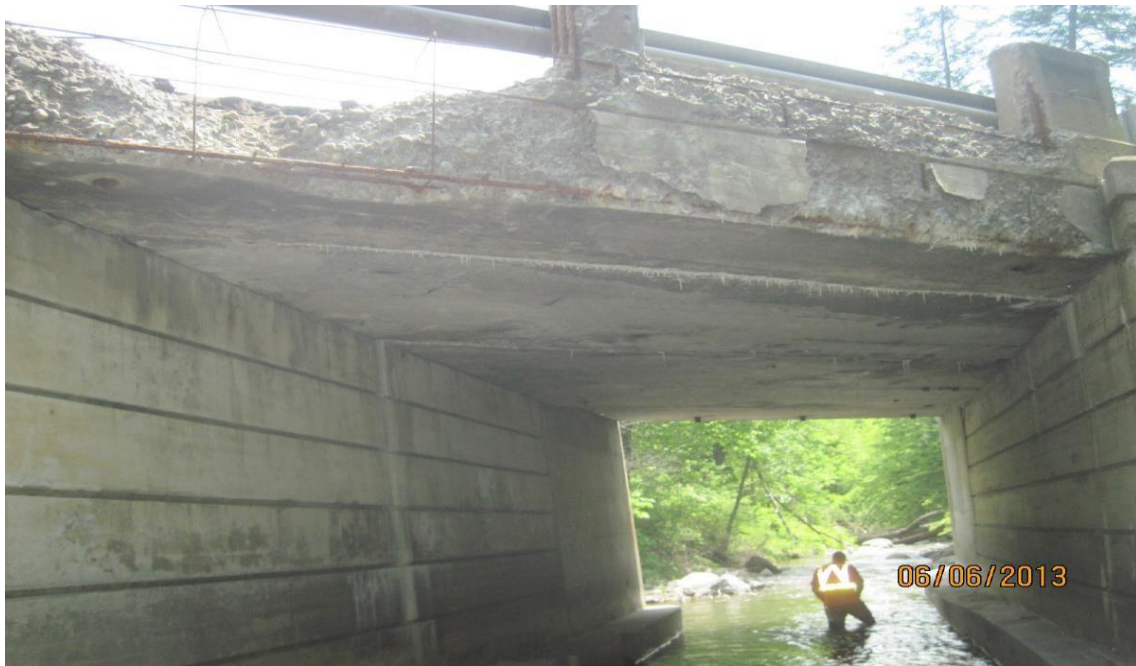
Figure 4.40 | 91 Hartford Br. #42-REPAIRED Abutment/Pier Repairs/Drain System \$125,000
