1. Report No.	2. Government Accession No.	3. Recipient's Catalog No.
4. Title and Subtitle Cost-Effective and Rapid Concrete Repair Techniques		5. Report Date February 8, 2016

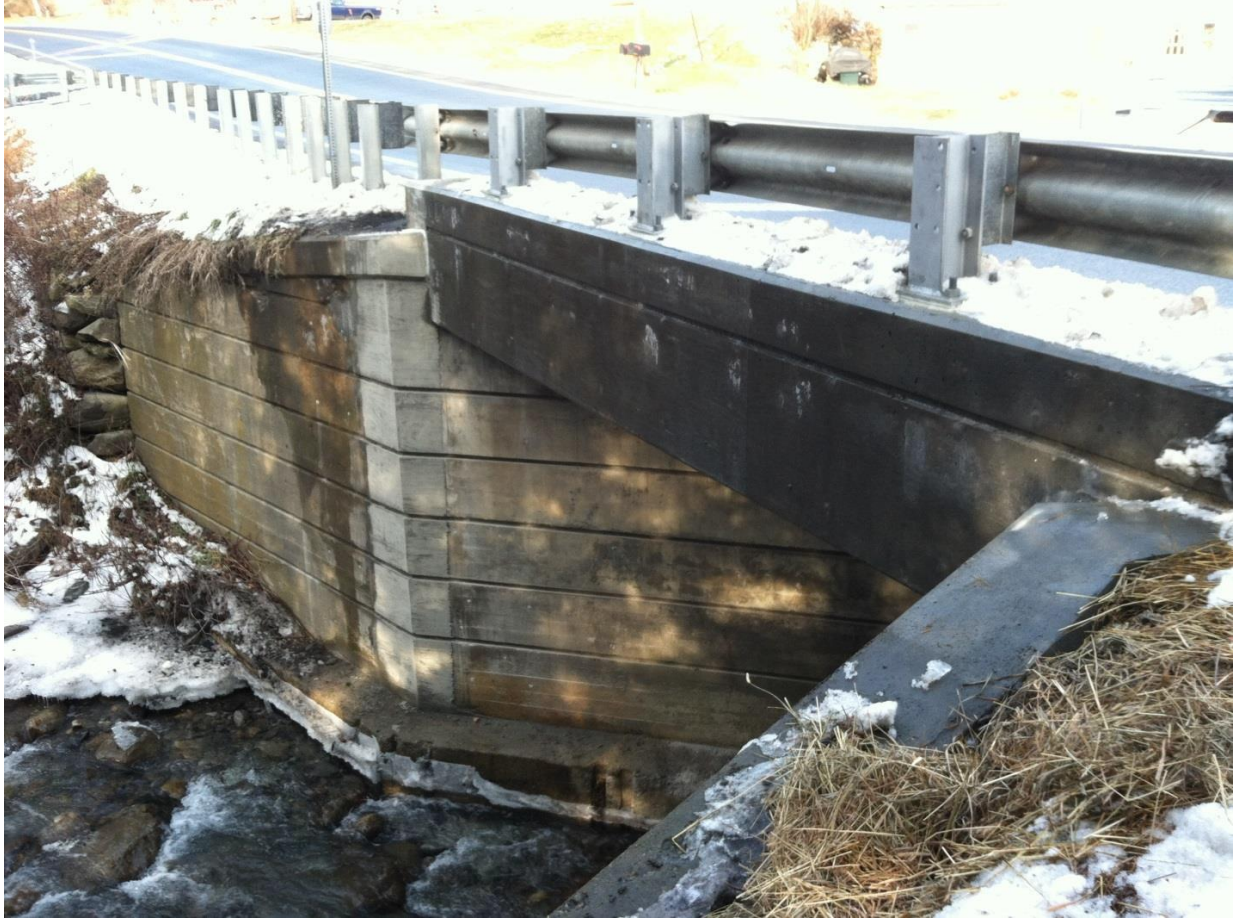
Figure 4.42 Vt. Rte. 113 Vershire Br. #11 - REPAIRED Deck/Wing Wall Repairs, \$150,000

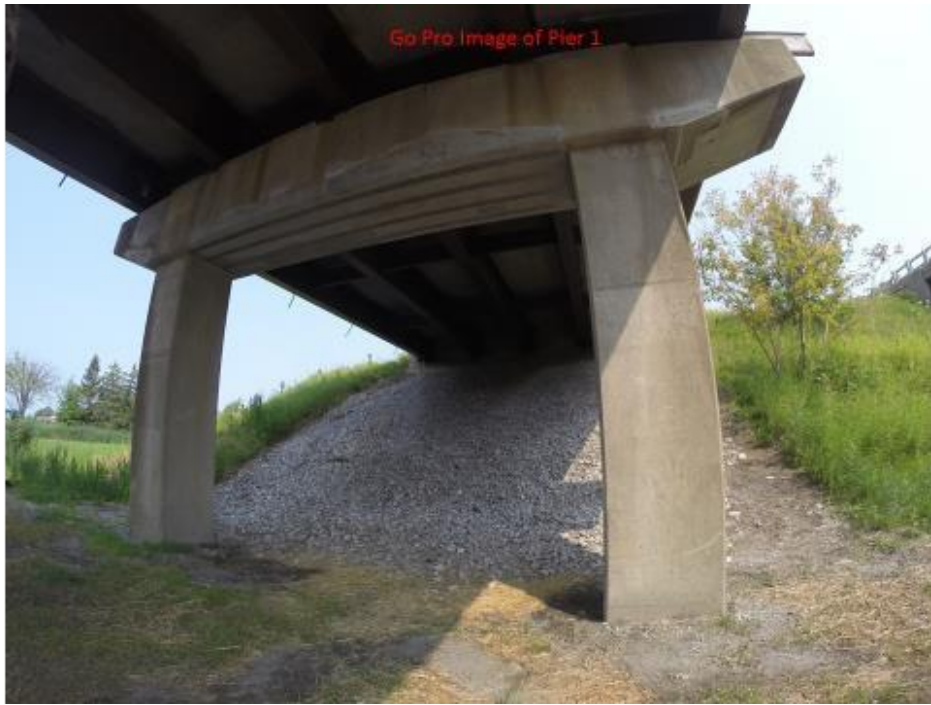
Figure 5.1 Swanton I 89 overpass bridge with FRP strengthening strips bonded to the pier cap

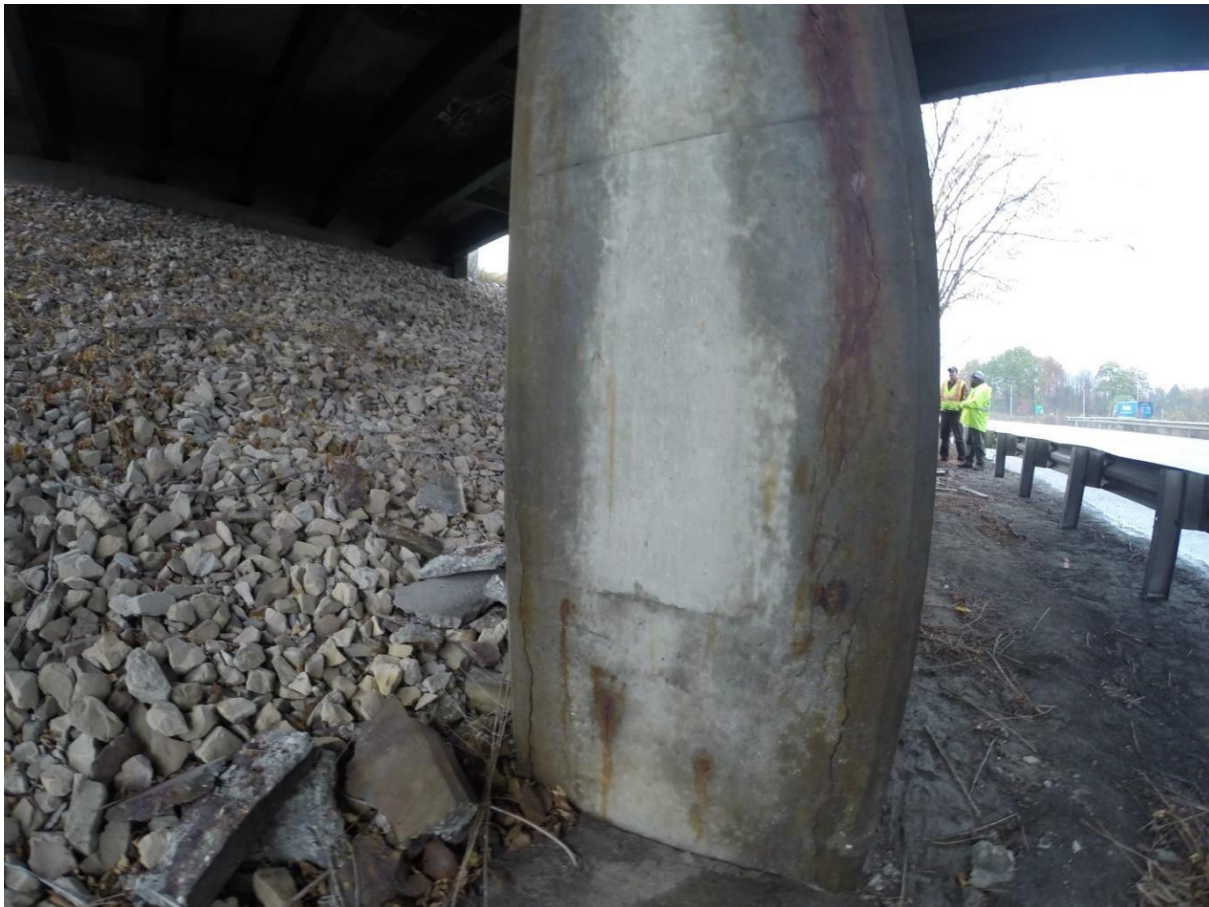
Figure 5.9 Column on Colchester/Milton I-89 Bridge showing cracking, likely due to swelling corroded reinforcing bars

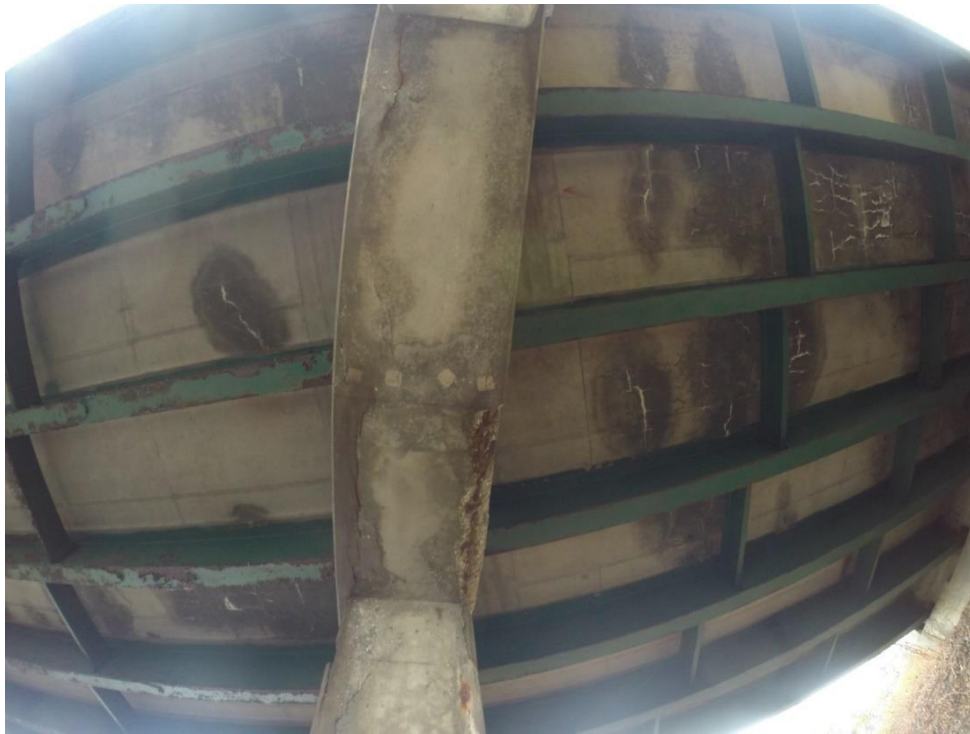
Figure 5.10 Spalling on underside of pier on Colchester/Milton I-95 Bridge. The deck is also showing some distress.

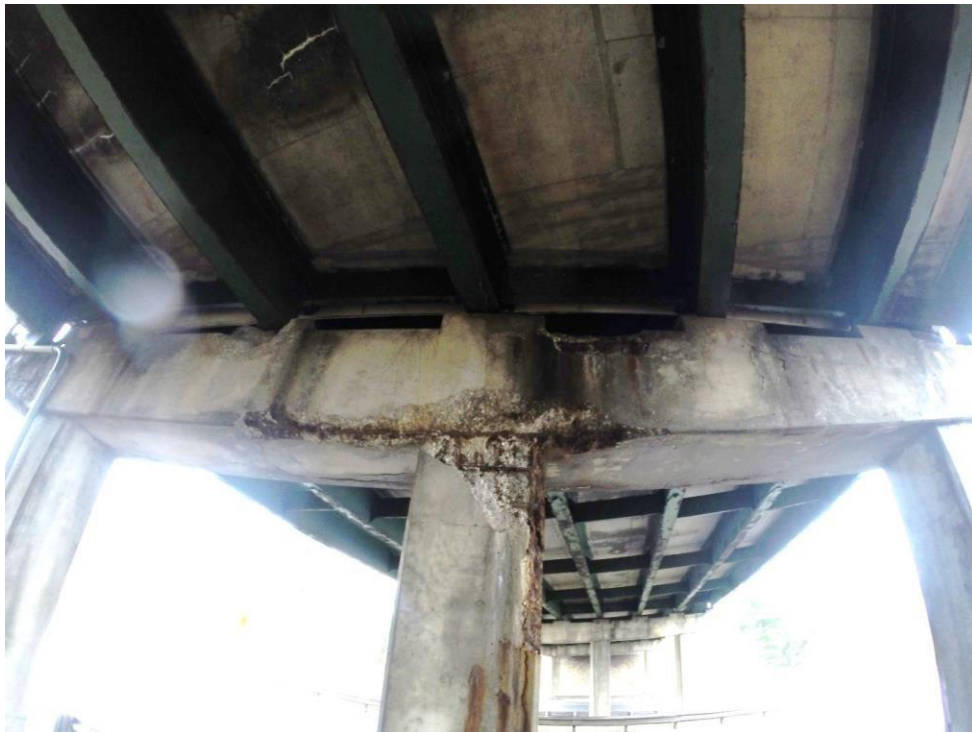
Figure 5.11 Spalling on pier cap of Colchester/Milton I-89 Bridge

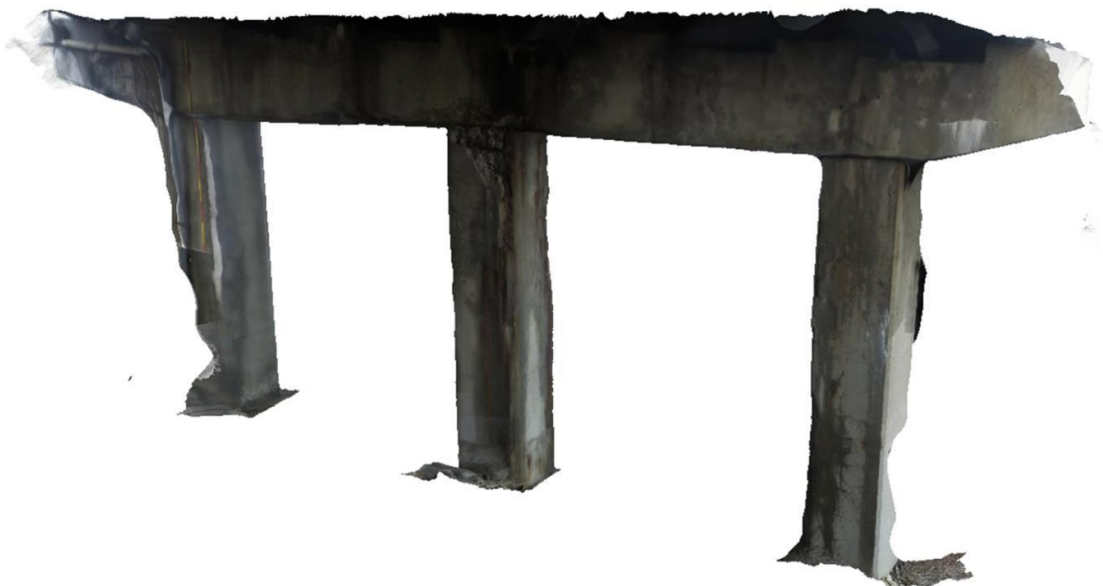
Figure 5.13 3-D photogrammetric point cloud rendering of Colchester/Milton I-89 Bridge

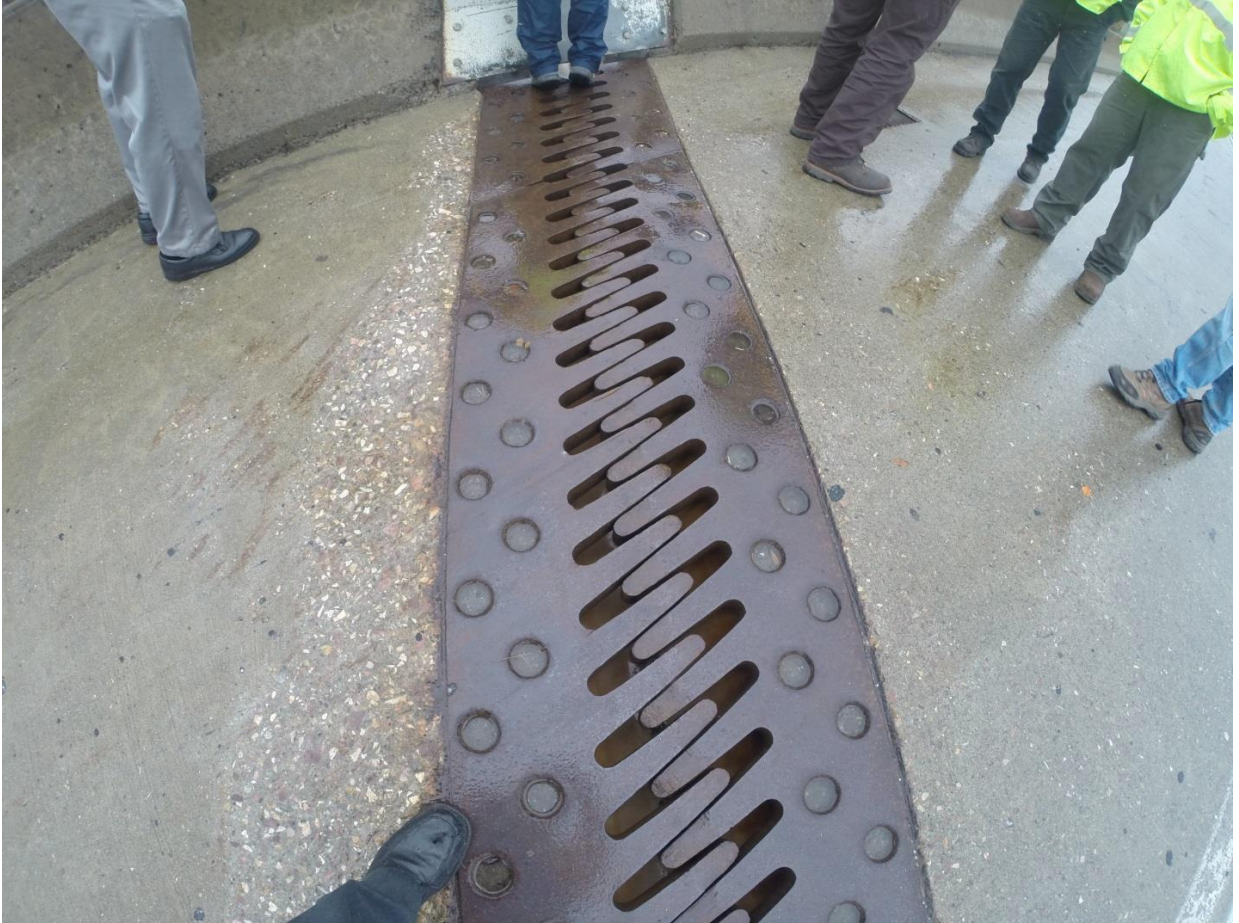
Figure 5.17 Finger expansion joint on US 2 Lamoille River Crossing Bridge

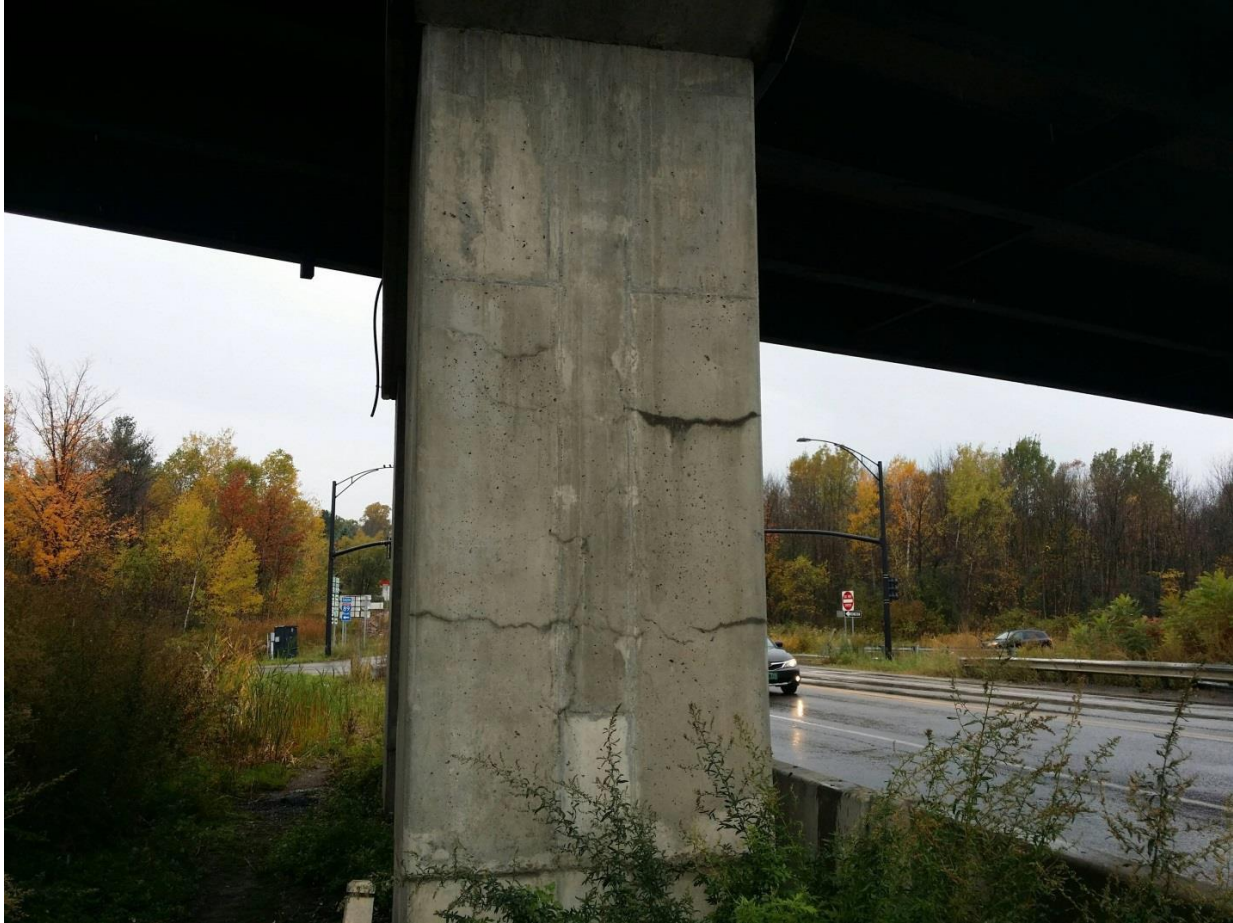
Figure 5.19 Encasement repaired column on Williston I-89 Overpass Tafts Corner, with visible cracking

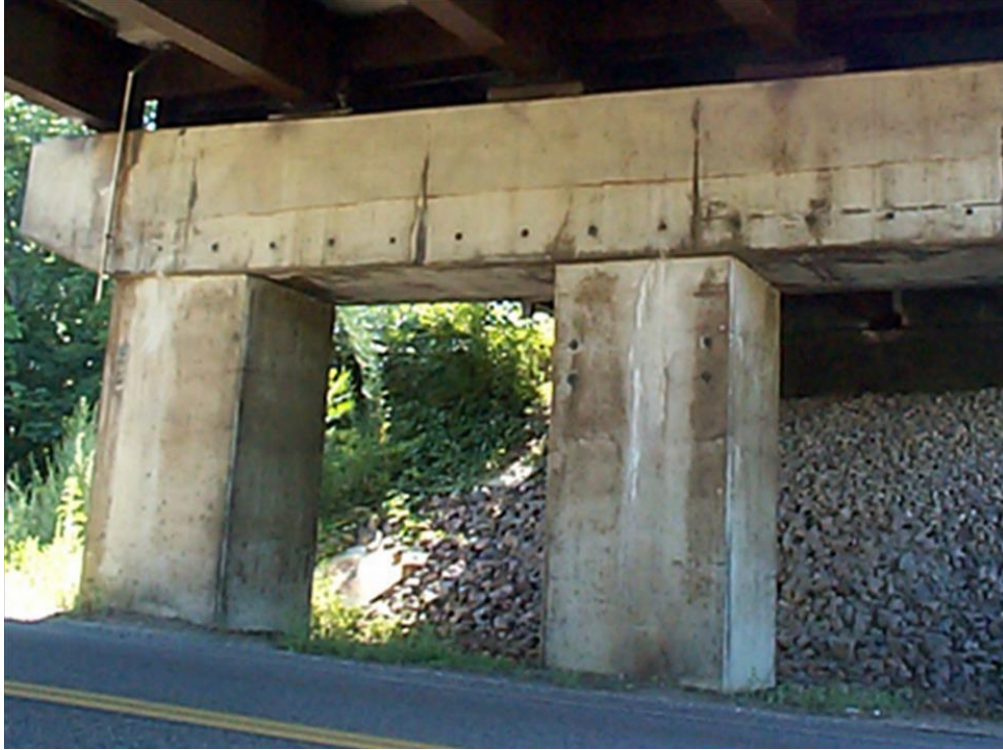
Figure 5.20 Spear St. I 189 Overpass Bridge pier in 2000 recently encased, with cracks

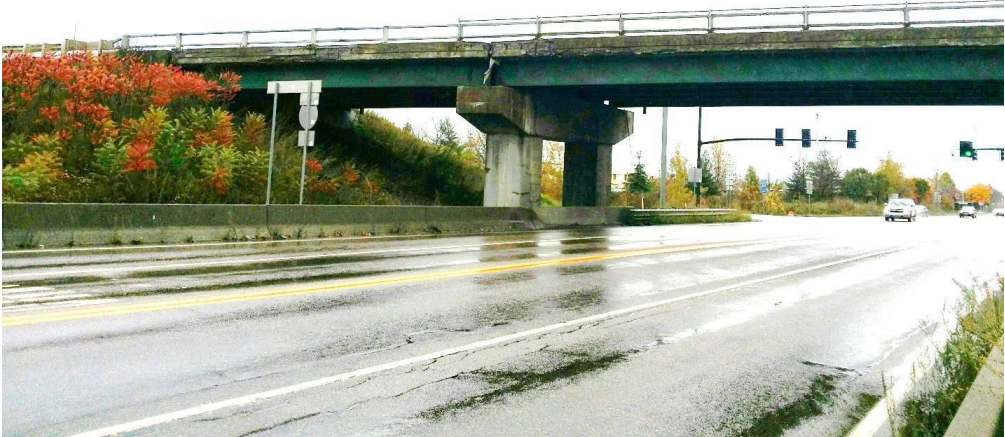
Figure 5.21 Williston I-89 Overpass Tafts Corner with encasement repair of the pier, failed expansion joint gutter and distressed fascia

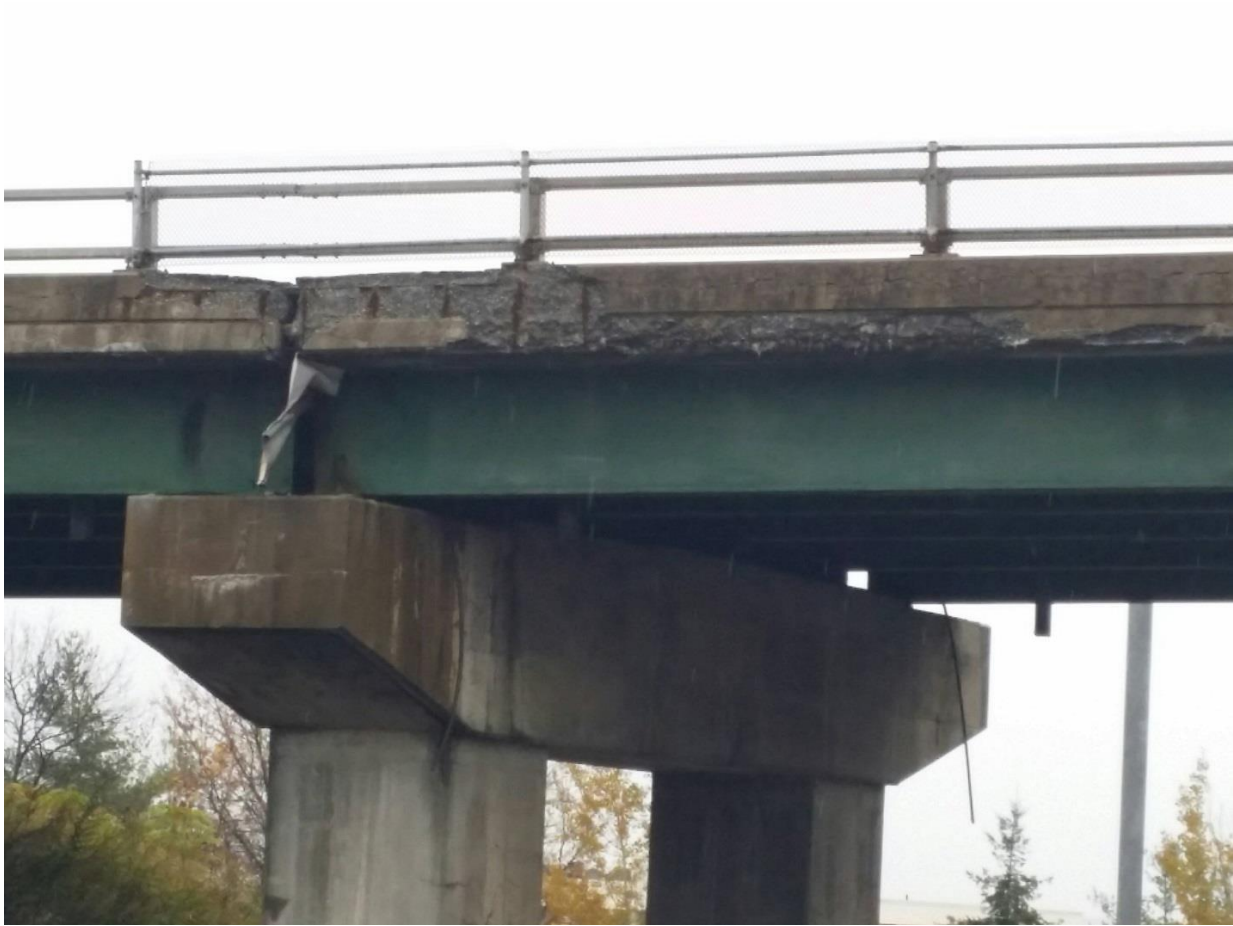
Figure 5.22 Closeup of Williston I-89 Overpass Tafts Corner with encasement repair of the pier, failed expansion joint gutter and distressed fascia

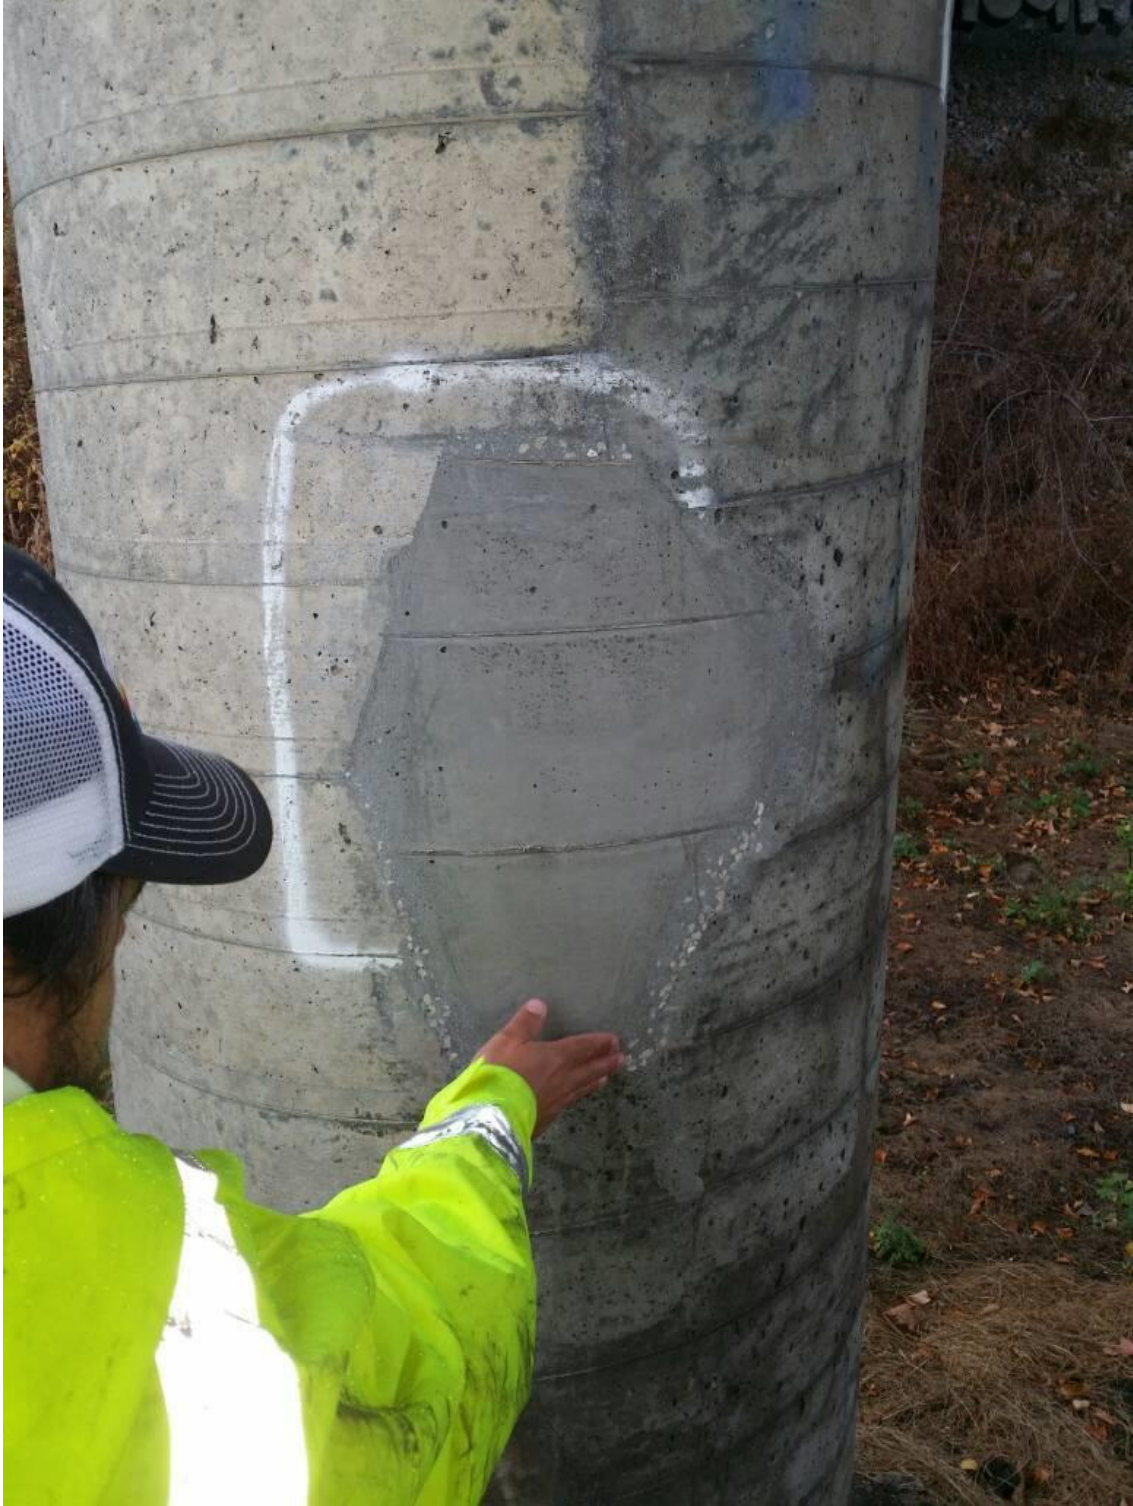
Figure 5.23 Small column patch repair #1 on Williston I-89 Oak Hill Rd Underpass Bridge

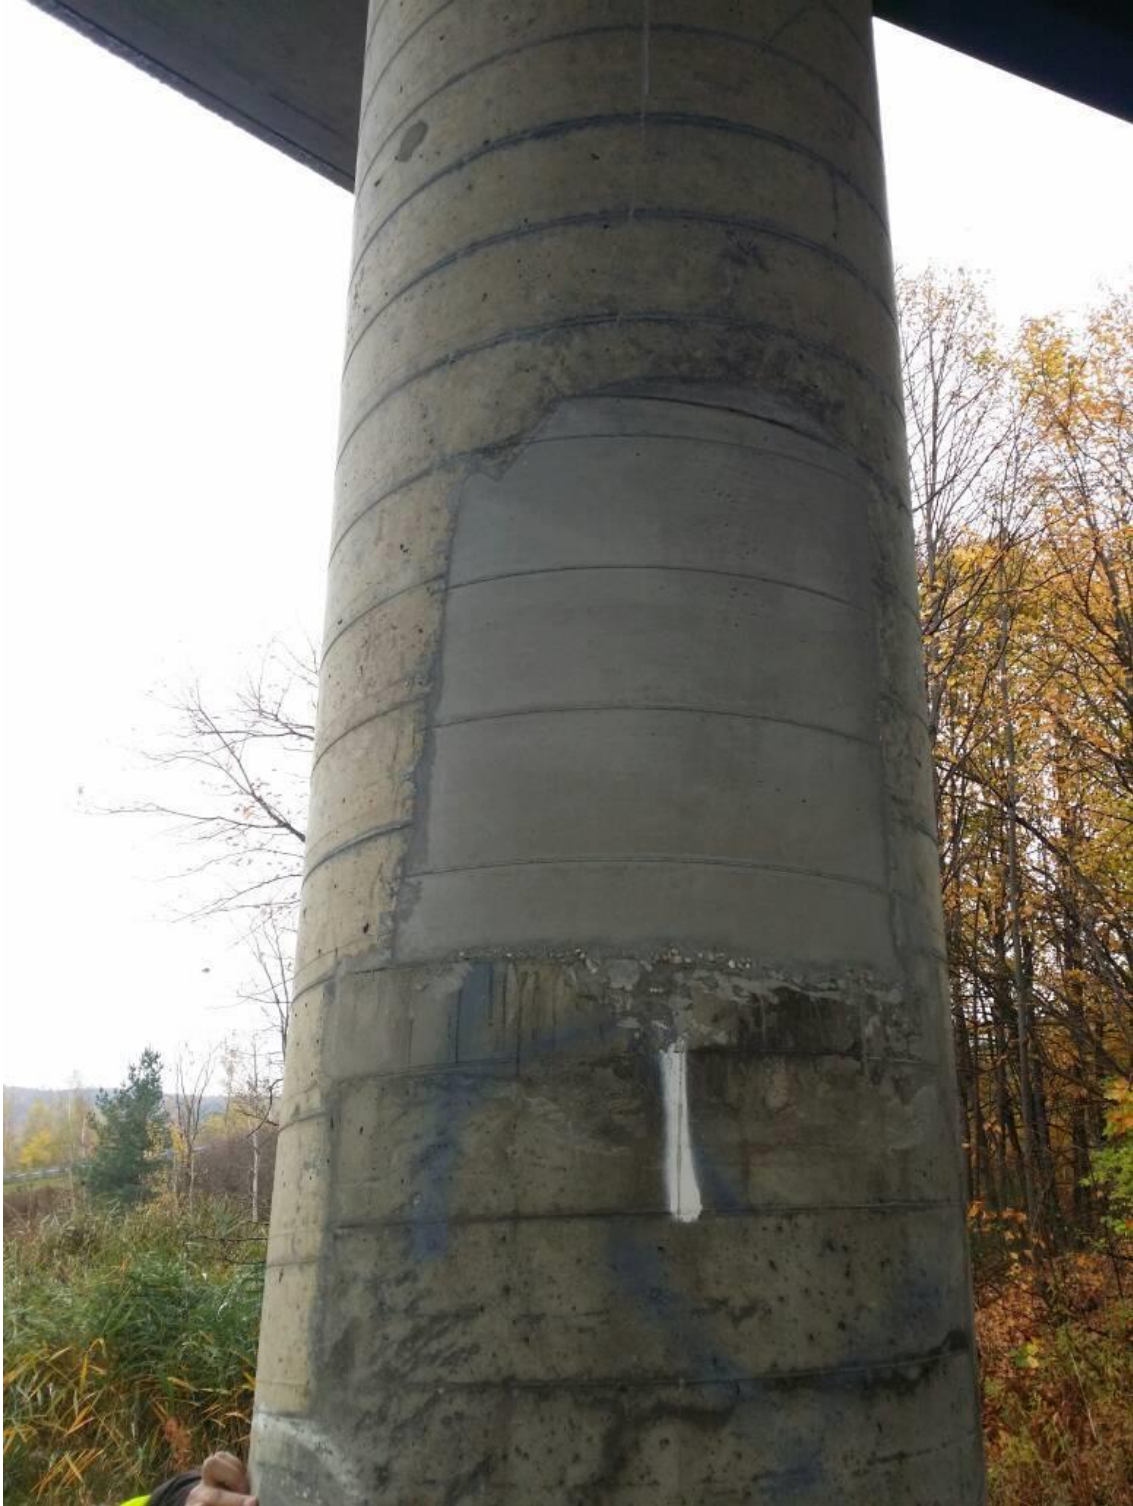
Figure 5.24 Small column patch repair #2 on Williston I-89 Oak Hill Rd Underpass Bridge

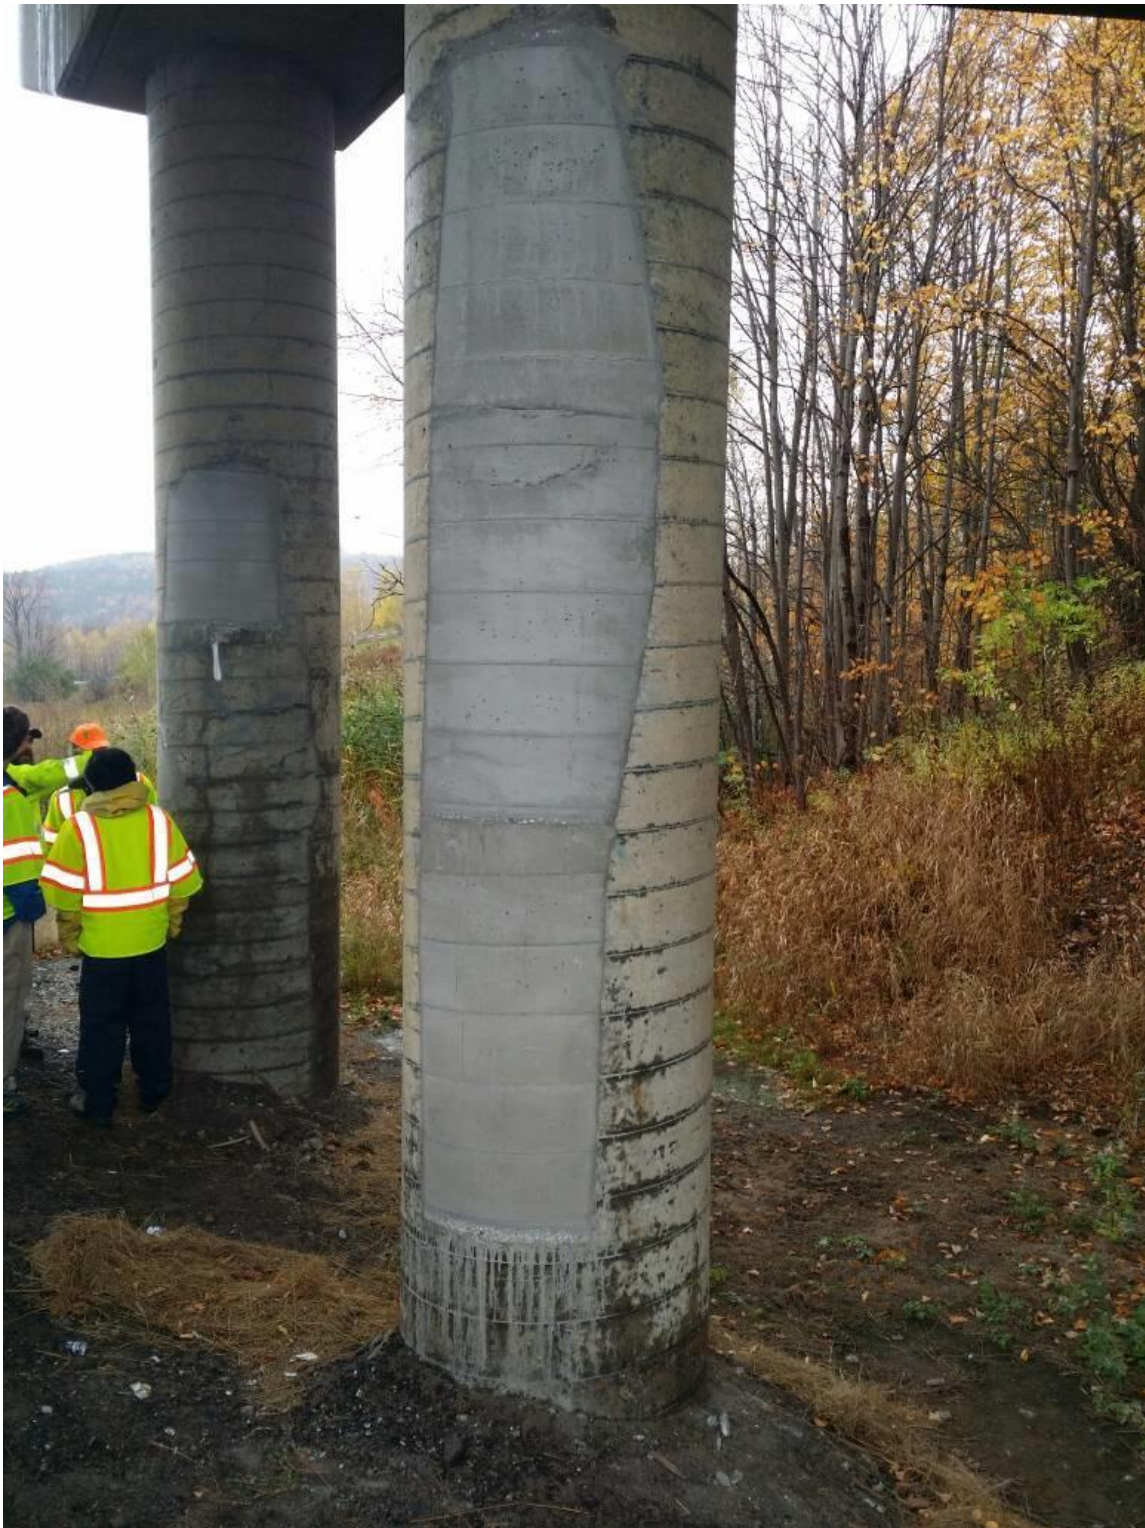
Figure 5.25 Large column patch repair #1 on Williston I-89 Oak Hill Rd Underpass Bridge

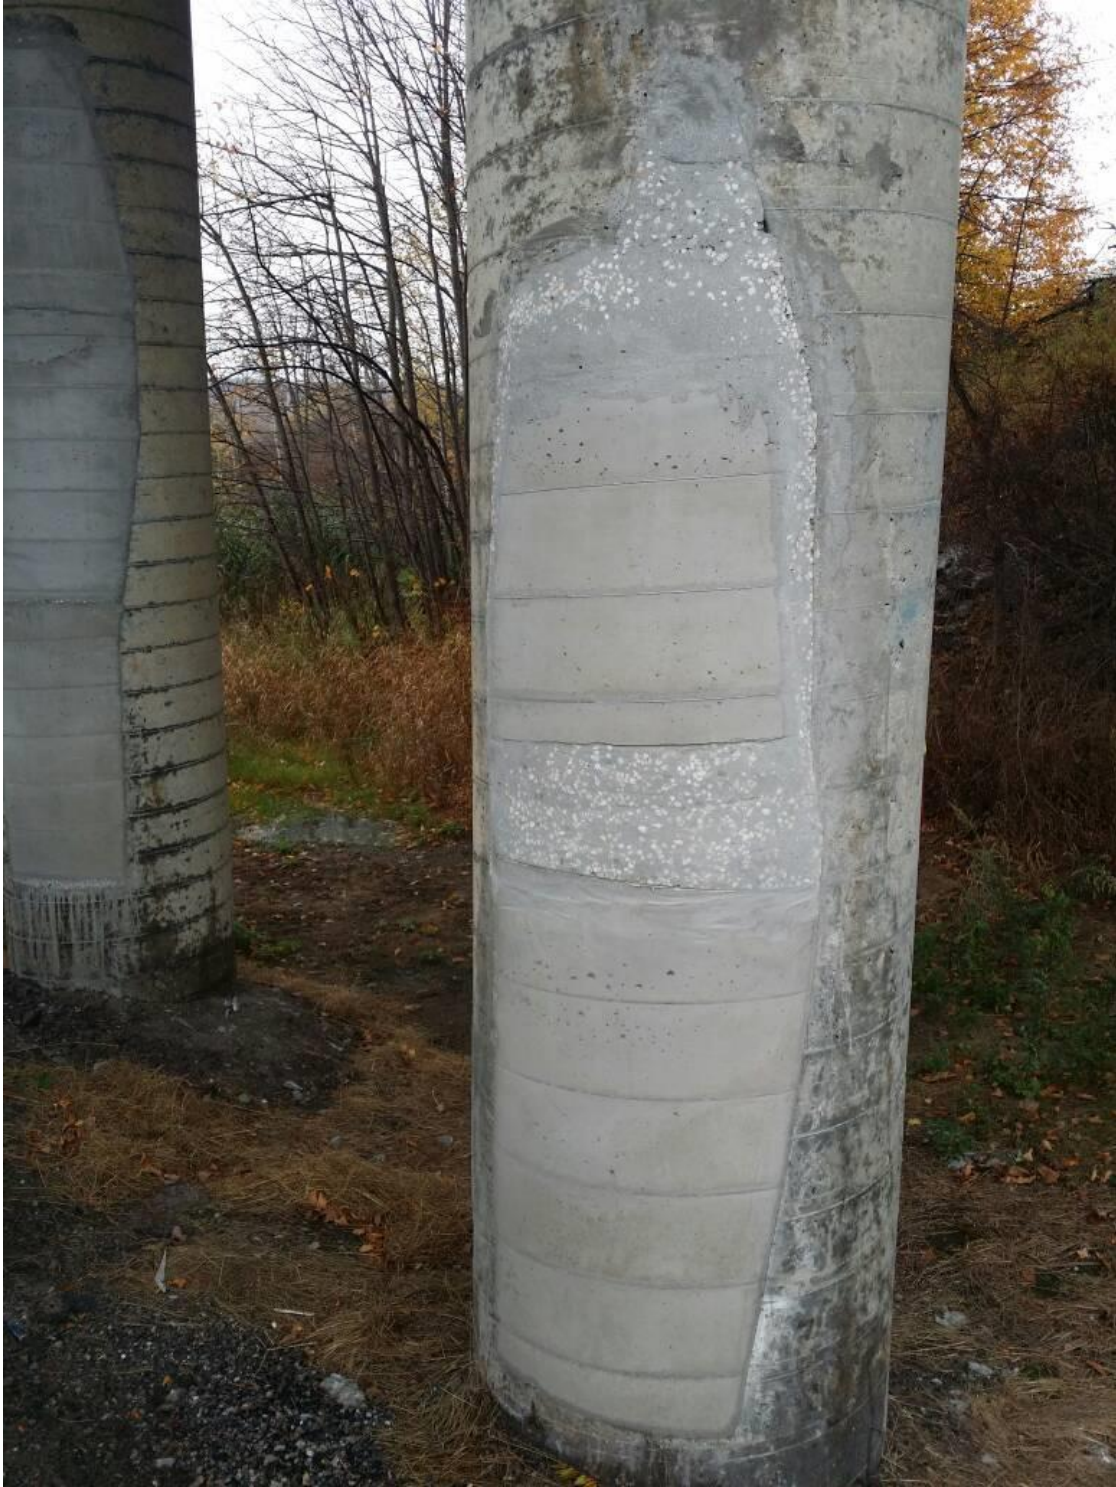
Figure 5.26 Large column patch repair #2 on Williston I-89 Oak Hill Rd Underpass Bridge

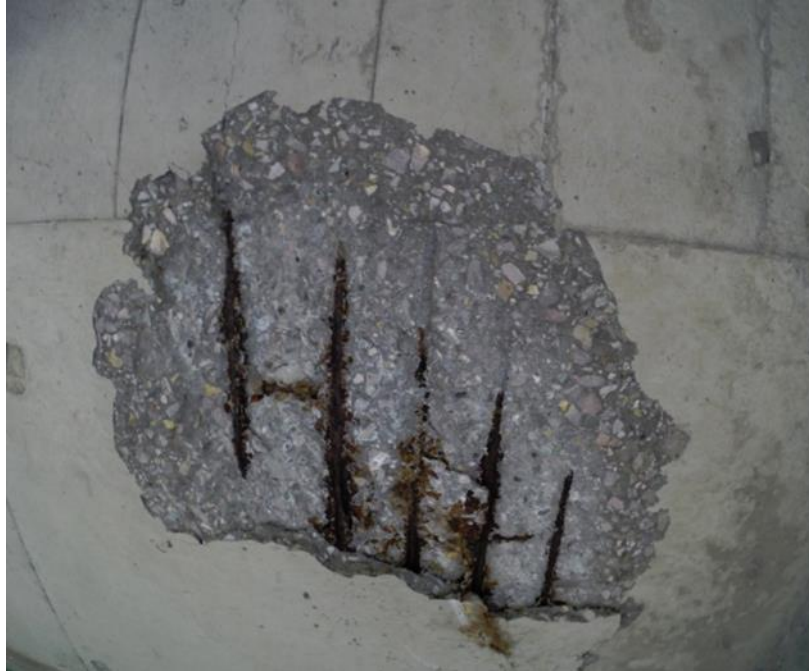
Figure 5.27 Underside Deck Spalling on Williston I-89 Oak Hill Rd Underpass Bridge

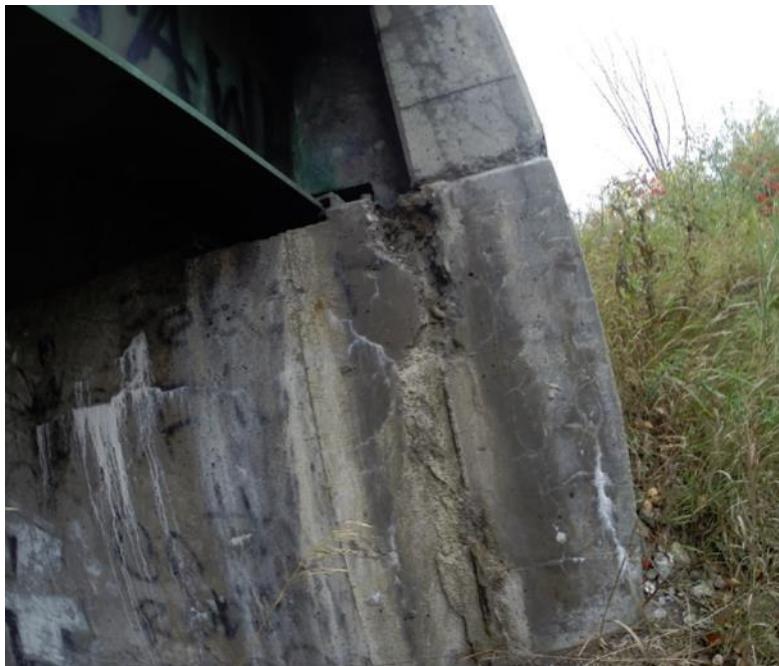
Figure 5.28 Scaling on Abutment and Beam on Williston I-89 Oak Hill Rd Underpass Bridge

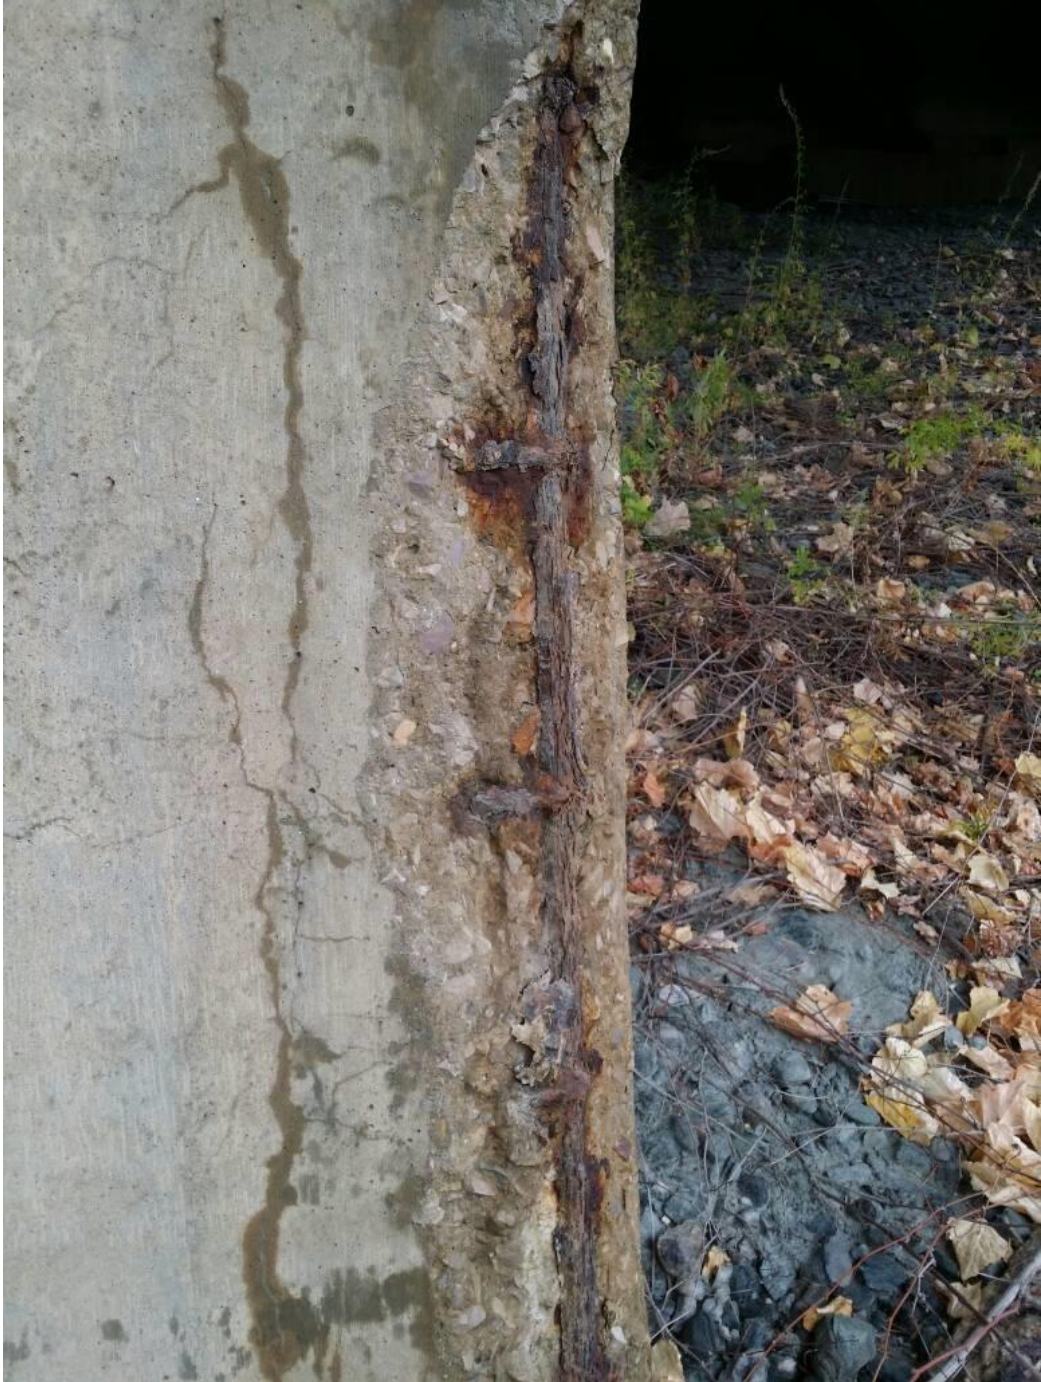
Figure 5.29 Distressed column on Richmond I-89 US 2 Underpass Bridge

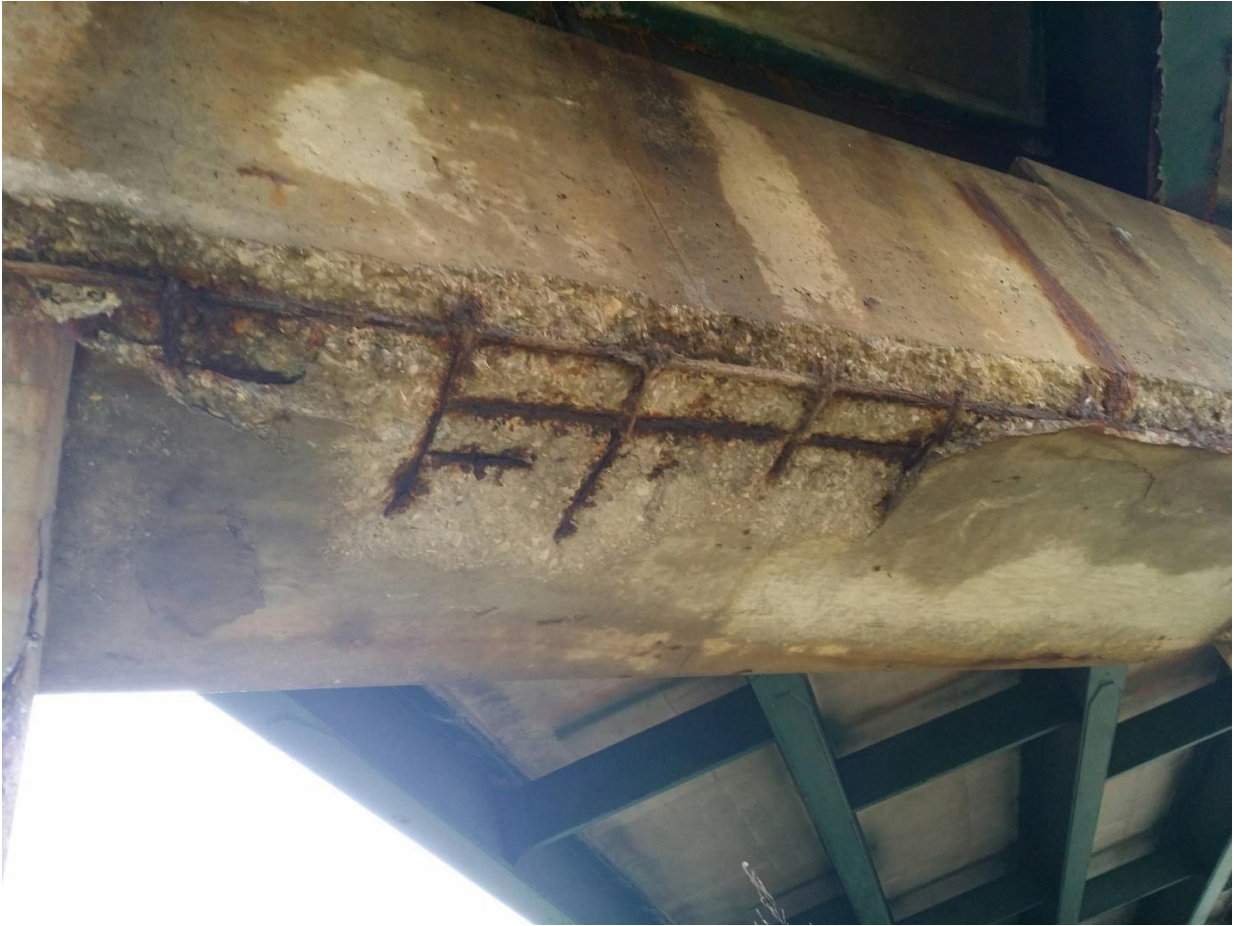
Figure 5.32 Pier cap with spalling on Richmond I 89 US 2 Underpass Bridge

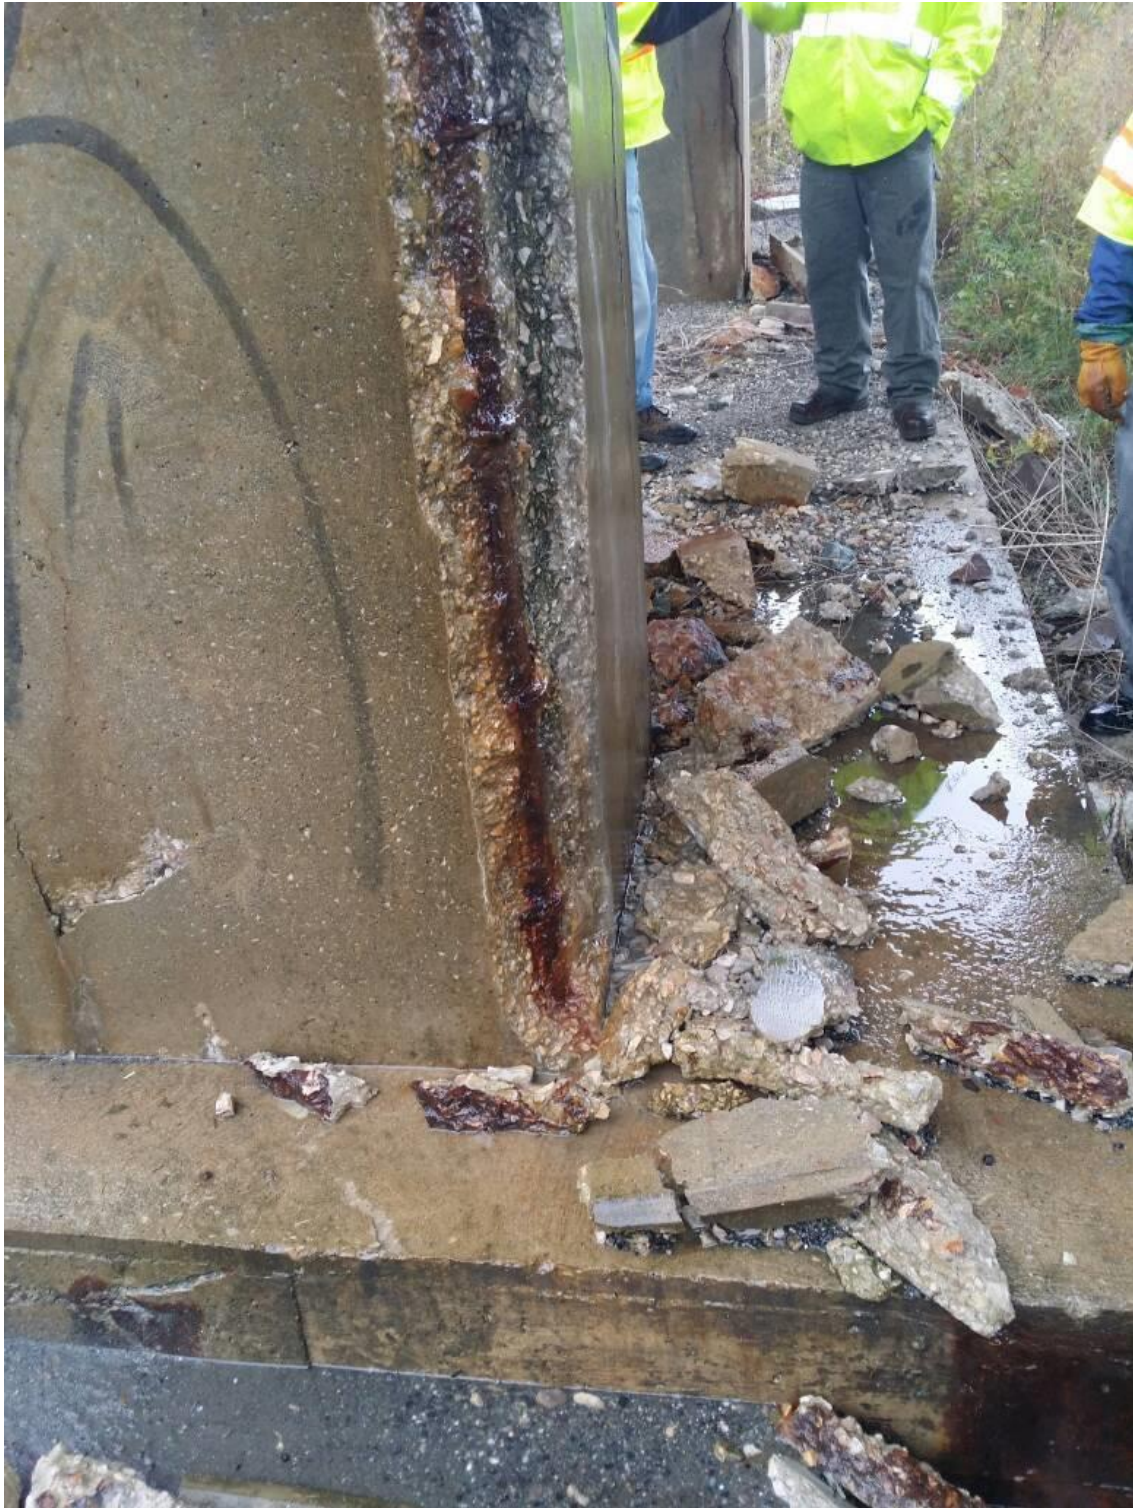
Figure 5.33 Square column with spalling at the corners on Richmond I-89 US 2 Underpass Bridge
