1. Report No.	2. Government Accession No.	3. Recipient's Catalog No.
4. Title and Subtitle Cost-Effective and Rapid Concrete Repair Techniques		5. Report Date February 8, 2016

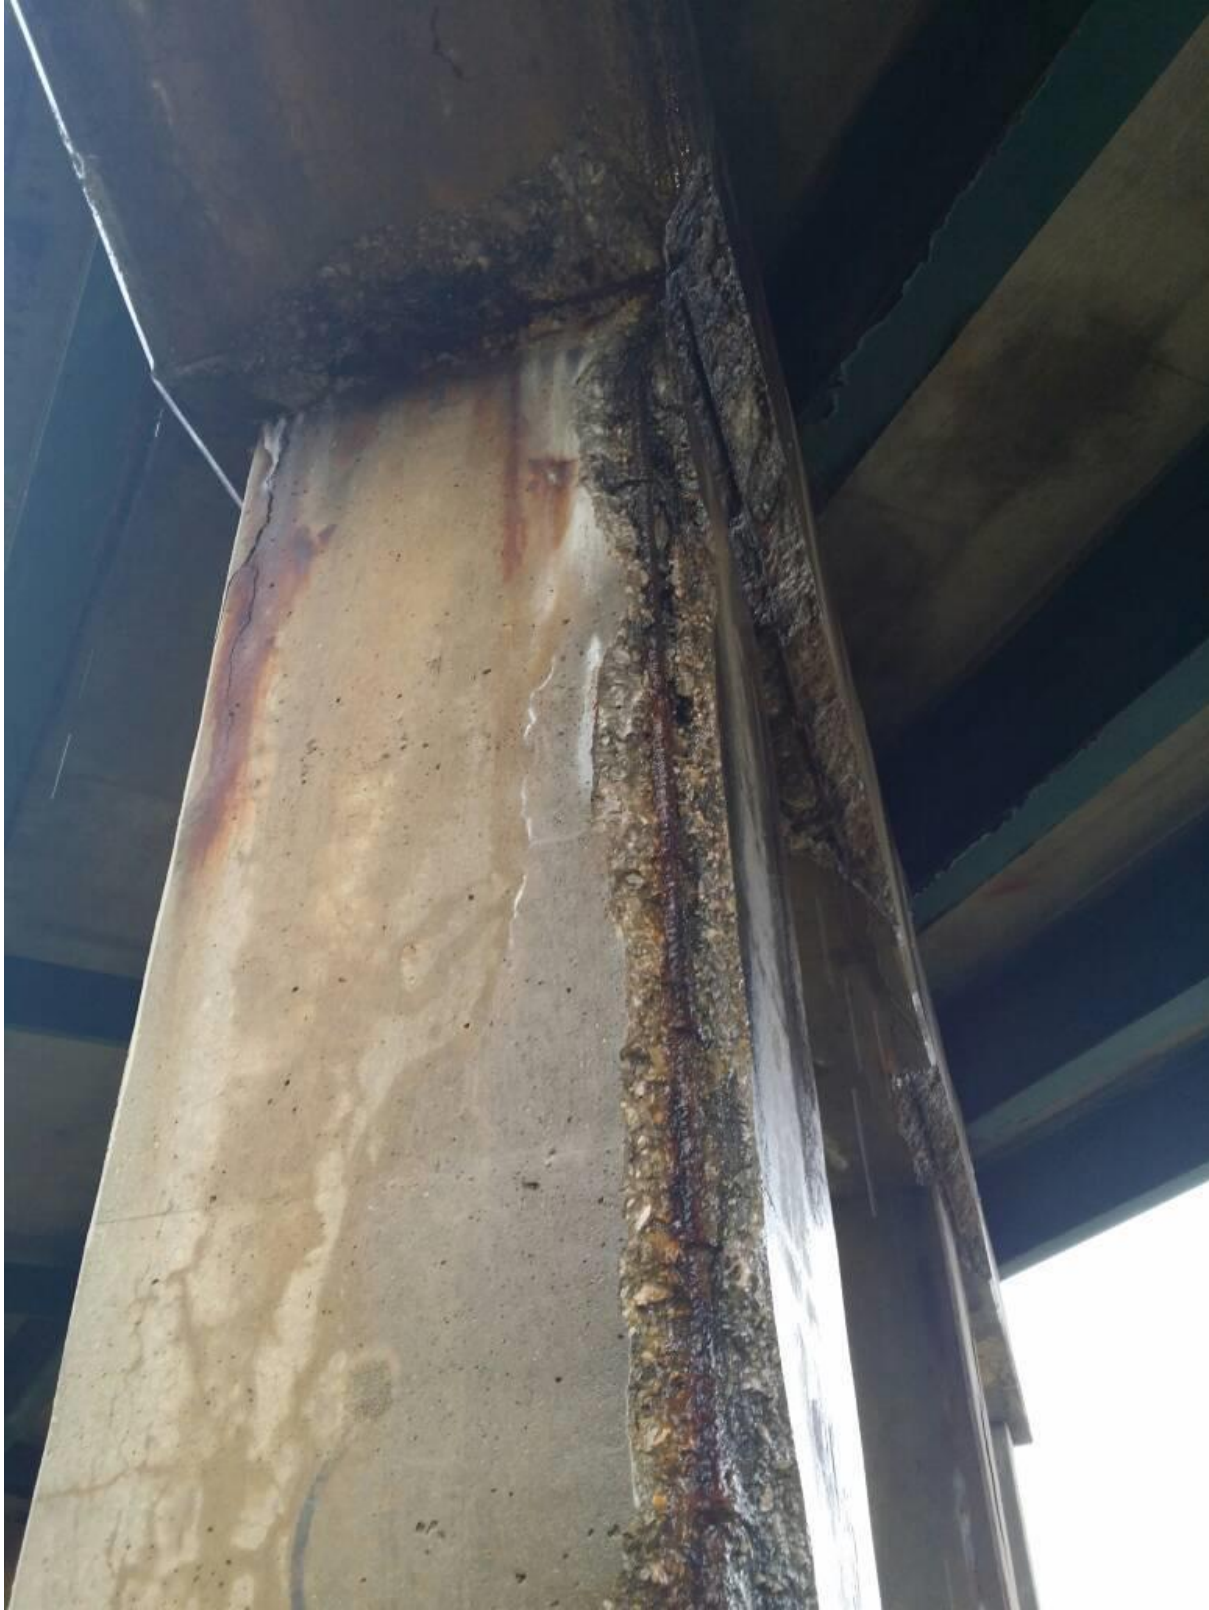
Figure 5.34 Square column with spalling at the corners and pier cap on Richmond I-89 US 2 Underpass Bridge

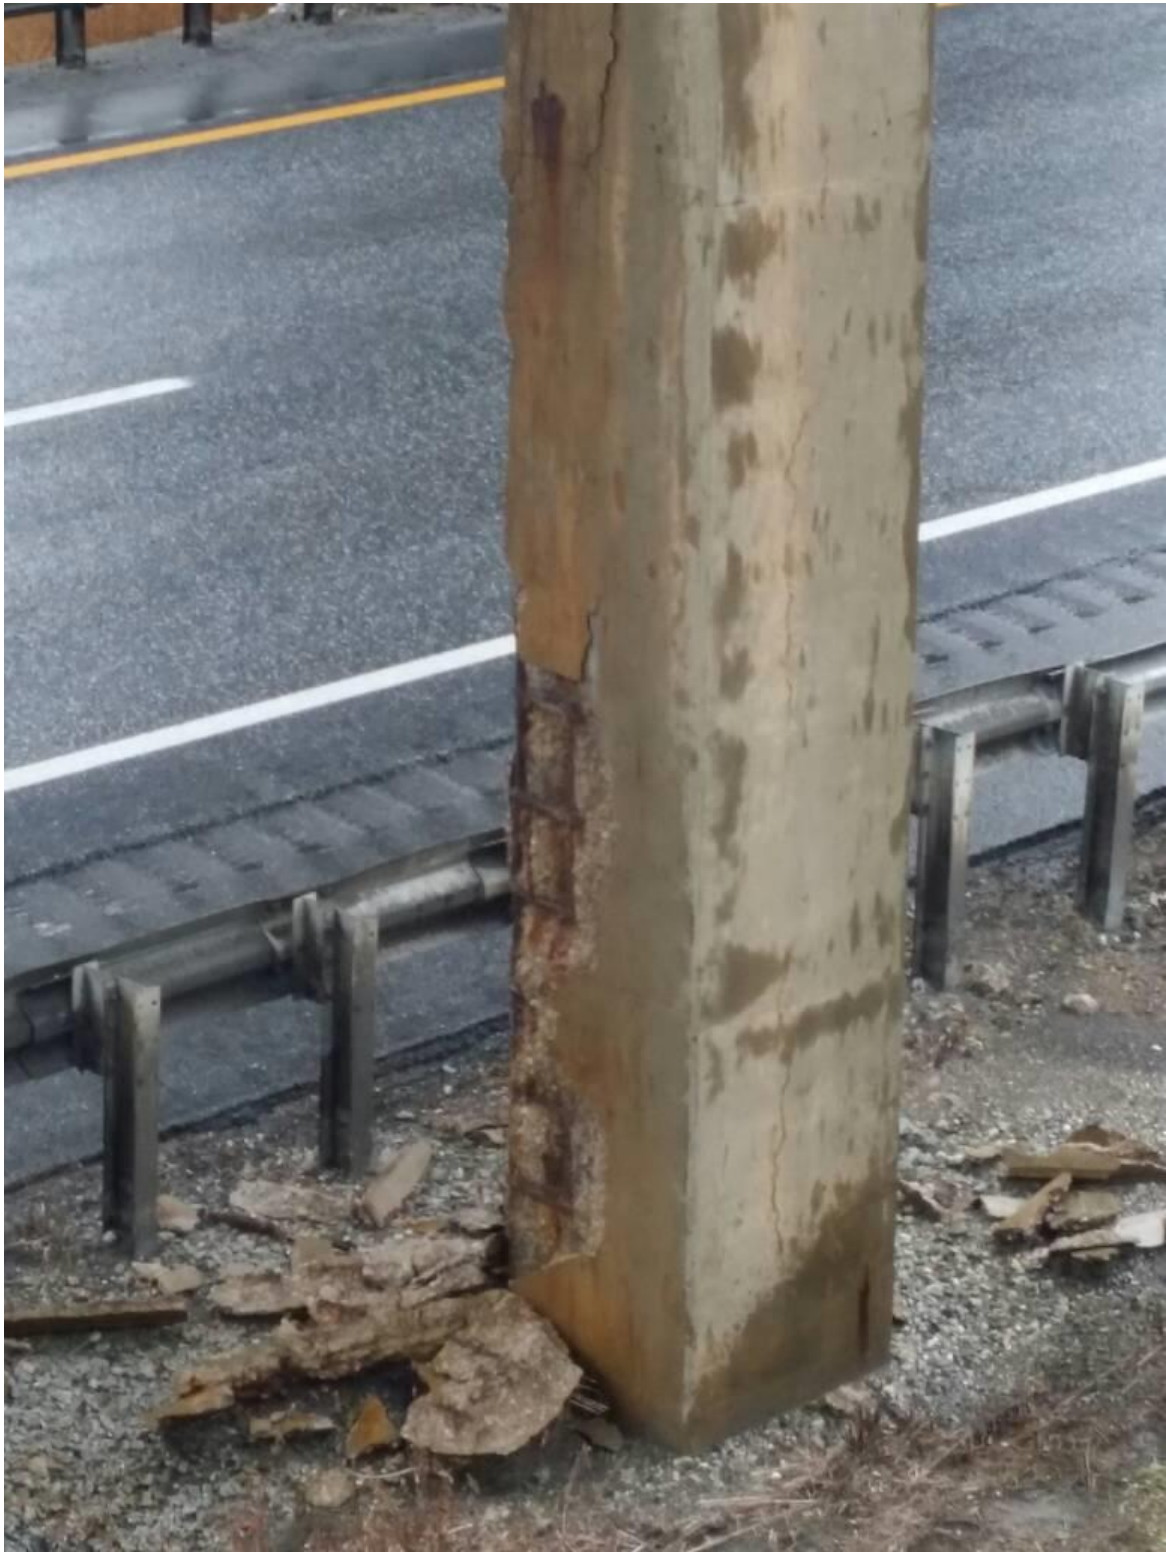
Figure 5.36 Column with spalling at the corners and side on Richmond I 89 US 2 Underpass Bridge

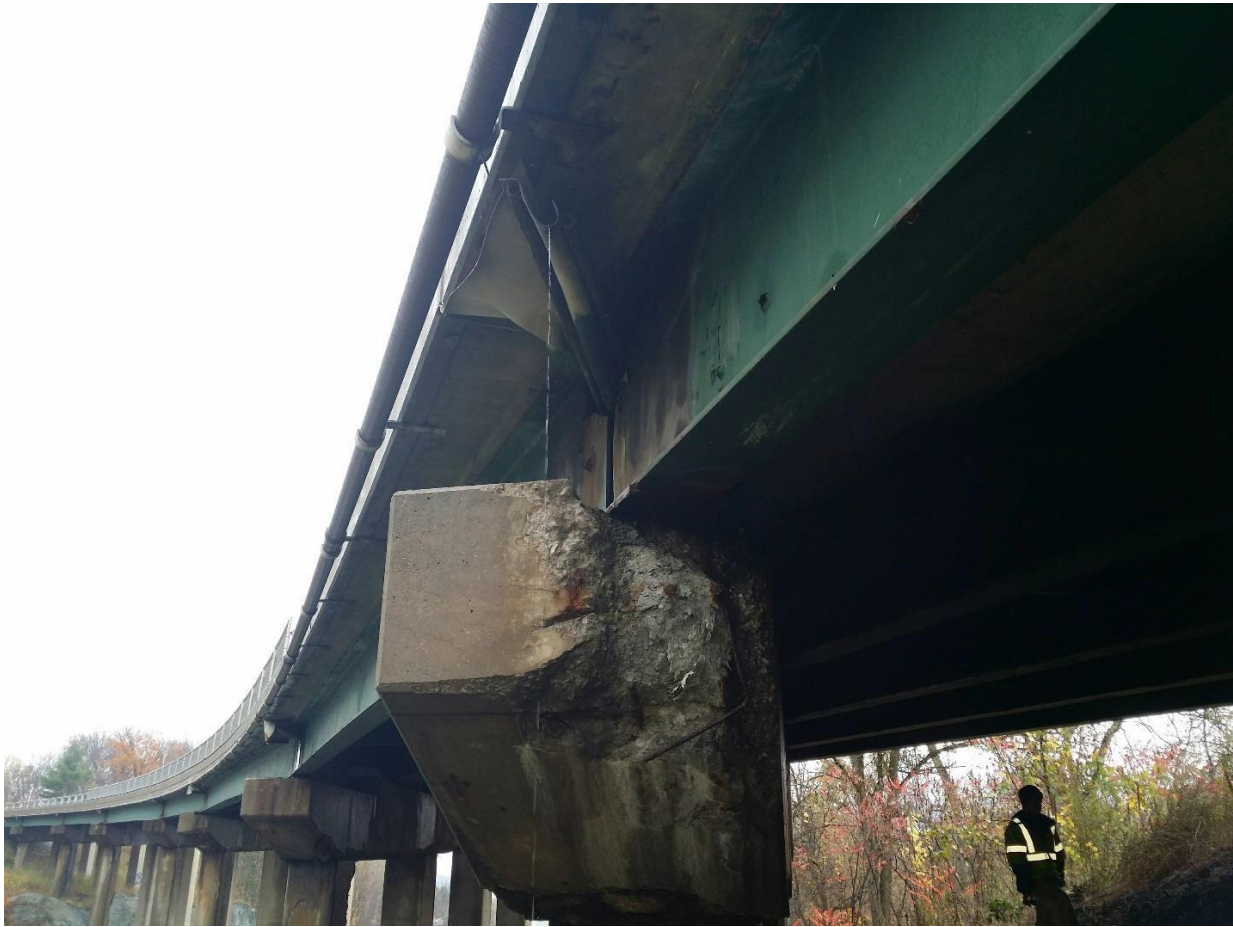
Figure 5.37 Pier cap with lost corner section leading to subsided bearing on Richmond I 89 US 2 Underpass Bridge

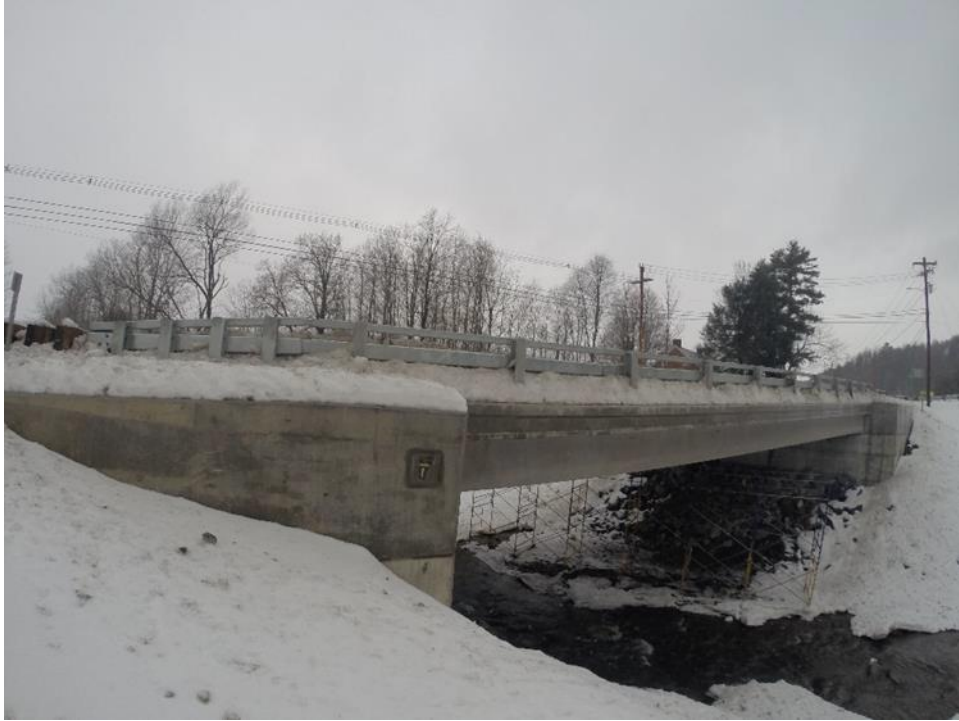
Figure 5.41 Stowe Rte 100 Gold Brook Crossing Bridge

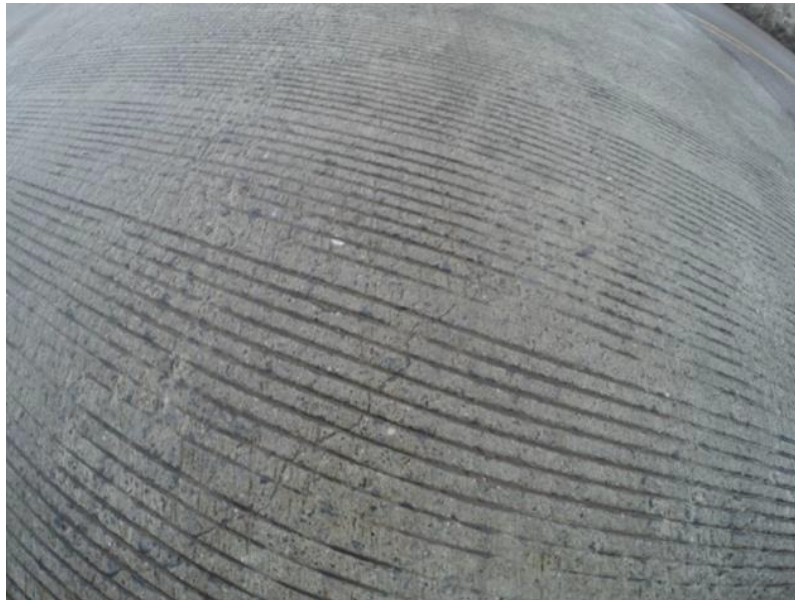
Figure 5.42 Deck patterned with cross-span cracks, approximately every 200 mm on Stowe Rte 100 Gold Brook Crossing Bridge

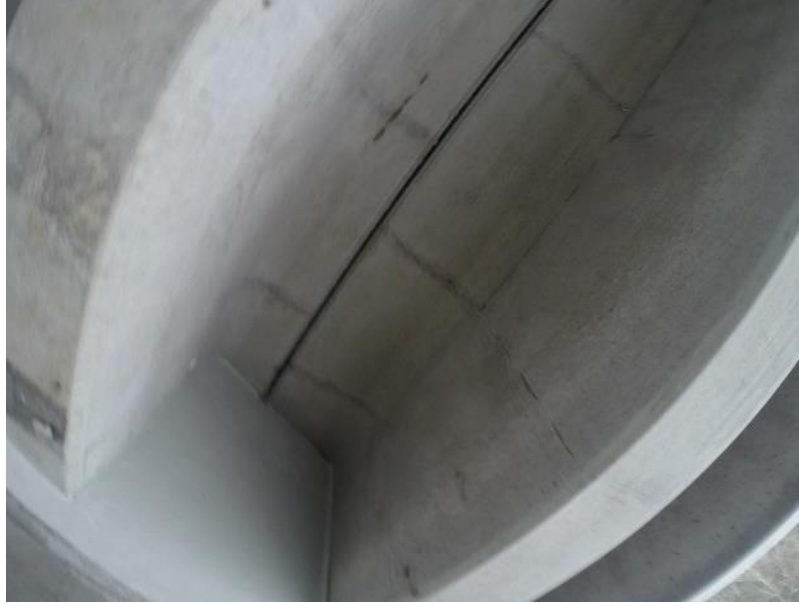
Figure 5.43 Girders have multiple cracks in top flanges, Stowe Rte 100 Gold Brook Crossing Bridge

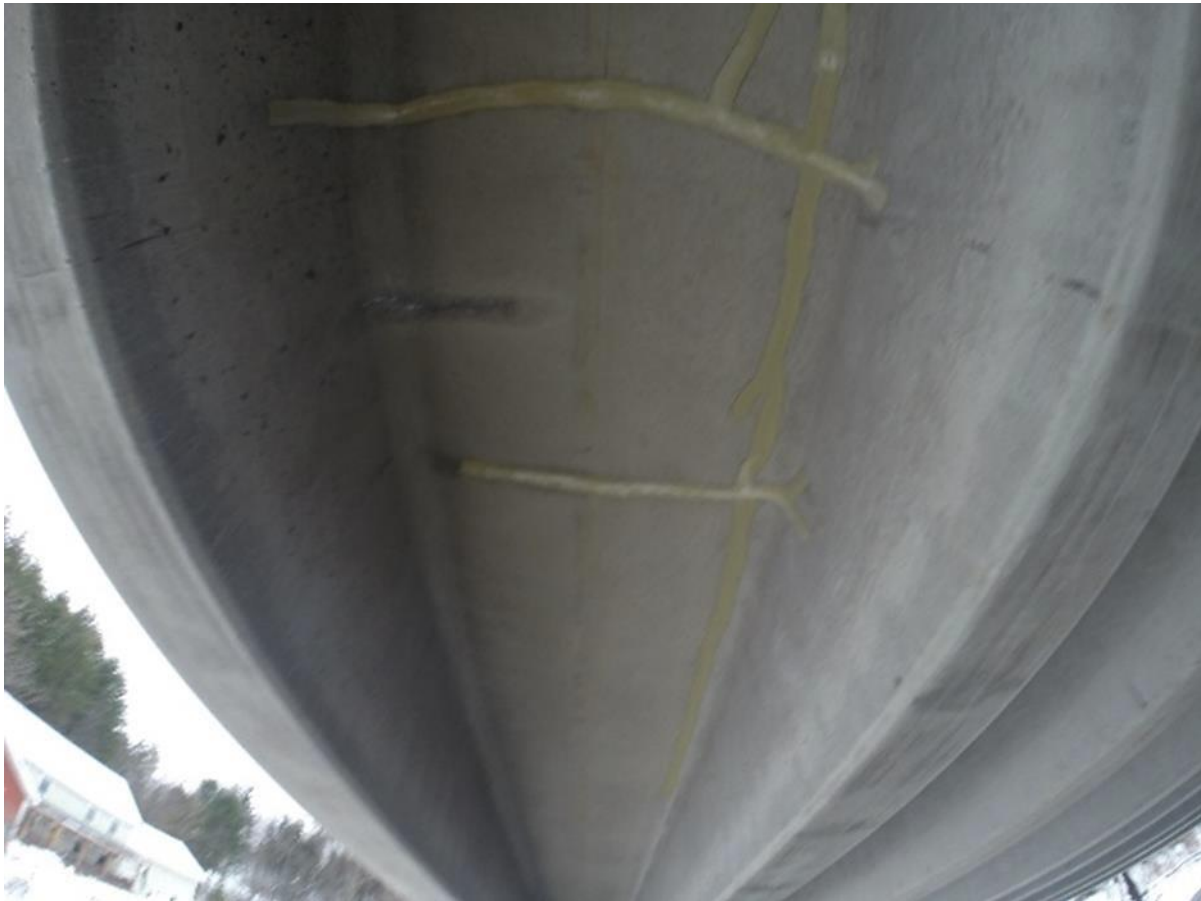
Figure 5.44 Girder cracks sealed Stowe Rte 100 Gold Brook Crossing Bridge

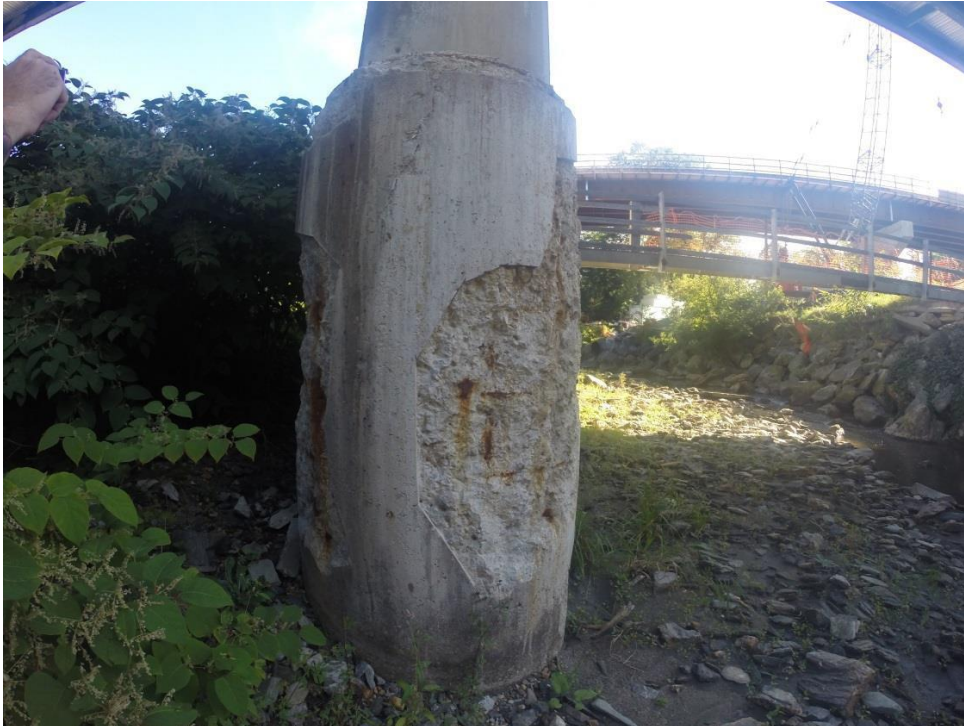
Figure 5.45 End view of pier base with damaged concrete removed on I-89 Waterbury Overpass Bridge

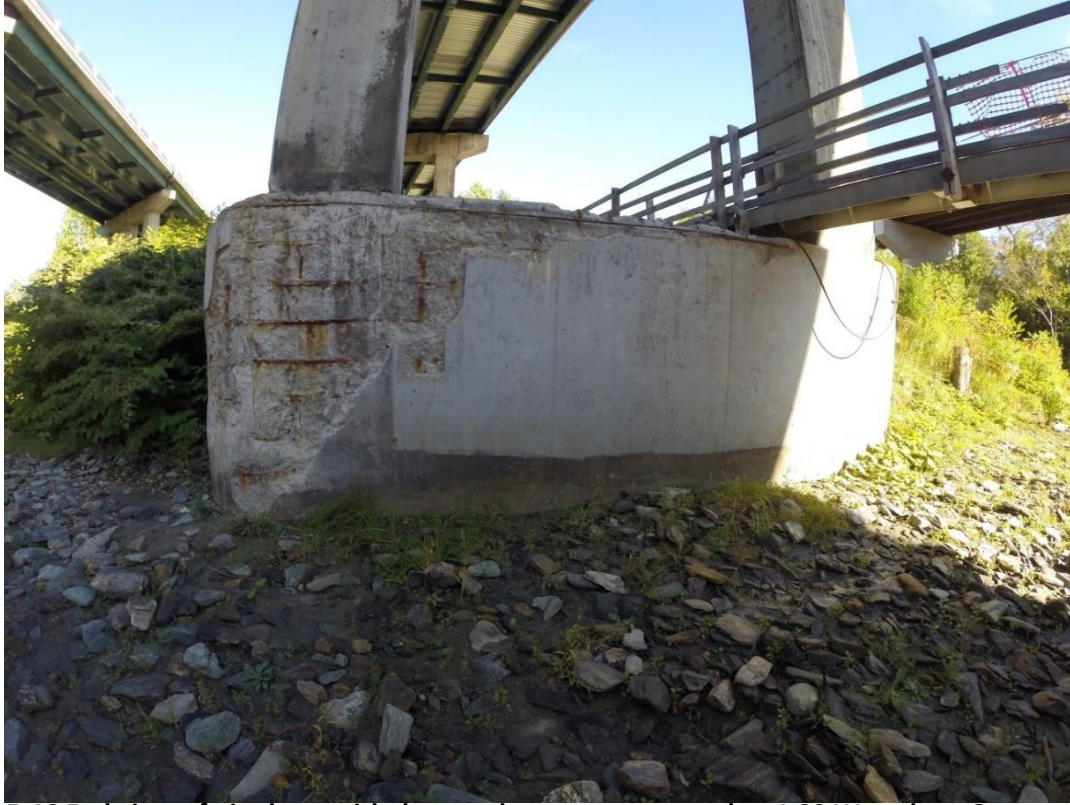
Figure 5.46 End view of pier base with damaged concrete removed on I-89 Waterbury Overpass Bridge

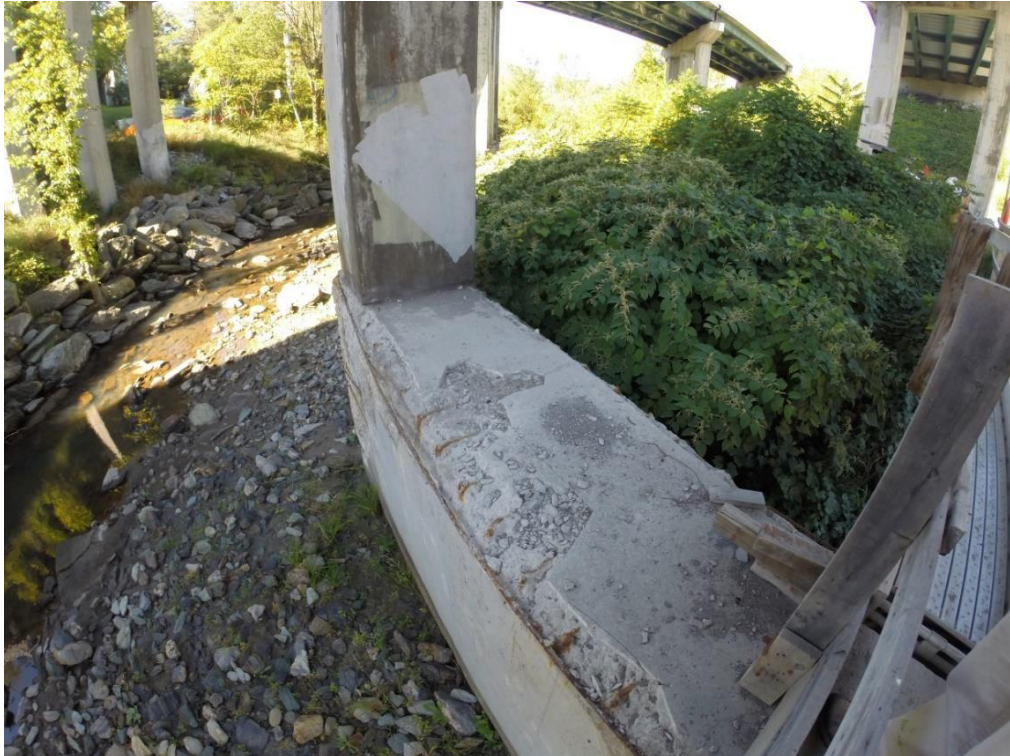
Figure 5.47 Top view of pier base with damaged concrete removed on I-89 Waterbury Overpass Bridge

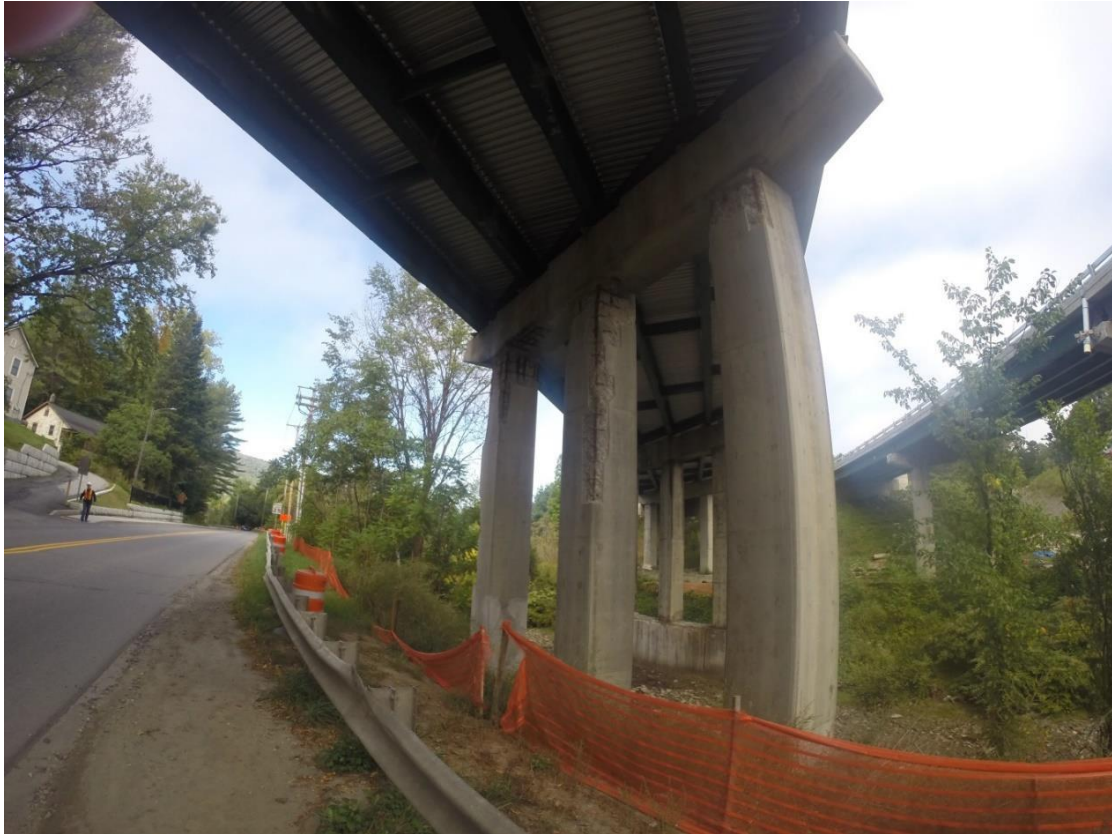
Figure 5.48 Pier on I-89 Waterbury Overpass Bridge with corners prepared for patch repairs

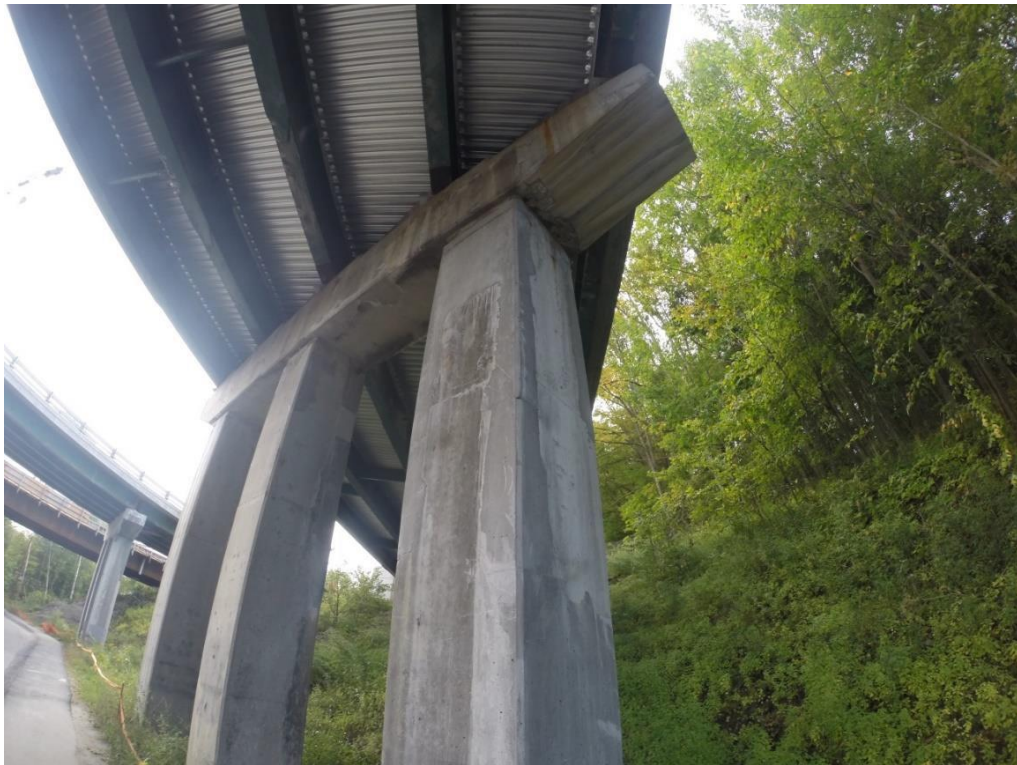
Figure 5.49 Pier on I-89 Waterbury Overpass Bridge with patch repairs

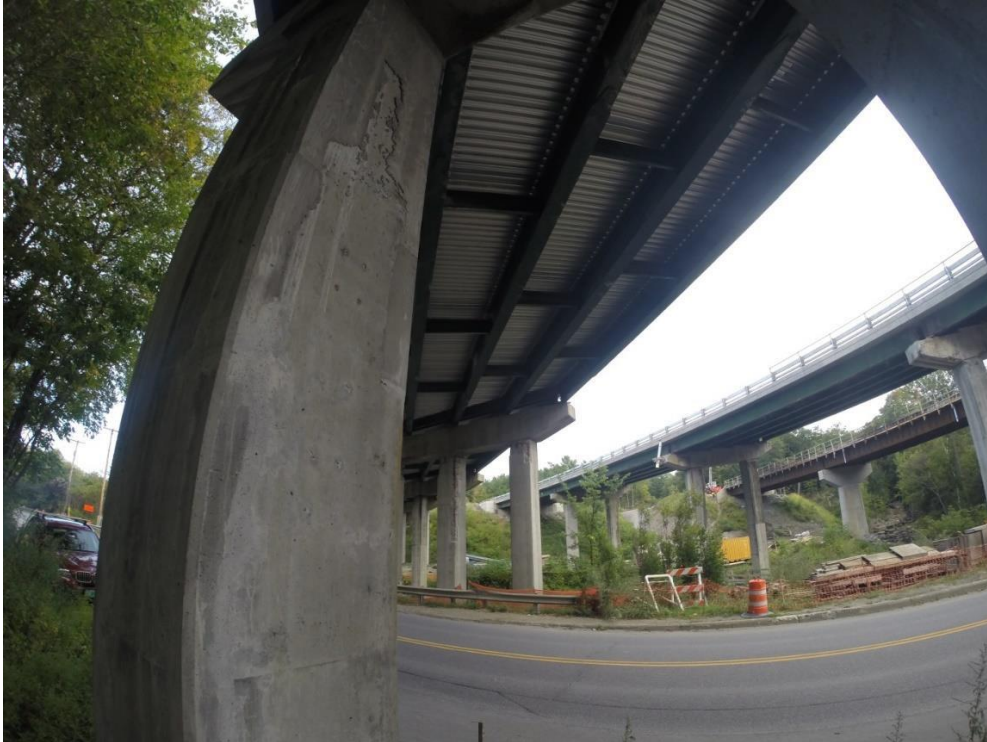
Figure 5.50 Pier on I-89 Waterbury Overpass Bridge with patch repairs, note the extended gutters on span in background

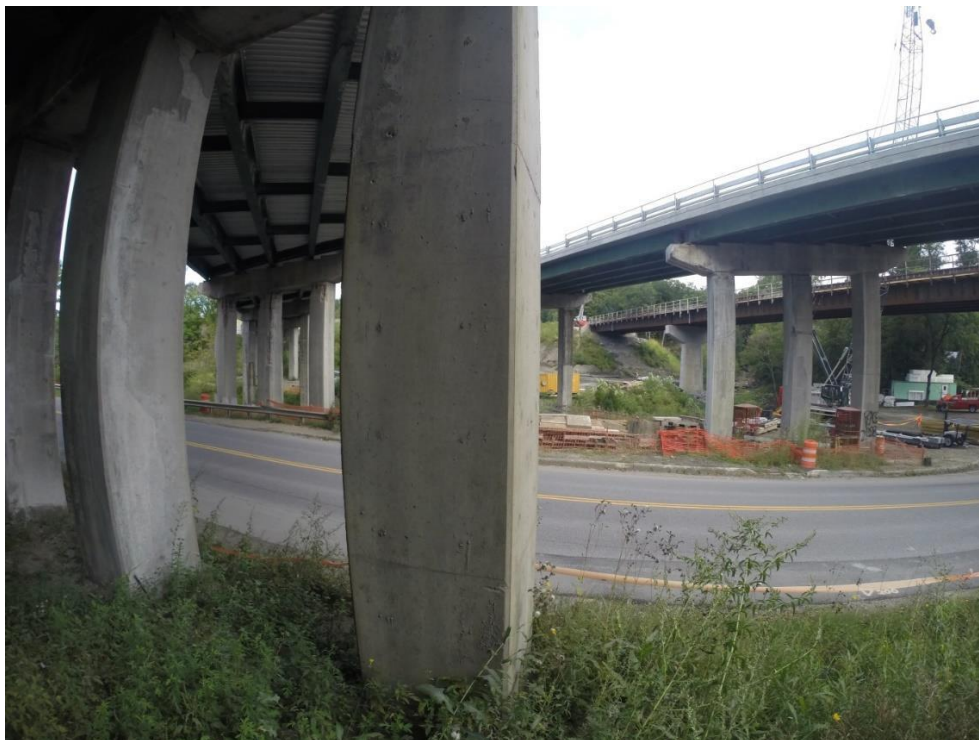
Figure 5.51 Pier on I-89 Waterbury Overpass Bridge with patch repairs

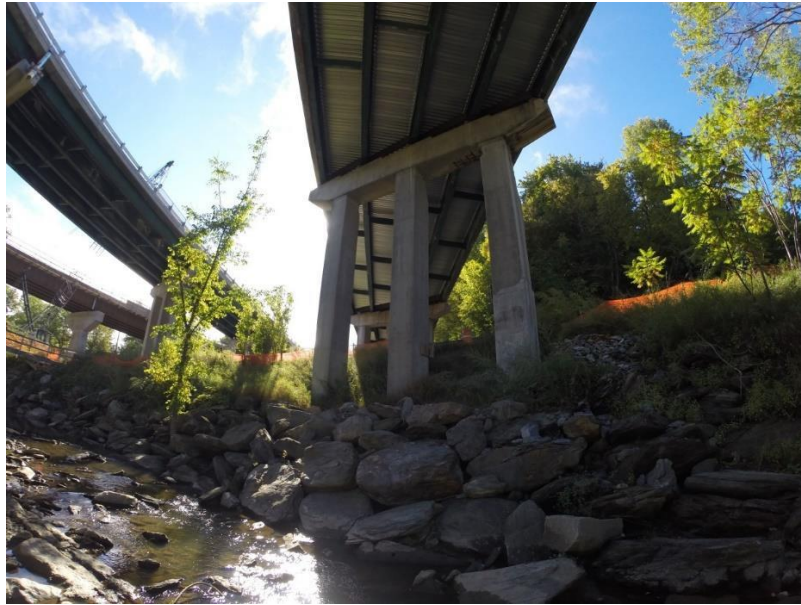
Figure 5.52 Repaired pier on I-89 Waterbury Overpass Bridge with patch repairs, note the use of integrated corrugated panels on new concrete deck.

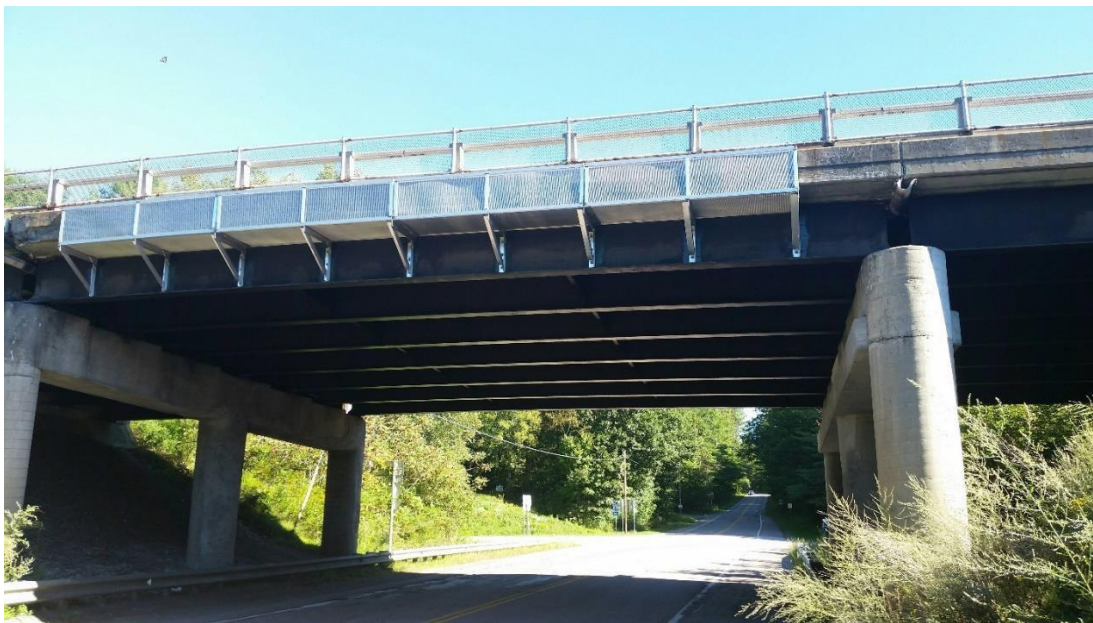
Figure 5.53 I 89 Middlesex Overpass Bridge with supplemental rack to protect vehicles passing under by catching pieces of concrete that spall and fall from the fascia

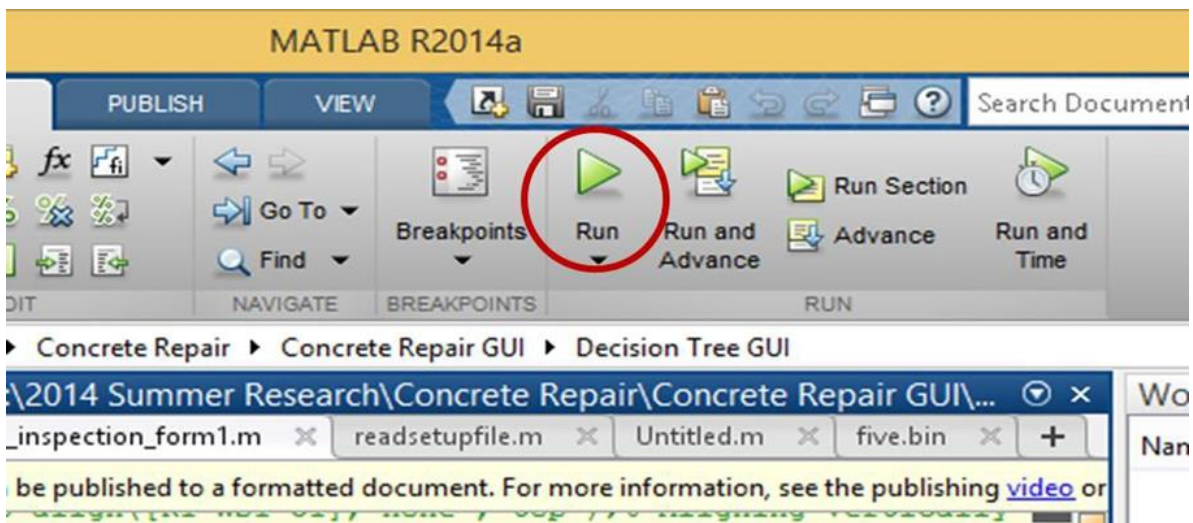
Figure 6.1 Bridge Inspection Form GUI with link to Field Inspection Coding Guide, coded in MATLAB, with executable file, exports Inspection Form to an Excel spreadsheet

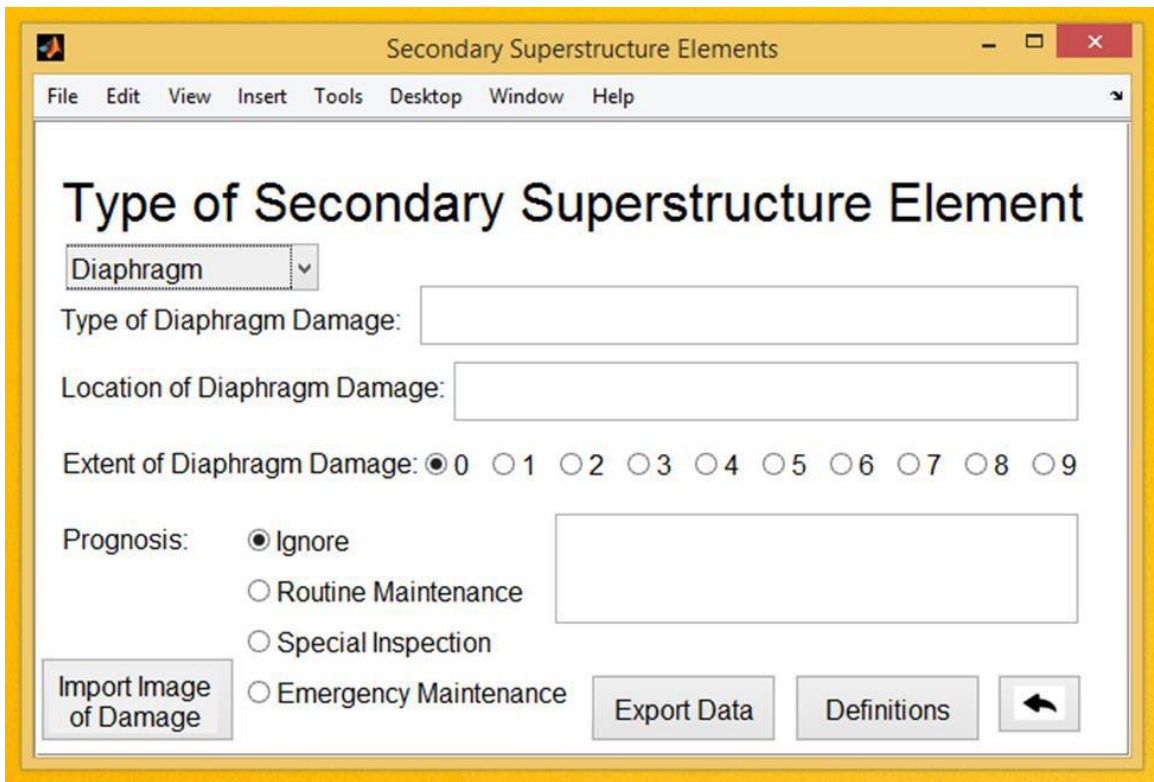
Figure 6.5 Assessment of bridge structure GUI, assessment of damage and prognosis, exports data to an excel spreadsheet. An image of structural damage can be uploaded.

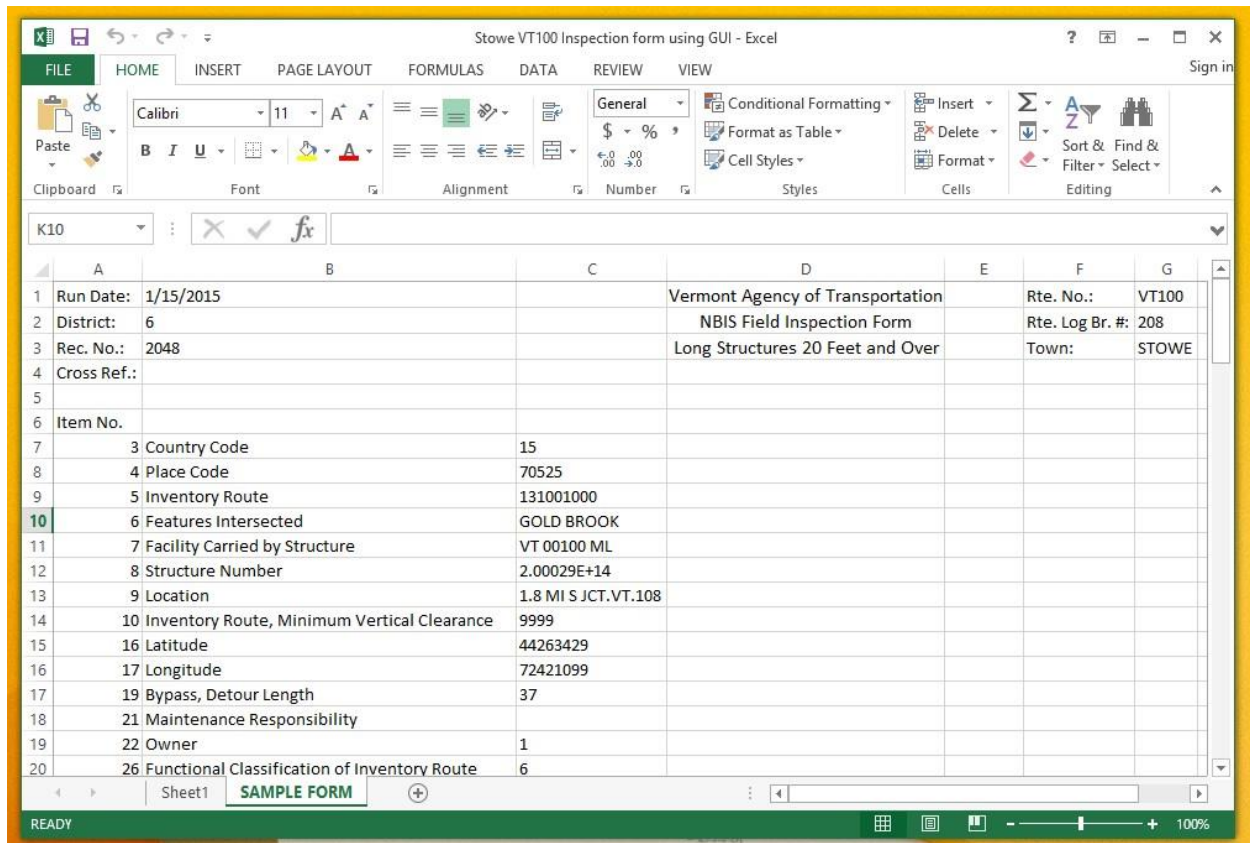
Figure 6.7 Bridge Inspection Form outputting data into an Excel spreadsheet

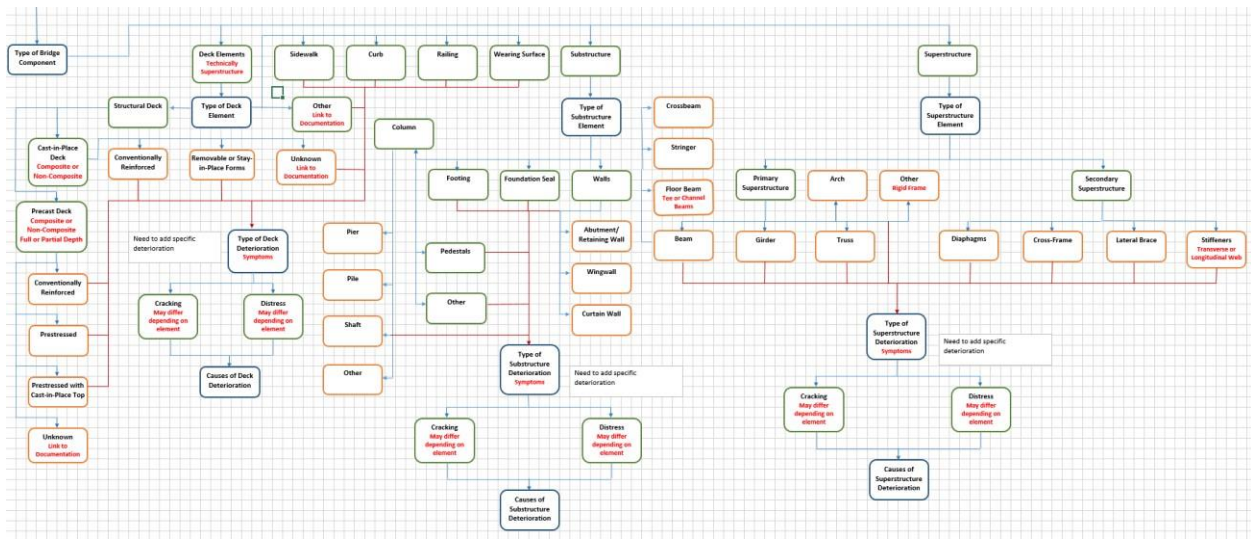
Figure 6.9 Bridge concrete repair decision tree, Adapted from ACI Concrete Repair Process Flow Chart (ACI Concrete Repair Manual 2013).

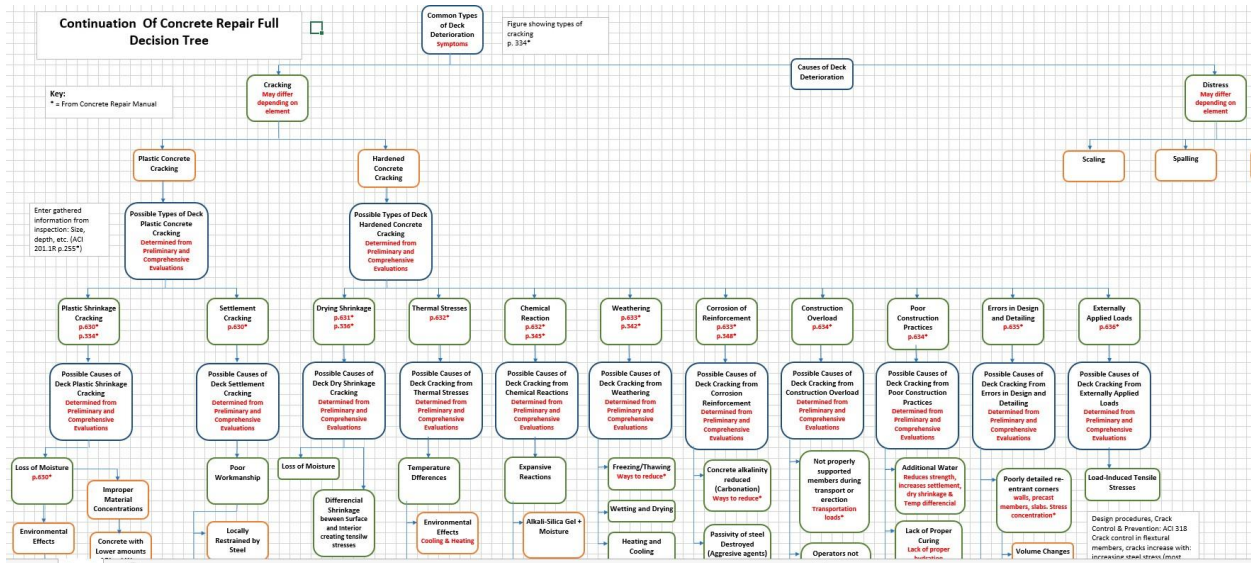
Figure 6.10 Deck branch of concrete repair decision tree, adapted from ACI Concrete Repair Process Flow Chart (ACI Concrete Repair Manual 2013)

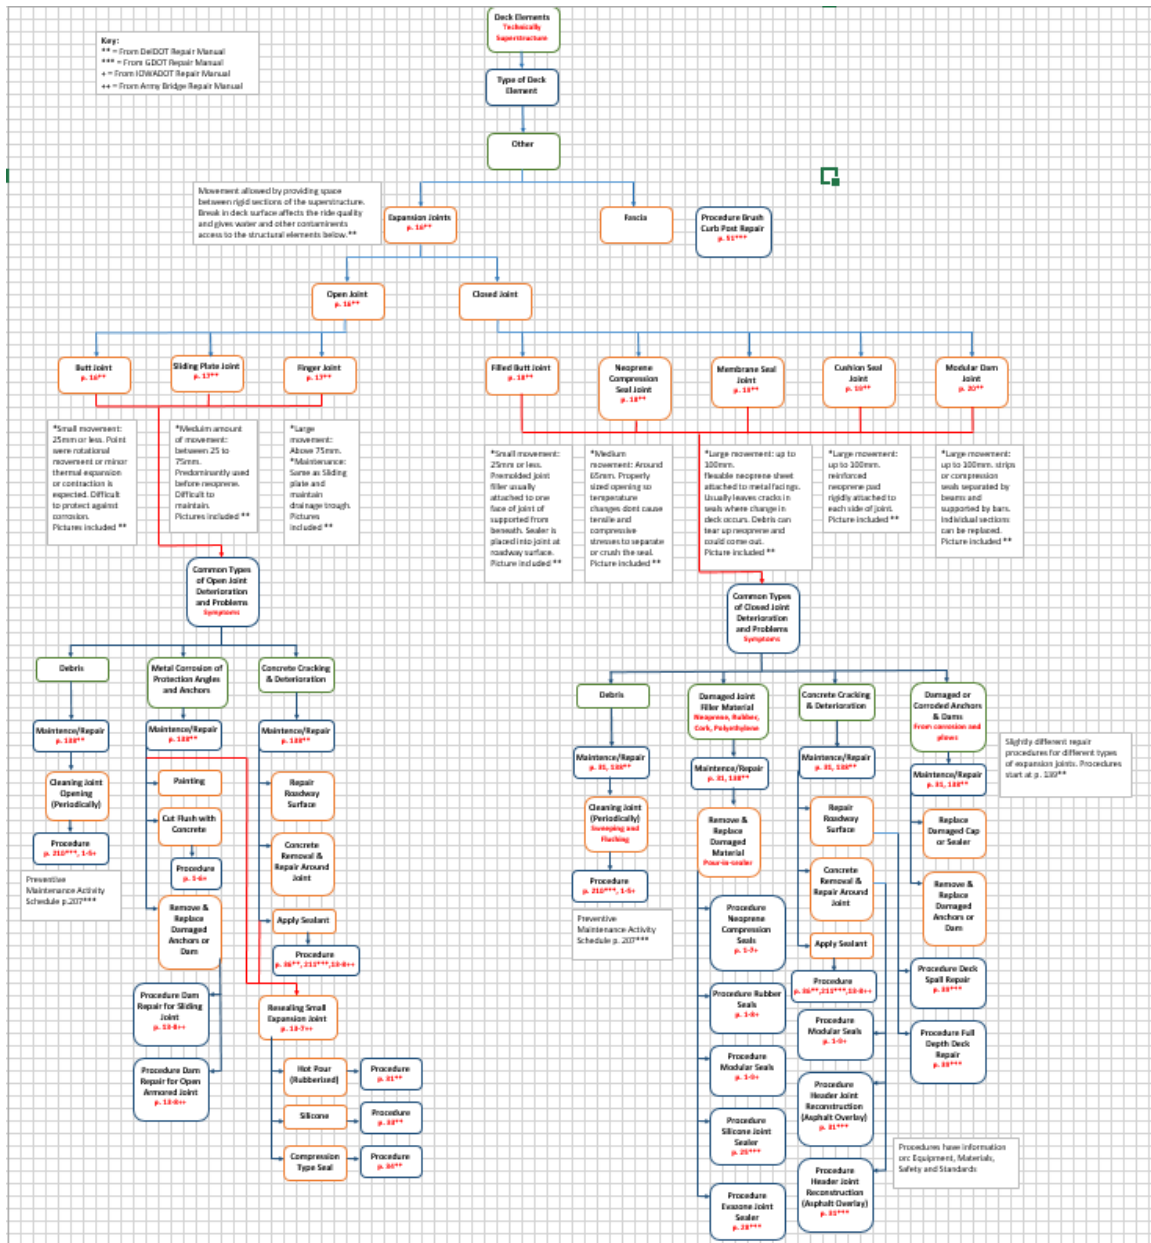
Figure 6.11 Expansion joint and fascia decision tree

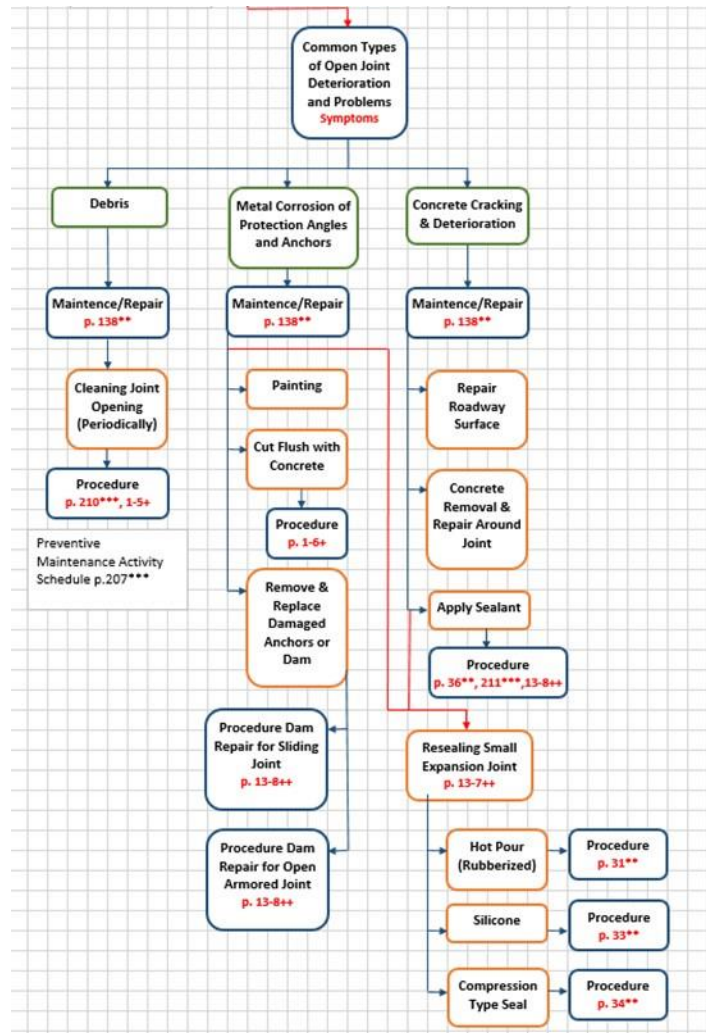
Figure 6.12 Bridge concrete repair decision tree – close-up of open expansion joint branch, adapted from ACI Concrete Repair Process Flow Chart (ACI Concrete Repair Manual 2013)

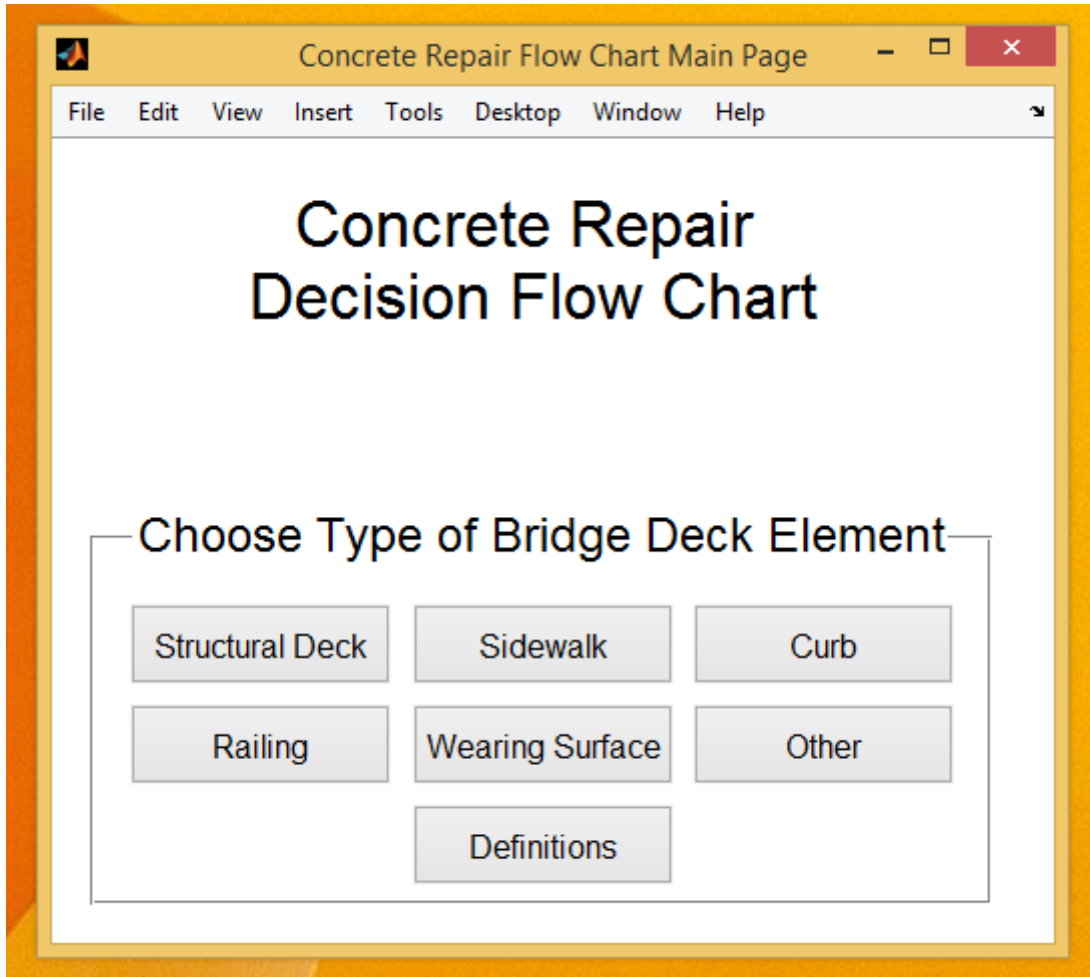
Figure 6.13 Screen shot of Concrete Repair Decision Flow Chart GUI main page, with user friendly features including definitions of terms in current GUI page

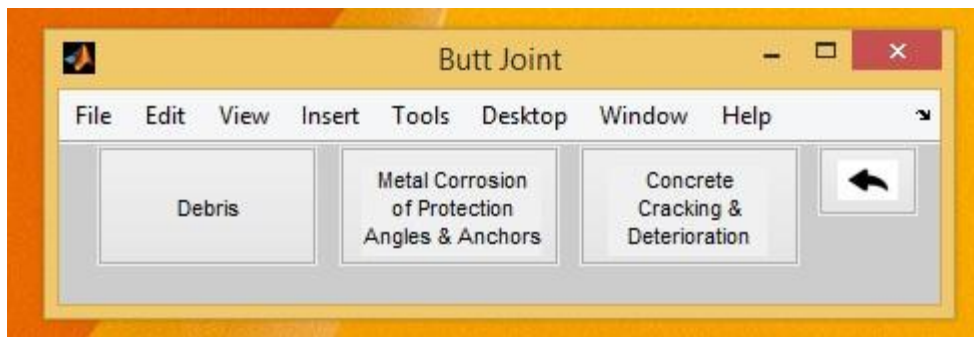
Figure 6.14 Screen shot of particular bridge deck element GUI (going through flowchart), enables picking type of damage to element to select proper repair procedure

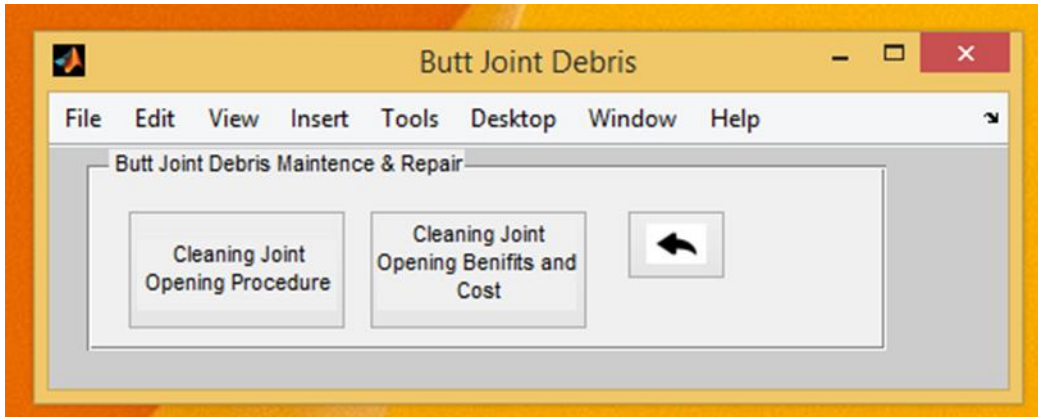
Figure 6.15 Screen shot of particular bridge deck element GUI (going through flowchart) with particular damage, user can pick correct repair procedure (links to repair procedures from list of data files) and determine benefits associated to repair and estimated cost of repair.
