1. Report No.	2. Government Accession No.	3. Recipient's Catalog No.
4. Title and Subtitle Cost-Effective and Rapid Concrete Repair Techniques		5. Report Date February 8, 2016

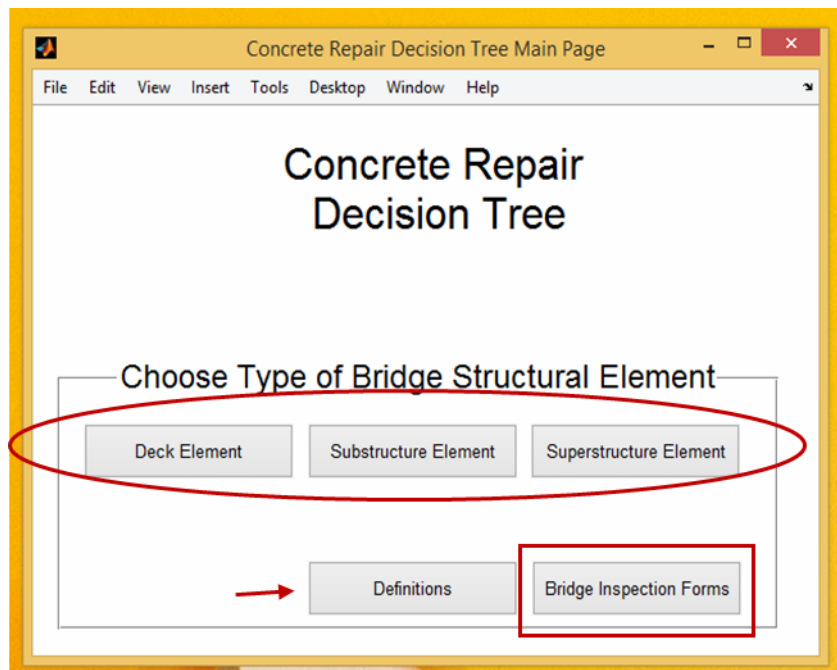
Figure 6.16 Concrete Repair Decision Tree Main Page

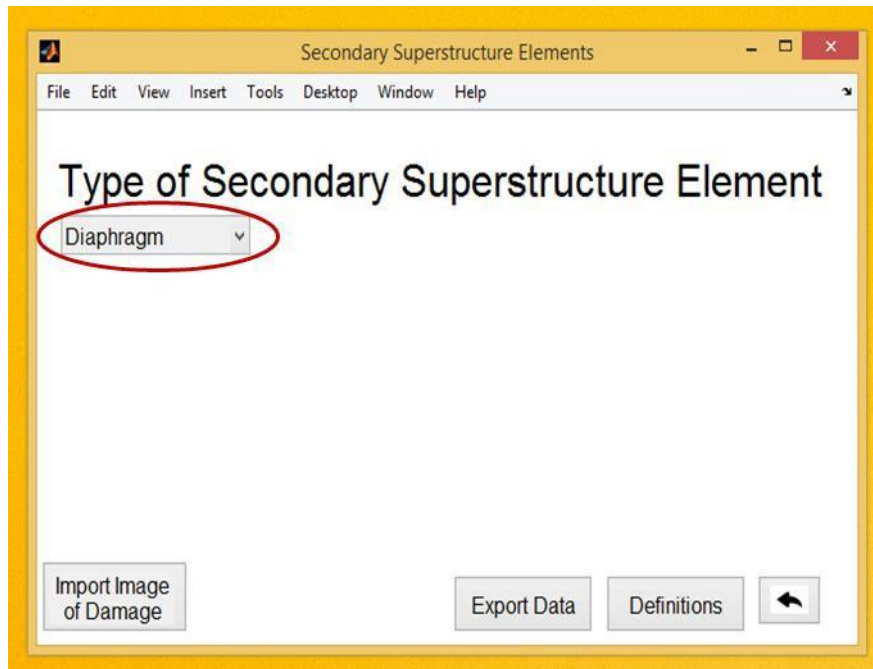
Figure 6.17 Damage and Prognosis Pop-up Window

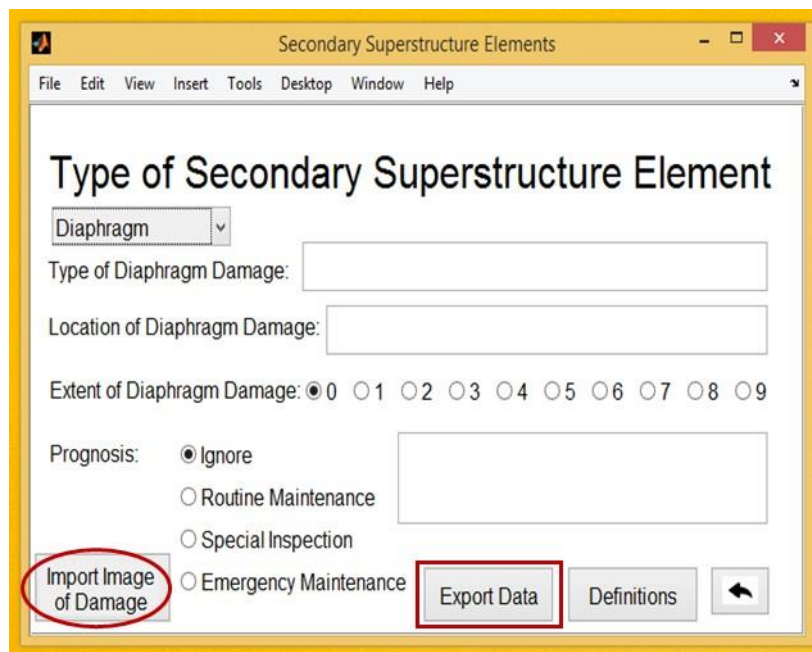
Figure 6.18 Damage and Prognosis Pop-up Window with Full Options

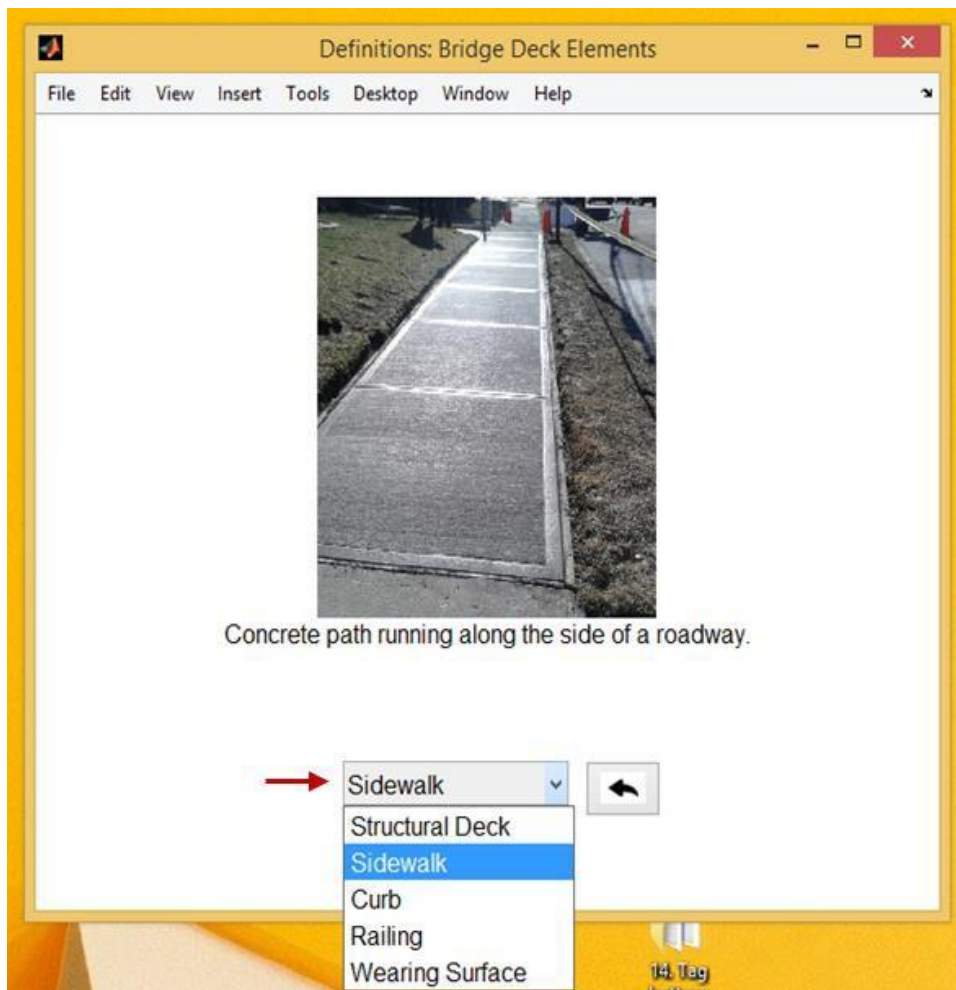
Figure 6.19 Clickable link to definitions

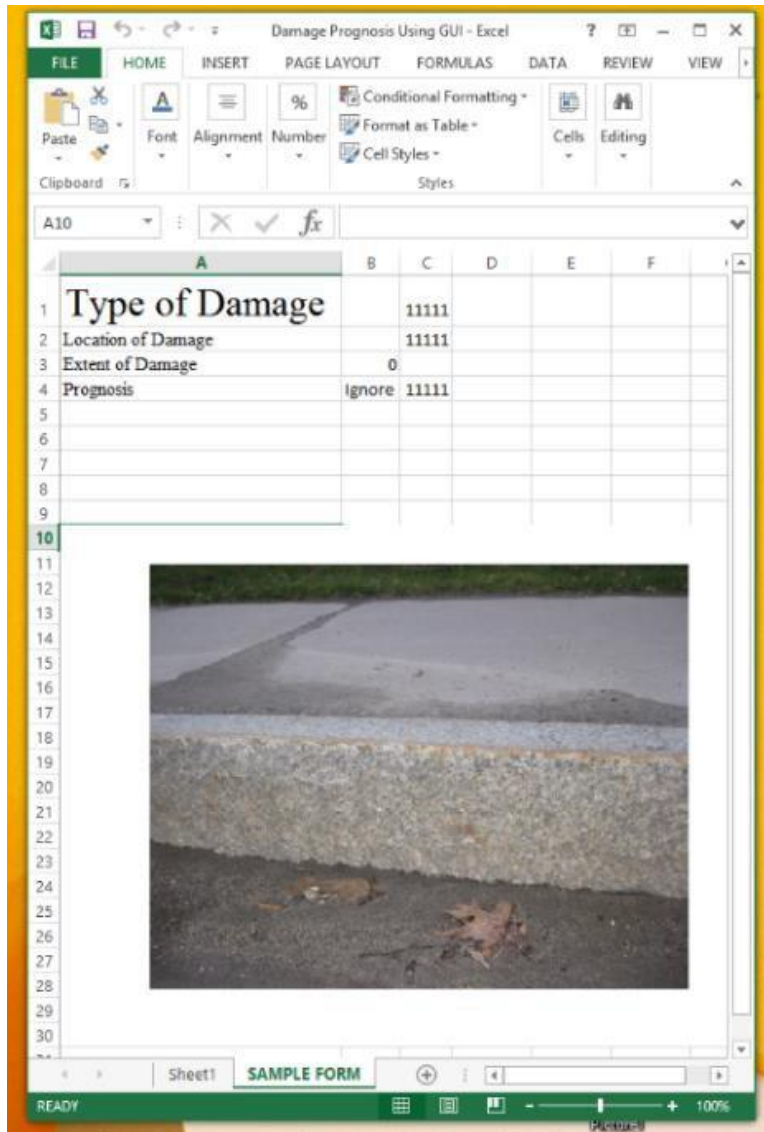
Figure 6.21 Exported Data from Decision Tree GUI

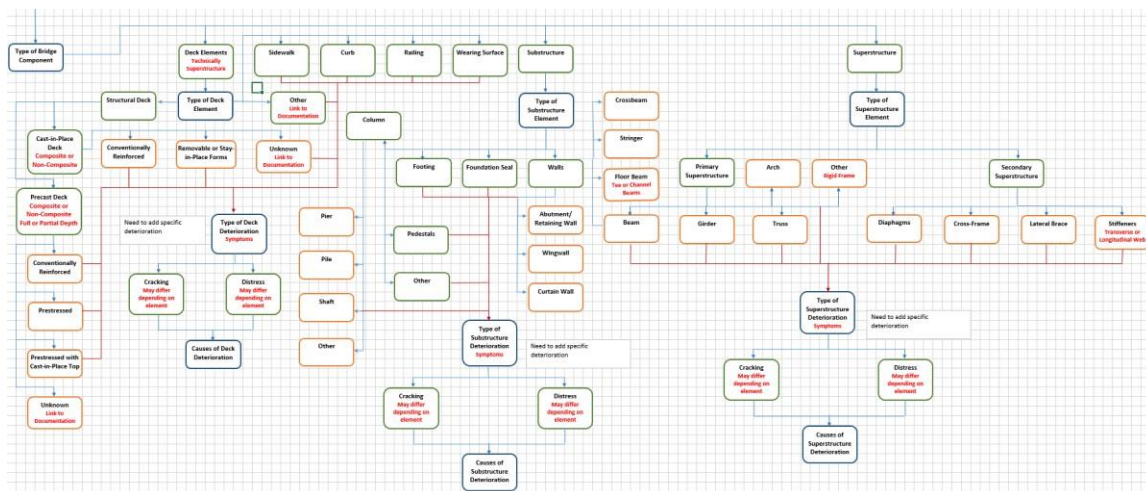
Figure 1: The Full Decision Tree can be accessed as the Excel File: (Concrete Repair Full Decision Tree)

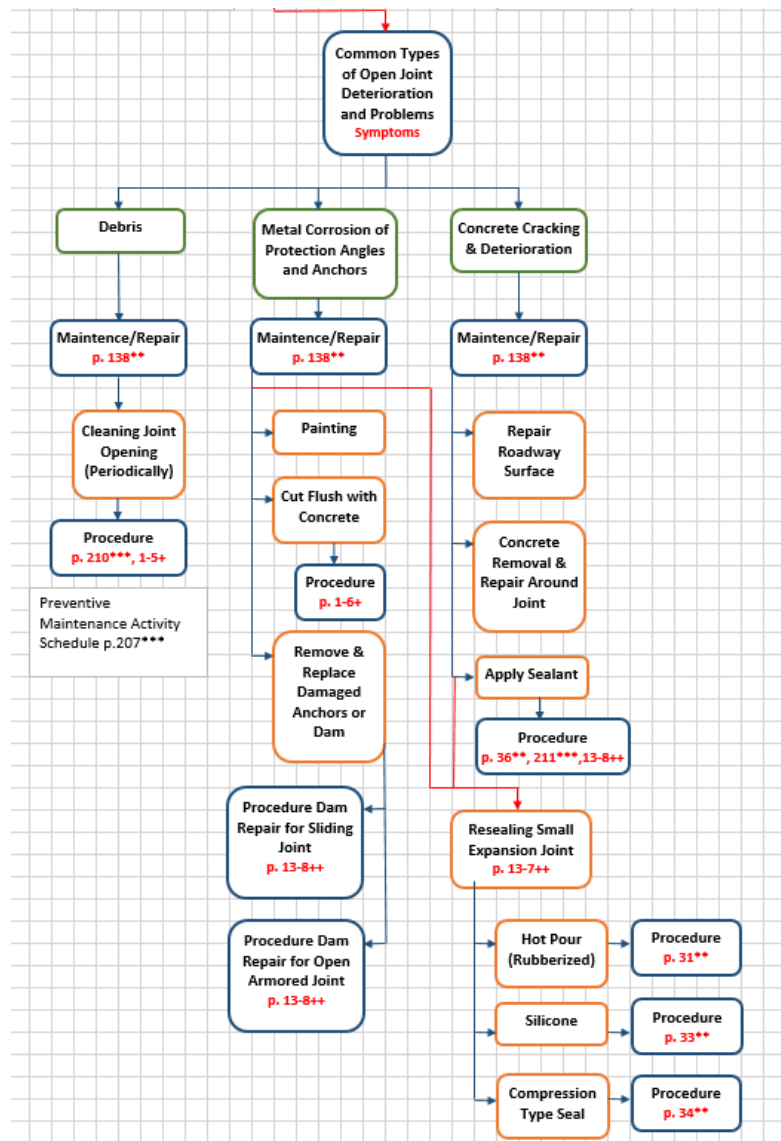
Figure 4: Figure 3: The Full Decision Tree can be accessed as the Excel File: (Expansion Joint and Fascia Deterioration Repair Decision Tree)

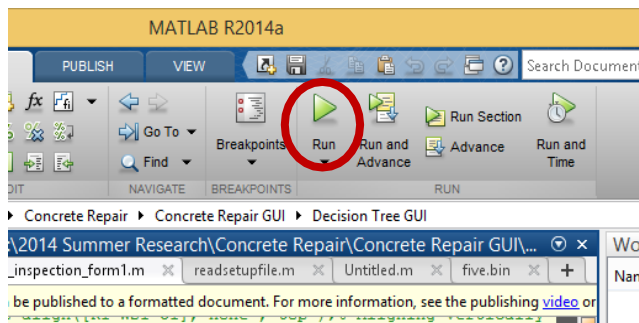
3. The **Bridge Inspection Form** window should pop-up, depicted in Figure (Figure 5). The window gives the user the option of clicking between two buttons:
 - a. The **Field Inspection Form** button, which directs the user to the electronic form
 - b. The **Field Inspection Coding Guide** button, which directs the user to a PDF version of the guide.

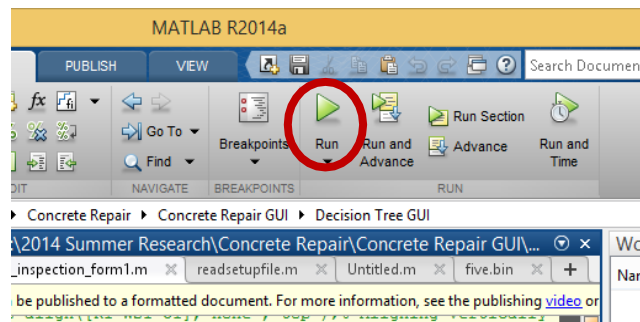
3. The **Concrete Repair Decision Tree** window should pop-up, depicted in Figure (Figure 10). The window gives the user the option of clicking between multiple buttons:
 - a. Choose from three structural element categories: **Deck Element**, **Substructure Element** or **Superstructure Element** (shown by red oval)
 - b. The **Field Inspection Form** button (shown by red rectangle), which directs the user to the electronic form
 - c. The **Definitions** button (to the right of the red arrow), which directs the user to a Definitions pop-up window that defines the bridge terminology of the previous window.

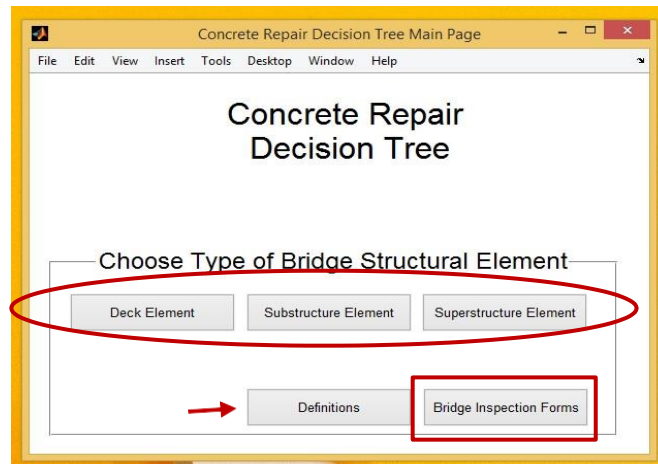
Figure 10: Concrete Repair Decision Tree Main Page

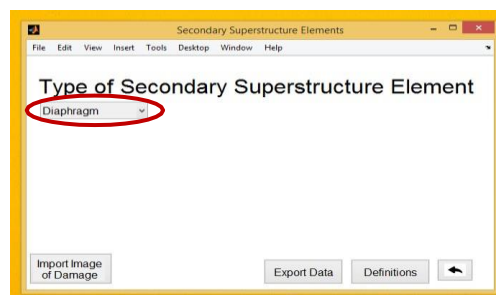
Figure 11: Damage and Prognosis Pop-up Window

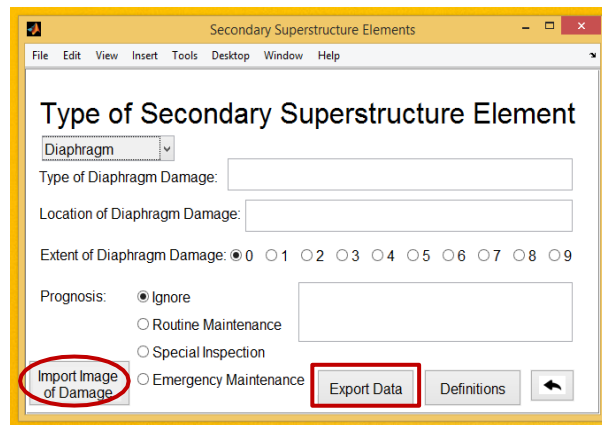
Figure 12: Damage and Prognosis Pop-up Window with Full Options

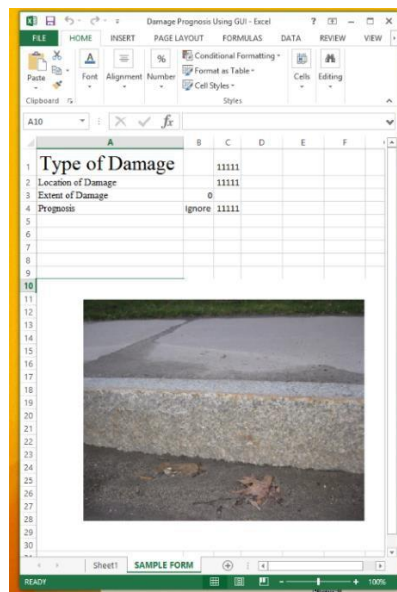
Figure 13: Exported Data from Decision Tree GUI

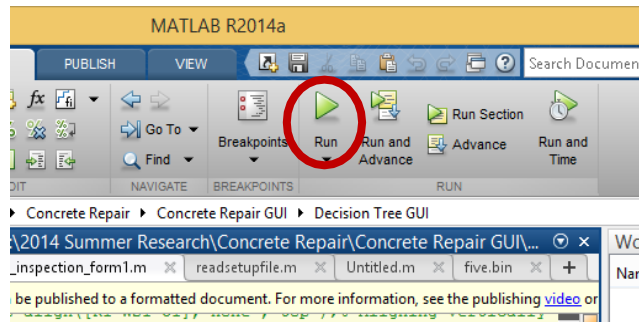
3. The **Concrete Repair Flow Chart** window should pop-up, depicted in Figure (Figure 15). The window gives the user the option of clicking between multiple buttons:
 - a. Choose from six deck elements: **Structural Deck, Sidewalk, Curb, Railing, Wearing Surface** or **Other** (shown by red oval) *Only **Other** is currently active*
 - b. The **Definitions** button (to the right of the red arrow), which directs the user to a Definitions pop-up window that defines the bridge terminology of the previous window. *For Further Information on the **Definitions** window, reference **Step 11** in **1.2. Decision Tree GUI.***

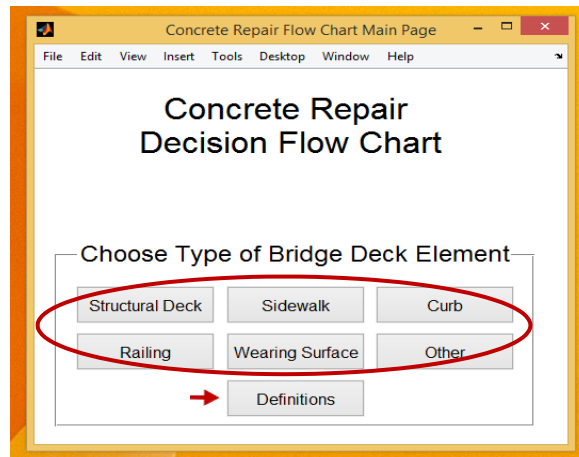
Figure 15: Concrete Repair Flow Chart Main Page

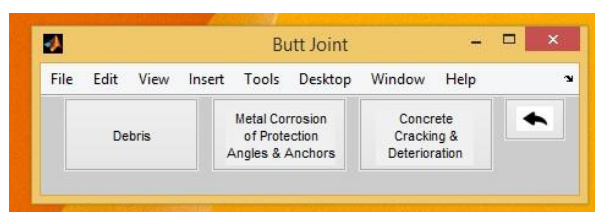
Figure 16: Butt Joint Pop-up Window

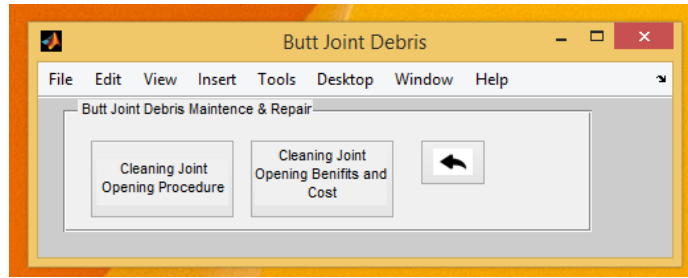
Figure 17: Butt Joint Debris Pop-up Window

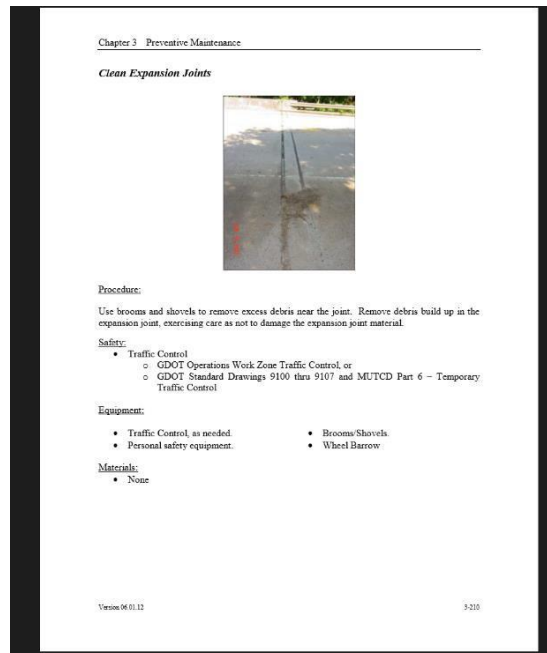
Figure 18: PDF Version of a Procedure from a Database

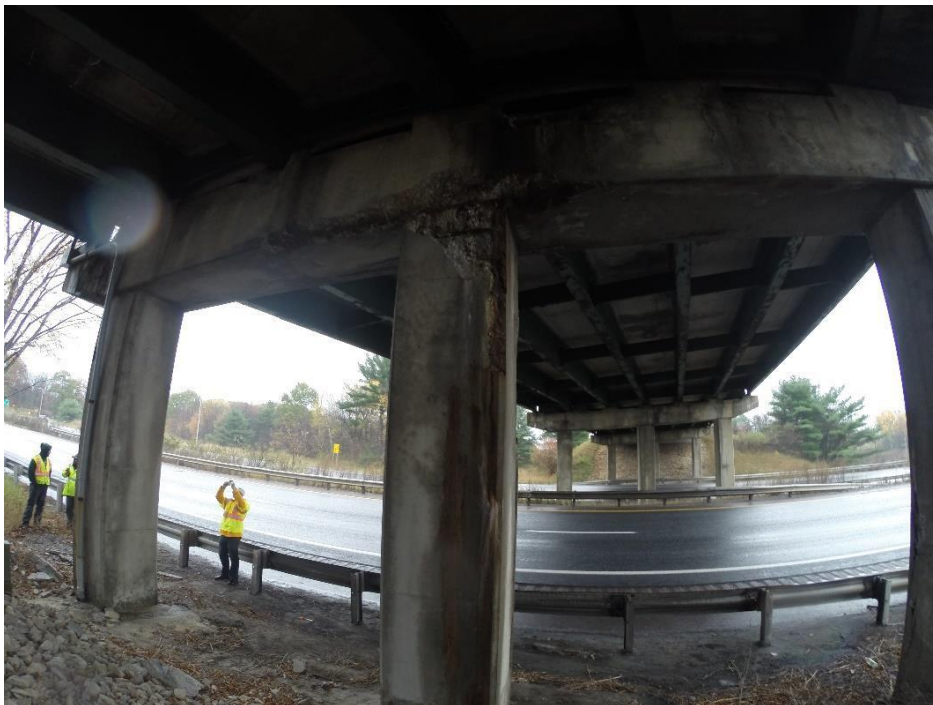
Figure 19: Column and cap Spalling and steel corrosion

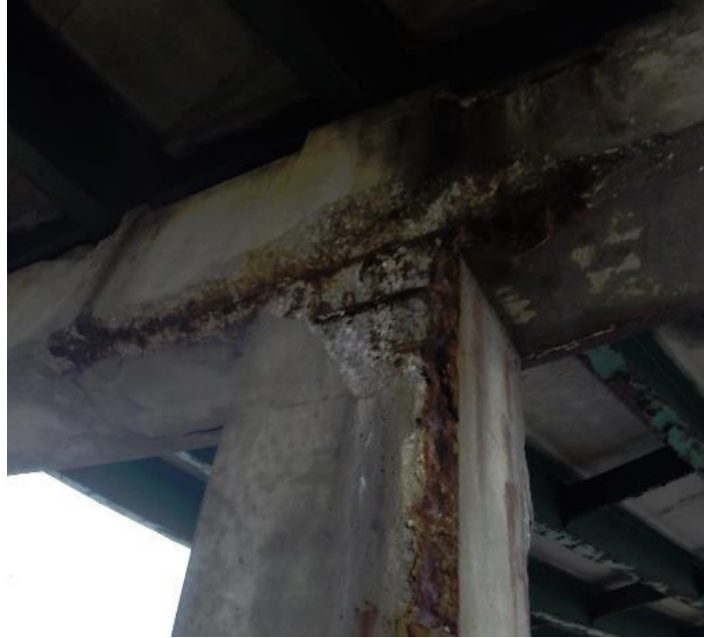
Figure 20: Close-up of concrete spalling and steel corrosion on middle column and cap

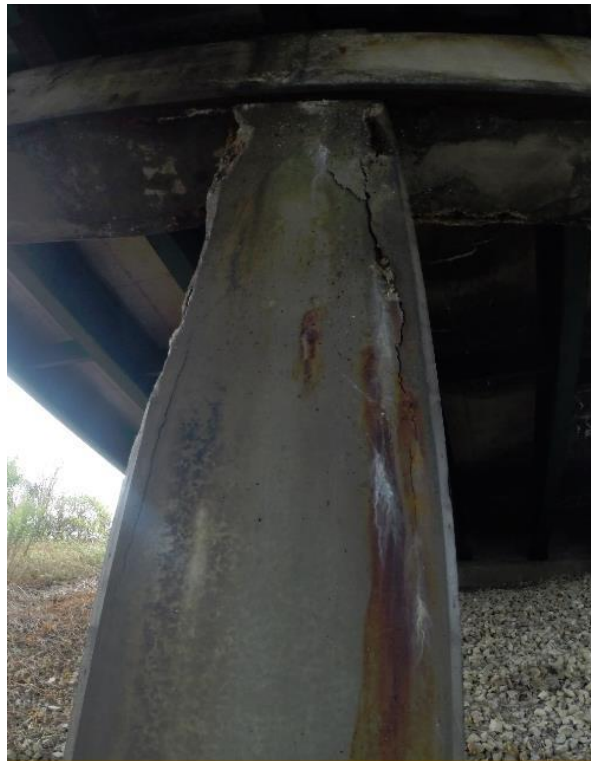
Figure 21: Other side of middle column. Notice Spalling, cracks and corrosion stains.

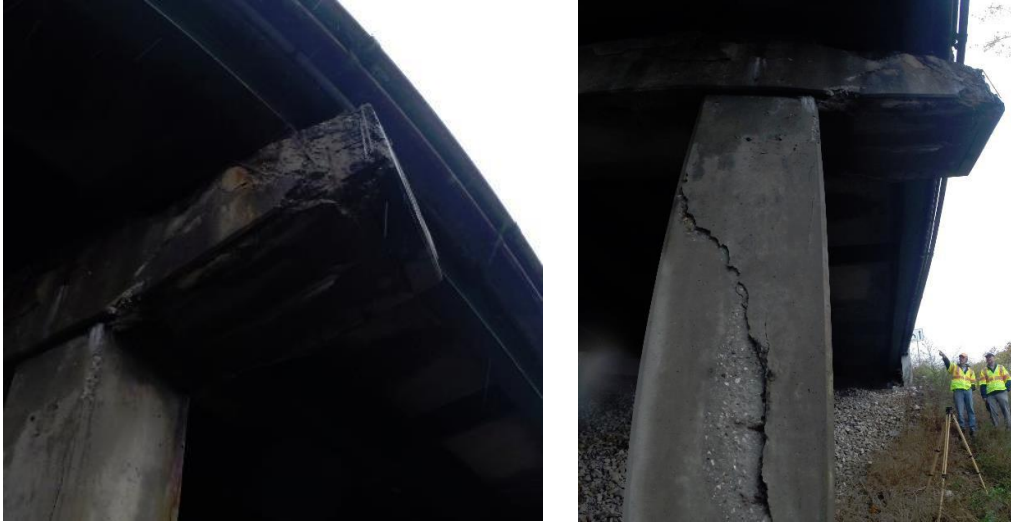
Figure 22: Spalling on end cap and a large crack on end column

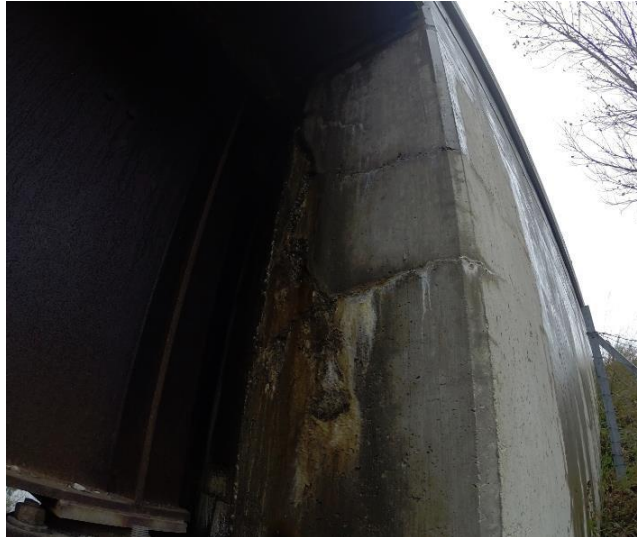
Figure 25: Scaling and cracking on abutment. Corrosion stains from steel beams

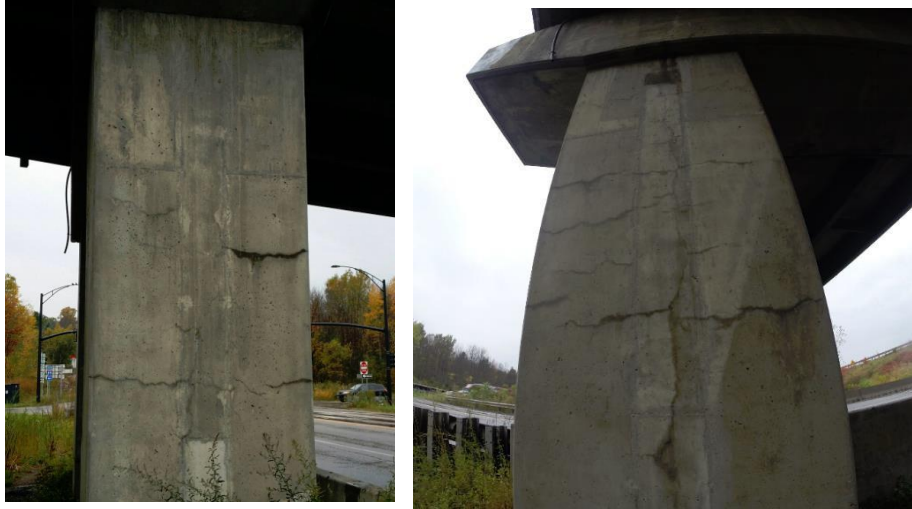
Figure 26: Possible dry shrinkage cracks on concrete column that has had a 6" thick concrete jacket around column.

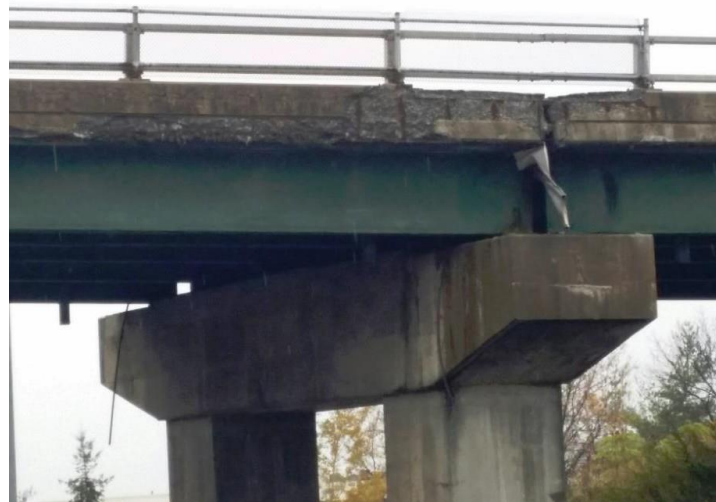
Figure 27: Spalling and steel corrosion on concrete fascia.

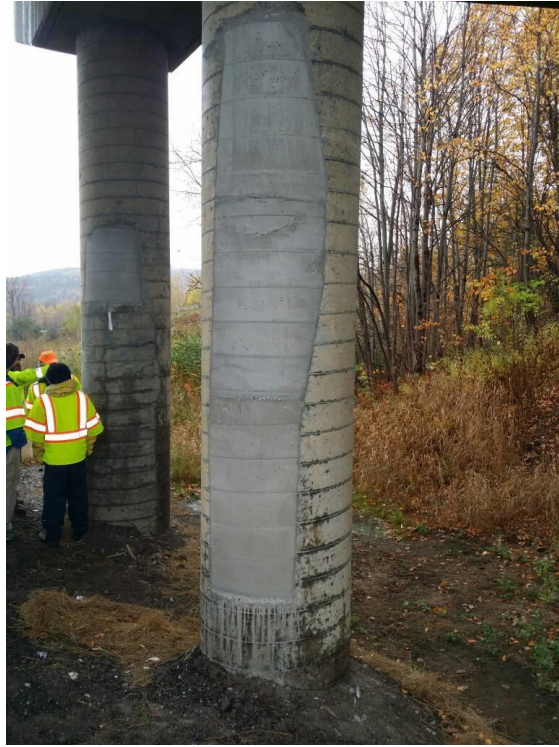
Figure 28: Patches on columns to fix spalling and cracking.

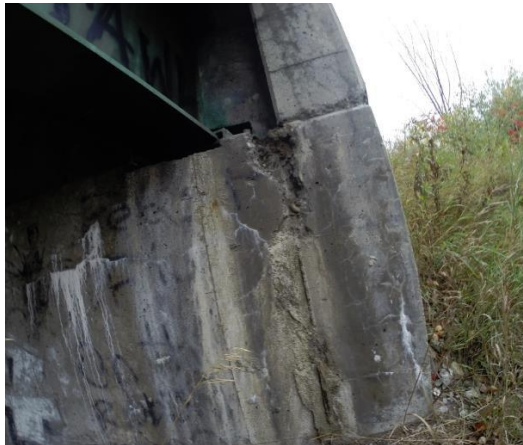
Figure 29: Scaling on abutment around bearing and beam

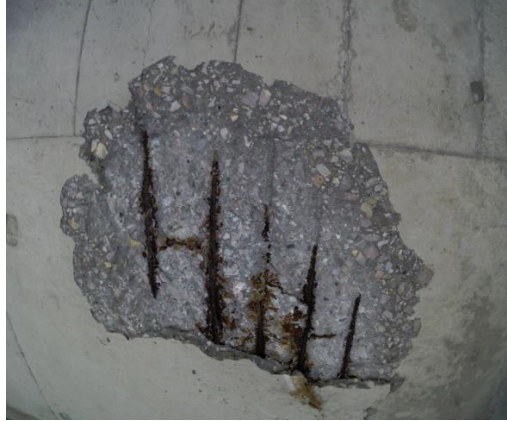
Figure 30: Spalling and slight steel reinforcement corrosion on underneath portion of concrete deck

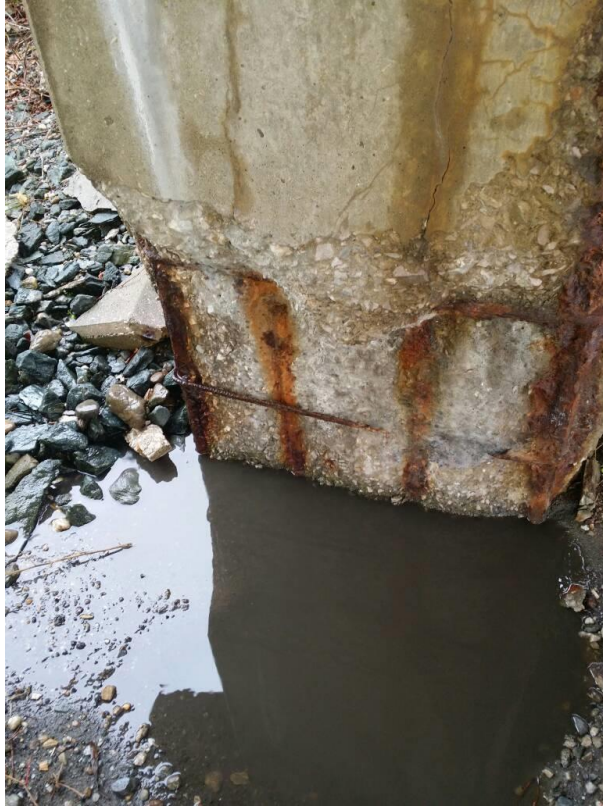
Figure 31: Severe spalling and steel corrosion on column and footing. Notice that some of the steel reinforcement is non-existing.

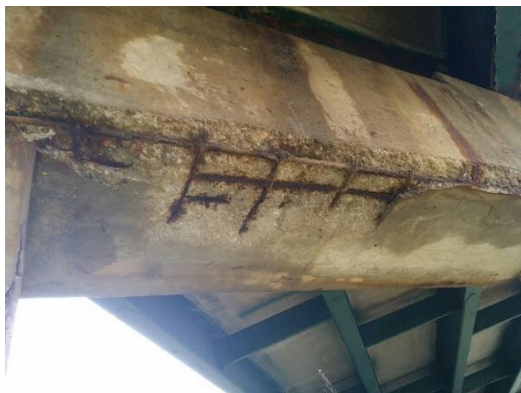
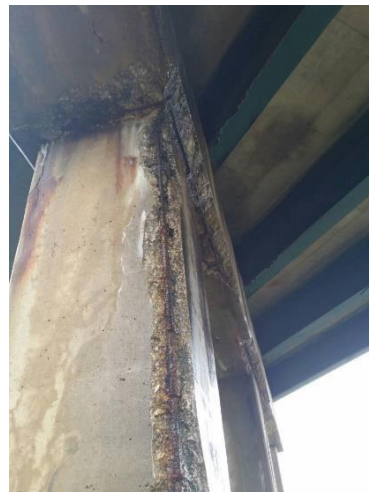
Figure 32: Spalling and steel corrosion on columns and caps

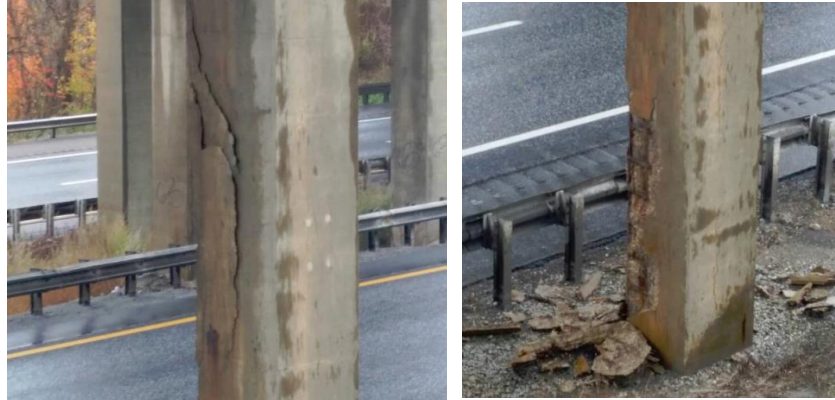
Figure 33: Spalling and steel corrosion on concrete column. Notice concrete fragments falling near road.

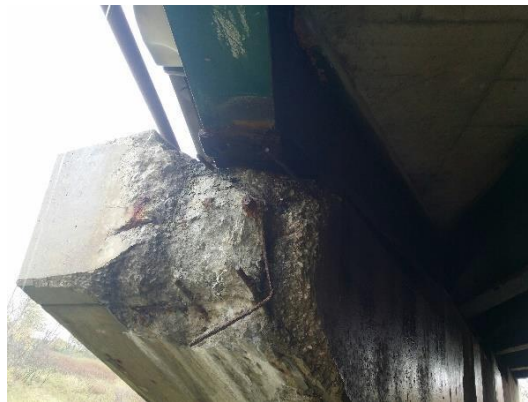
Figure 34: End cap spalling and steel corrosion with non-existing bearing.

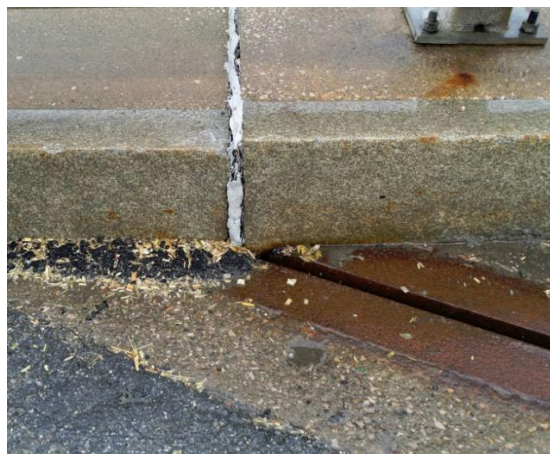
Figure 35: Bridge deck and expansion joint. Because of non-existing bearing bridge deck has settled down about 1.5”.

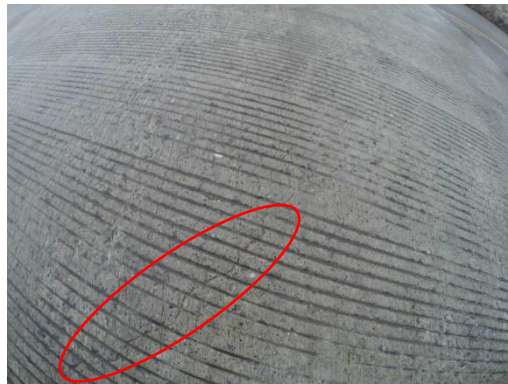
Figure 37: Crack on Deck Surface. Highlighted by Red Oval

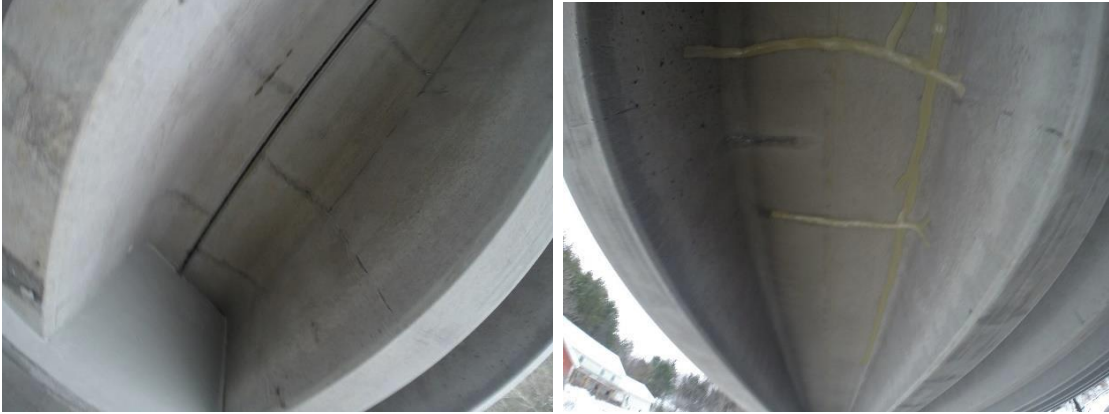
Figure 38: Underside of Concrete Deck. Left Image: shows cracks going at the way through concrete deck. Cracks are highlighted by red ovals. Right Image: sealant used to seal large cracks.
