Accelerated Innovation Deployment (AID) Demonstration Project  
Field Metalizing of a Steel Beam Bridge  
Vermont Agency of Transportation  
Structures Design Section  
Final Report  
J. B. McCarthy, VTrans Project Manager  
August 11, 2023

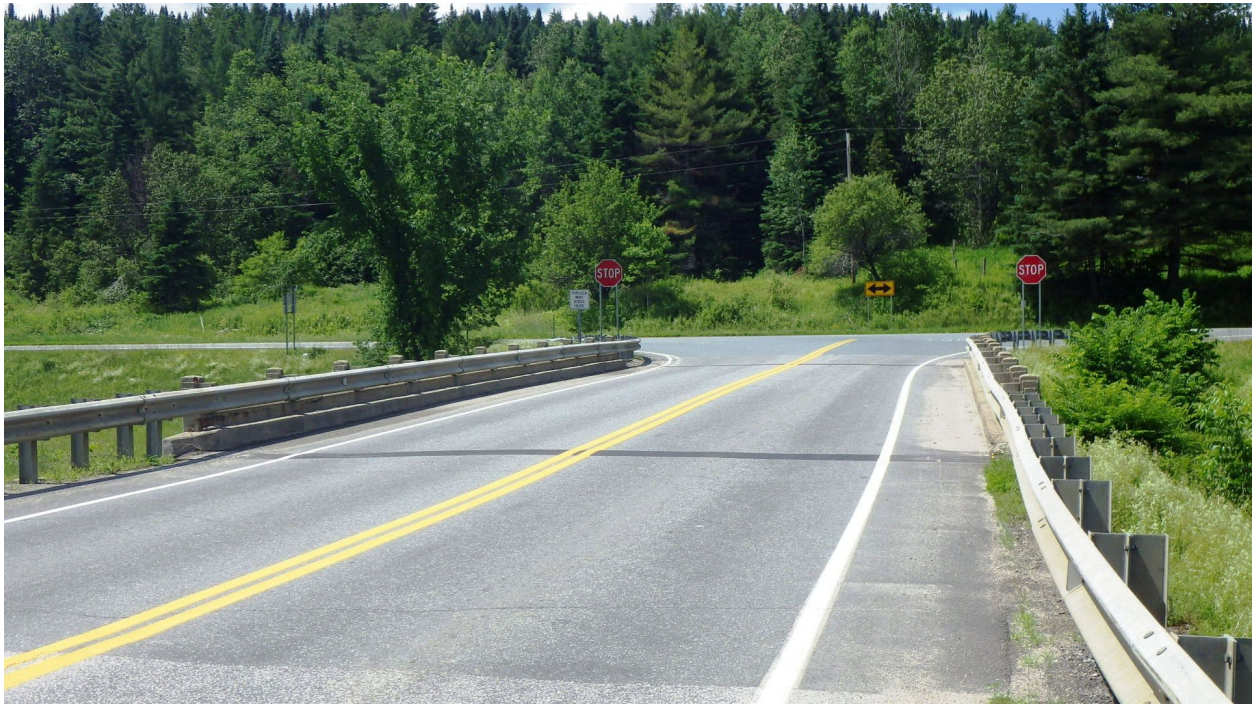
Hardwick VT 16 Br. 1 (Looking south toward VT 15)

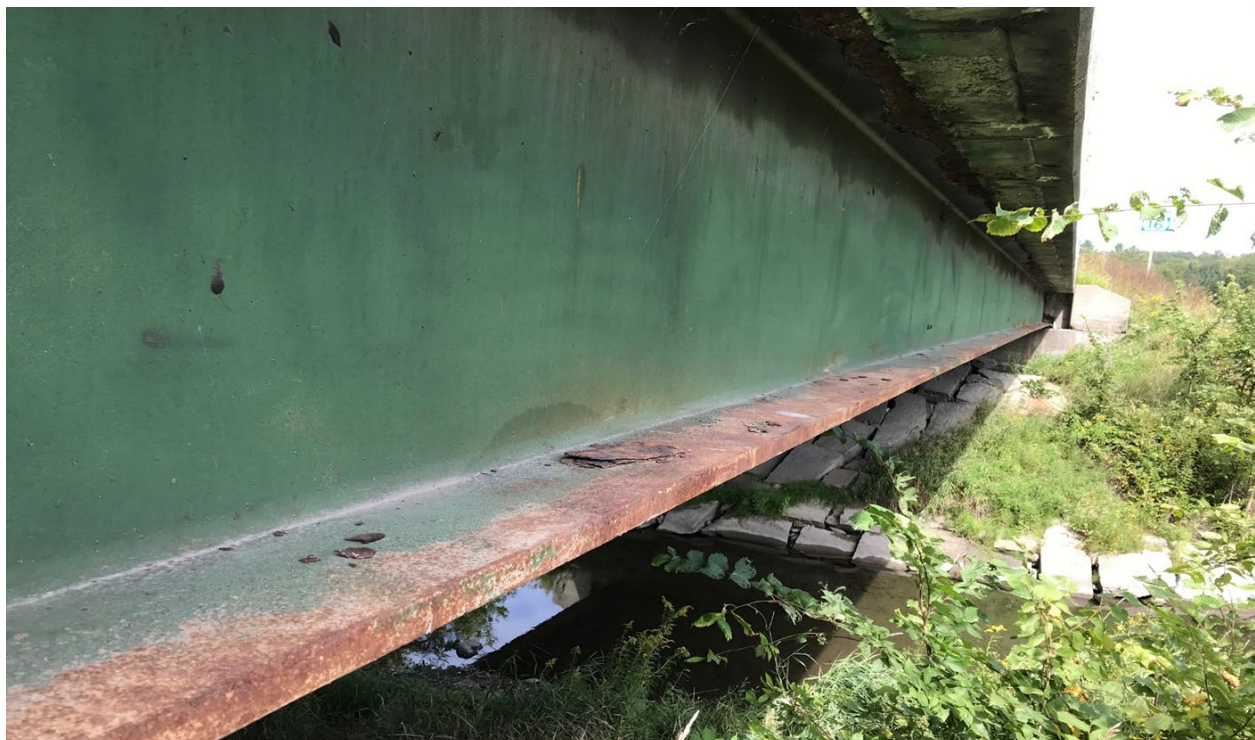
Hardwick VT Br. 1 (Fascia beam paint deterioration)

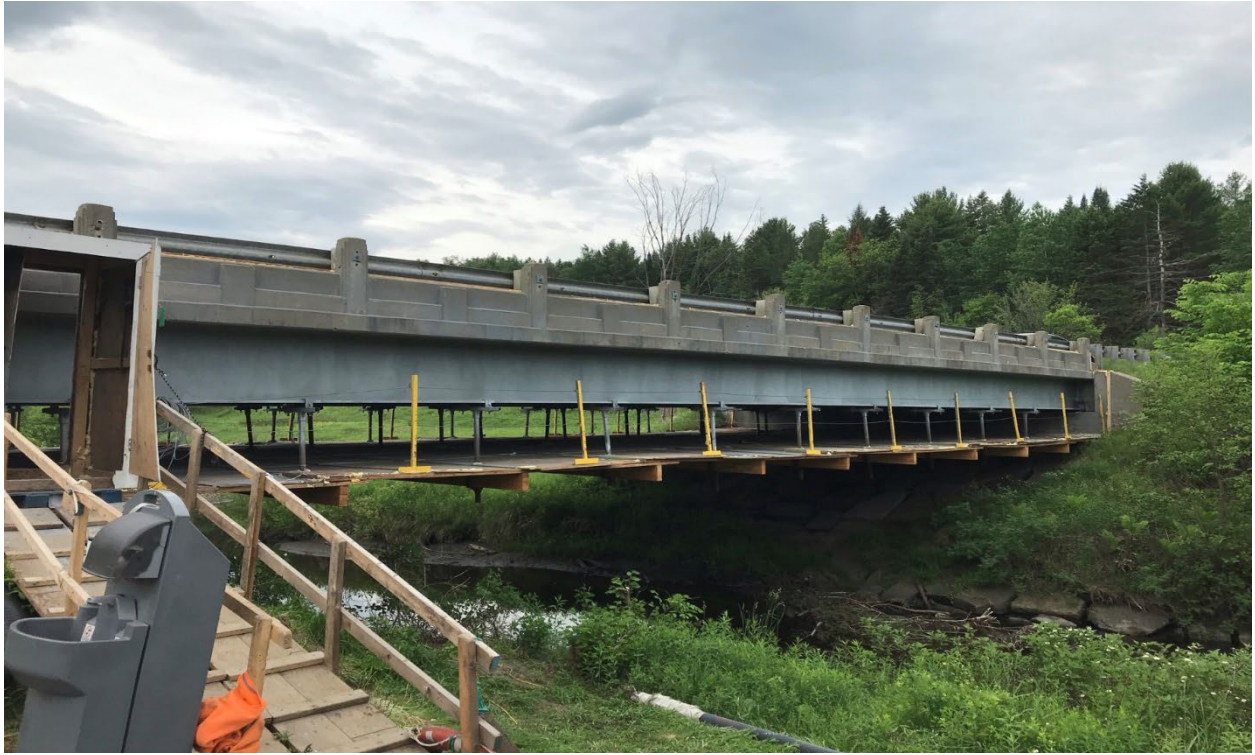
Work Platform Suspended from Beams

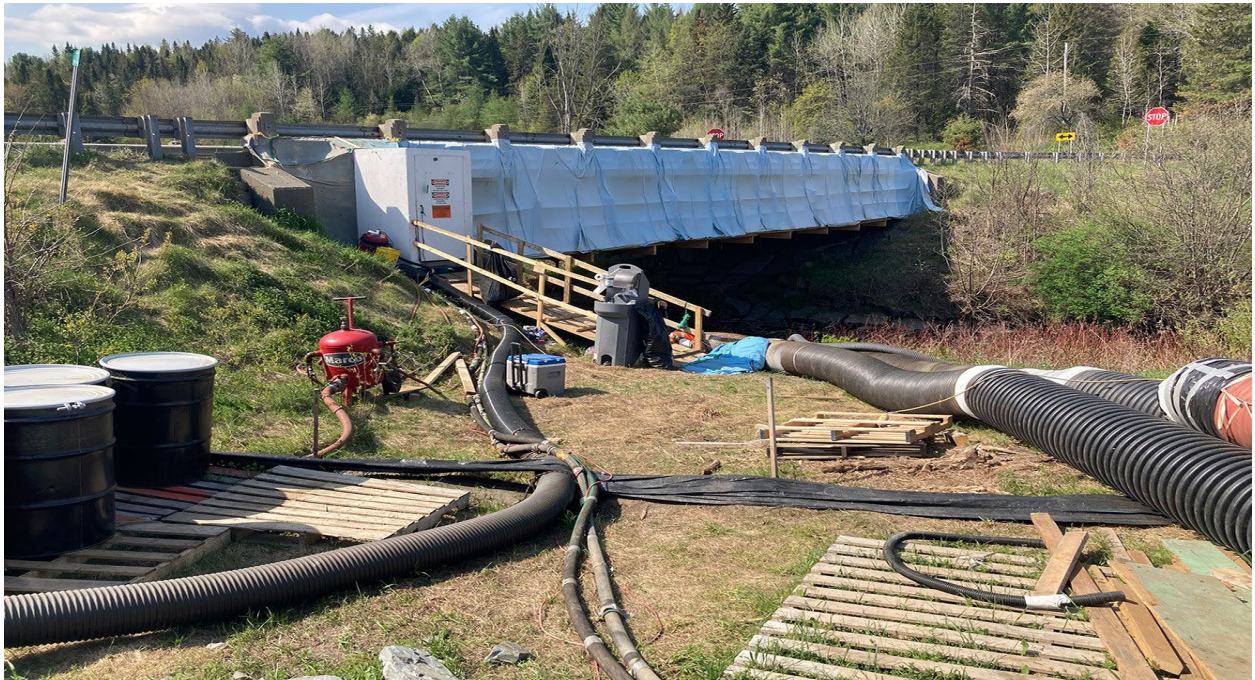
Structure Containment in Place

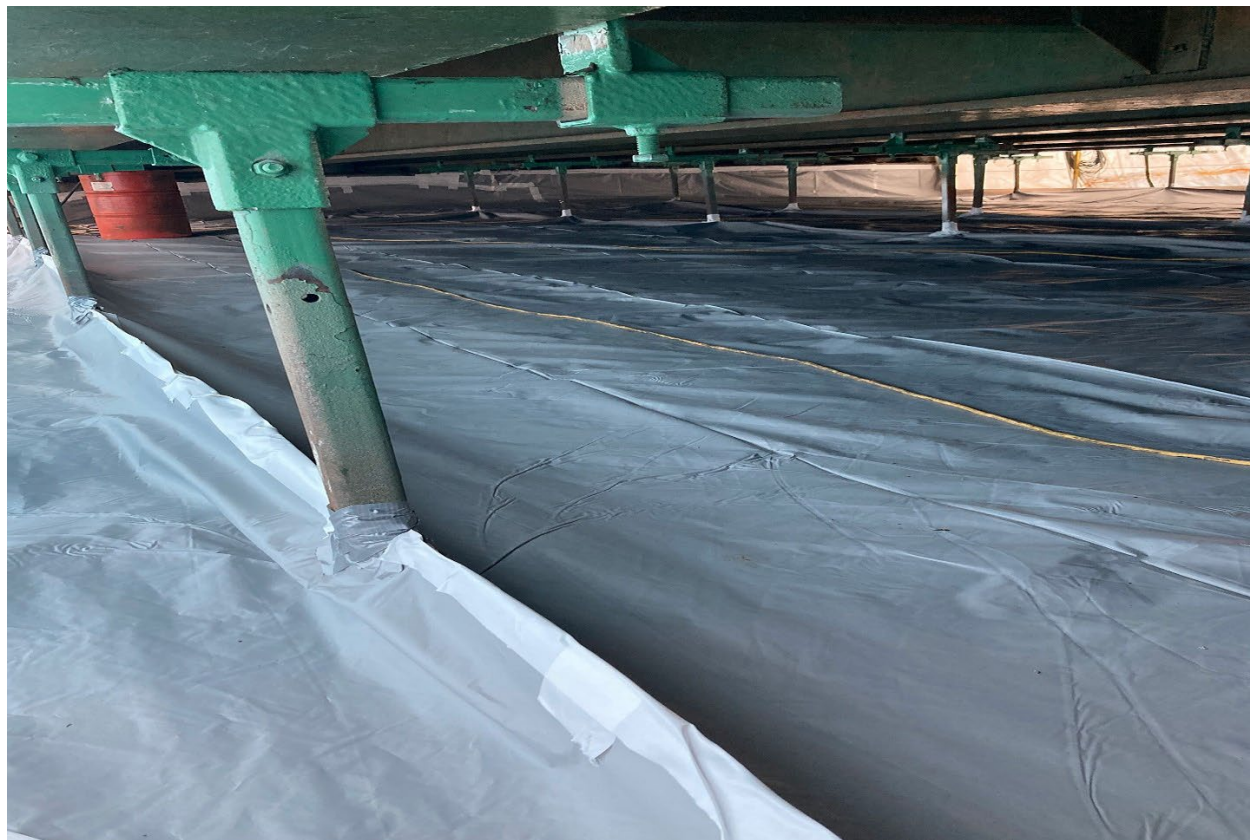
Bottom of Sealed Work Platform

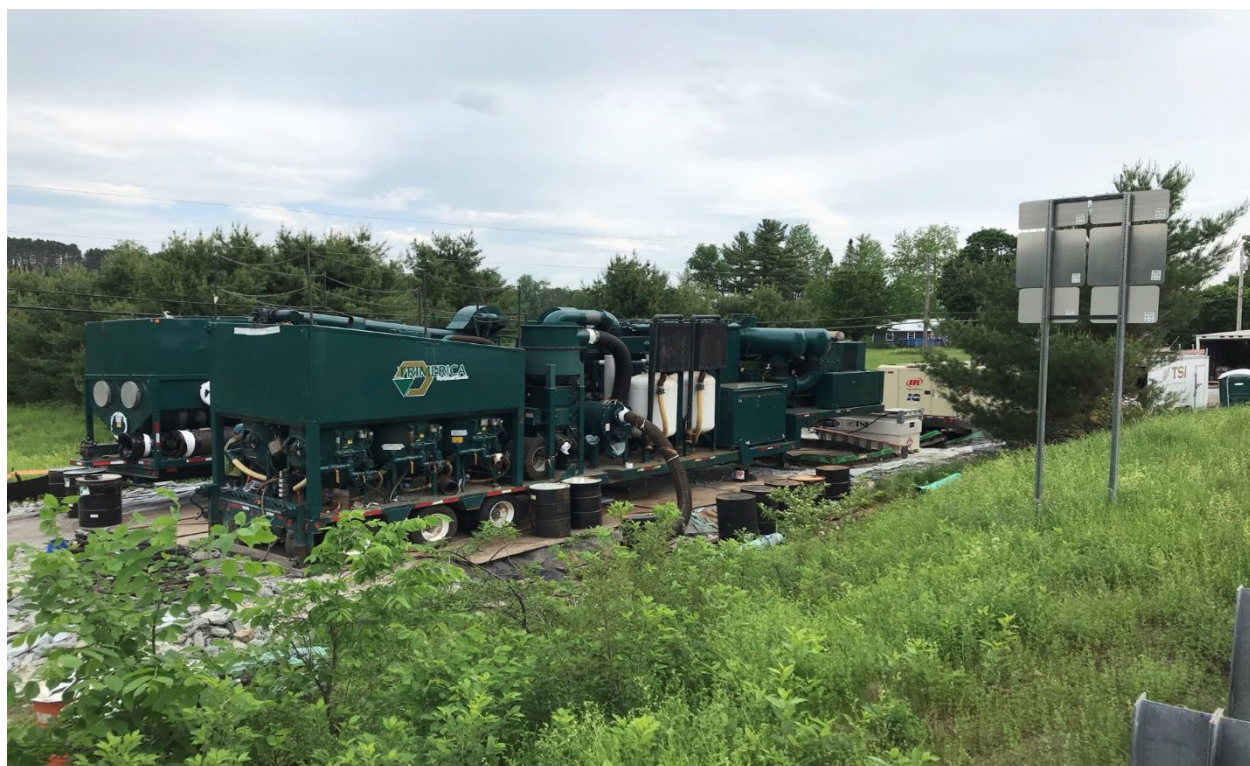
Air Filtration Equipment

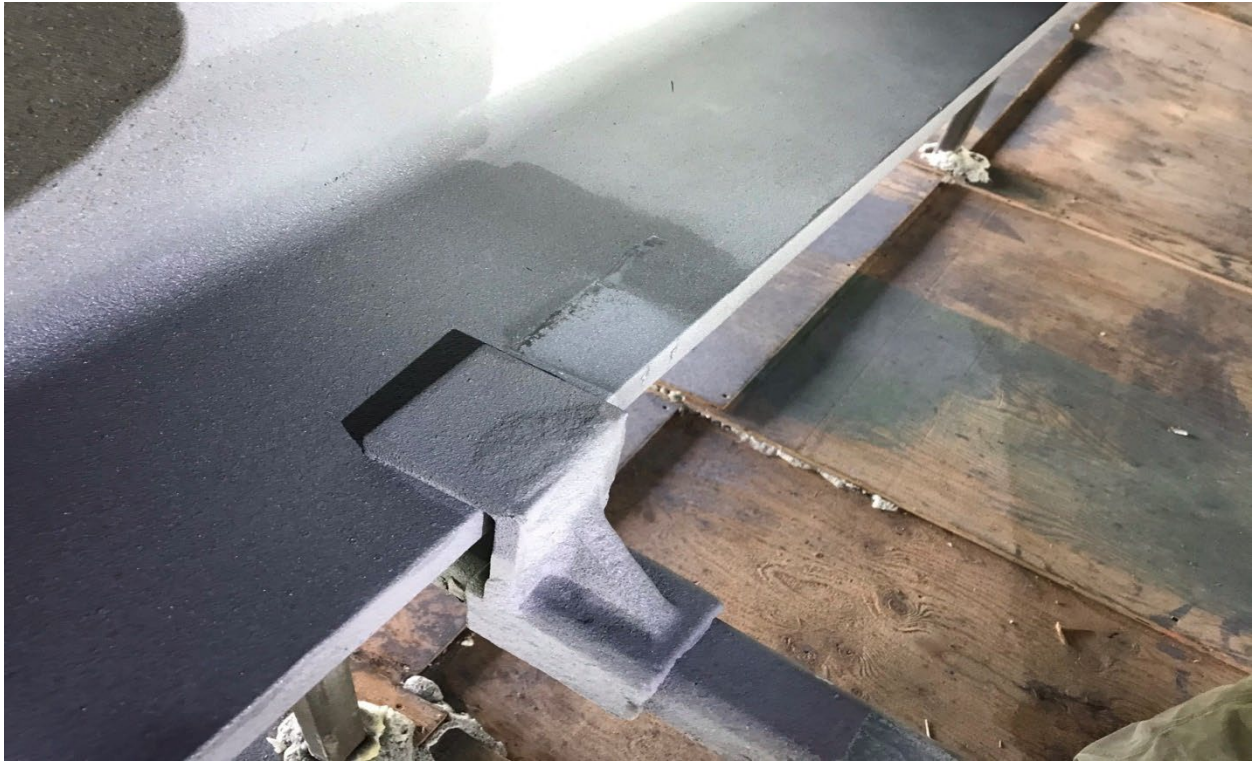
Repair Areas for Hanger Attachment

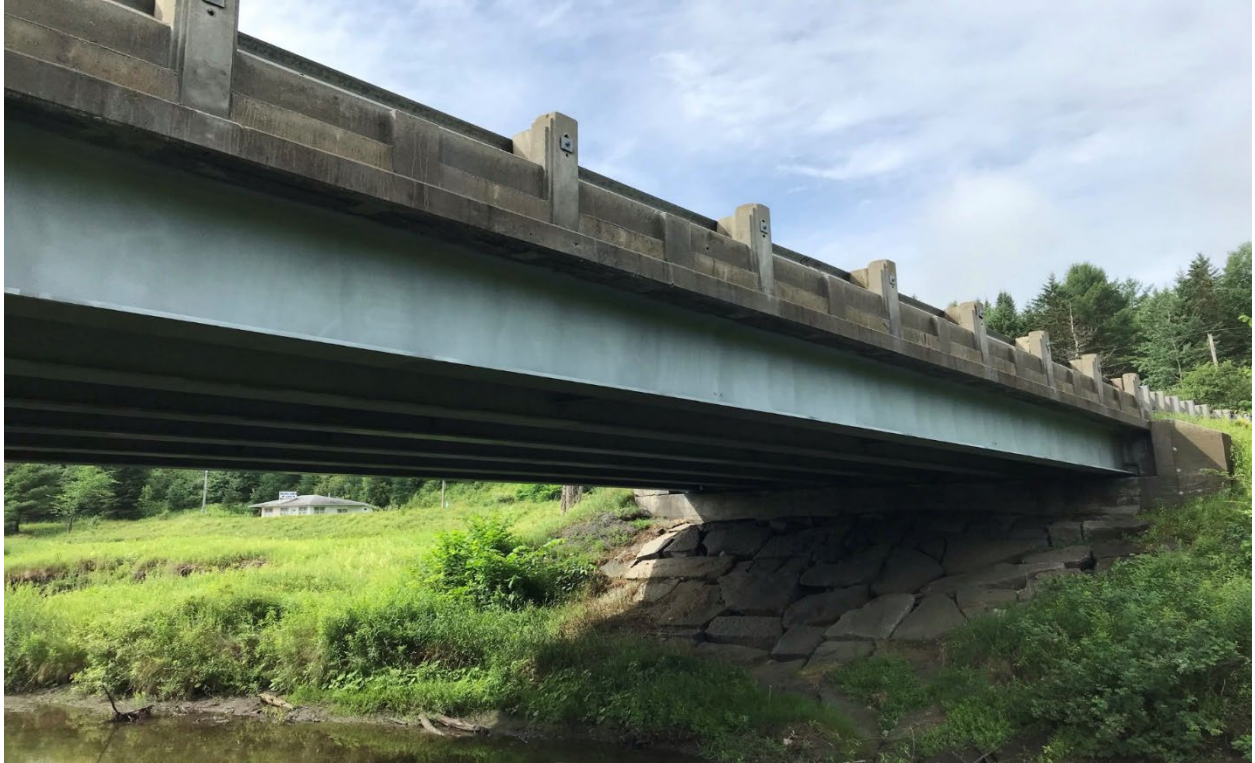
Finished Metalizing (Fascia Beam)
