PREVENTATIVE MAINTENANCE TREATMENTS

Final Report 2017 – 01

Reporting on Work Plan 2006-R-02

STATE OF VERMONT
AGENCY OF TRANSPORTATION

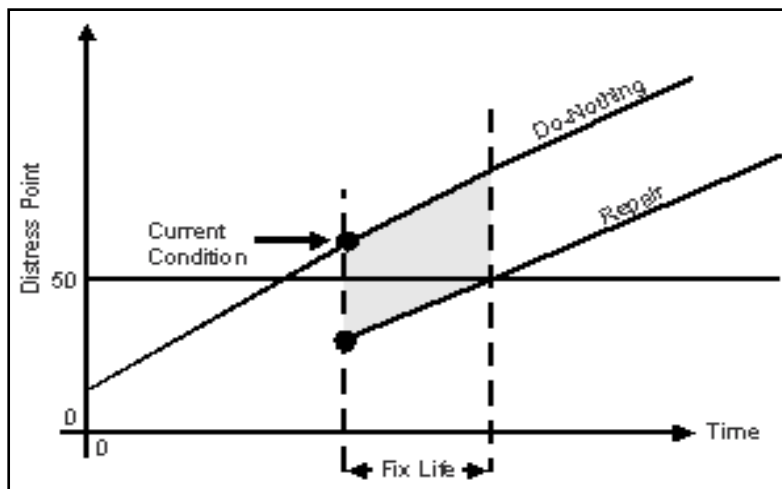
Figure 1: Preventative maintenance applied to an unsatisfactory pavement (4).

As illustrated in the graphs in Figure 1 and in Figure 2, when applied at the correct time, a PMT can prolong pavement life considerably.

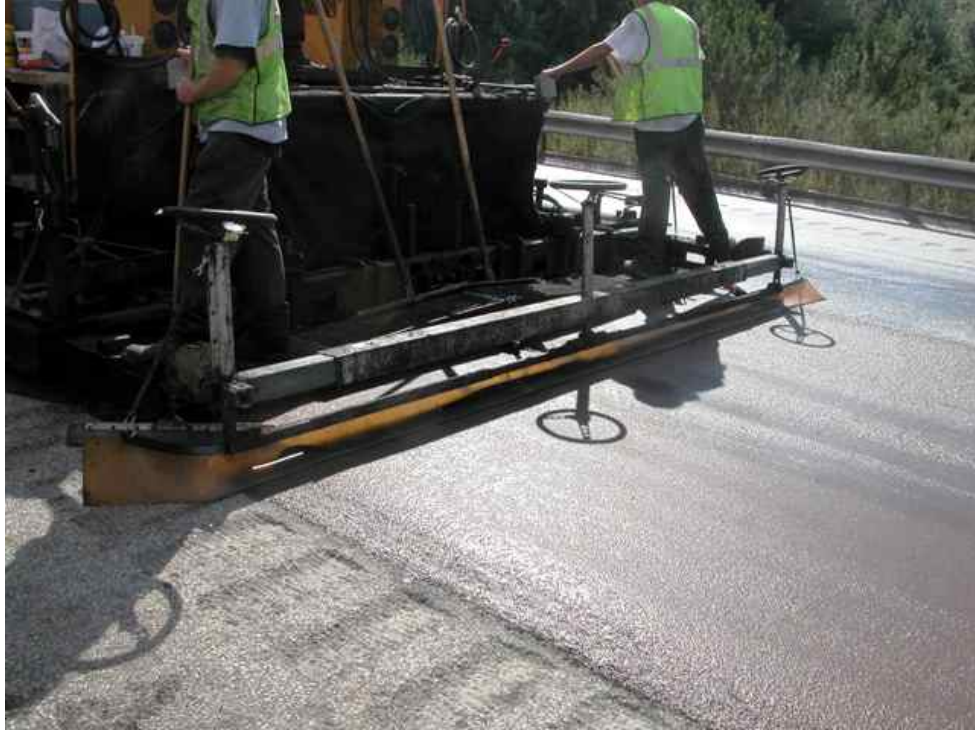
Figure 4: Slurry Seal paving.

A sub-contractor, Sealcoating, Inc. of Braintree, Massachusetts applied the Slurry Seal on September 11 and 12, 2006. Specifications require that the treatment be applied when the temperature is 50°F and rising and stay above 50°F for a period of 24 hours after application during its cure time. For the first day of application, temperatures dropped below 50°F at approximately 8pm that evening until 10am the following day. The low temperature during this period was 38°F. On the second day of application the temperature again fell below 50°F at approximately 8pm and did not rise above 50°F until 9am the next day (19). According to the Daily Work Report no other issues were reported during construction (20). Figure 4 and Figure 5 show the paving process and completed top finish. Note the condition of the slurry seal in Figure 4 especially the brown hue.

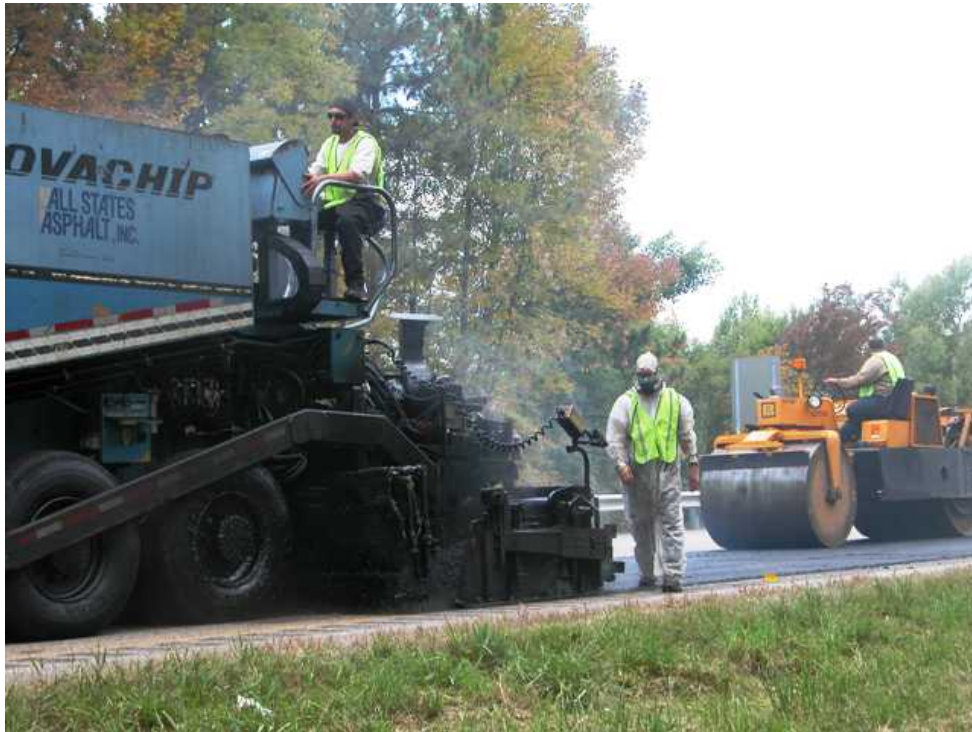
Figure 6: NovaChip® paving.

A sub-contractor, All States Asphalt Inc. of Sunderland, Massachusetts placed NovaChip®, the paver placed surface treatment, on September 20, 21, and 22, 2006. Temperatures during application were above the required 45°F and rising. The material was placed on the roadway surface using a self-primer paver. It was immediately rolled using one 12 ton steel-wheeled double-drum roller that made one static pass. No issues were reported regarding the application (20). Figure 6 and Figure 7 show the paving process and completed top finish.

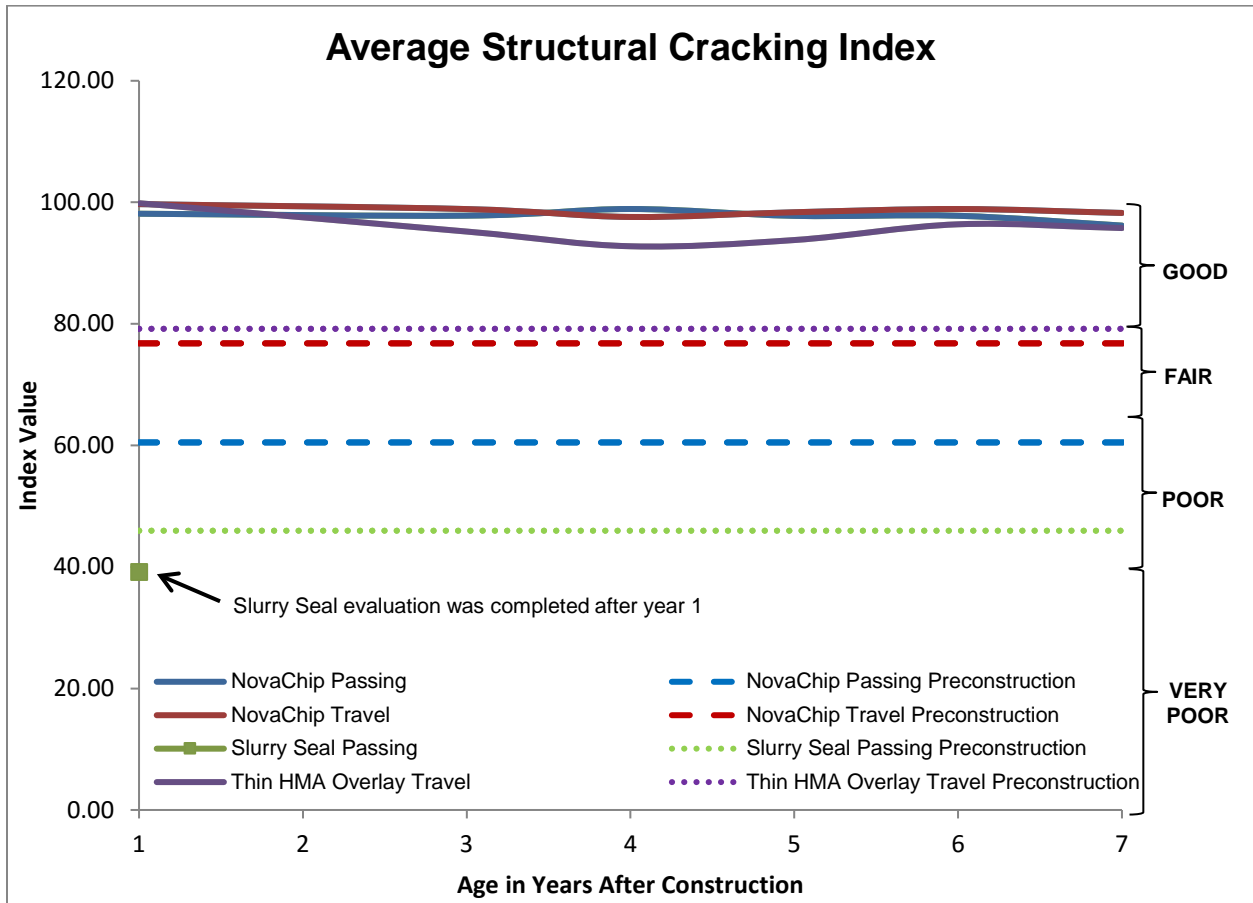
Figure 9: Structural Cracking Index.

As seen in Figure 9, the Slurry Seal section had significant wear within the first year of application. Preconstruction values were considered to be “very poor” in the PCI scale, averaging 45.96. One year after application, the treatment did not perform substantially better than preconstruction conditions, averaging 39.12. The other treatments far outperformed the Slurry

Seal. All treatments exhibited consistent Structural PCI values throughout the course of the study. At the end of the evaluation, all treatments were in the high end of the good PCI category, averaging 95-98.

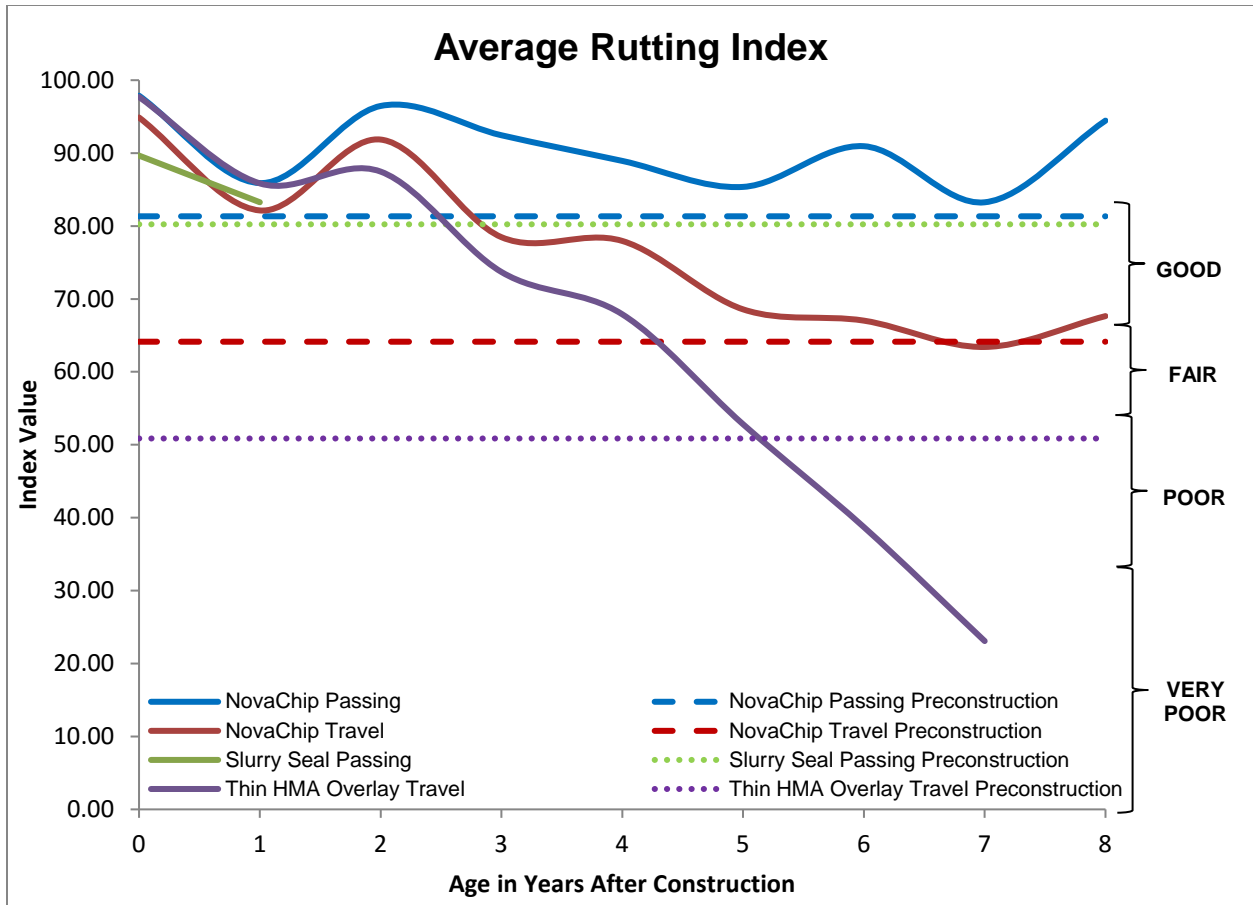
Figure 12: Rut Index.

Rutting values (see Figure 12) were noted to be far more variable between treatments over the evaluation period. The Slurry Seal ended with a value of 83.26; however, this was one year after application. NovaChip in the passing lane performed the best, ending at a value of 94.45 at the end of eight years after application. NovaChip in the travel lane ended in the Fair/Good range. The Thin HMA Overlay section sharply decreased beginning at two years after application, ending with a 23.08 value seven years after application.

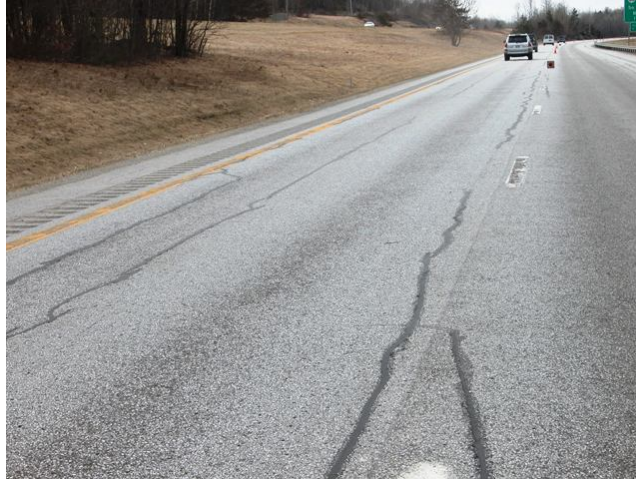
Figure 14: Overview of the project site.

Prior to construction on April 11, 2006, the site was visited to characterize and document the existing condition and surface distresses of the site. Minimal cracking was noted at the site. Most cracks were longitudinal in nature and were primarily load related failures in the wheel paths. The cracks appeared to have received some sort of maintenance treatment to remediate them in the form of cold patch, hot mix, and/or crackfill. The hot mix patches appeared to have worked the best where the crackfill had begun to delaminate in areas. Aggregate stripping, creating an irregular surface and exposing additional aggregate in the pavement was observed throughout the project location (23). Figure 14 and Figure 15 show the site prior to construction.

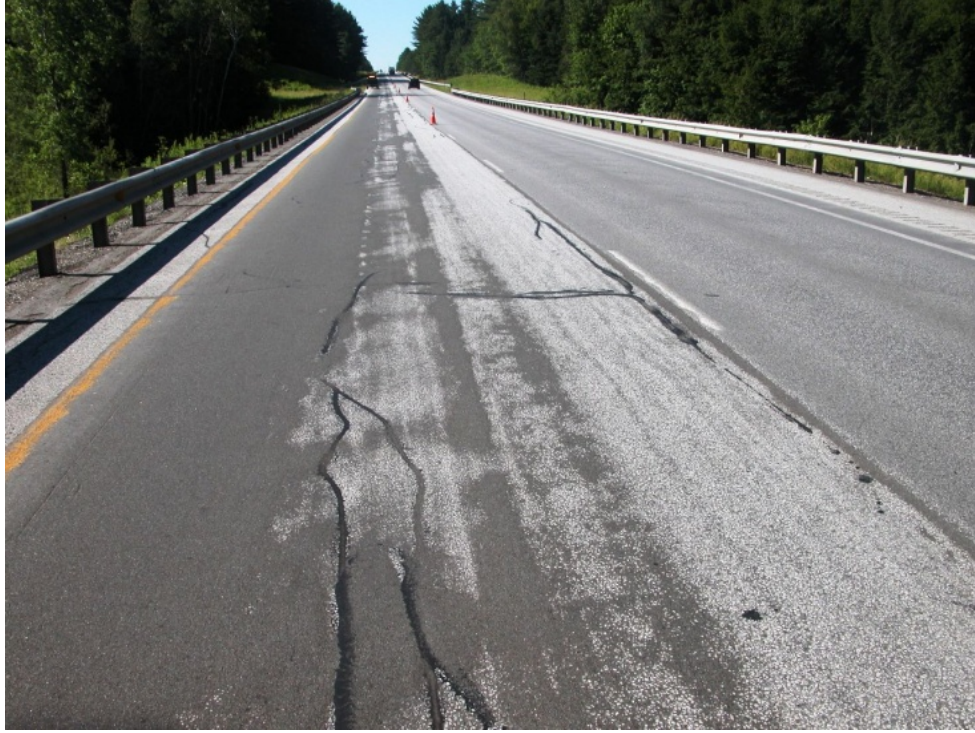
Figure 16: 2007 Slurry Seal and Thin HMA Overlay overview.

The site was inspected by Research and Pavement Design Unit personnel on July 17, 2007. Within the Slurry Seal section, the treatment remained on approximately $\frac{1}{2}$ to $\frac{2}{3}$ of the lane, Figure 16. The areas that were crackfilled approximately one week before the treatment application were still sealed however the Slurry Seal had severely worn on both sides of the sealed crack in many areas, shown in Figure 17.

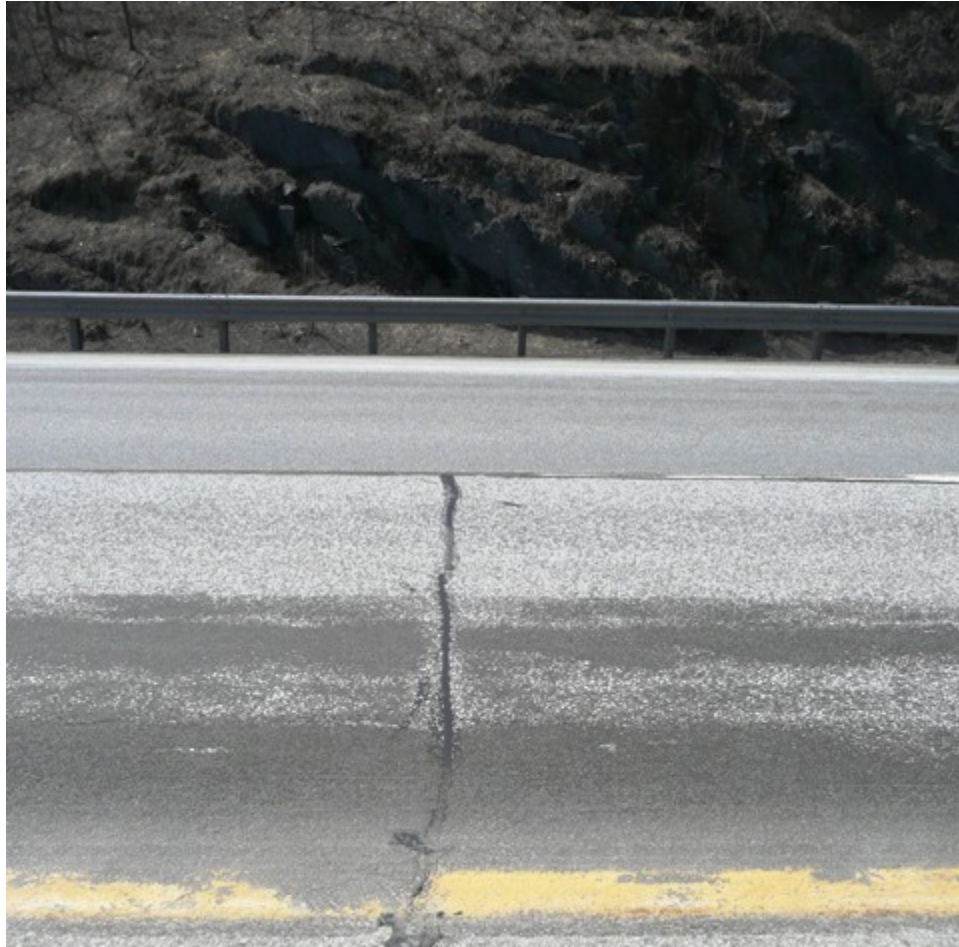
Figure 19: Overview of Slurry Seal and the Thin HMA Overlay treatments.

A site visit was completed on April 10, 2008 after the site received a second year of winter maintenance. The Slurry Seal section remained on approximately 40% of the lane and the treatment along the sides of crackfilled areas continued to wear, Figure 19. The Thin HMA Overlay remained in excellent condition, excluding a few potholes noted just north of the Exit 7 off-ramp, Figure 20. The NovaChip® also was noted to be in excellent condition. Approximately 19 transverse cracks were noted, a majority of which began in the passing lane and did not extend across the full roadway width. This could be attributed to the steep slope decrease from the passing side to the travel side with consideration to the relatively (for the season) high water table; one can

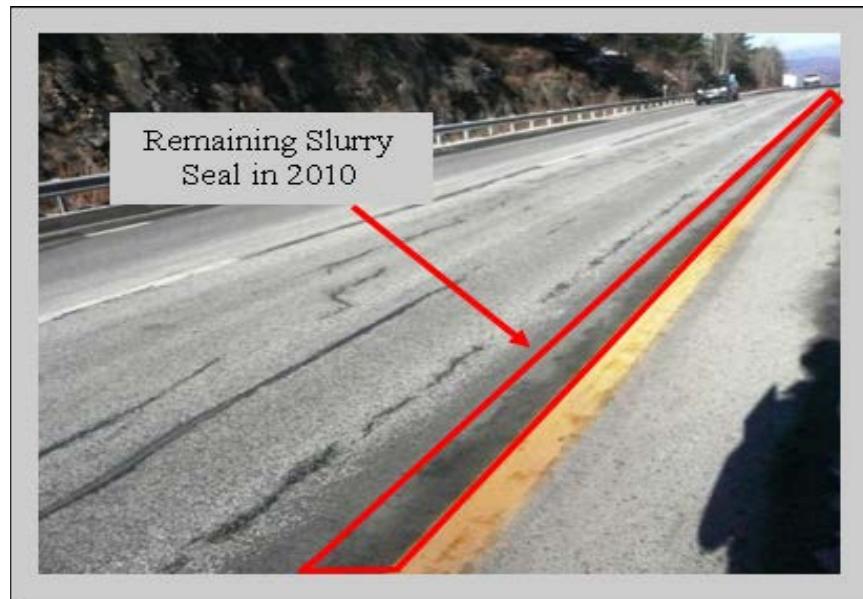
Figure 22: Remaining Slurry Seal Treatment in 2010.

Site visits were performed over the next six years, from 2009 to 2014. All of the treatments increased in distresses. The Slurry Seal treatment was estimated to be 5% remaining in 2009, three years after placement. Figure 22 shows the treatment at the 2010 site visit. VTrans Maintenance and Operations Bureau repaved the Slurry Seal section in 2012, through a maintenance paving contract due to poor surface conditions and excessive rutting, subsequently ending this portion of the evaluation.

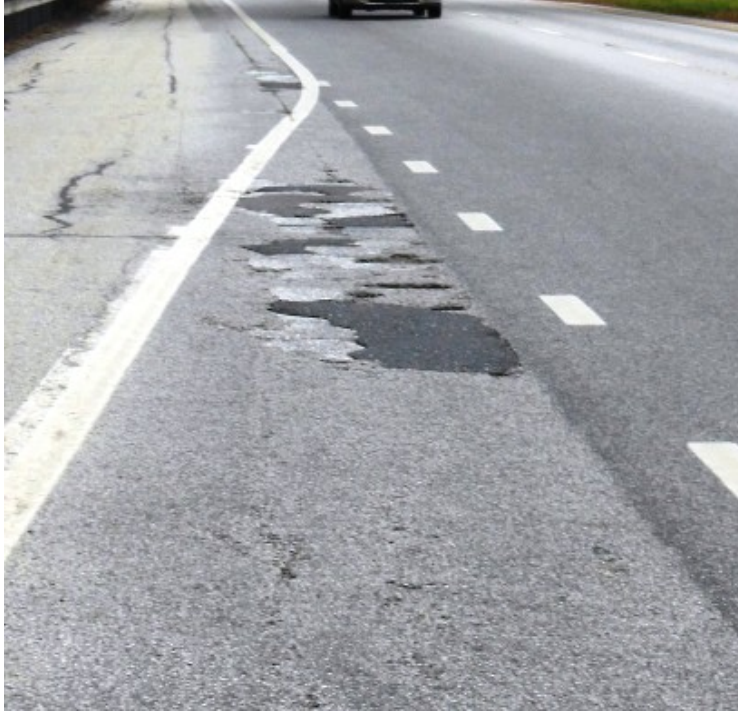
Figure 23: Potholes near Exit 7 in 2013.

Cracking, both transverse and load related longitudinal cracking, was noted in the Thin HMA Overlay section beginning in 2009 and progressing throughout the following evaluation years, Figure 20 and Figure 23. The potholes located just north of the Exit 7 ramp first observed in 2008 continued to need repair maintenance, including filling and patching. A year after the Slurry Seal section was repaired in 2013, it required paving as well due to safety concerns associated with excessive rutting creating hydroplaning situations, Figure 24. Figure 25 shows what presumably is the underlying pavement course where stripping and raveling was evident.

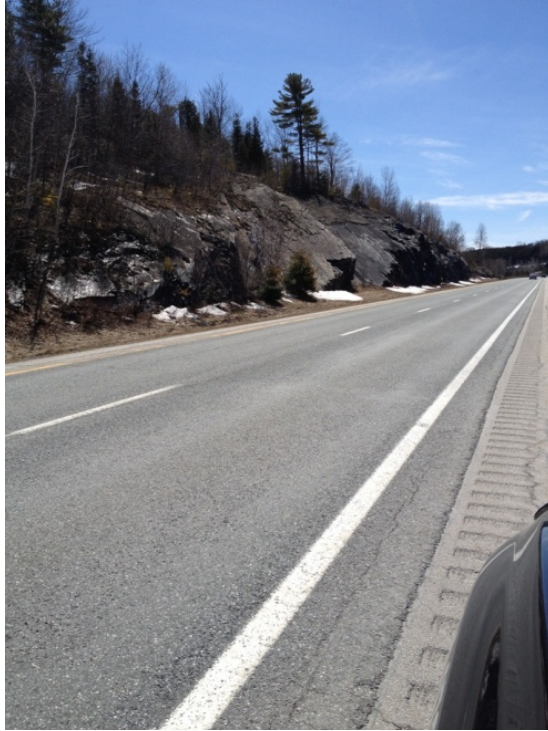
Figure 26: NovaChip® overview in 2014.

Transverse cracking persisted in the NovaChip[®] section over the evaluation time. In 2009, there were approximately 132 transverse cracks, either partial or full lane width in length were noted in this section. These increased at each annual site visit and the total number was not continued to be recorded. The localized depressions did not appear to get much worse in the six years following first observing them in 2008. This condition suggests that the depression were principally a construction rather than wear phenomenon. The final site visit was conducted in the spring of 2014 prior to the rehabilitation project, IM 089-1 (61) that spanned the length of the entire three previously treated areas. There were several transverse cracks noted, most full lane width. Figure 26 is an overview of the treatment at this visit.
