**Reclaimed Base Course Stabilized With Calcium Chloride  
Brandon-Goshen, VT. Route 73  
Final Report**

**June 2008**

**Report 2008 - 4  
Reporting on Work Plan 93-R-6**

State of Vermont  
Agency of Transportation  
Materials and Research Section

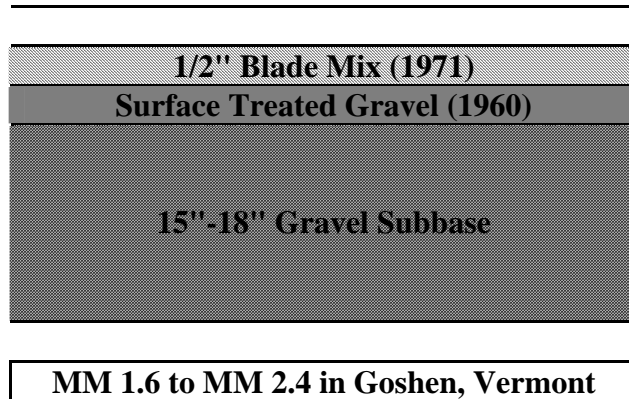
**Figure 1 –Goshen Historical Pavement Treatments**

According to historical data, the subbase consists of 15 to 18” of gravel. There is little information regarding the original construction of the pavement in 1960 where the test sites are located. During this timeframe an undetermined thickness of surface treated gravel was applied. This was constructed of a single tack consisting of refined tar and blade mix, pea stone seal with cutback asphalt. Historical records show that there were three rehabilitation projects in years following the original construction. The pavement received a ½” of blade mix in 1971, a 1” plant mix in 1978, and a bituminous seal in 1984. Like the surface treated gravel, the thickness of bituminous seal is unknown. The preexisting pavement profile is provided Figure 1.

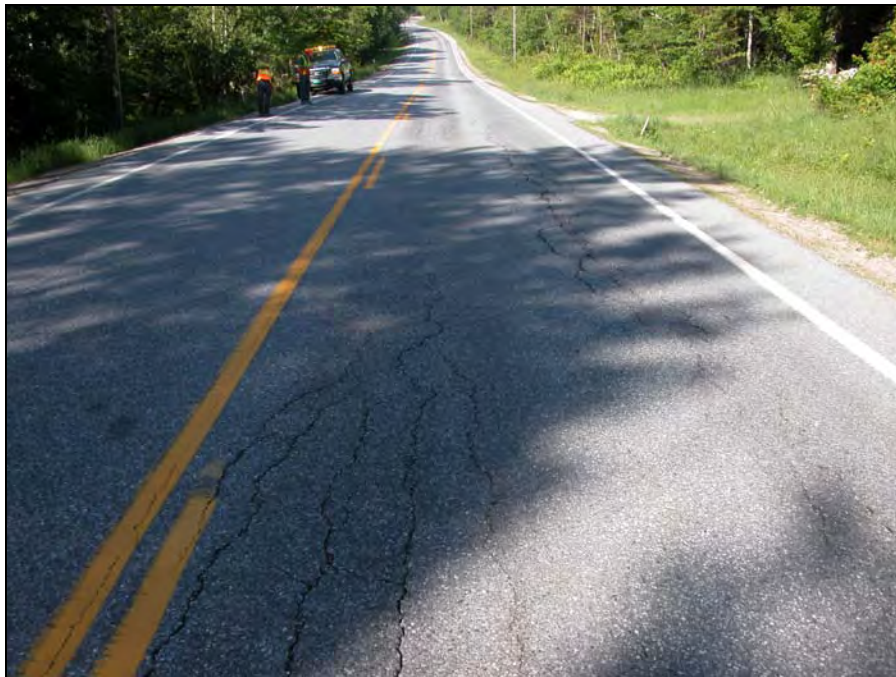
**Figure 2 – Typical Fatigue Cracking**

The following assessment began with examining longitudinal or fatigue cracking. As indicated by the "Distress Identification Manual", fatigue cracking occurs in areas subjected to repeated traffic loading, or wheel paths, and may be a series of interconnected cracks in early stages of development that progresses into a series of chicken wire/alligator cracks in later stages as shown in Figure 2. For this investigation, the wheel paths were determined to be three feet in width with the center of the left wheel path and right wheel path 3.5' and 8.5', respectively from the centerline on either side of the roadway.

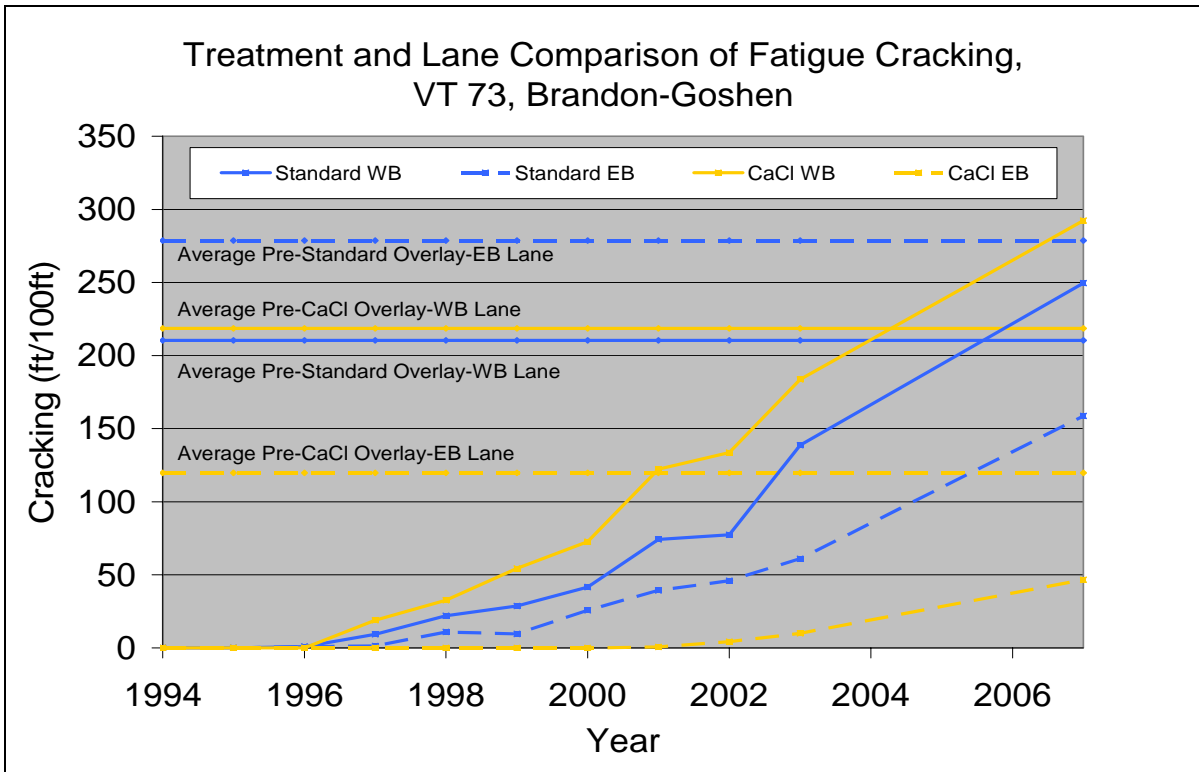
Figure 3 – Fatigue Cracking Comparison

Clemson University as “the effect on pavement performance of any combination of axle loads of varying magnitude equated to the number of 80-kN (18,000-lb.) single-axle loads that are required to produce an equivalent effect.” Basically, pavements are designed to structurally support traffic loads which are often calculated by average annual daily traffic (AADT) or ESALs with regards to roadway use. ESAL information was not available for this investigation. Figure 3 provided below contains a comparison between the average onset and rate of cumulative fatigue cracking of the experimental and control sections in association with preconstruction conditions.

It is interesting to consider the amount of fatigue related distress prior to construction. While the westbound lane appears to be relatively homogenous throughout the test sections, the eastbound is highly variable. The causations for this phenomenon are unknown. Fatigue distresses are typically caused by inadequate lateral support due to the underlying pavement structure and soils or an inability to carry loads in excess of design loads. An investigation of AADT and truck traffic recorded throughout the investigation by the Traffic Research Section following construction does reveal some variation in the amount of vehicles and percentage of truck traffic within and between test sections as shown in Table 2. In general there is a greater amount of traffic between MM 2.2 and MM 2.4; however the amount of truck related traffic is roughly equivalent. It is important to note that preconstruction traffic stream data was not available. If the traffic stream is assumed to be the same prior to and following construction, varying lateral support along the eastbound lane is suspected.

A further examination of the onset and rate of fatigue related distresses following construction reveals comparable responses between the westbound and eastbound lanes, respectively. The slopes are not constant, with higher amplitudes resultant of increased failure rates. As expected, this may be attributed to the traffic stream during this time period. In addition, the amount of fatigue distresses may have been influenced by nearby timber harvesting operations in the Green Mountain National Forest. The Commercial Vehicle Permit Unit was contacted for historical permit information. However, permits provided for logging purposes do not impose any routing regulations. Therefore it is not possible to confirm the presence of heavy log truck traffic. Correspondence from the Forest Service does confirm logging operations in the early 1990's. However, specific documentation is limited. Fatigue distresses may have been influenced by braking forces associated with an intersection at Goshen Four Corners immediately upstation of the test section between MM 1.6 and MM 1.8 and downstation of the test section between MM 2.2 and MM 2.4. If the breaking theory is true, fatigue cracking would be more predominate in the two westbound test sections as traffic descends down Brandon Gap as shown in Figure 3. It is impressive to note that the experimental pavement treatment constructed along the eastbound lane did not display any fatigue distresses until 2001, seven years following construction. Conversely fatigue cracking within the two standard sections along the east and westbound lanes was first observed in 1996, only two years following construction. However, the overall performance of each test section is highly variable making inferences difficult. This may be attributed to construction sequence and increasing familiarity with associated equipment. Averaging indicates that the experimental sections met or exceeded preconstruction levels while the standard sections displayed 85% of preconstruction values in 2007, thirteen years following construction. Additional fatigue and longitudinal crack data can be found in Appendix B and C.

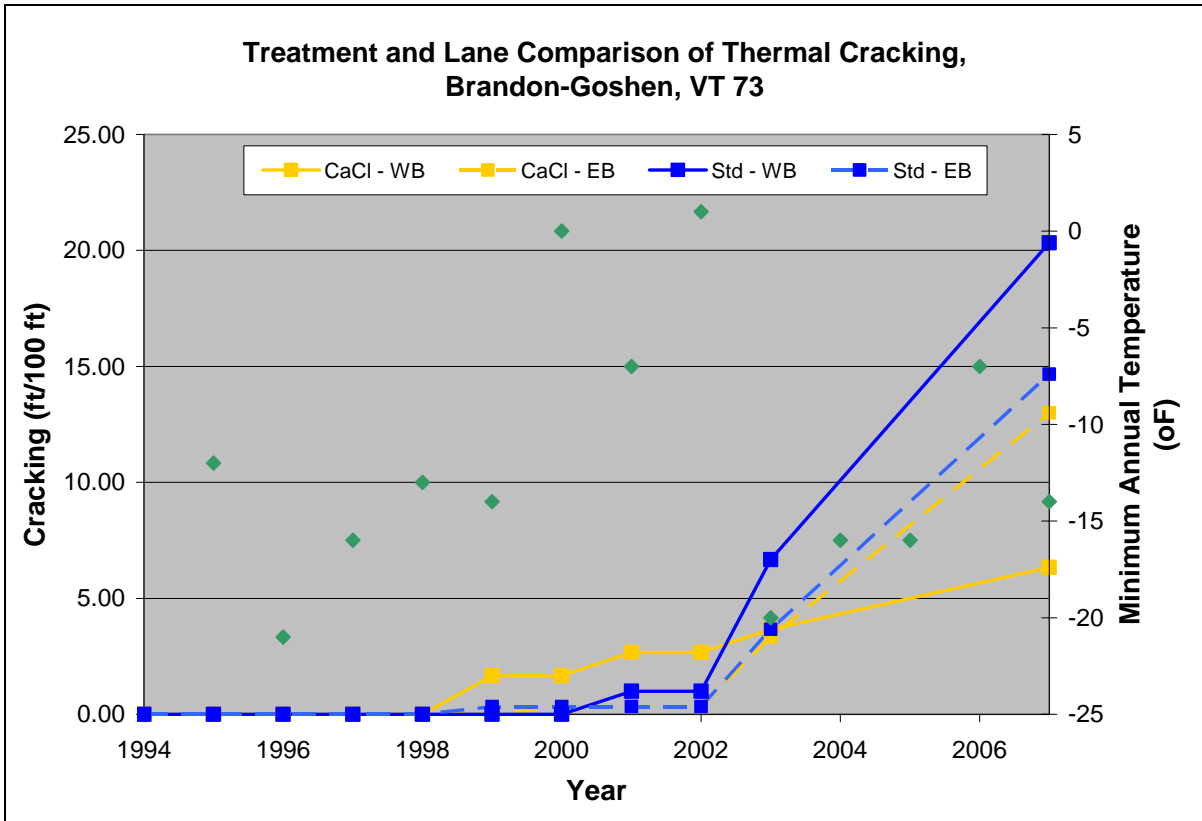
Figure 4 – Thermal Cracking Comparison

provided in Figure 4. Unlike AADT, temperature remains a constant variable across all test sections.

Very little to no thermal cracking was observed during the preconstruction pavement surveys. An average of 1' to 2' of thermal cracking was recorded in the experimental and standard sections, respectively. This is somewhat counterintuitive as the soils throughout this area are supposedly moderately susceptible to frost action. The lack of thermal cracking may be attributed to the drainage capabilities of the underlying soil profile.

The occurrence of thermal cracking was first observed in 1999 between MM 1.6 and MM 1.8 in both the standard and control section. The rate of thermal cracking appears to steadily increase from 2002 through 2007 across all test sites and does not appear to be a function of annual minimum temperatures. As the amount of thermal cracking prior to construction is relatively consistent across all test sites, performance will be assessed as the amount and rate of cumulative thermal pavement distress. In this case, the experimental sections outperform the control section regardless of location. The large variation of thermal cracking in the westbound lane contradicts the large variation in fatigue cracking in the eastbound lane, as described in the previous section. The causations for this phenomenon are unknown. As calcium chloride is intended to reduce frost heaving, it may be due to inconsistencies of application during construction. However this is a theory and cannot be verified through daily work reports. Overall, the performance of both sections is impressive with a maximum average amount of 20' of

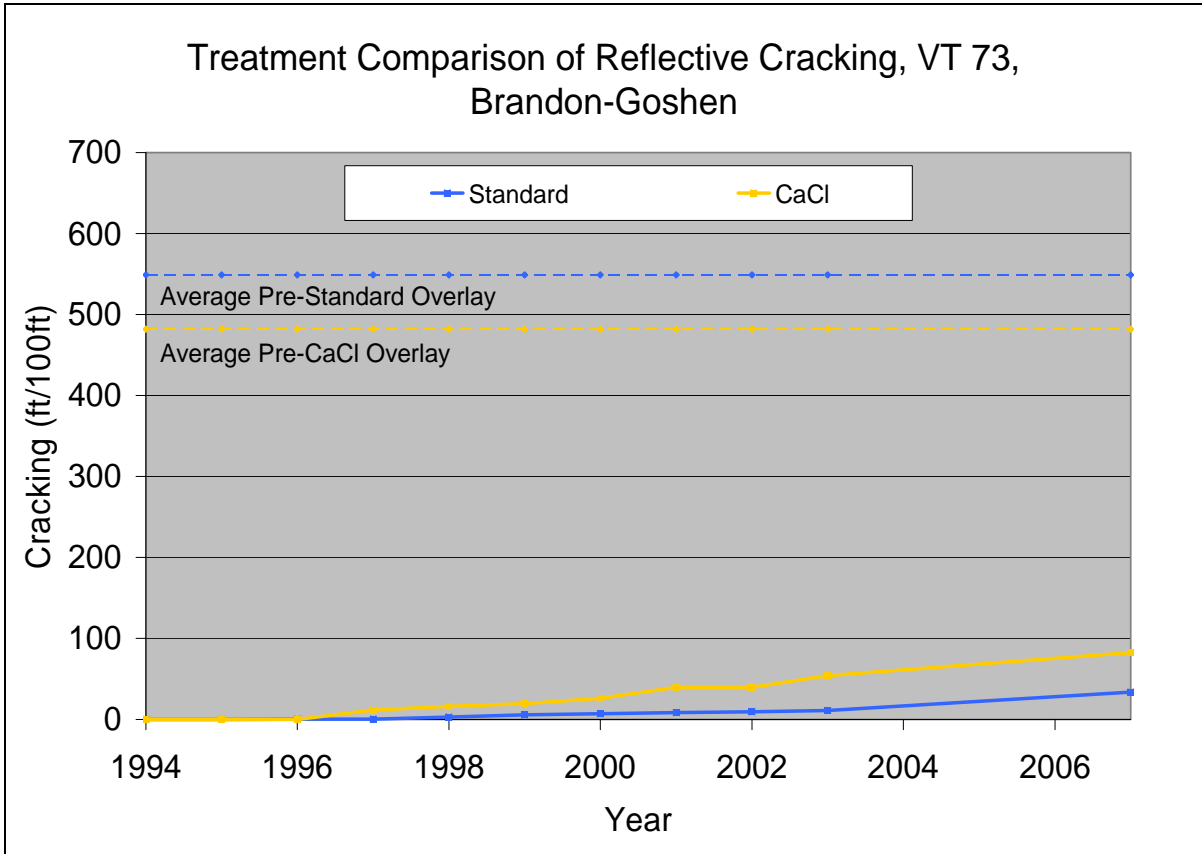
**Figure 5 – Reflective Cracking Treatment Comparison**

The onset and rate of reflective cracking is a function of the amount of preconstruction cracking. This means an area with a greater amount of cracking prior to construction would display a greater amount of reflective cracking following construction. The average amount of preconstruction cracking within the standard and experimental sections was 549 and 482 feet, respectively. Therefore, it is easy to presume that the amount of reflective cracking in the control section would be greater over time. This theory presumes however that all of the cracks observed within the wearing course descend beyond 6” below the pavement surface, otherwise known as bottom up cracking, and does not account for any top down cracking. The propagation of total reflective cracking over time by treatment in comparison to the pre-construction total cracking is displayed in Figure 5.

The experimental sections displayed a greater amount of reflective cracking over time as compared to the control sections. Given a greater amount of total cracking in the control sections prior to construction, one would have anticipated a direct correlation such that more reflective cracking would have been anticipated in the control section. Therefore, it is easy to conclude that the addition of  $\text{CaCl}_2$  does not mitigate reflective cracking. However, given the results from the fatigue and thermal analysis above and suspected problems within the westbound lane, a plot of each test section is provided in Figure 6 below.

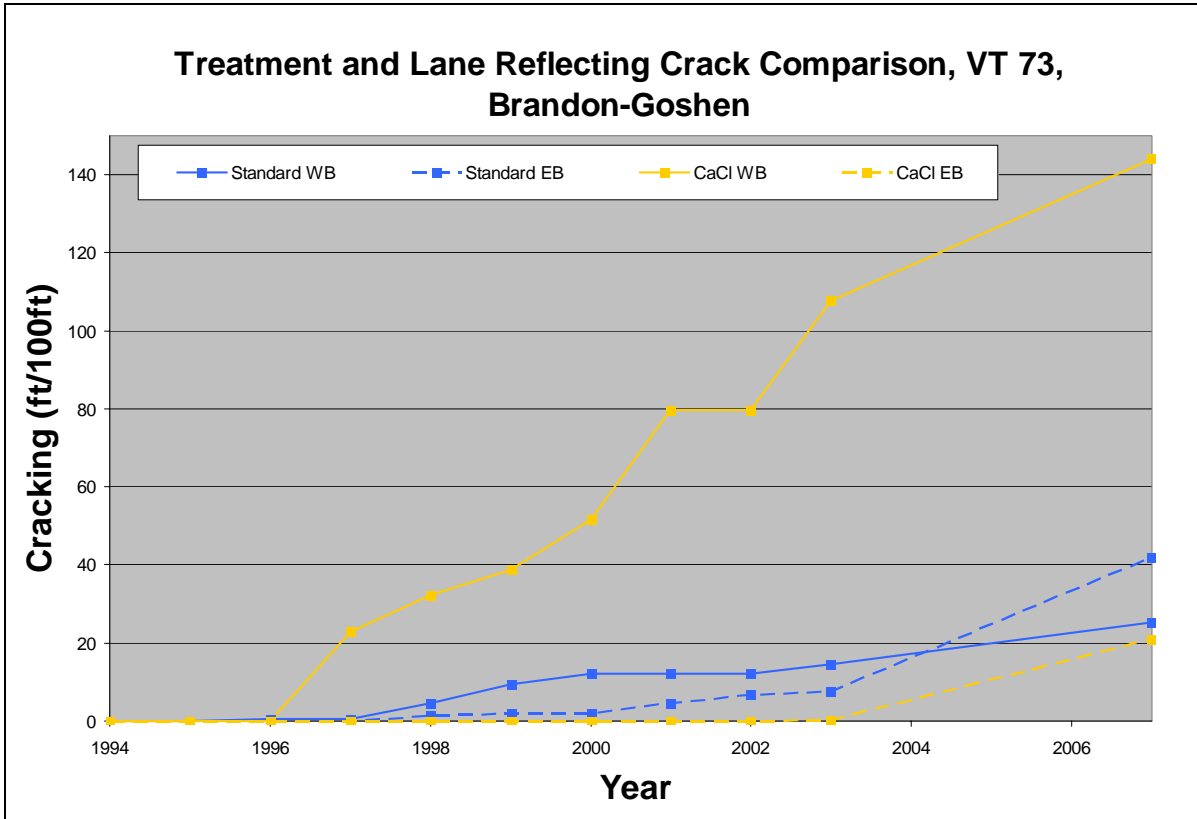
Figure 6 – Reflective Cracking - Treatment and Lane Comparison

The results from Figure 6 are quite interesting again indicating some type of instability of the experimental sections within the westbound lane. The responses from the control sections are fairly consistent regardless of location. This further supports a theory problems associated with constructability. The reclaiming process does require optimum moisture content for proper compaction. Any additives must be incorporated carefully to ensure adequate mixing which requires a second pass of a reclaiming machine. If any of these parameters are not executed properly, the new roadway base will not perform properly resulting in premature cracking and rutting. If data from the experimental sections within the westbound lane are discounted, it would appear that the addition of  $\text{CaCl}_2$  assists to mitigate reflective cracking as the amount of reflective cracking from the experimental sections is less than the amount of reflective cracking within the control sections. It is important to note that the experimental section stabilized with  $\text{CaCl}_2$  did not display reflective cracking until 2003, nine years following construction. Comparatively, reflective cracking was observed in 1997, only four years following construction within the control test sections.

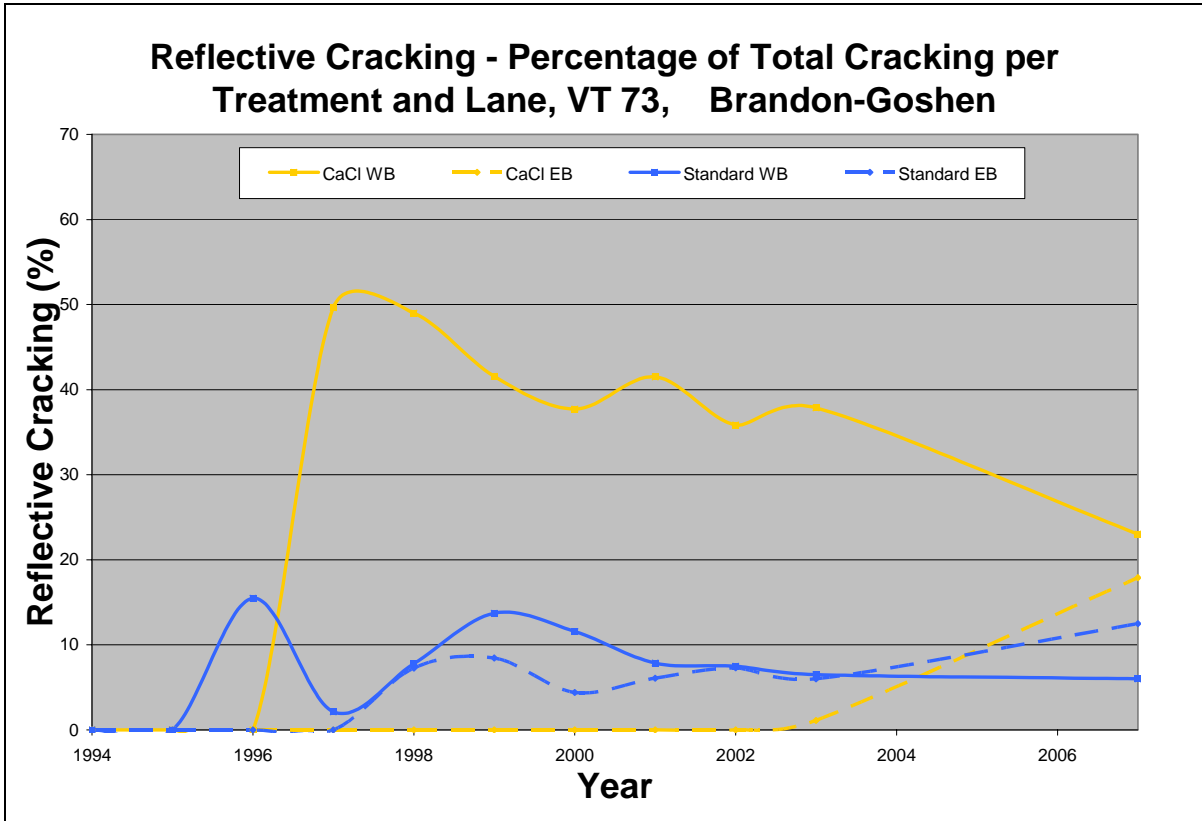
**Figure 7 – Percentage of Reflective Cracking - Treatment and Lane Comparison**

In order to examine the propagation of reflective cracking as a function of total cracking per year, a graph of the total amount of reflective cracking divided by the amount of total cracking is provided in Figure 7.

Once again, the westbound lane within the experimental limits displays unexplainable results due to previous assumed factors. When all other sections are considered, the results show that until 2005, the CaCl<sub>2</sub> exhibited a lesser amount of reflective cracking as a percentage of the total cracking than that of the standard treatment. It should be noted that there is a fairly steep inclining slope from 2003 and 2007, indicating if studied longer, results would likely increase at this rate. However, due to lack of data, in 2004, 2005, and 2006, the slope should not be considered accurate. Remaining reflective crack data is located in Appendix E.

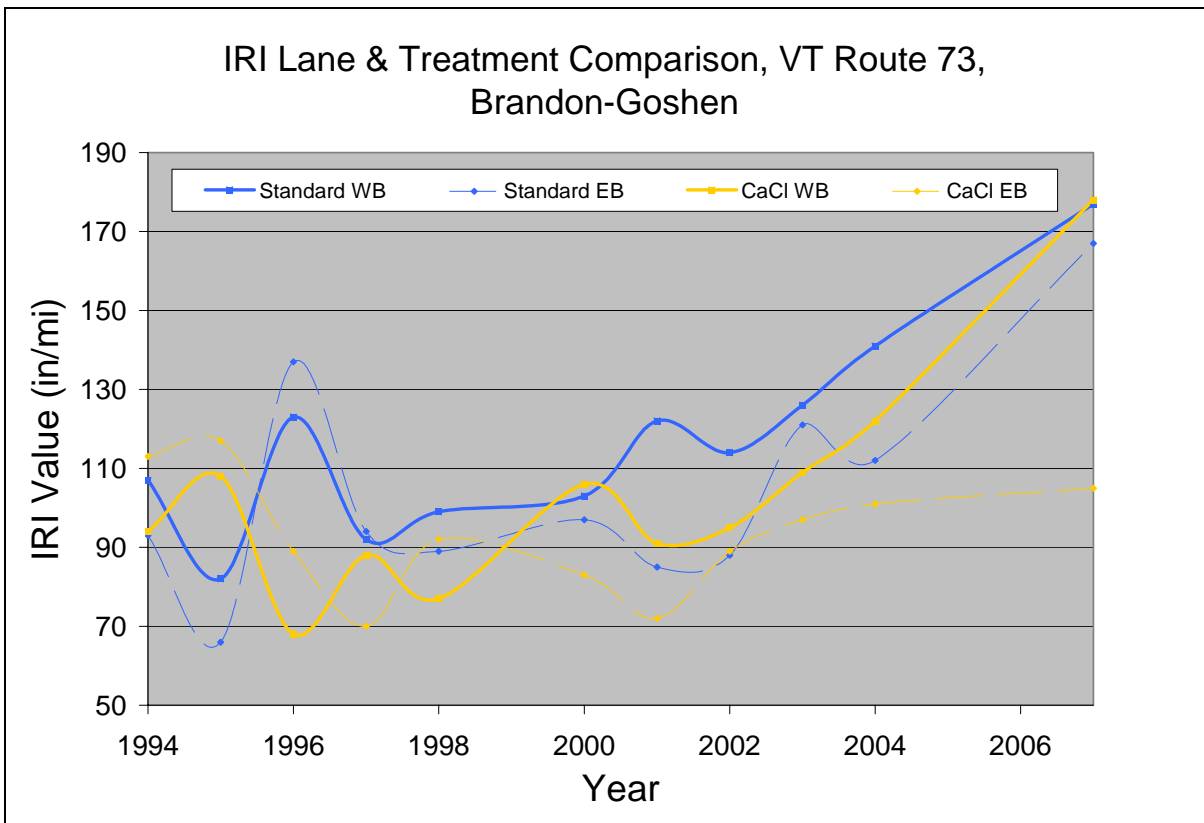
Figure 8 – IRI Summary

IRI, or International Roughness Index, is utilized to characterize the longitudinal profile within wheel paths and constitutes a standardized measurement of smoothness. According to Better Roads Magazine, “the pavement’s IRI in inches per mile measures the cumulative movement of the suspension of the quarter-car system divided by the traveled distance. This simulates ride smoothness at 50 miles per hour.” IRI values were collected on an annual basis from 1994-2007 with the exception of 1999, 2005, and 2006 through the Pavement Management Section of VTrans utilizing road profilers. The pre-construction IRI data was also not available for comparison. Please note that the data was collected by different vendors through the investigation which resulted in poor correlation between collection events. Figure 8 displays the IRI data for both the experimental and standard overlay sections.

There are some discontinuities within the data set. Usually IRI values are at a minimum immediately following construction as the pavement condition is optimum and will then

degrade over time. Therefore, it was anticipated there would be an upward trend throughout the years of data collection. However, in this project the IRI values fluctuated at various times throughout the project. These discrepancies are most likely caused by a variation in testing equipment and calibration methods. It may also be a response from the underlying pavement condition due to frozen conditions increasing the IRI values. However, all IRI values were collected from June through August when the underlying structure would not be subjected to freezing conditions.
