**Development and Implementation of Early Detection Systems for Ground Movement  
[Vermont Agency of Transportation Project Assignment 05-01]**

**Final Report**

7 July 2008

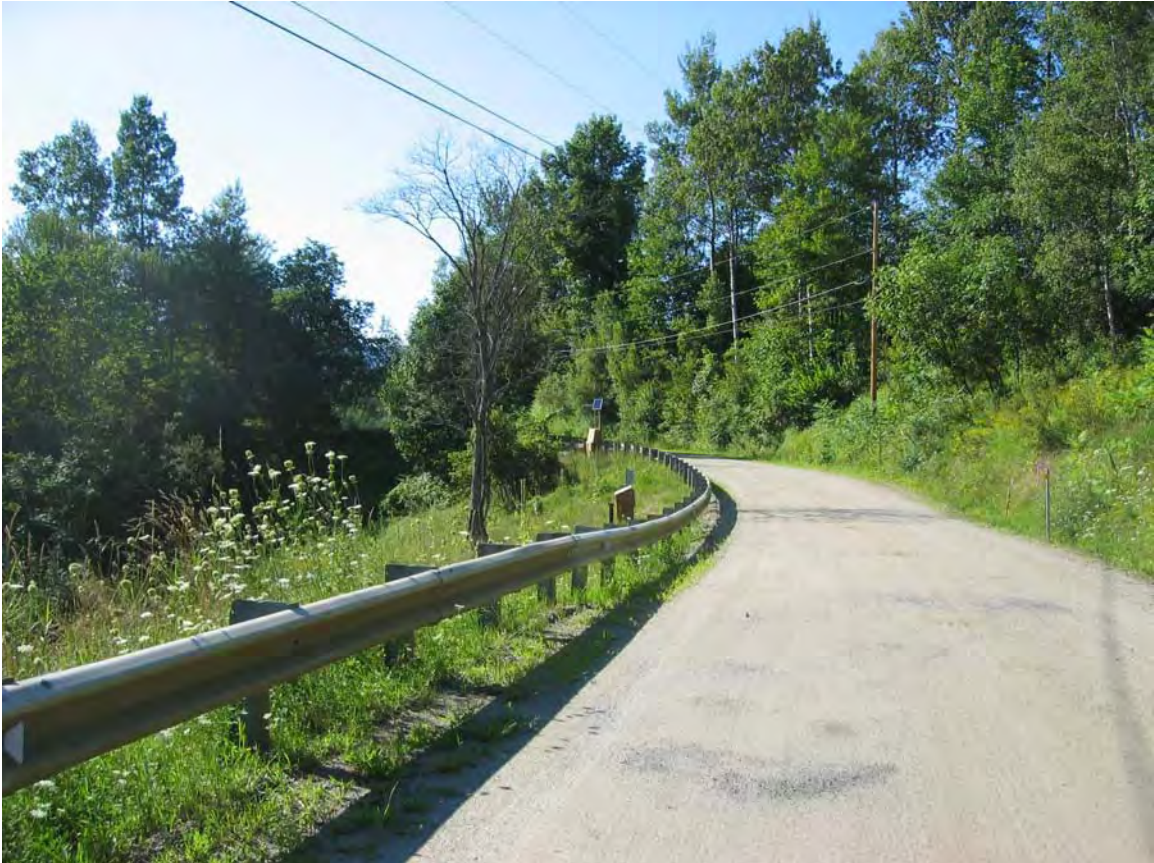
**Figure 3.2** General site layout, with Inclinerometers 1 & 2 in the foreground and Inclinerometer #3 and the data acquisition system in the background.

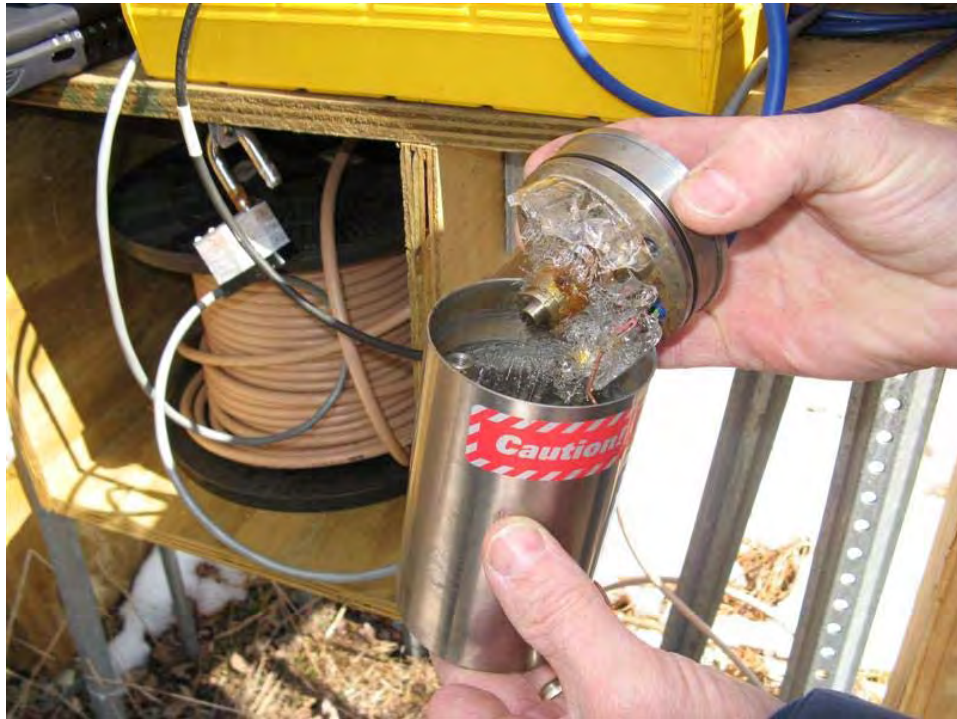
**Figure 3.6** Ice damage inside the sealed barometer.

On January 24, 2006, a Geokon series 4580 vibrating wire barometer (SN 05-12273) was installed by UMass Amherst. This barometer is used to correct the monitoring well piezometers for fluctuations in atmospheric pressure. Initial readings were taken with a GK-403 readout box before connecting the barometer to the datalogger. The 4580 series barometer is vented to the atmosphere and is susceptible to water infiltration and damage. Initially the barometer performed as expected but by late July, 2006, intermittent over-range values were being recorded with increasing frequency. On December 5, 2006, the barometer stopped working. During a field visit by UMass Amherst and Geokon on April 11, 2007, it was discovered that the barometer was full of water and ice despite being located in the protective plywood instrument box, and it was

assumed that expanding ice during the winter destroyed the vibrating wire. The barometer was returned to Geokon for repair and was reinstalled (new SN# 07-8954) in a more protective location in the instrument box on May 19, 2007. Figure 3.6 shows ice damage to the barometer.

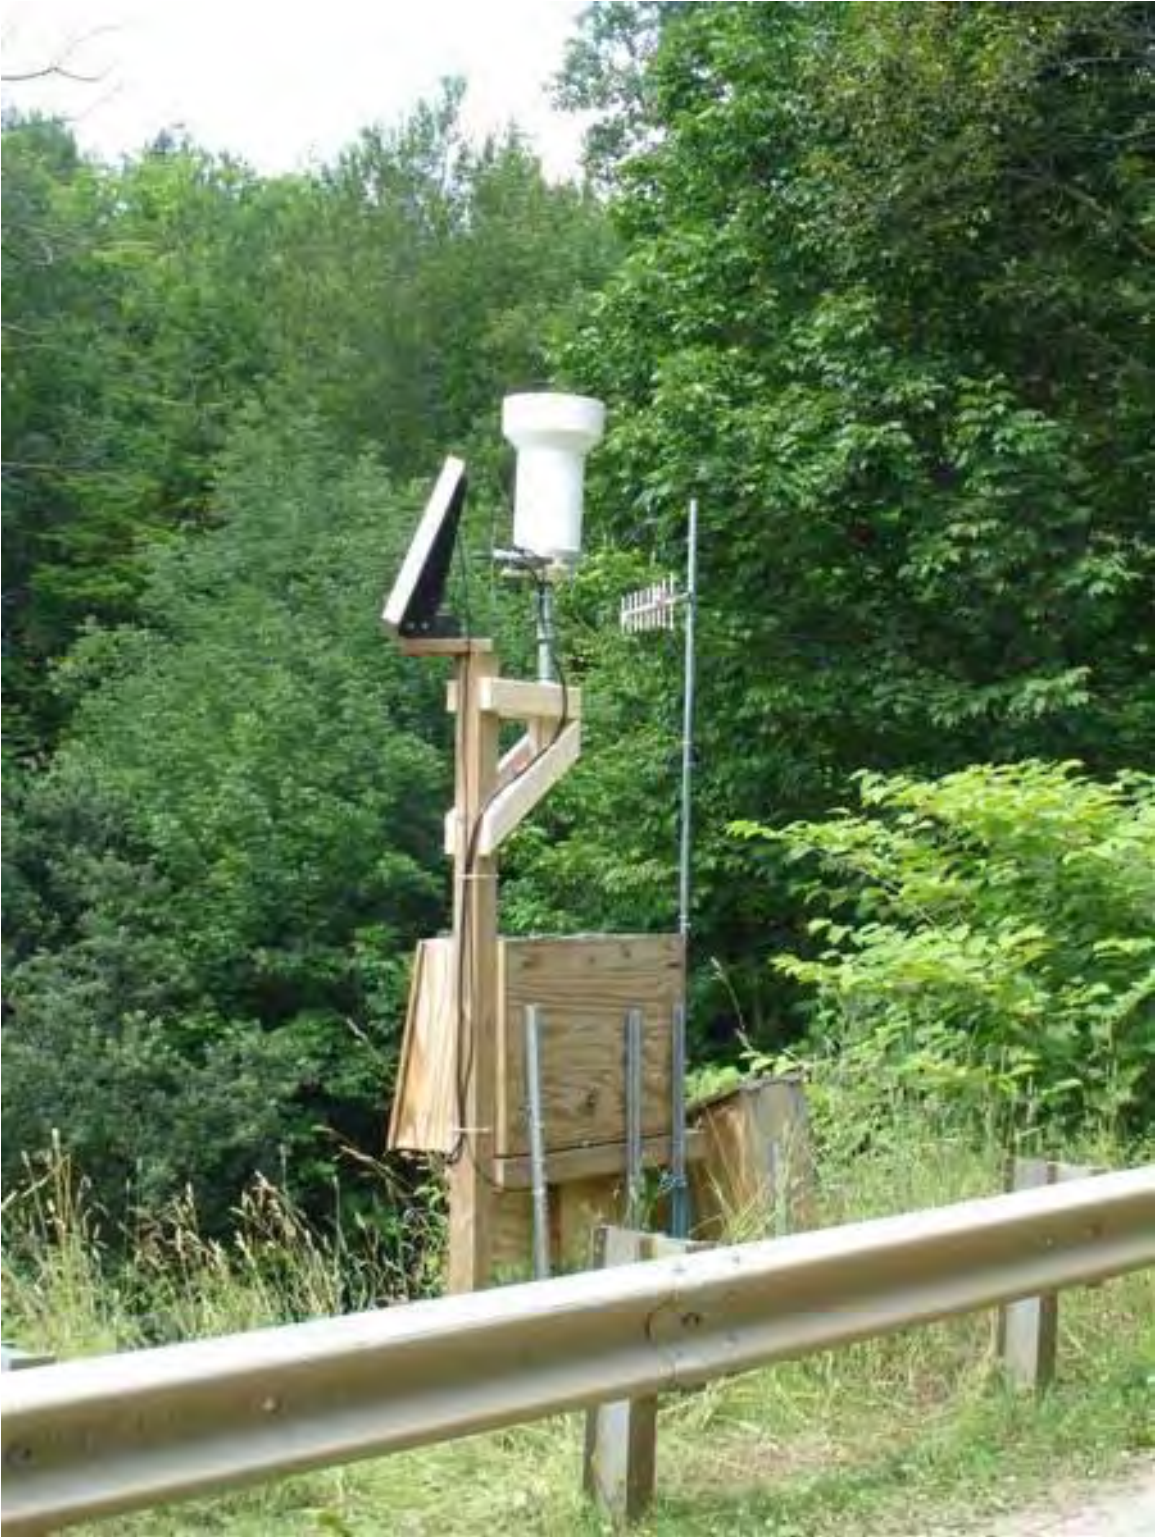
**Figure 3.7** Installed rain gauge.

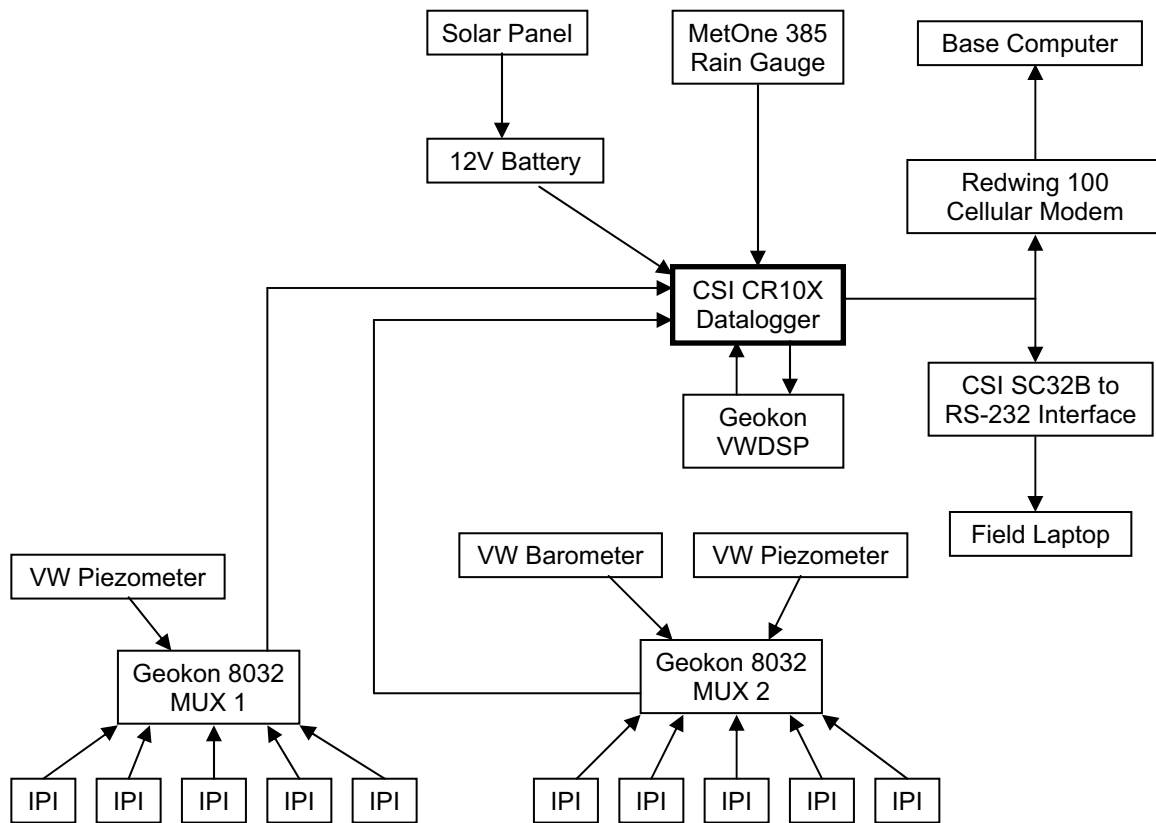
**Figure 3.8** Flow Diagram of the instrumentation and datalogger installation.

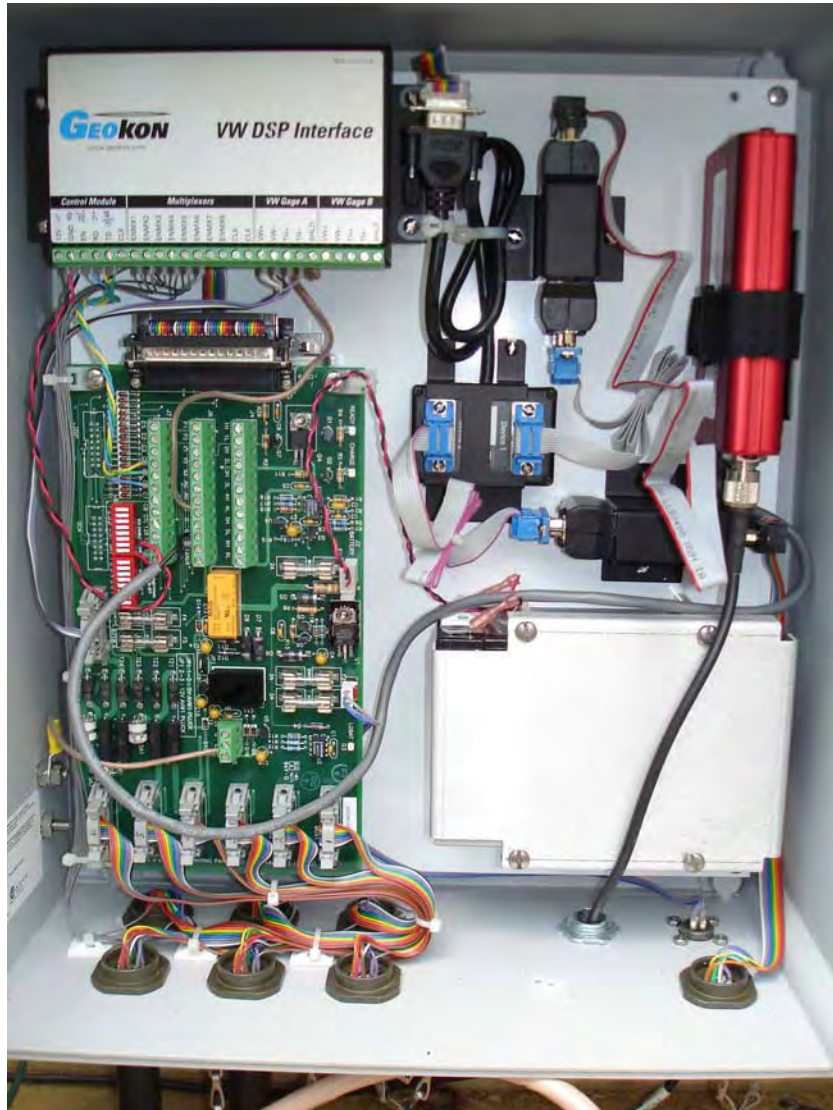
**Figure 3.9** Geokon Micro-10 datalogger.

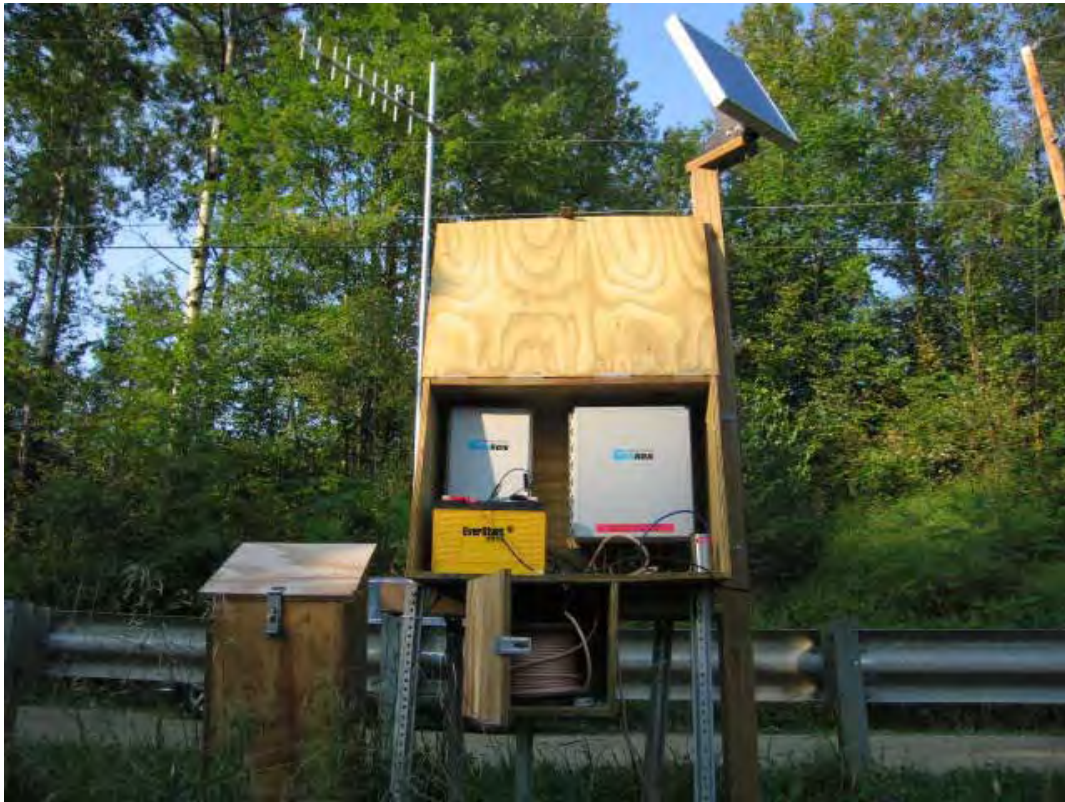
**Figure 3.10** View of the data acquisition system when the protective box is open. The battery is in the front left, the multiplexer behind, and the datalogger to the right. The cell phone antenna is in the upper left and the solar panel in the upper right.

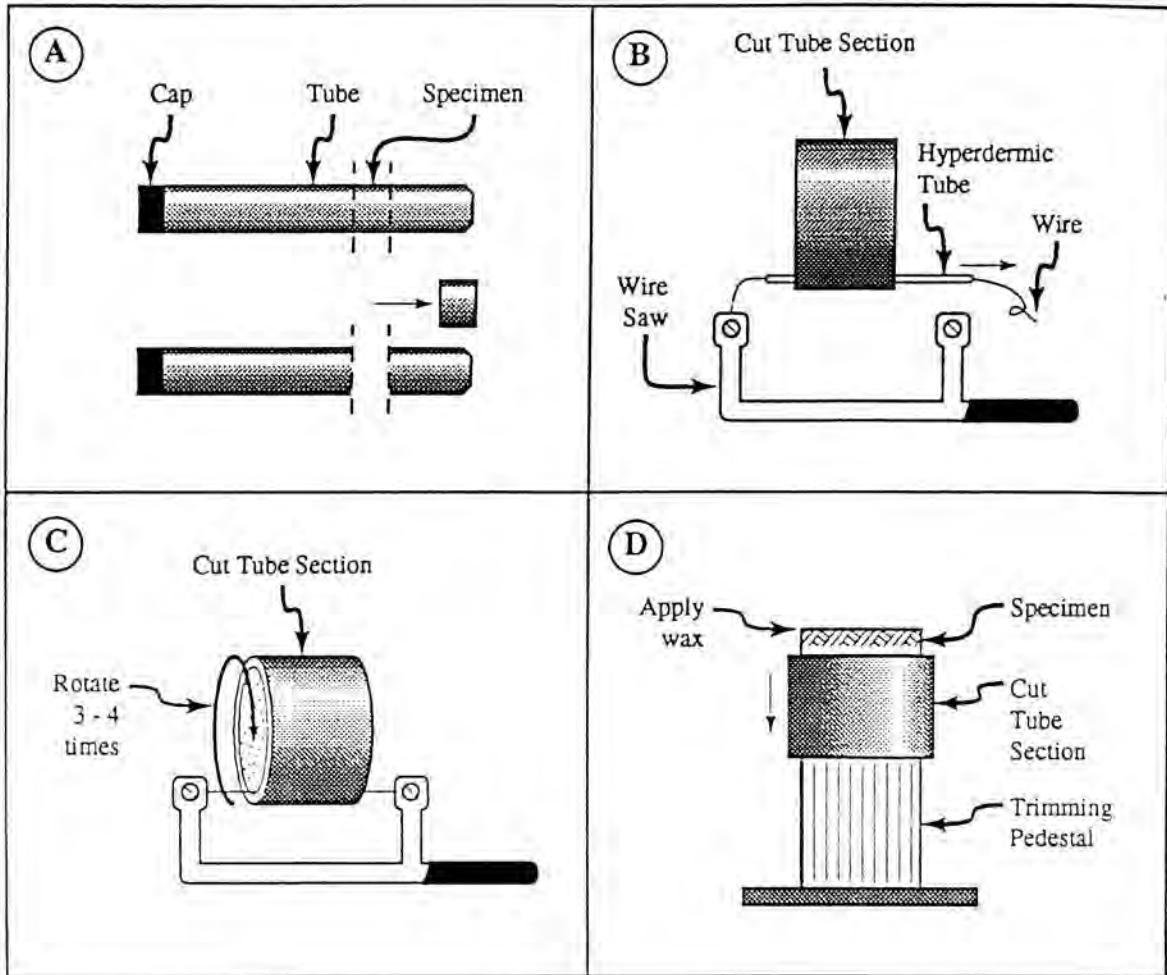
**Figure 3.17** Procedure for sample extrusion for DS and CRS specimens (after Ladd and DeGroot 2003).

Samples for DS and CRS tests were extracted from the thin-walled sampling tubes by UMass Amherst in general accordance to the method recommended by Ladd and DeGroot (2003) as outlined in Figure 3.18. The section of the sampling tube containing the desired

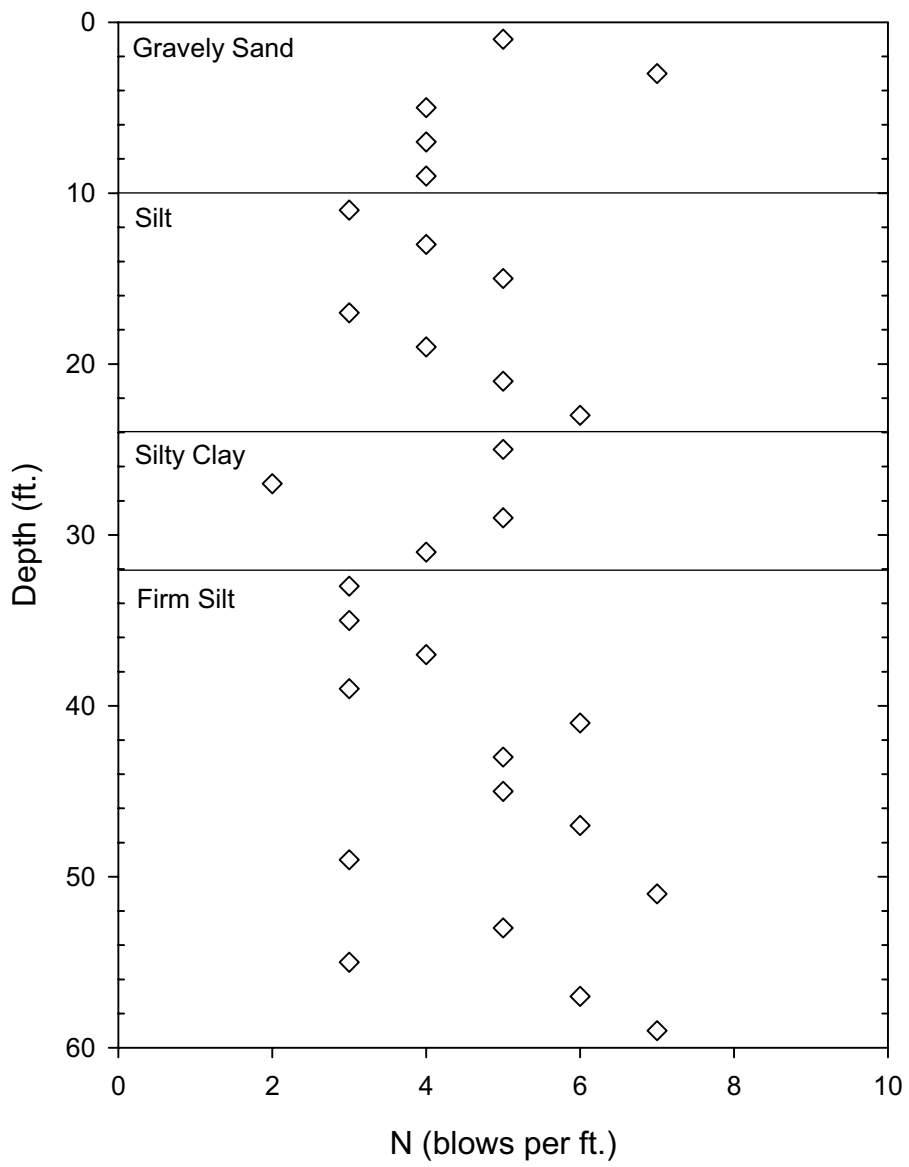
**Figure 4.5** SPT blow counts versus depth for Inclinator 1.

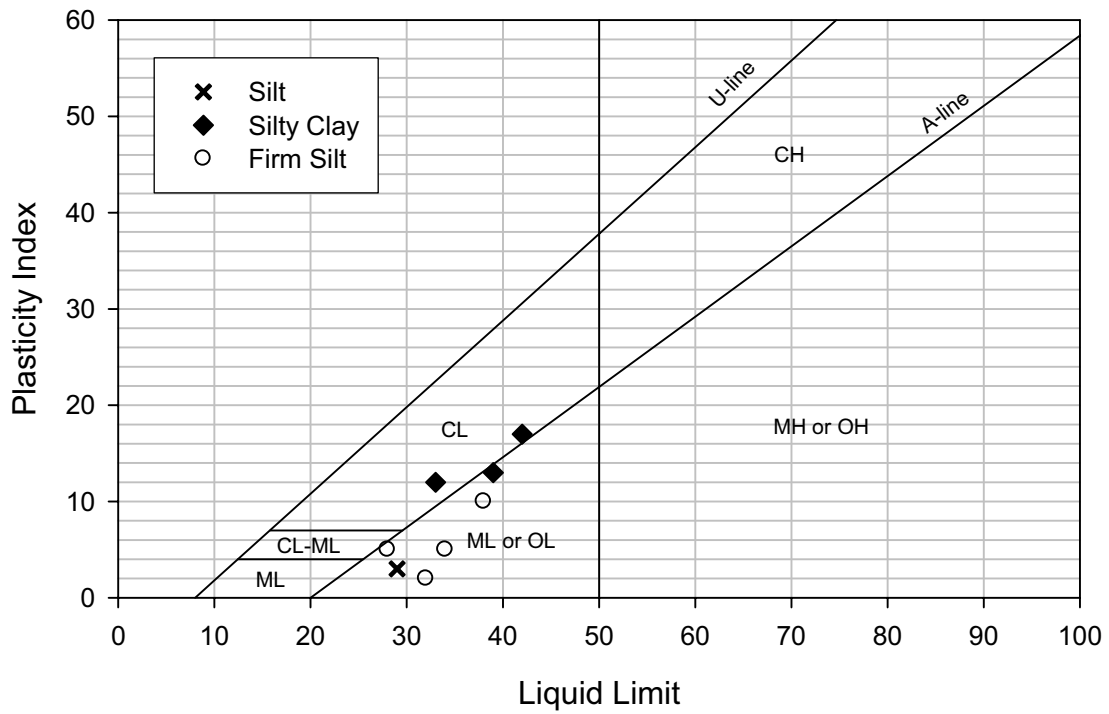
**Figure 4.6** Casagrande's plasticity chart for Inclinator 1.

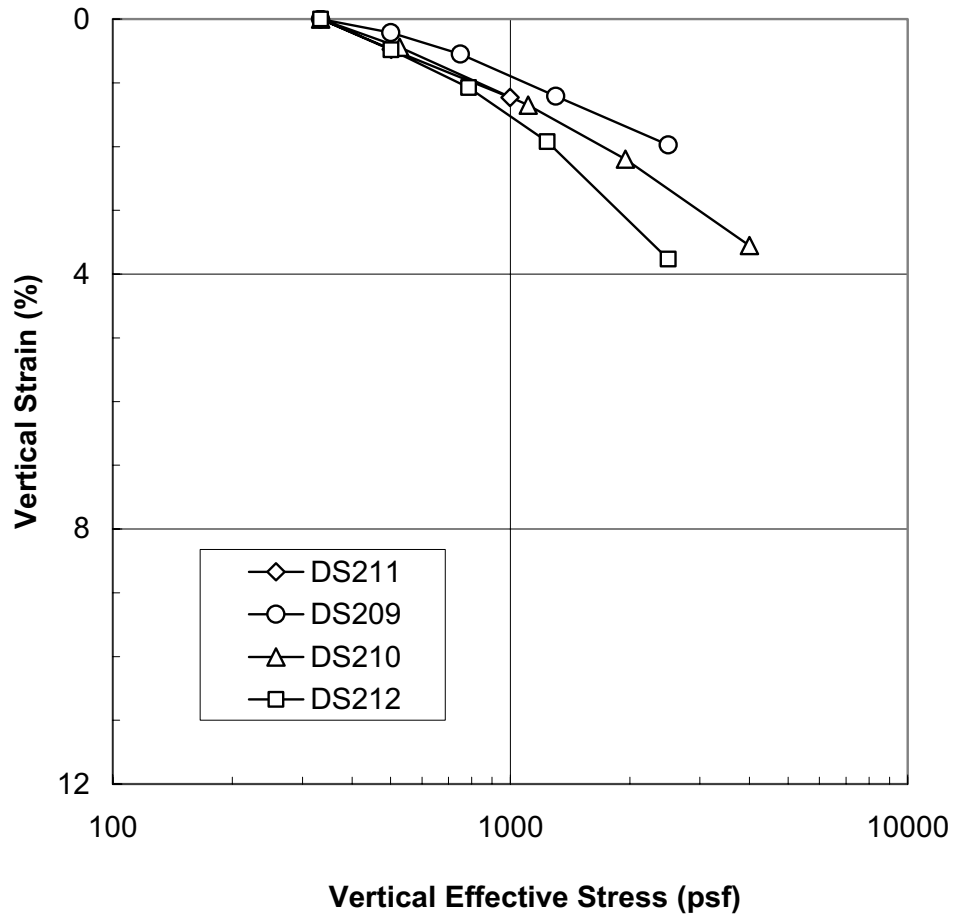
**Figure 4.10** Vertical strain versus vertical effective stress for consolidation phase of the Direct Shear tests.

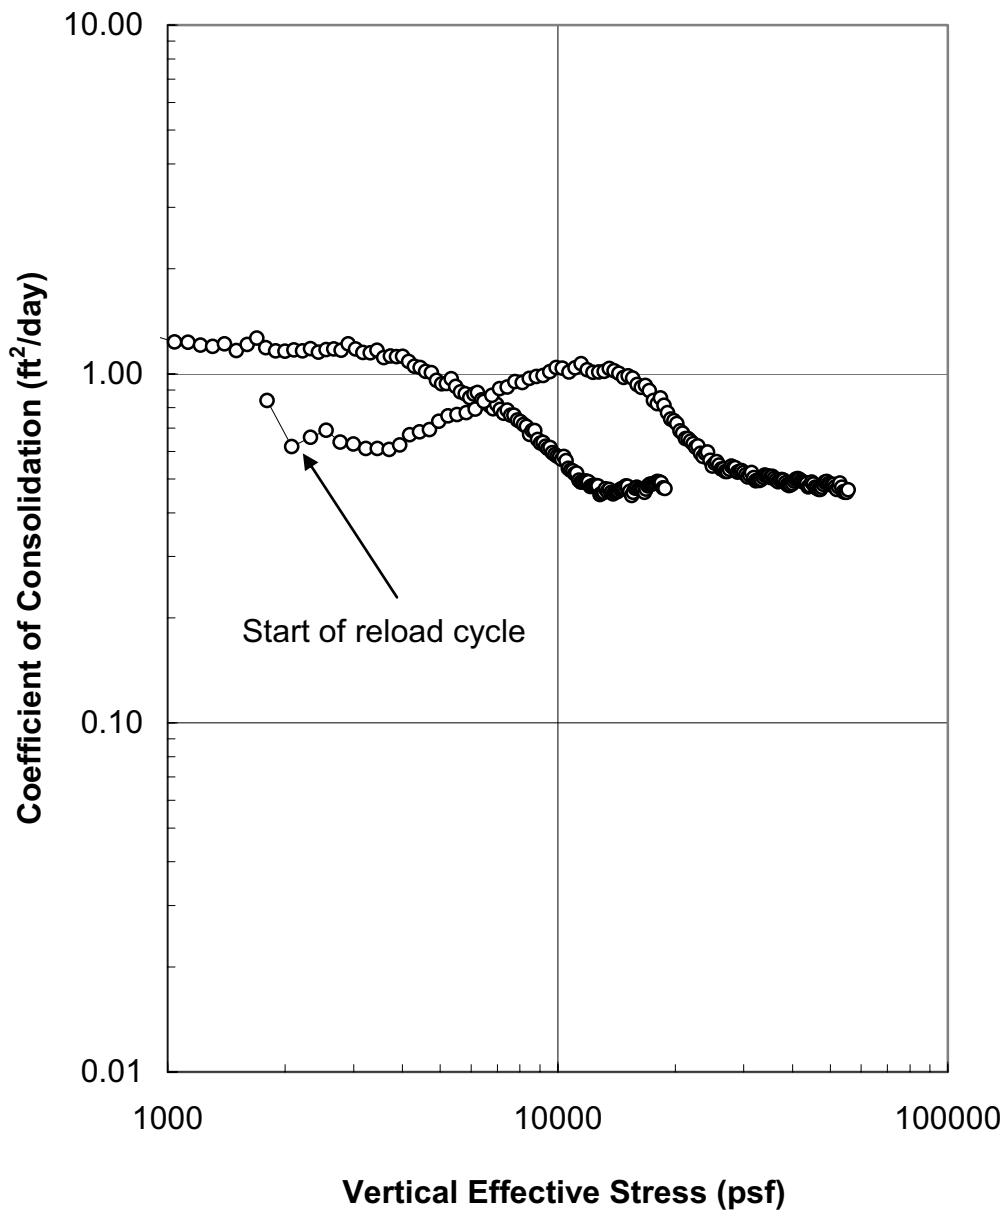
**Figure 4.20** CRS coefficient of consolidation versus vertical effective stress from test CRS111 on sample INCL#3 25-27 ft.

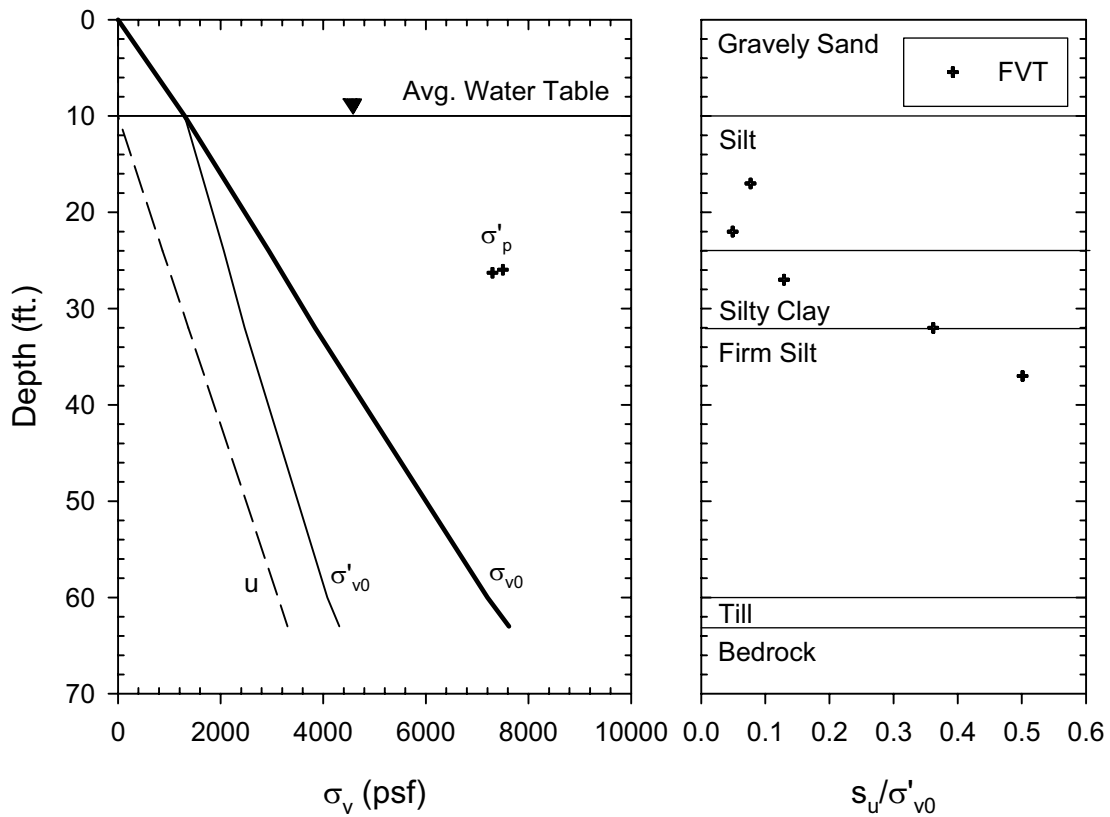
**Figure 4.23** Vertical stress versus depth for Inclinator 1 assuming hydrostatic pore pressures compared to the normalized undrained shear strength FVT results.

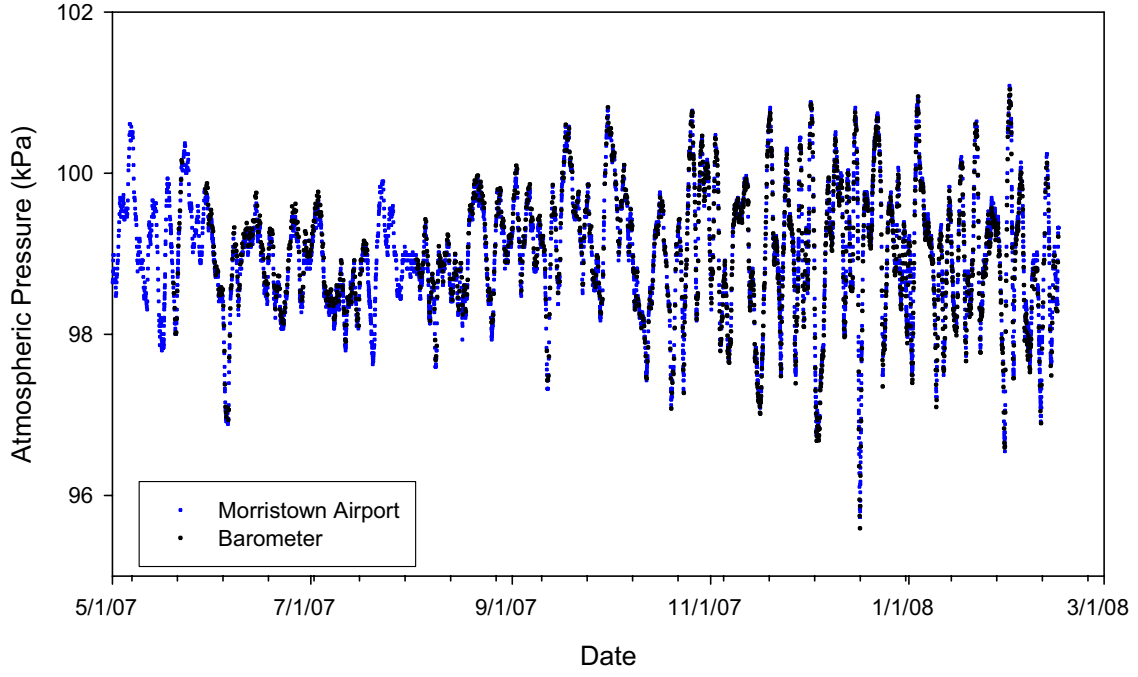
**Figure 5.4** Atmospheric pressure measured at Morristown Airport (elev. 225m) and on the site barometer (elev. 200m) since the repaired barometer was reinstalled.

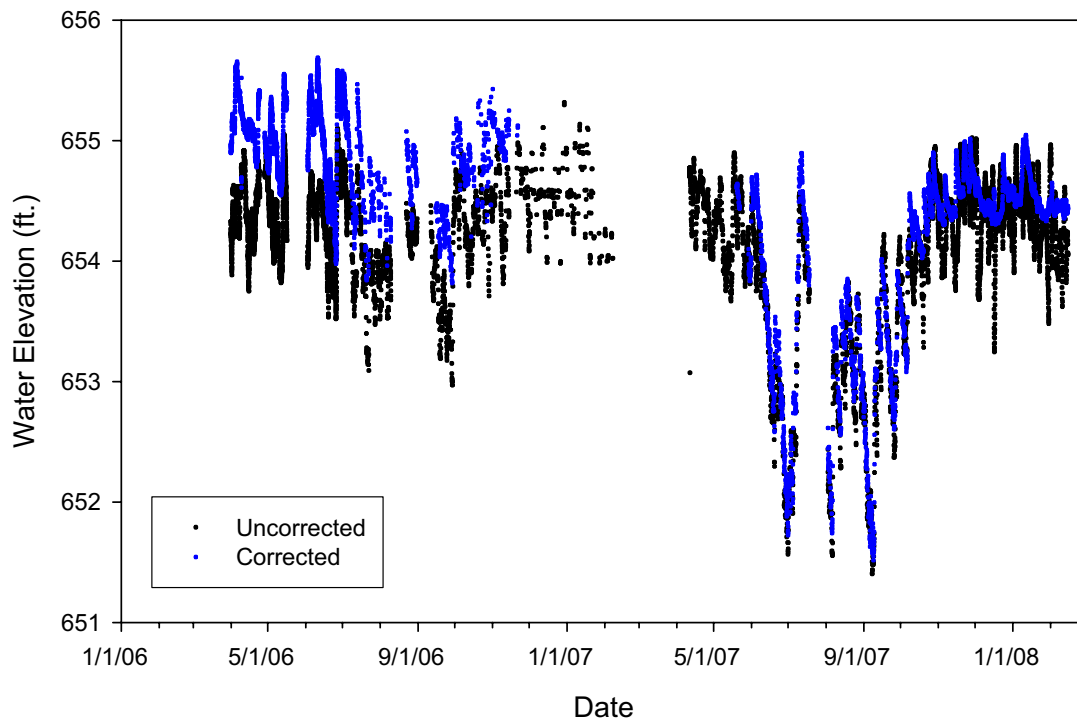
**Figure 5.7** Corrected and uncorrected water table elevations for Monitoring Well #2.

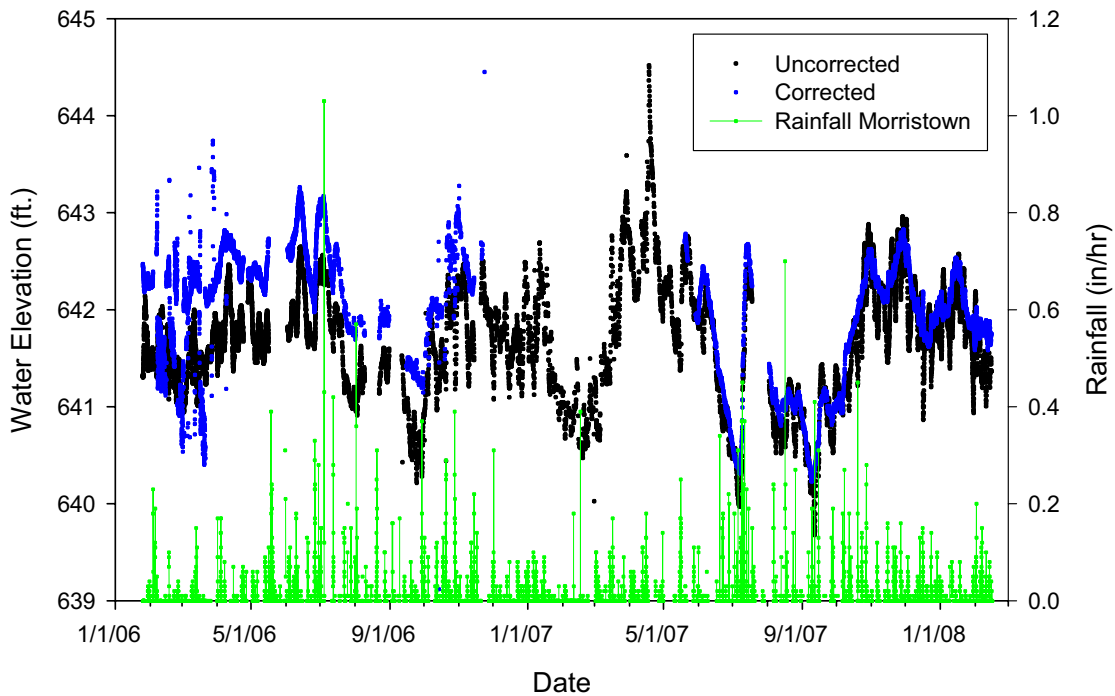
**Figure 5.8** Corrected and uncorrected water table elevations for Monitoring Well #1 compared to measured rainfall at Morrystown Airport.

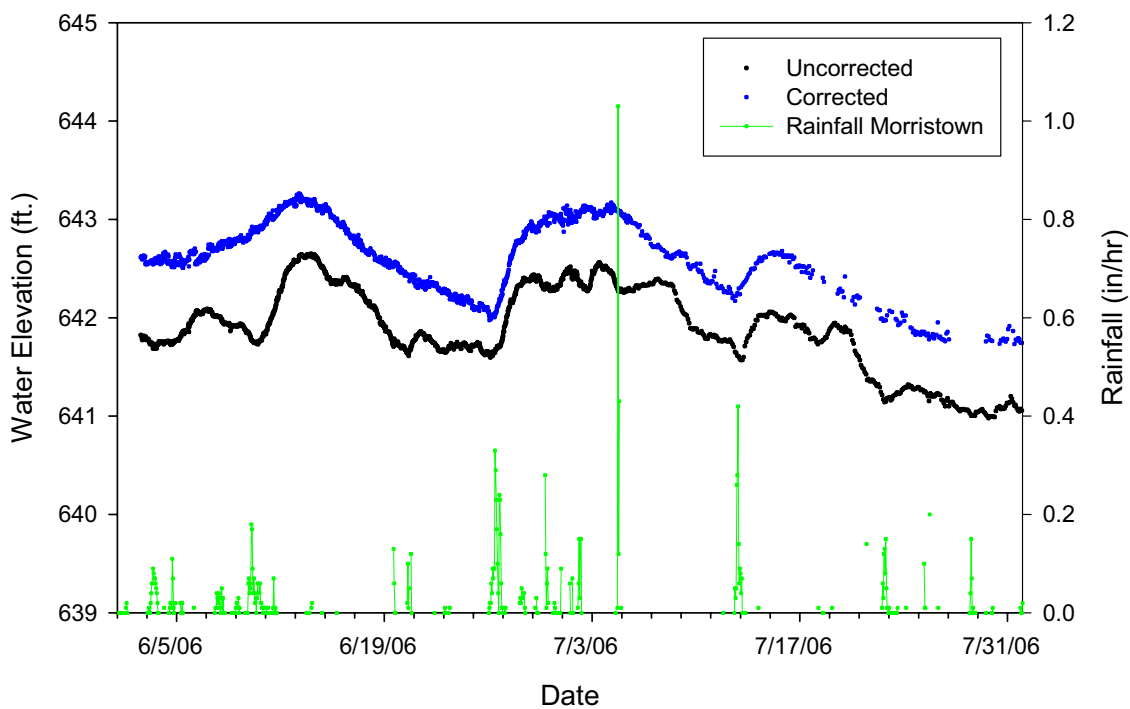
**Figure 5.9** Corrected and uncorrected water table elevations for Monitoring Well #1 compared to measured rainfall at Morrystown Airport for June and July, 2006.

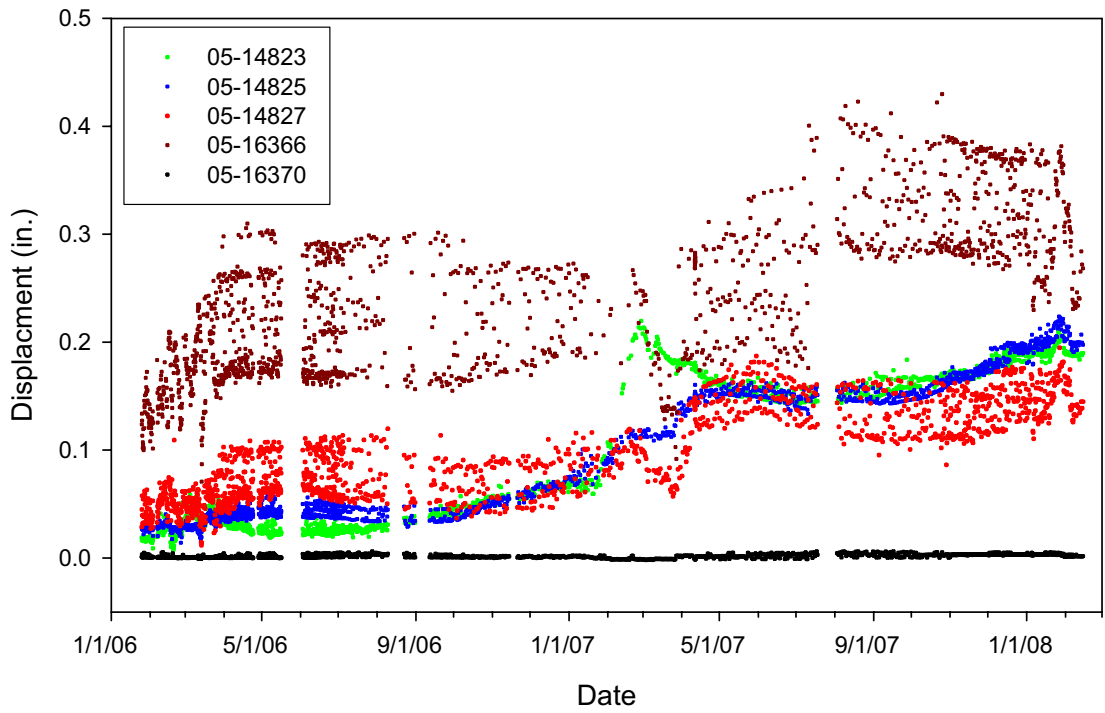
**Figure 5.13** Calculated displacements for each IPI installed in Inclinometer #3.

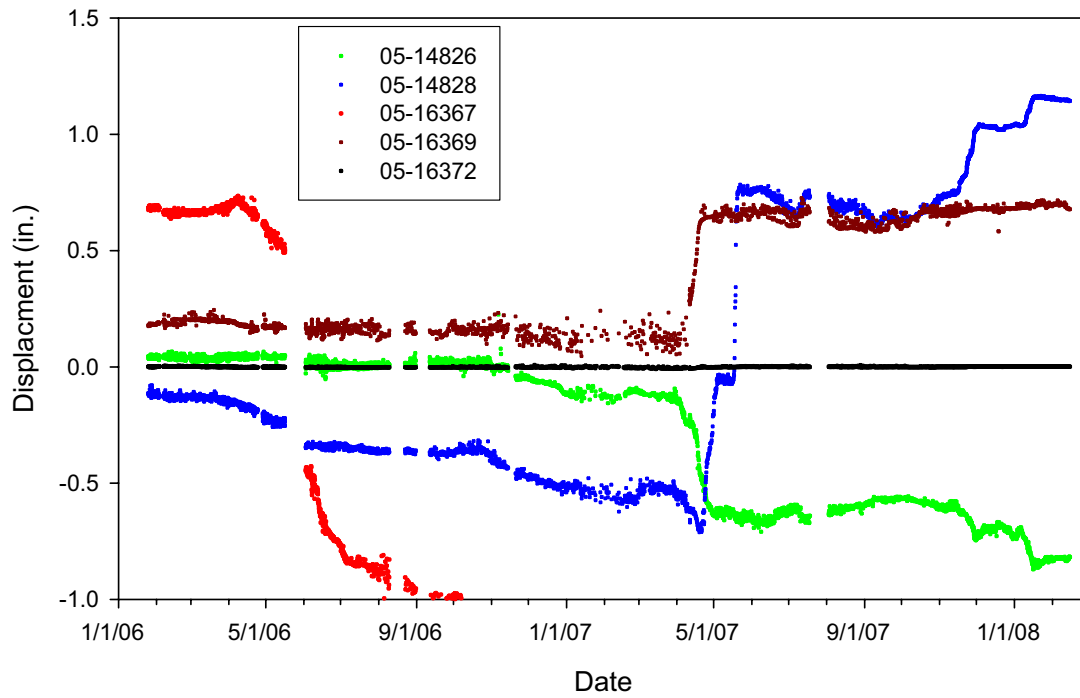
**Figure 5.21** Calculated displacements for each IPI installed in Inclinator #2 when the displacement scale has been reduced.

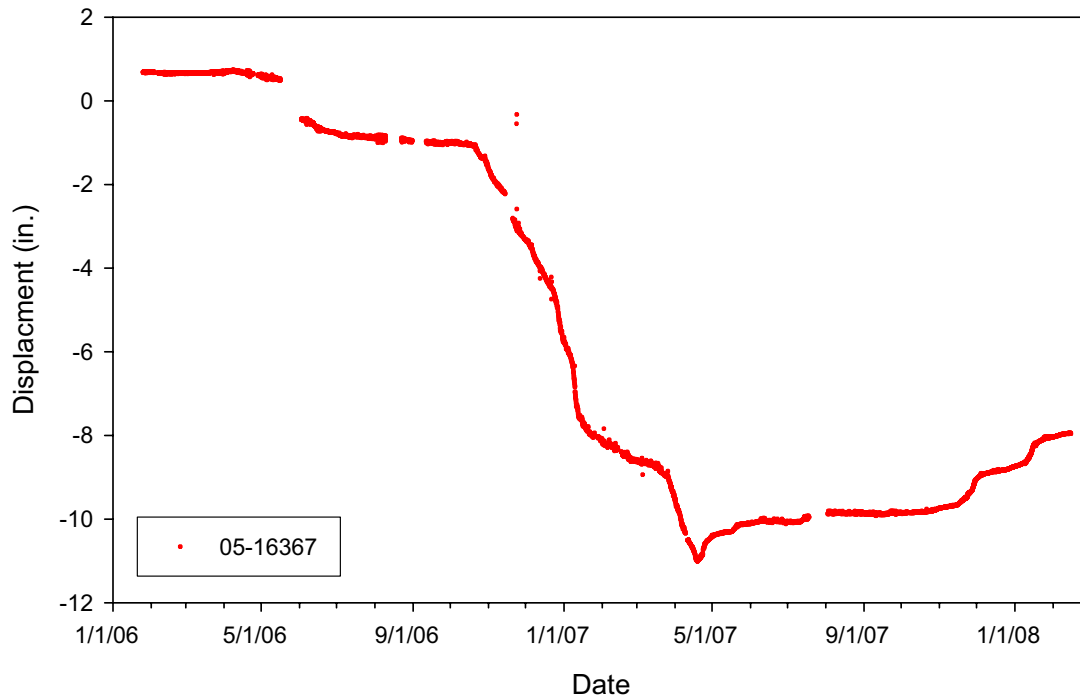
**Figure 5.24** Calculated displacement for IPI 05-16367 installed at a depth of 6.86m (22.5 ft.) in Inclinator #2.

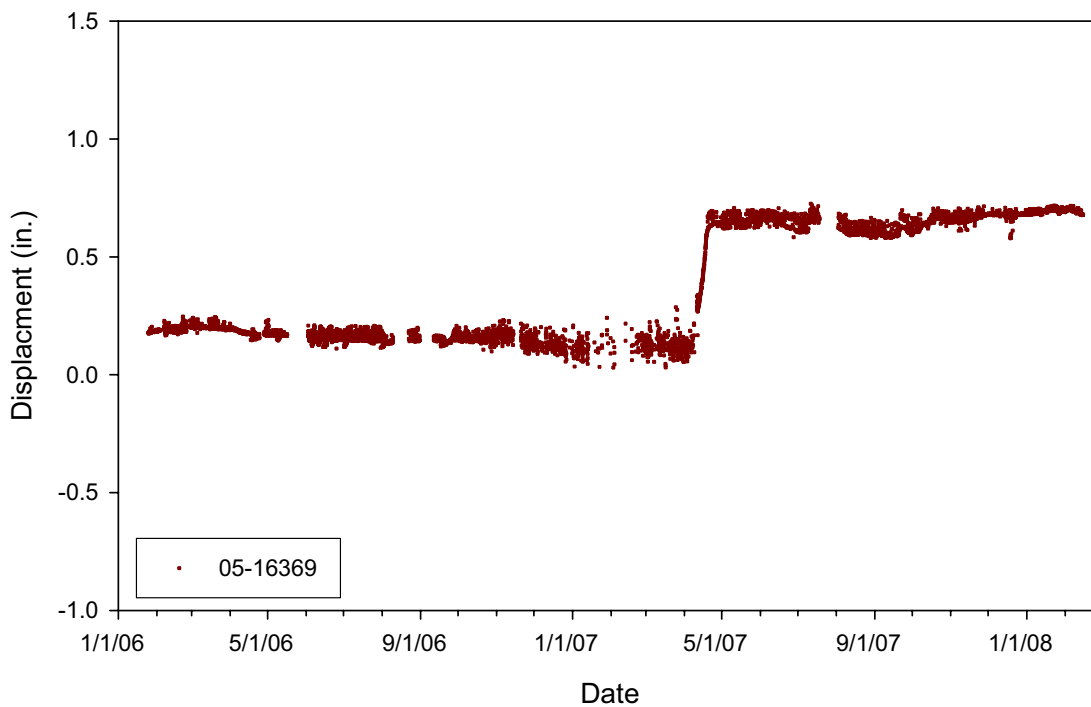
**Figure 5.25** Calculated displacement for IPI 05-16369 installed at a depth of 12.95m (42.5 ft.) in Inclinator #2.

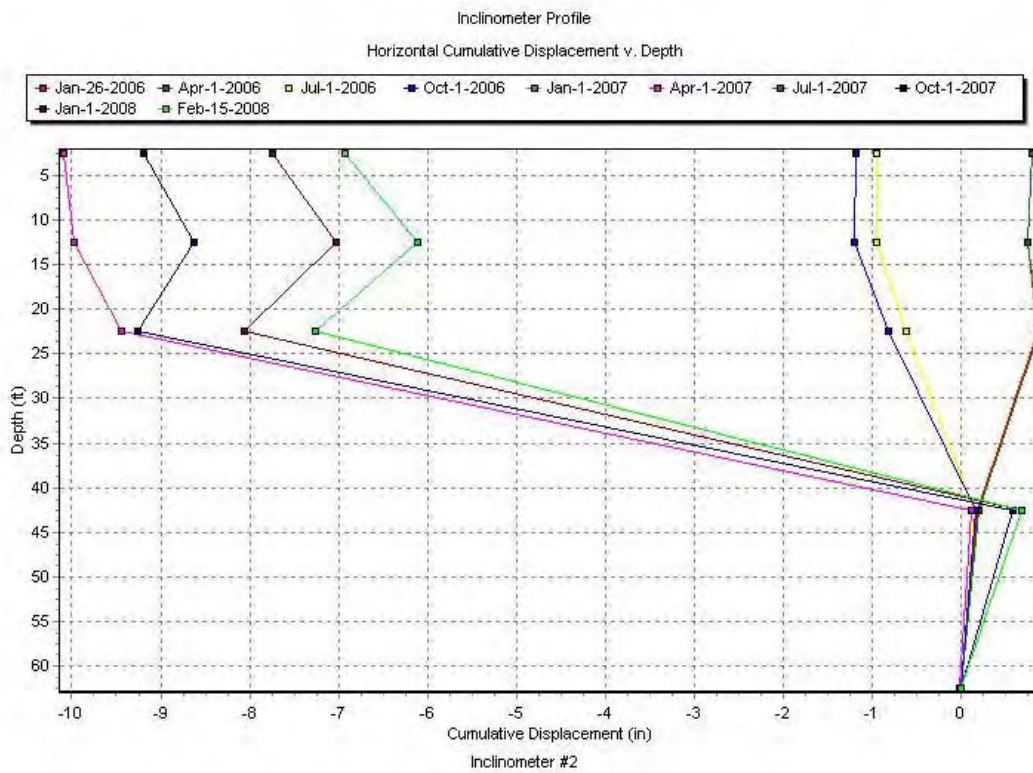
**Figure 5.27** Inclinometer profile of horizontal cumulative displacement versus depth for Inclinometer #2.

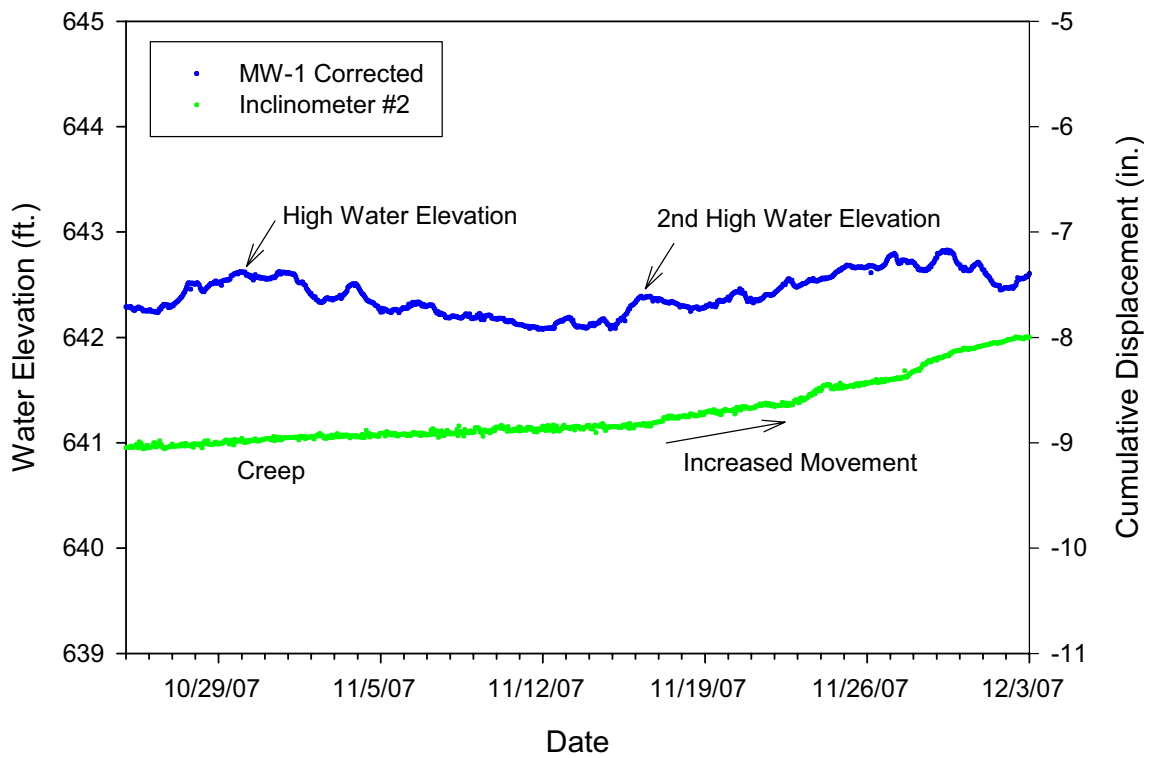
**Figure 6.10** Measured water elevation and inclinometer movement, November, 2007.

**Figure 6.11** Factor of safety on 11/16/07 (see Figure 6.10).

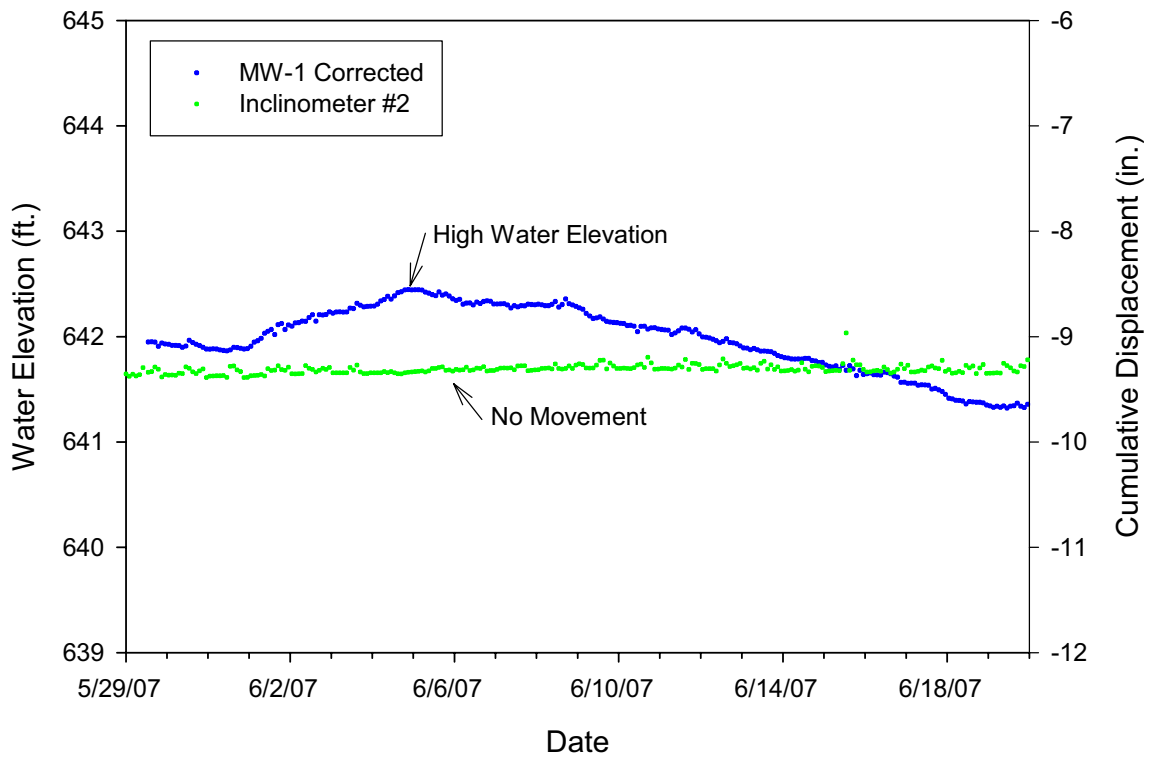
**Figure 6.12** Measured water elevation and inclinometer movement, early June, 2007.

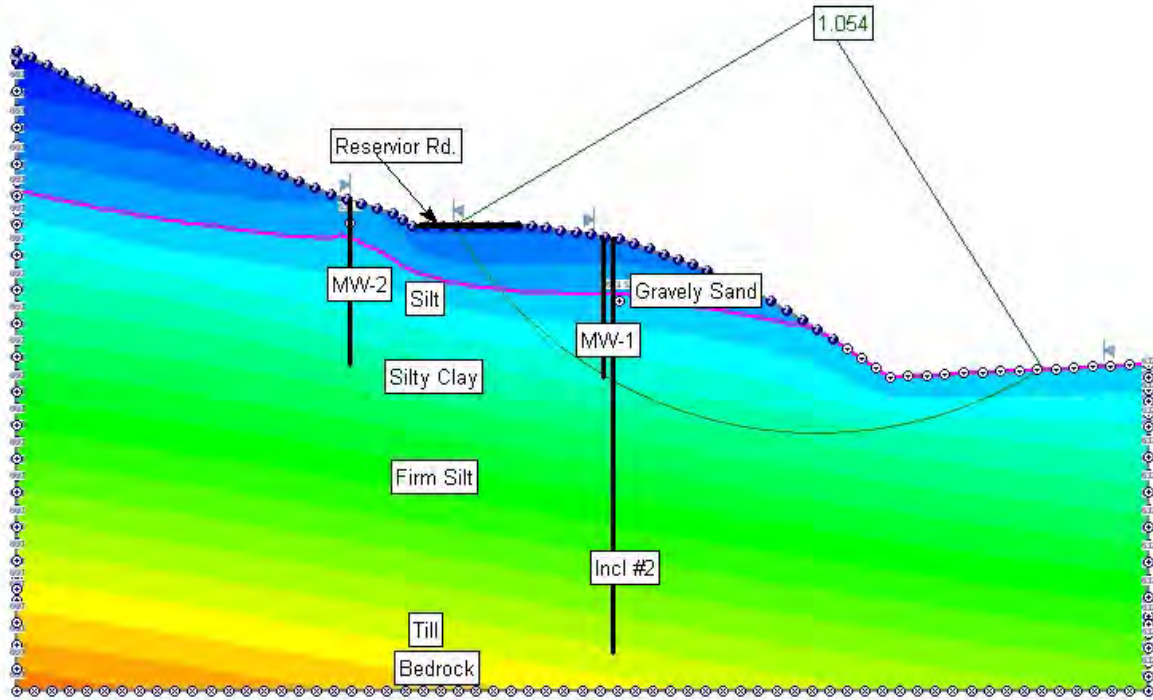
**Figure 6.19** Factor of safety on 4/17/07 using the refined seepage analysis model with an assumed far left boundary condition of 660 ft. for the water table (purple line).
