**Development and Implementation of Early Detection Systems for Ground Movement  
[Vermont Agency of Transportation Project Assignment 05-01]**

**Final Report**

7 July 2008

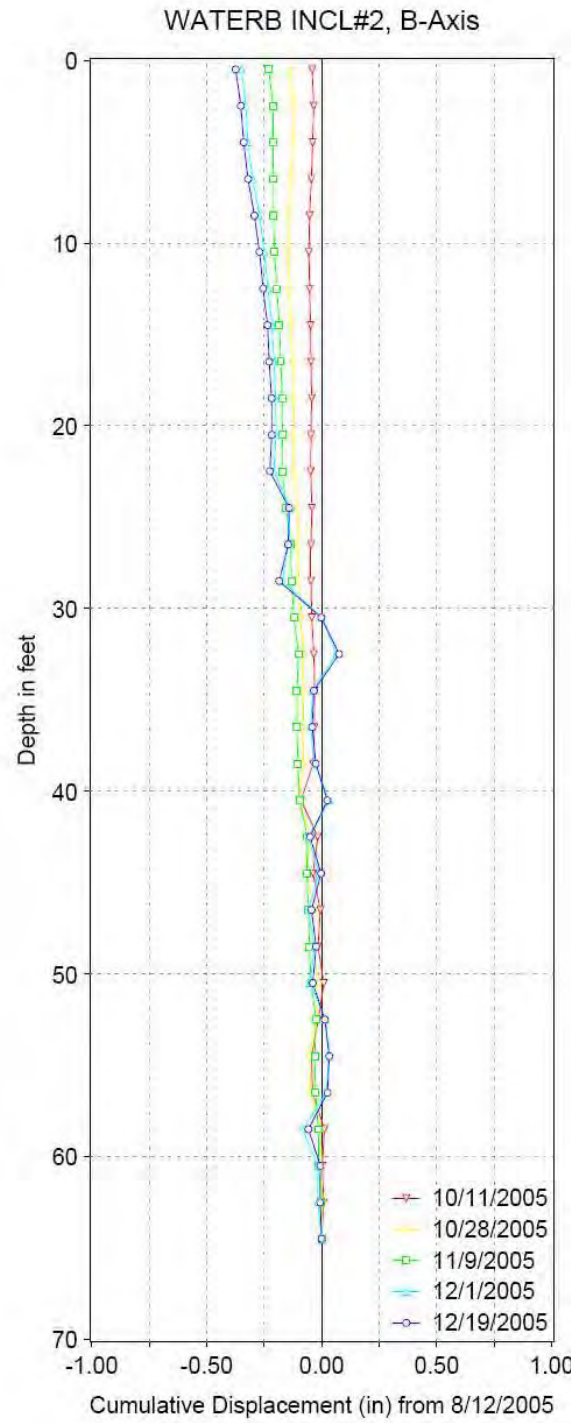
**Figure B.2** Inclinometer #2 cumulative displacement profiles.

This appendix contains the cumulative displacement profiles generated by VTrans during manual inclinometer readings of Inclinometers #1, #2, and #3 prior to the installation of the in-place-inclinometers into Inclinometers #2 and #3.

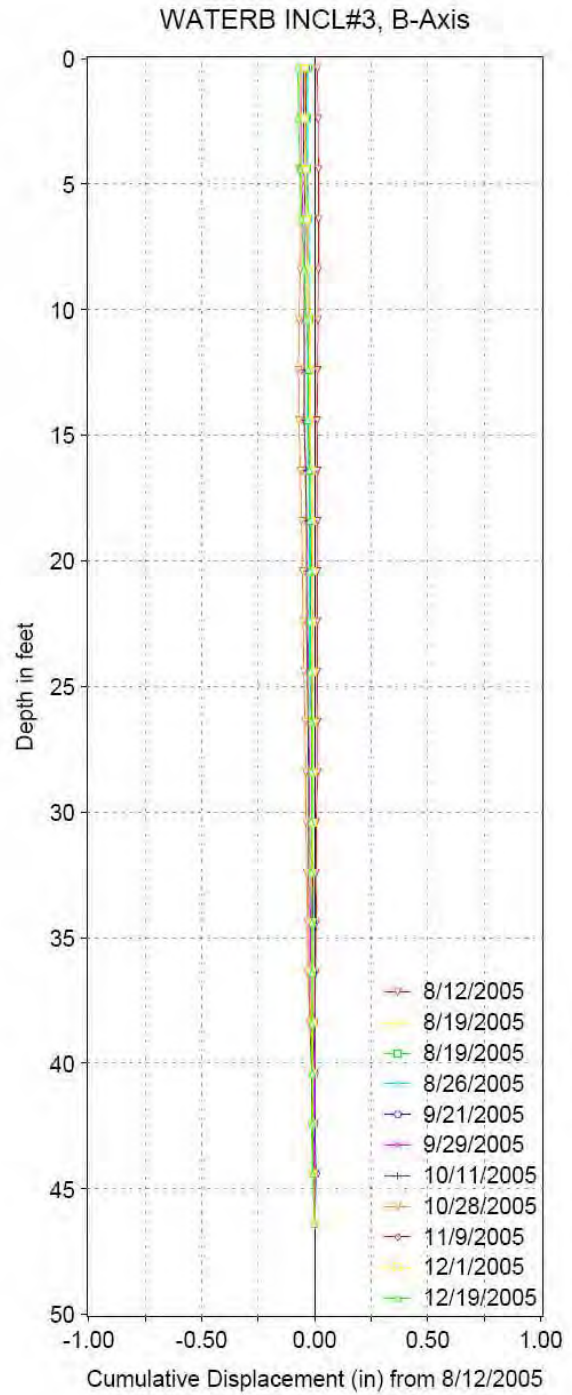
**Figure B.3** Inclinerometer #3 cumulative displacement profiles.
