**Terminal Blend Asphalt Rubber Hot Mix  
Lowell-Westfield, VT Route 100  
Final Report**

**May 2008**

**Report 2008 - 2  
Reporting on Work Plan 94-R-3**

State of Vermont  
Agency of Transportation  
Materials and Research Section

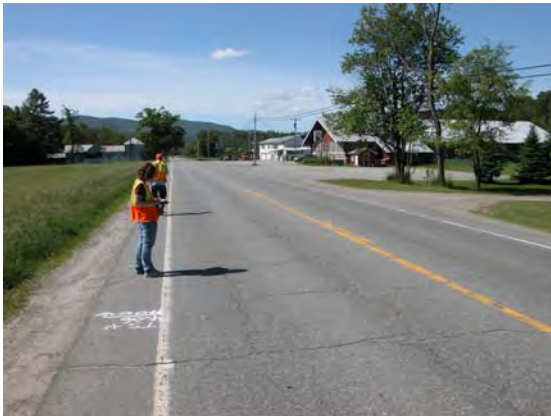
Figure 3. Test Site 4 (Standard Overlay)

A total of eleven test sites were established throughout the length of the project. Of these eleven test sites, four sites were located within the control section and seven sites were identified within the experimental section as shown in Table 1. Each test site consisted of a length of 100' in the direction of travel and were approximately 22' wide encompassing both the north and southbound lanes. Generally, each test site was examined annually for cracking, rutting, and IRI. Figure 3 and 4 below depict a typical test site within a control and experimental treatment area 13 years following construction.

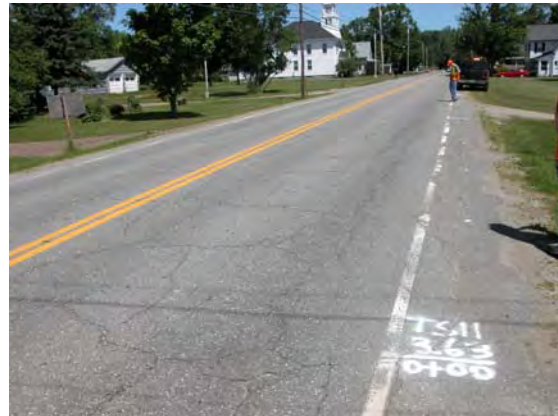
Figure 4. Test Site 11 (ARHM)

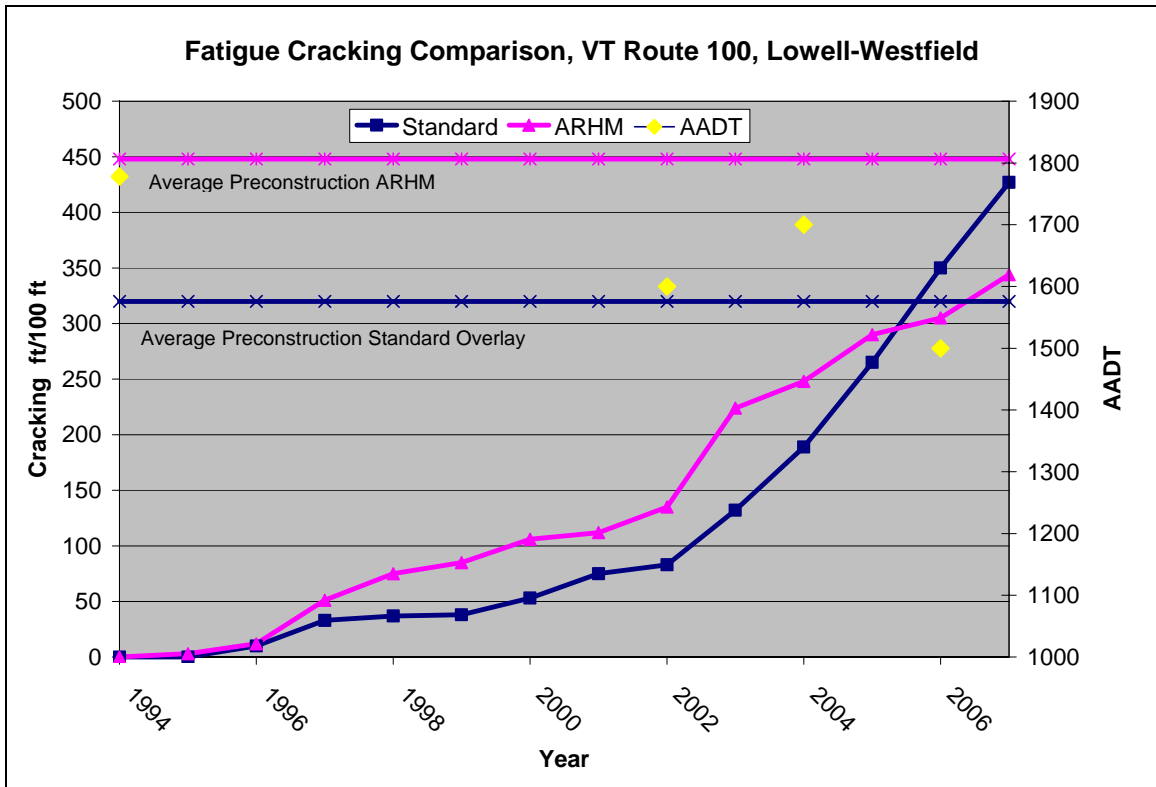
Figure 5. Fatigue Cracking VT 100 Lowell-Westfield

As shown above in Figure 5, there are no significant differences in the condition of the road with respect to total fatigue cracking. However, as stated within the “Project Description” section, the standard section received roughly 33% more traffic on average over the study duration as compared to the experimental section. Therefore, it is easy to presume that the control section should display more fatigue related distresses following construction. Yet, the experimental section originally displayed a much greater amount of fatigue cracking as recorded during the preconstruction survey at a rate of roughly 46% greater than the standard section. This could indicate that the pavement structure below the experimental section is not sufficiently designed to withstand current loading and may not be a reflection performance of the wearing course. In either case the standard overlay reached preconstruction cracking at 11 years of service while the ARHM has yet to meet preconstruction values. This difference is significant, extrapolating to a 40 percent increase in pavement life.

As shown in the table, preconstruction values reveal that roughly 12% of all traffic on the roadway, both north and southbound lanes, was classified as truck traffic. The values dropped about 3% for the following 8 years. In 2004 there was a marked upswing in the truck traffic, above 10%. This upswing coincides with a dramatic increase in the amount of fatigue cracking across all test sections along the control and experimental treatments, as shown in Figure 5.

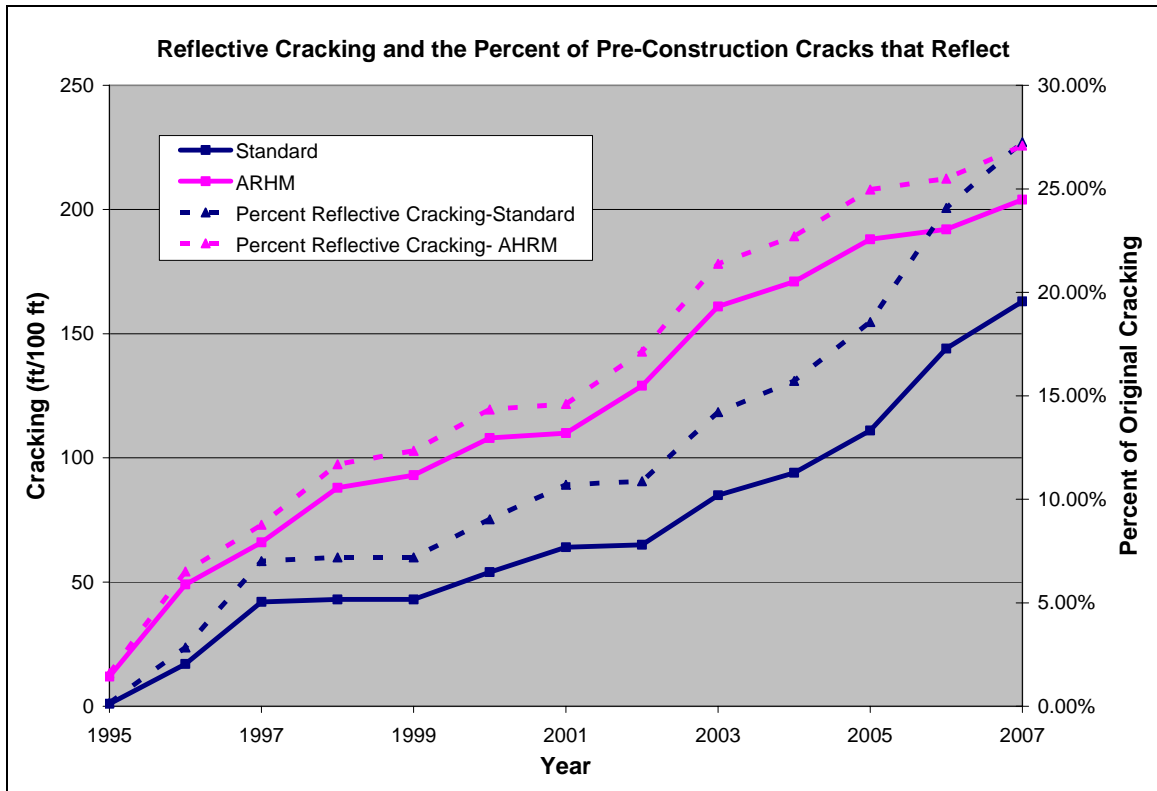
Figure 7. Reflective Cracking VT 100 Lowell-Westfield as a percent of pre-construction cracking.

The amount of reflective cracking depends on the total amount of cracking observed during the preconstruction survey. It is important to note that a much greater amount of cracking was observed within experimental section as compared to the control section. This means that one would expect a greater occurrence of reflective cracking in the ARHM to occur, as is the case. Therefore, the percentage of pre-construction cracks that reflect has been introduced. This includes data that is more relative and provides a more representative comparison. This is calculated simply by dividing the length of reflective cracks observed for a given year by the length of original cracking observed during the pre-construction site visit. As shown in Figure 7, a greater percentage of pre-construction cracks have appeared through the ARHM over time, with the two dotted-line plots finally converging in 2007, where the percentage of reflective cracking showing in both of the current pavement treatments have become equal. This suggests that the ARHM may be more susceptible to reflective cracking than standard overlays. Conversely, the ARHM section may have been more susceptible to cracking due to the underlying soil structure, subgrade or subbase, such

as the greater incidence of high frost action soils as noted earlier. Overall, both pavements are performing adequately as only approximately 27 percent of the preexisting cracks have propagated through the wearing course 12 years following construction.

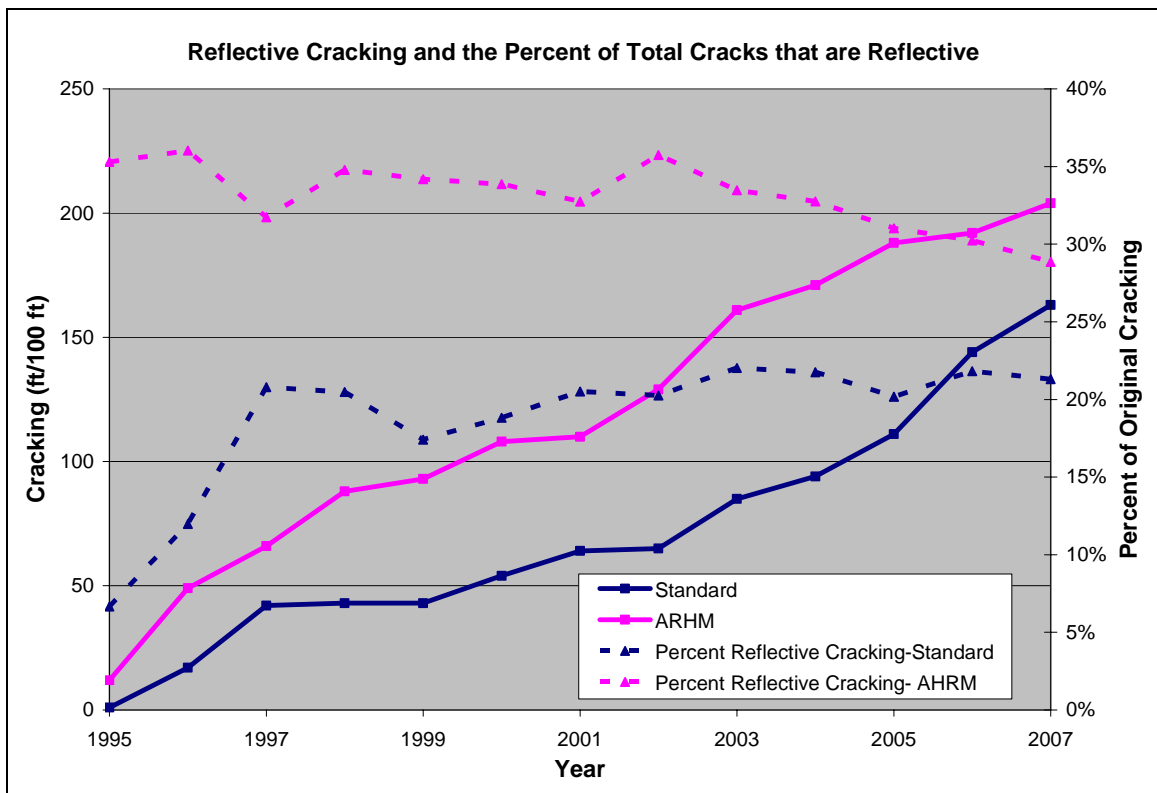
Figure 8. Reflective Cracking VT 100 Lowell-Westfield as a percent of total cracking.

A second methodology in tracking reflective cracking is shown in Figure 8. The percentage axis and data series represent the percent of total cracks for a given year that actually are reflective cracks. This is computed by dividing the length of reflective cracking for a particular year by the total length of cracking for that year.

It is generally accepted that the percentage of reflective cracking to increase rapidly during the first few years of a new surface, then level out to a consistent rate throughout the remainder of its life. This is the case with the standard overlay through to the present time. The amount of reflective cracking increased from about 7% to 22% within the first 3 years, and has remained around the 22%. This is not the case for the experimental section; it started at a high level of 35% cracking and remained near this point until the past 4 years, at which time it has started a slight decline. This, along with the fact that it has displayed on average roughly a 10% higher ratio of reflective cracking than the standard overlay, is evidence that it did not take on the extra flexibility from the crumb rubber as was expected. This may support the

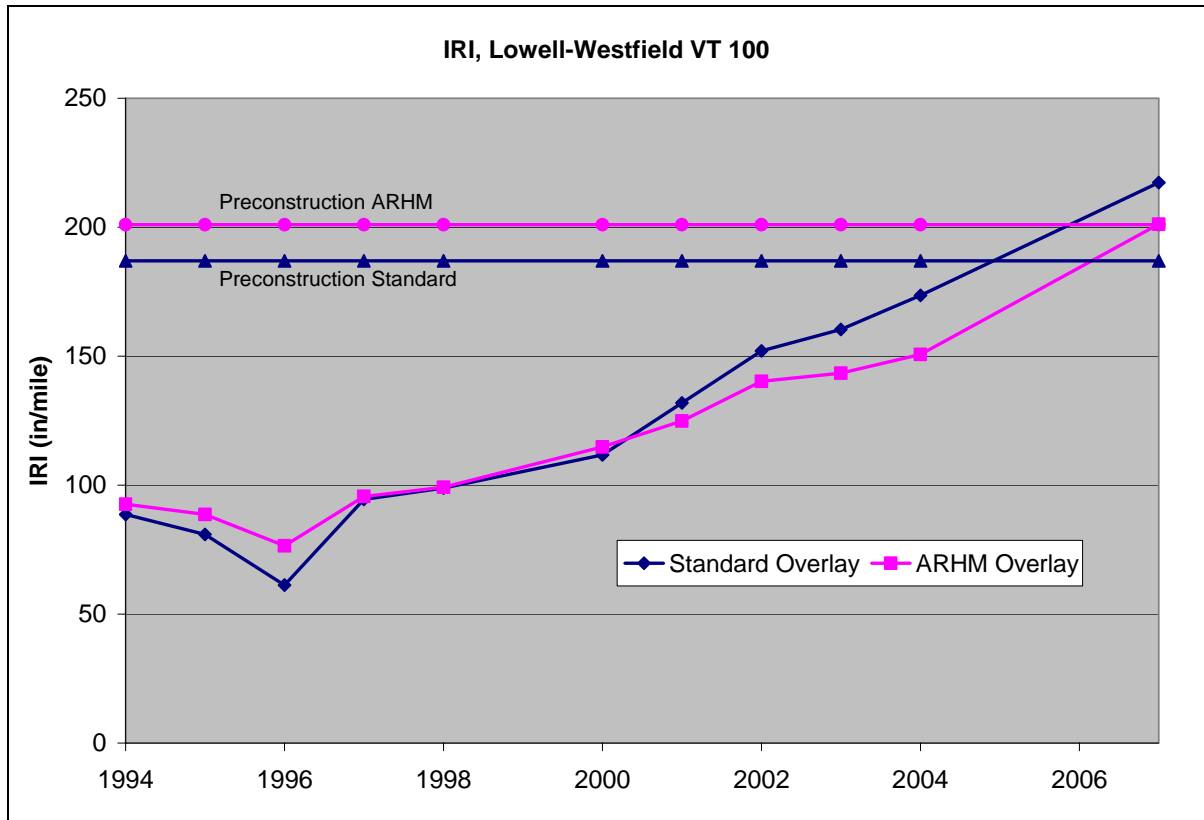
Figure 9. IRI data.

There are some discontinuities within the data set. Usually IRI values are at a minimum immediately following construction as the pavement condition is optimum and will then degrade over time. Therefore, it was anticipated there would be an upward trend throughout the years of data collection. However, in this project the IRI values fluctuated for the first few years before settling into the pattern of increasing values. The initial IRI values in 1994 (year 0, shortly after project completion) are higher than those from 1995 and 1996. These discrepancies are most likely caused by a variation in testing equipment and calibration methods. It may also be a response from the underlying pavement condition due to frozen conditions increasing the IRI values. However, all IRI values were collected from June through August when the underlying structure would not be subjected to freezing conditions.

There is a general upward trend in the IRI values between 1996 and 2007 for both the experimental and control sections. The values have approximately doubled in the first 10 years of the pavement lifespan. The ARHM overlay seems to exhibit a lower average increase in roughness than the standard overlay, however the standard is on the portion of the road with the higher AADT. From this data, one can conclude that both overlays, as well as both northbound and southbound directions, performed as near equals, as all trends within the graph are consistent to each variable.

The IRI values recorded in 2007 are 217 in/mile for the standard overlay and 201 in/mile for the ARHM overlay. These are considered fairly high values. According to a figure published in “The Little Book of Profiling, Basic Information about Measuring and Interpreting Road Profiles”, these values fall in the middle of the ‘Older Pavement’ range and is quickly approaching the value (around 300) which describes a road as having ‘Surface Imperfections’. The standard overlay section exceeded preconstruction values between 2005 and 2006, roughly 11 years following construction. The ARHM section has yet to exceed preconstruction values.
