## MATERIALS AND RESEARCH

INITIAL REPORT

U 2006-8

### 50 GYRATION SUPERPAVE MIX ROCHESTER/GRANVILLE, VT 100

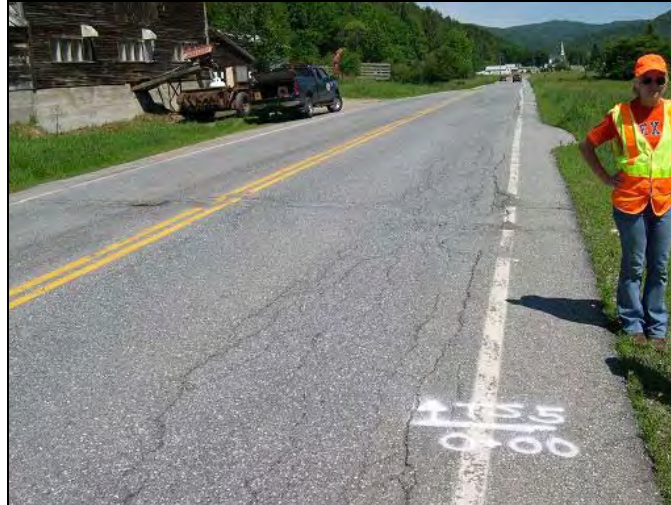
Figure 1: Test Site 5

As stated within the work plan, six test sites were established throughout the entire length of the roadway segment. Each test site was located in an area with good sight distance on a straight away and consisted of a total length of 100 feet in the direction of travel and are approximately 22’ wide encompassing both the north and southbound lanes. Of the six test sites, two were located within the control section and four sites were identified within the experimental sections. Figure 1, provided below, displays a typical test section prior to construction:
