**Cold Recycled Bituminous Pavement  
Troy-Newport, VT  
Final Report**

**February 2007**

**Report 2007 - 4  
Reporting on Work Plan 92-R-8**

State of Vermont  
Agency of Transportation  
Materials and Research Section

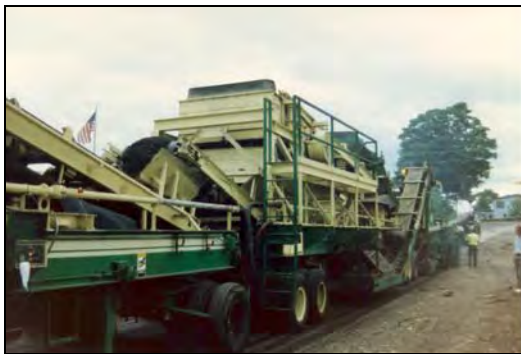
**Figure 1 – Recycle Train Screen/Size Unit**

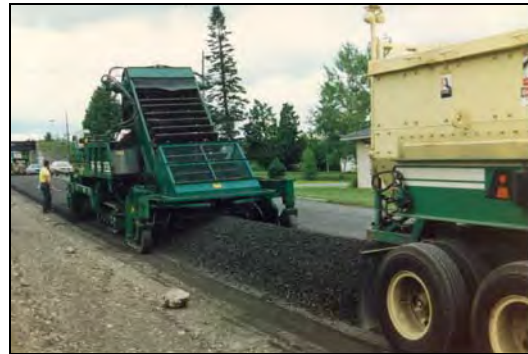
**Figure 2 – Recycle Train Mixing Unit/Paver**

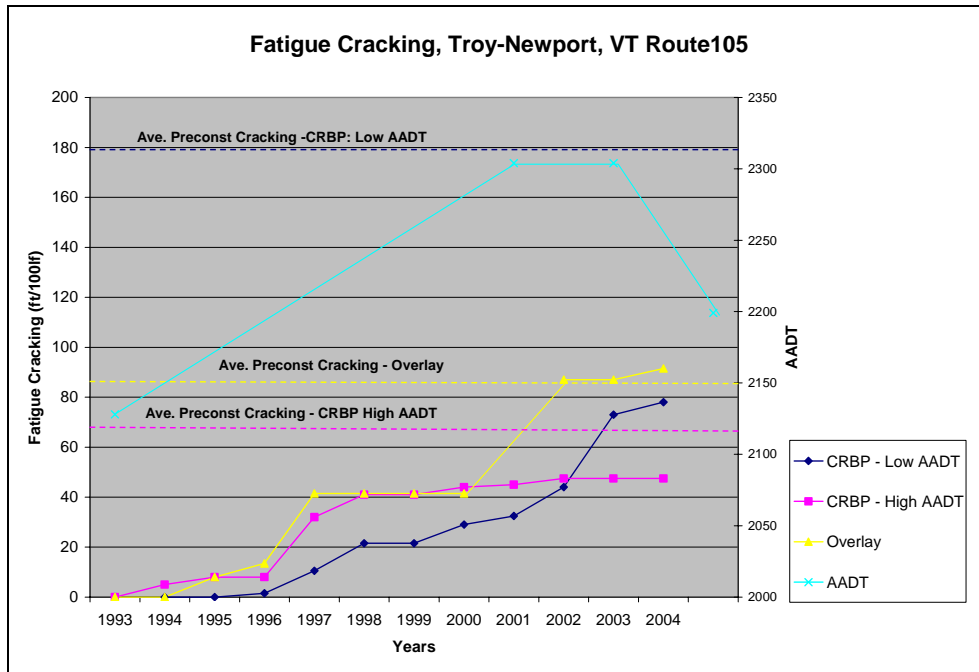
**Figure-4 Fatigue Cracking VT 105 Troy-Newport**

A weighted average AADT was utilized in Figure 4, otherwise defined as an average of quantities that have been adjusted by the addition of a statistical value to allow for their relative importance in a data set. However, it is important to keep in mind that the AADT, provided in Appendix B, was not a constant variable across all test sites. The AADT was relatively consistent between from MM 5.730 in Troy to MM 0.200 in Newport which contains four test sites, two in the CRBP and control sections respectively. The AADT from MM 0.200 to MM 2.682 increased by 30% as compared to previous segment. As previously discussed, AADT is an important parameter when defining the traffic loading across a pavement. While the AADT only describes the average number of vehicle passes a day, it may be surmised that additional vehicles will include additional truck traffic or heavier weighted vehicles resulting in an increase in fatigue cracking. This theory is proven within Figure 4 for the CRBP sections as the percentage of current fatigue cracking to preconstruction fatigue cracking is 43% and 74% within the low and high AADT sections, respectively. However, fatigue cracking within the overlay section exceeded preconstruction levels in 2000 which may be a function of the pavement treatment rather than traffic volume and composition.

It is also interesting to examine the shape of the fatigue cracking rate vs. time plot. In the case of the CRBP and standard overlay sections located within the lower AADT area, the shape of the fatigue cracking rate appear to be consistent with each other. This indicates similar pavement responses over time. Fatigue cracking from the CRBP sections with a higher AADT, exhibits a slope that is not consistent and remains relatively level for the seven years between 1998 and 2004. Additionally, the graph depicts a positive correlation between an increase in traffic loading and an increase in fatigue cracking.

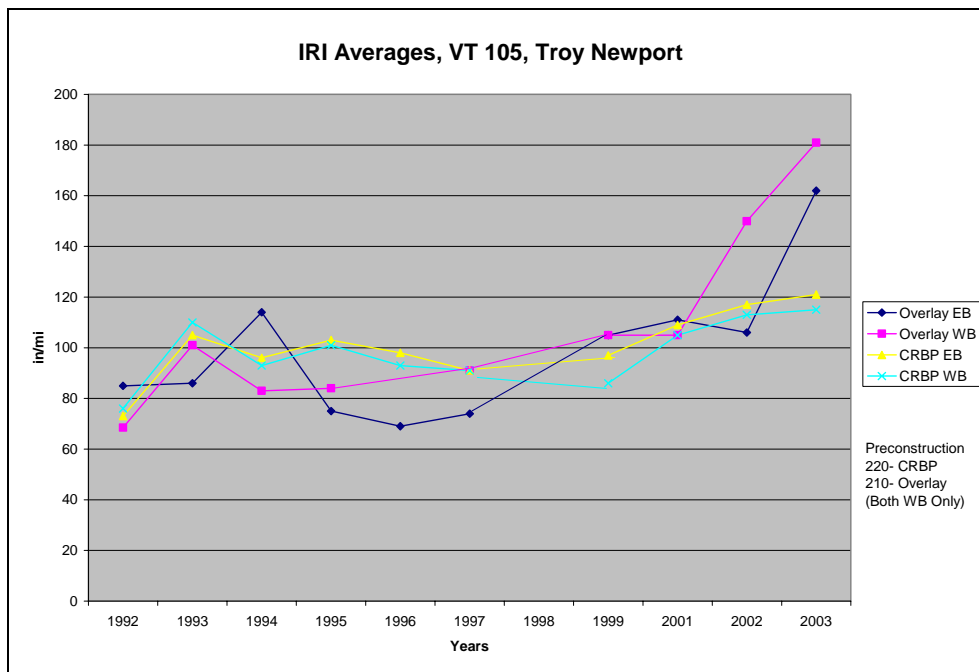
Figure 7 – IRI Averages,

There are some discontinuities within the data set. Usually IRI values are at a minimum immediately following construction as the pavement condition is optimum and will then degrade over time. Therefore, it was anticipated there would be an upward trend throughout data collection. However, the initial IRI values are greater than those from following years which is most likely caused by the variation in testing equipment. It may also be a response from the underlying pavement condition due to frozen conditions increasing the IRI values. However, all IRI values were collected from June through August when the underlying structure would not be subjected to freezing conditions. There is a general upward trend between 1998 and 2004. In 2004, the average IRI value for each pavement section was well below preconstruction values. This inference may not be accurate due to the variability of sampling equipment. It was documented that three different road profilers were utilized for the collection of the IRI values throughout the investing period. Each of the road profilers vary from one another which causes discontinuities between annual data sets. The ratio between the IRI data collected in

2004 as compared to preconstruction values are fairly consistent across all test sites and were found to range between 52 percent in the westbound CRBP section to 86 percent in the overlay section. This again suggests sufficient lateral support throughout the length of the project. It is also important to keep in mind that IRI is directly related to all pavement distresses. It is recommended that all future IRI values are collected by the same profiling device for research projects evaluating various pavement treatments in order to provide consistency and accuracy. If this is not possible, it would be desirable to establish specific highway sections to be used for statistical correlation between the equipment in consecutive years
