## MATERIALS AND RESEARCH

INITIAL REPORT

U 2006-7

### Cold Weather Waterborne Paint with XSR

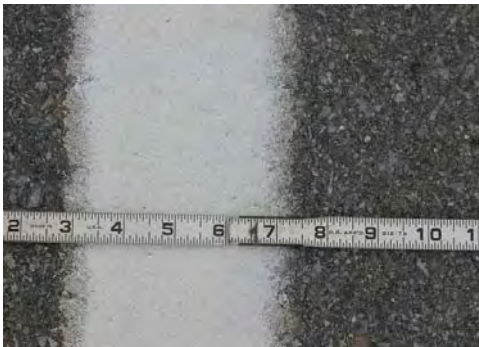
Figure 1 – XSR White Edge Line

Following application and proper dry time, the overall appearance of the experimental paint markings appeared to be much better in comparison to the standard waterborne paint as the cold weather paint retained a consistent texture and greater dry thickness. Figures 1 and 2, as provided below, depict the white and yellow experimental markings following sufficient dry time.

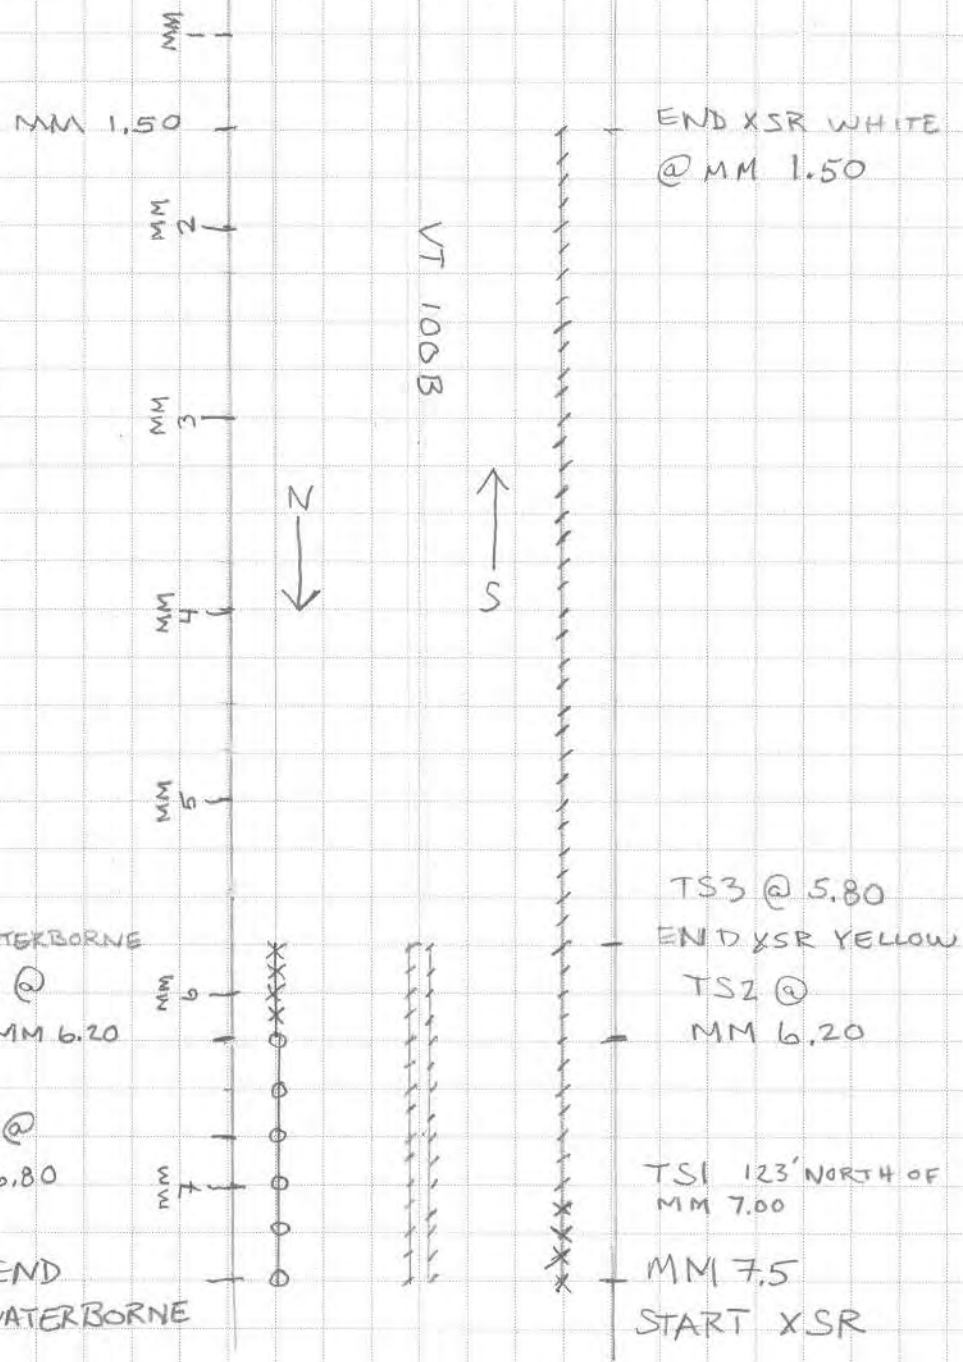
# **Appendix A**

with white marking paint along the shoulder of the driving lane in order to ensure that all future readings will be collected from the same location. Retroreflectivity and wear readings were collected on the day of application (11/3/06) following adequate cure time and once a week following application (11/9/06) per the associated work plan. Please note that Test Site 1 through 3, consist of readings collected on the experimental markings along the shoulder of the southbound lane and centerline markings and Test Site 4 and 5 consist of readings collected on the control markings along the shoulder of the northbound lane. Please refer to Appendix A for a layout of all test site locations.

COLD WEATHER WATERBORNE  
TRAFFIC PAINT WITH XSR  
DRAWN BY KAT PATTERSON  
///// XSR  
OOOO WATERBORNE  
XXXX MIX
