**Evaluation and Comparison of
Epoplex LS-50 Epoxy
Lyndon/Sheffield IM 091 – 3(11)
Final Report**

July, 2007

**Report 2007 - 11
Reporting on Work Plan 2002-R-8**

State of Vermont
Agency of Transportation
Materials and Research Section

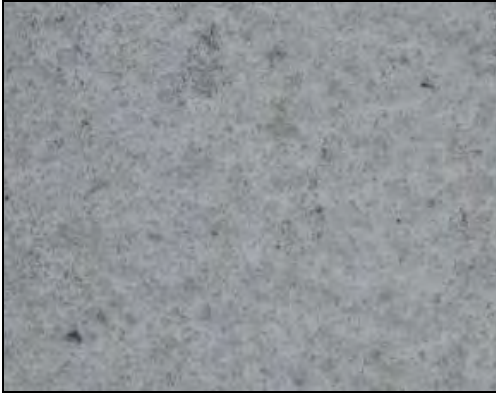
As anticipated, a significant drop in retroreflectivity, 156 mcdl on average, is evident across all markings following the first winter season. This is most likely attributed to shearing effects resulting from winter maintenance practices. In general, the markings continuously decay over time although there does appear to be a spike in December of 2003, one year following installation. Given the lower readings prior to and following this particular data collection event, the spike may have been caused by salt residue on the surface of the markings. In addition, while the retroreflectivity readings displayed a large loss following the first winter season and throughout this investigation, the durability readings remained high. This indicates that the epoxy binder was highly resistant to wear from tire abrasion and winter maintenance practices furtherer supporting a problem with the application of glass beads. This may be caused by a number of factors including bead rate, the position sprayer in relation to the binder and/or insufficient ambient and roadway temperatures. Figures 3 and 4 display the condition of the binder in 2003 as compared to 2006, three years following application.

**Figure 3 – Test Site 1 (2003)
Durability =10**

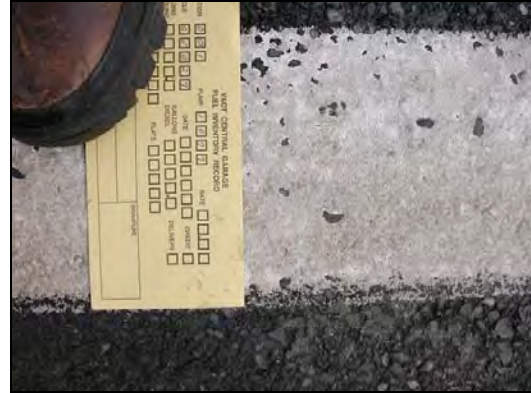
**Figure 4 – Test Site 1 (2006)
Durability = 9**

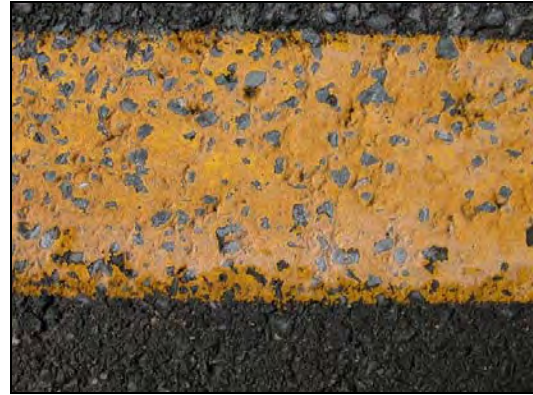
Once again, a significant drop in retroreflectivity, 95 mc dl on average, is evident following the first winter season. This indicates a substantial initial decay rate of 61%. The retroreflectivity continues to decay over time residing below the FHWA recommendation several months following application with greater losses during winter seasons and a slight rebound during summer months. Once again, the epoxy binder held up well in terms of durability and resistance to wear as shown in Figure 5 and 6 below. As stated previously, wear readings suggest a strong bond to the underlying pavement while the retroreflectivity readings indicate a weak bond to the epoxy binder.

Figure 6 – Test Site 2, 2006
Durability = 7
