**Evaluation of ATM 300 Permanent Durable Tape  
Montgomery, Vermont  
Final Report**

**December 2010**

**Report 2010 – 7  
Reporting on Work Plan 2007-R-5**

State of Vermont  
Agency of Transportation  
Materials and Research Section

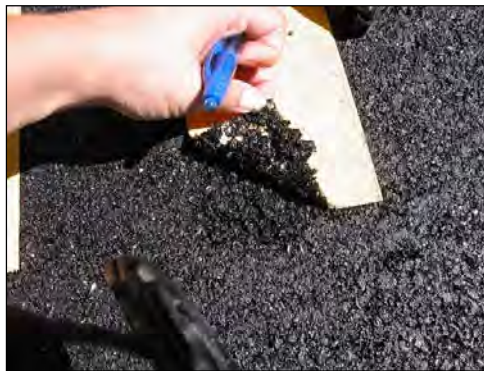
General observations during application included the ease of tape removal. As depicted in Figure 1, the tape readily lifted with minimal hand force while the pavement was still warm. However, the tape appeared to be well adhered to some portions of the pavement. This may indicate that the pavement was not thoroughly cured. There was also some evidence of shrinkage at the beginning and ending of each continuous tape section. The shrinkage appeared to pull the surface of the HMA as well. Interestingly, application literature states, “if tape distorts or wrinkles, surface temperature may be too hot or roller speed may be too fast.” These areas were monitored periodically during the study duration.

**Figure 1. Tape lifted**

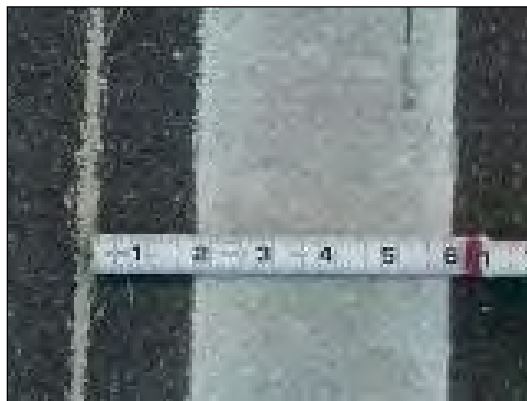
Thermoplastic markings, or the control markings for this study, were applied during the first week of October. Unfortunately, Research personnel were not onsite to monitor the application process. However, the appearance of gas bubbles within the thermoplastic markings, as well as shadows was noted during a site visit performed on October 10<sup>th</sup> as displayed in Figures 2 and 3. According to literature provided by Ennis Paint, gas bubbles are generally caused by either moisture or solvent trapped in the hoses or from overheating. Thermoplastic shadows may be generated by a heavily undulated road surface or die not riding evenly on the substrate. In either case, evidence suggests some problems during application, which may have ultimately affected long-term durability and retroreflectivity.

**Figure 3. Material shadows on line (test site 2)**

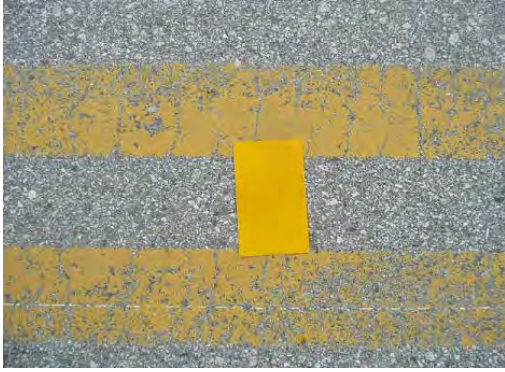
As shown above, the thermoplastic marking were less resistant to wear over time as compared to the experimental permanent tape markings. Within 40 days of application, the average wear rates for the control markings decreased by 50% while the wear rates for the ATM markings decreased by only 10% within the same timeframe. Following the winter season, the wear readings for the thermoplastic markings remained constant while the experimental markings decreased slightly. However, after two years of service, the wear readings for the experimental markings are almost twice that of the standard markings. Observations of the thermoplastic markings immediately following application indicated that the markings were likely not applied properly as evidenced by bubbles in the line and overshadowing. This may have resulted in premature wear. In addition, as stated previously, the tape markings were recessed into the pavement most likely shielding the substrate from damage induced by winter maintenance practices and tire treads. Figures 4 through 7 below demonstrate general wear of the ATM and thermoplastic traffic marking after approximately two years of service.

**Figure 4. Yellow thermoplastic photo from 7/27/2009**
