RESEARCH UPDATE

U2013-06

2013 Pavement Marking Data Collection Summary

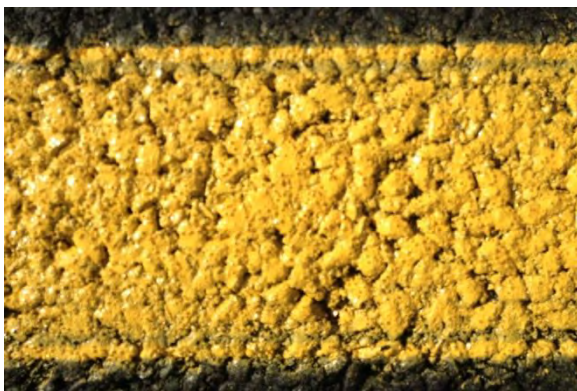
Figure 3: Yellow Edge Line.

Retroreflectivity readings in millicandelas per lux per meter squared (mcdl/lx/m²) from the first two visits on October 4th, 2013 and October 21st, 2013 have been:

- White Edge 467 and 473
- White Skip 443 and 482
- Yellow Edge 328 and 316

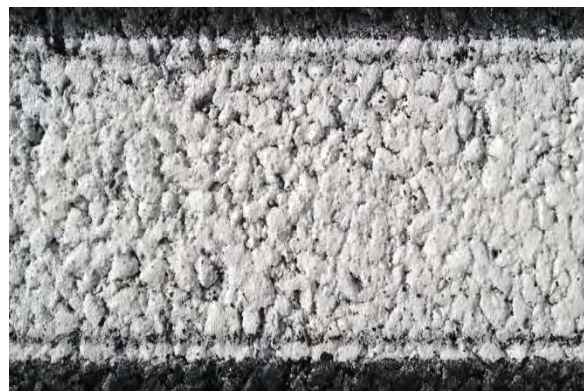
Figure 4: White Edge Line.

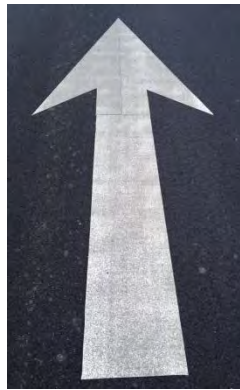
Figure 1: ATM 400 Arrow.

Saint Albans - "The Wal-Mart Project"				
Product	Line Type	Date		
		7/30/2013	8/20/2013	9/30/2013
Briteline HDX	White Long	238	279	292
Briteline HDX	Yellow Long	165	164	203
ATM 400	Arrows	498	536	781
Briteline HDX	Yellow Gore	147	161	172
Briteline HDX	White Stop	312	266	185

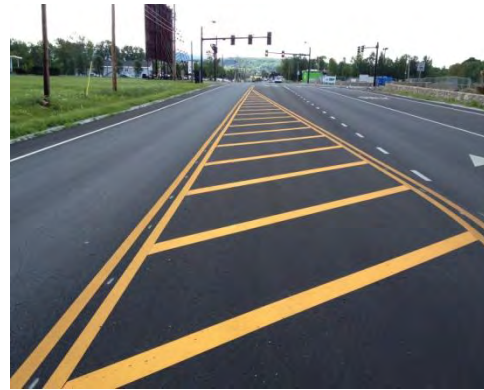
Figure 2: Brite-Line Gore Marking and Long Line Markings.
