THE MIDDLEBURY SAND HILL BRIDGE

Gregory S. Goodrich, PE Vanasse Hangen Brustlin, Bedford, NH
Kristopher G. Kretsch, PE Vanasse Hangen Brustlin, Watertown, MA

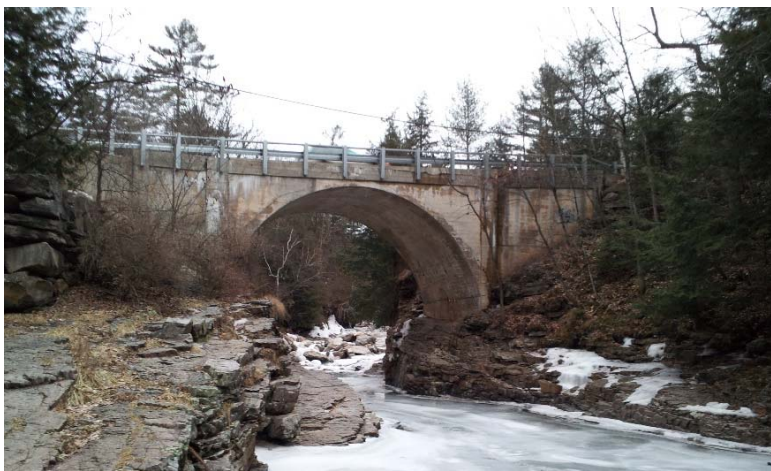
Figure 1: Existing Bridge

The existing 1924 single span closed spandrel arch concrete bridge was in need of replacement. The curb-to-curb width of the bridge was 20-feet 6-inches, and it was located in the middle of a sharp reverse curve on the steep and scenic Vermont Route 125, at the base of Breadloaf Mountain at over a 7.5 percent grade. The bridge spans a 42-foot rock gorge carrying the Middlebury River (see Figure 1). The site also serves as a popular recreational swimming hole, and was also home to the archaeologically sensitive site known as the East Middlebury Iron Works site. This archaeological resource contains the remnants of the early 1830's iron works, which was the last operating iron works in Vermont, and is thought to be the best preserved example of this type of iron works in the state.

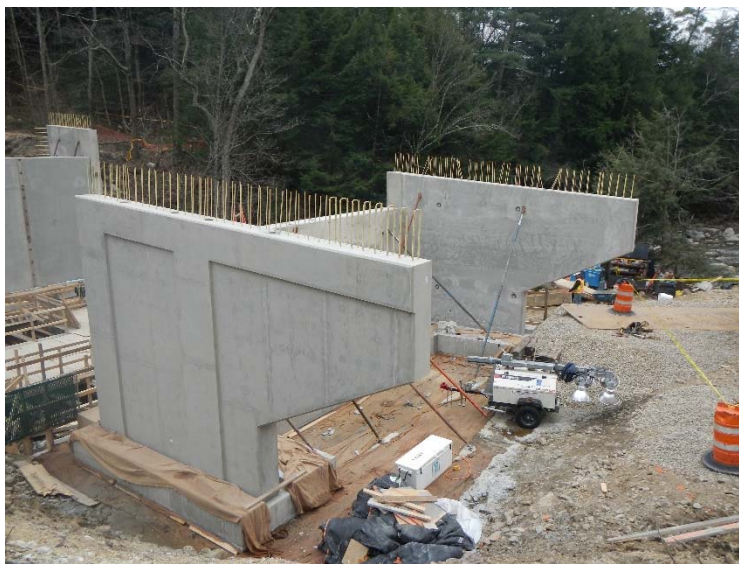
Figure 5: One Piece Precast Wingwalls 26' Long x 15' Tall

The precast fabricator who was awarded the job was located in the Town of Middlebury. This allowed for the fabricator to produce the footings, abutments, and wingwalls using as few pieces as possible, whereas transporting the pieces only a few miles to the site made it possible to fabricate larger pieces. This made for quicker construction and a nicer overall aesthetic on the wingwalls, since there were fewer joints in the precast (see Figure 5).

Precast abutment stem pieces were approximately 12-feet tall at the north abutment and 20-feet tall at the south abutment. Horizontal joints in the abutment stems were not permitted. Grouted and keyed vertical joints were permitted, with limitations on number of joints and placement of joints relative to bearings. Stem and wingwall pieces were joined to precast footings using grouted splice sleeves.

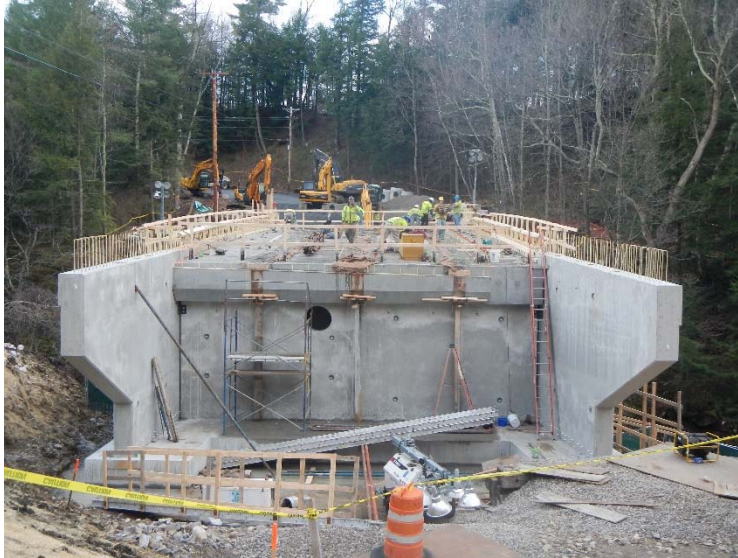
Figure 6: Abutments and NEXT Beams – Note Precast Curtain Wall

Prestressed NEXT D beams were utilized to minimize the amount of cast-in-place concrete required. They were detailed to incorporate a precast curtain wall which was cast onto the back side of the beam, and was designed to support the end of the approach slabs. These curtain walls were cast on the ends of the beams at the

fabrication plant in order to eliminate the need for casting backwalls in the field. This detail also provided a “jointless” bridge, as the curtain wall was designed to extend below the top of the bridge seat, thereby eliminating the need for a traditional bridge joint (see Figure 6). In effect, once the beams were set on the bridge seats, the beam closure pours could be completed, the abutments backfilled, and the precast approach slabs set.

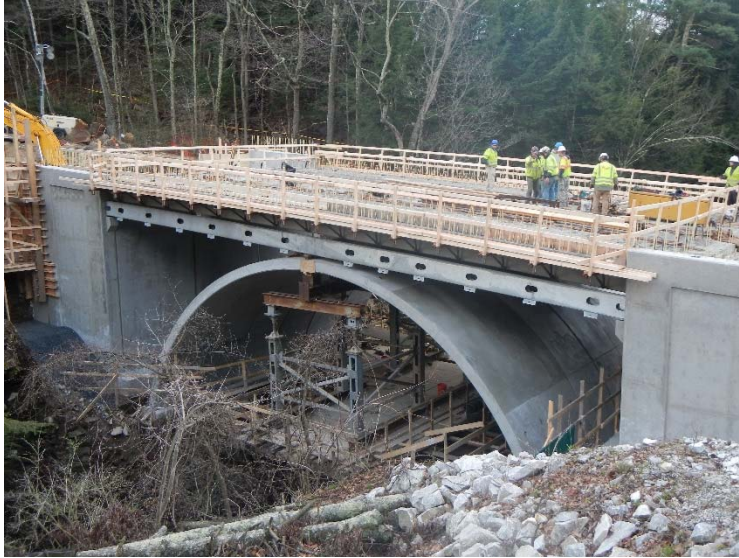
Figure 7: Bridge Elevation – Prior to Hanging Face Panels

Architectural face panels were detailed to hang off of a galvanized steel box support beam. A steel box shape was selected due to torsional and weak axis rigidity. Face panels were hung off of the support beam so that the dead load would not be supported by the superstructure, thereby not subjecting the panels to live load deflections. The support beam was supported by the abutments, which is independent from the precast arch itself (see Figure 7). The panels hang in front of the arch, thereby concealing the precast arch in elevation. This also serves to keep the arch panels from imparting any vertical load on the arch itself.

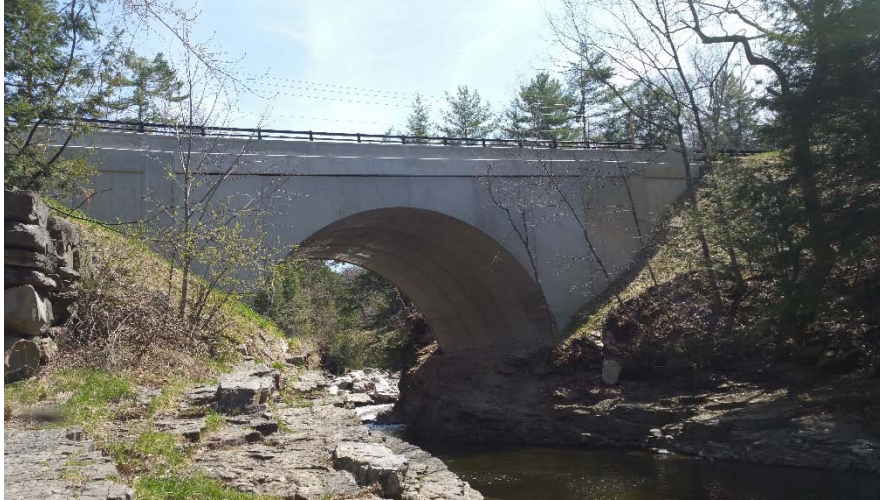
Figure 8: Completed Bridge

Access doors were provided on each end of the bridge, on the east bridge fascia only, as the west fascia is the side facing the recreational swimming hole, and is the side most viewed from the roadway and by pedestrians (see Figure 8). Permanent lighting was installed inside the arch enclosure to facilitate inspections and future maintenance. Louvered vents were also provided on the east fascia to promote air circulation.

The new bridge was completed at a total construction cost of \$2,650,000 (see Figure 8).

- 6 footing pieces (82,000 lb. max piece weight)
- 5 abutment pieces (69,000 lb. max piece weight)
- 4 wingwall pieces (79,000 lb. max piece weight)
- 12 arch pieces (30,000 lb. max piece weight)
- 6 approach slab pieces (38,000 lb. max piece weight)
- 4 NEXT beams (109,000 lb. max piece weight)
- 16 architectural face panels (14,000 lb. max piece weight)
