Reducing Wildlife Mortality on Roads in
Vermont:
Determining Relationships Between Structure
Attributes and Wildlife Movement Frequency
Through Bridges and Culverts to Improve
Related Conservation Investments

Paul Marangelo, Senior Conservation Ecologist
The Nature Conservancy – Vermont Chapter

Research Project
Reporting on SPR-A 332 (2017-2019)

Final Report 2019-15

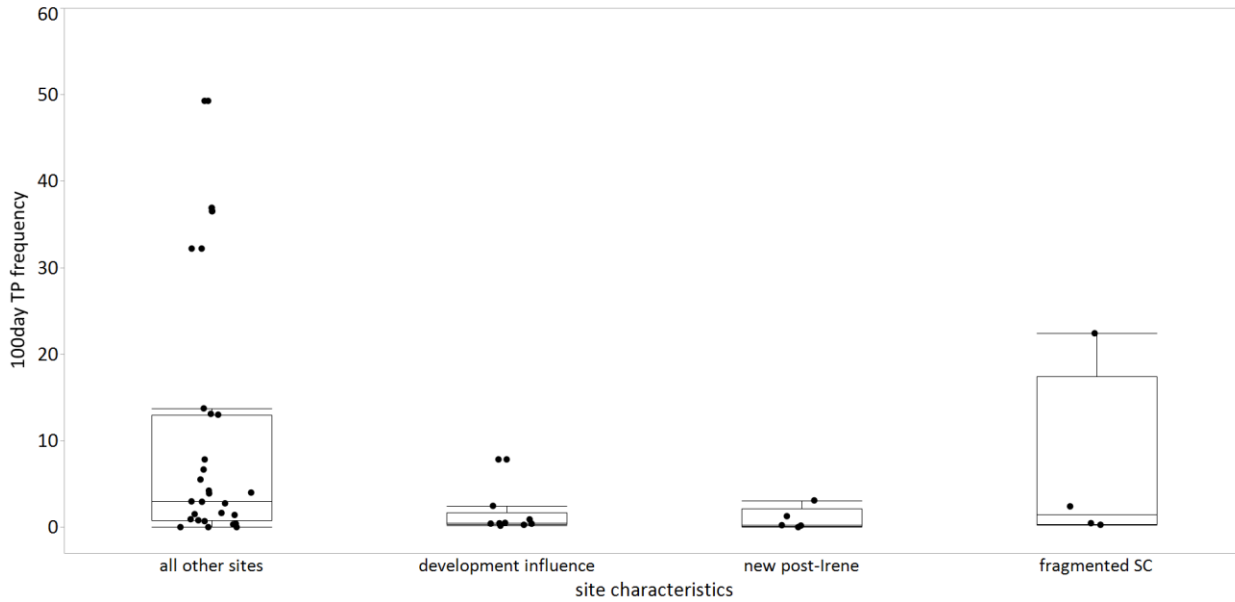
Figure 12. Through-passage frequency data for all Phase 2 and Phase 1 (Marangelo and Farrell 2016) sites by site characteristic category, with overlaid box-plots. Category specific results were used to justify excluding sites in the “development influence”, “new post-Irene” and “fragmented SC (Structural Connectivity)” categories from the analysis on the effects of structure design on through-passage frequency.

The relationship between stream bankfull width and structure width intuitively would seem to influence over the amount of dry movement surface availability in a structure: the wider a structure is with respect to the size of the stream, the greater the availability consistently dry movement surfaces for wildlife. To investigate this relationship, we calculated stream bankfull width from hydraulic geometry equations for Vermont (using estimates of upstream watershed area using USGS streamstats (<https://streamstats.usgs.gov/ss/>)) and plotted bankfull width estimates against through-passage frequencies, excluding all sites in low wildlife use categories from Figure 12.

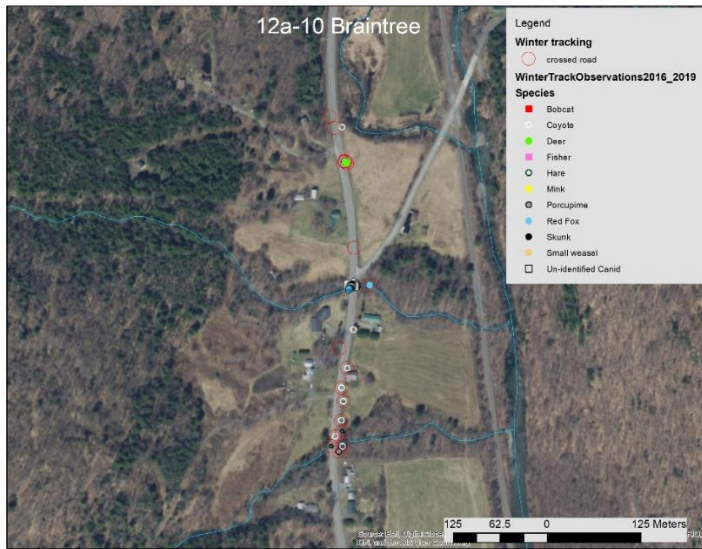
Figure 22. Map of focal species road crossings at Site 12-10, (Braintree). This site had only 1 deer through-passage during the project and had a relatively high development index. Road crossings denoted by red circles. Red circles without a species identifier represent crossings of non-focal species.

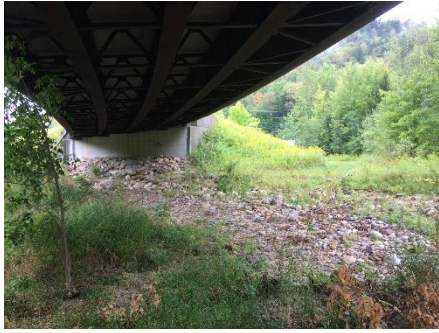
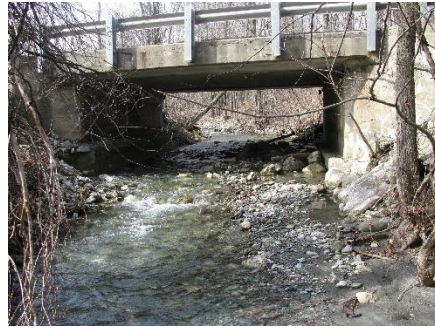
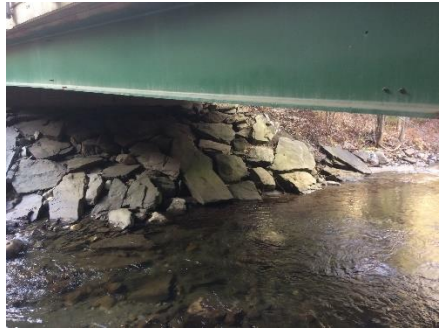
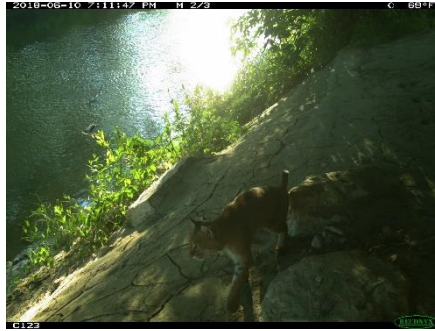
Figure 25. Examples of the variety of movement surface types that *spans* can provide. Upper left: “even floodplain” under valley-spanning bridge (9-25b, Searsburg). Upper right: “dry streambed” in a *span with footing shelf* where nearly all through-passages occurred on the streambed, which was typically entirely dry during summer months. Lower left: “riprap” streambank movement surface commonly found under many *spans* (not a project site). Lower right: “even streambank” of fine sediments under a *span* that does not cross an entire river valley (Union Street, Brandon, VT).

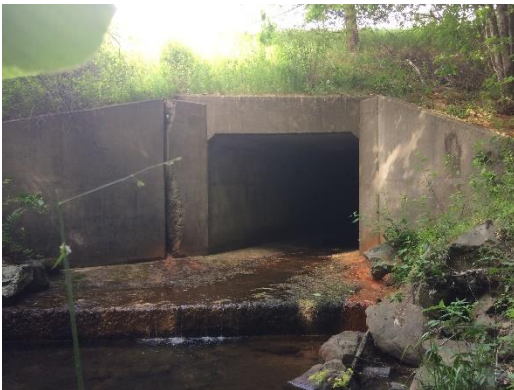
Figure 29. Example of a *V bottom box culvert*, with “dry concrete” movement surfaces along culvert walls. Site I91-17-2, Putney.

These structures are very rare – we found only 2 suitable for game cameras. By channeling water into the center of the culvert, they offer superior dry movement surface availability compared to the wet flat bottoms of typical of *old box culverts* (Figure 29). Project data probably does not reflect the potential of this design type for encouraging wildlife through-passage, as both structures studied were much longer than most wildlife prefer (both were over 235 feet long). Since newly constructed box culverts are likely to feature embedded designs, and are thus more likely to have more favorable movement surfaces than dry concrete (Figure 11), the relevance of “V bottomed box culverts” to the management of road corridors for increased permeability for wildlife appears questionable.
