VERMONT AGENCY OF TRANSPORTATION

Materials & Research Section
Research Report

CARGILL SAFELANE® HDX OVERLAY

Report 2014 – 04

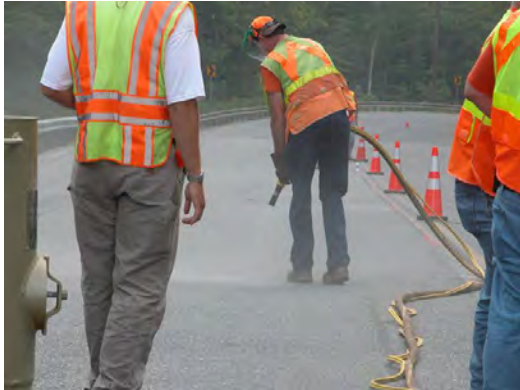
Figure 2 Sand Blasting

Preparation included sandblasting the pavement with a medium sand to remove oils and pavement markings to provide proper adhesion between the epoxy and the roadway surface shown in Figure 2 below. Prior to this, high-pressure water blasting and high-pressure water blasting with sand proved to be ineffective. The use of powered air blowers to remove the sand was insufficient due to the capacity, so it was swept off using a sweeper.

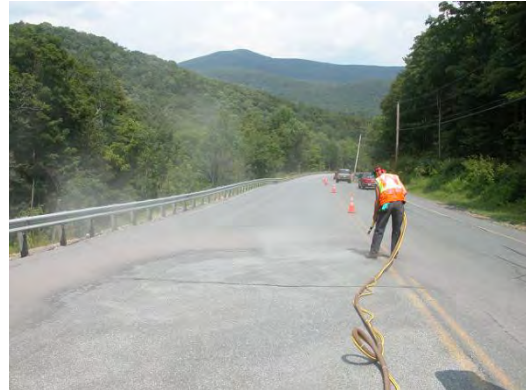
Figure 3 Air Compressor

On the following day, the remaining particles were blown off with an air compressor shown in Figure 3 below. Upon completion of the cleaning process, duct tape was used to delineate the area of application.

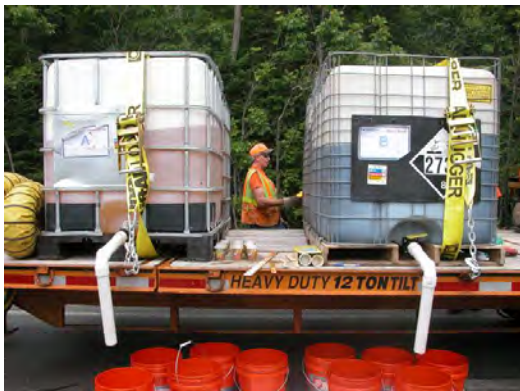
Figure 4 Part A and Part B

The mixing of the two-part epoxy was the next step in the process. The two parts of the epoxy were individually poured into 5-gallon buckets as shown in Figure 4 below. The two parts

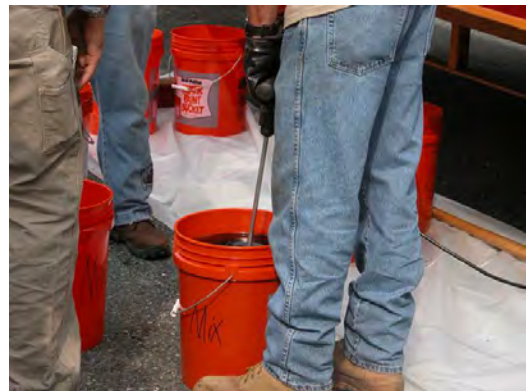
Figure 5 Mixing the Epoxy

were then poured into a larger container in a 1 to 1 volumetric ratio and mixed using a large paddle mixer for approximately 3 minutes shown in Figure 5. Due to unfamiliarity with the product, the representative from the manufacturer had the workers start with a small load size of about 3.7 gallons.

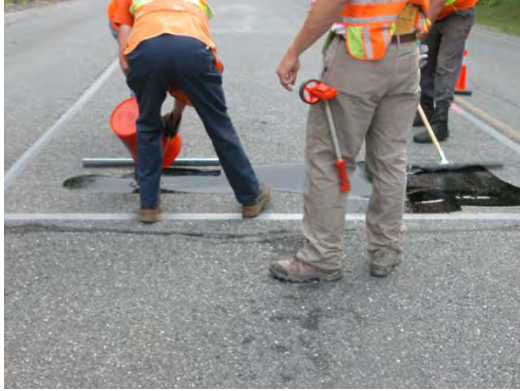
Figure 6 Spreading Epoxy

Once properly mixed, the epoxy was immediately poured onto the road surface beginning at the top of the test section where it was spread uniformly with grooved V-notched squeegees shown in Figure 6. The aggregate was then spread over the epoxy layer using shovels shown in Figure 7. An approximate length of 1 foot of epoxy was left uncovered at the end of each pour so the pour that directly followed could form a smooth joint. The duct tape was removed before the epoxy completely cured at about 15 to 20 minutes after application.

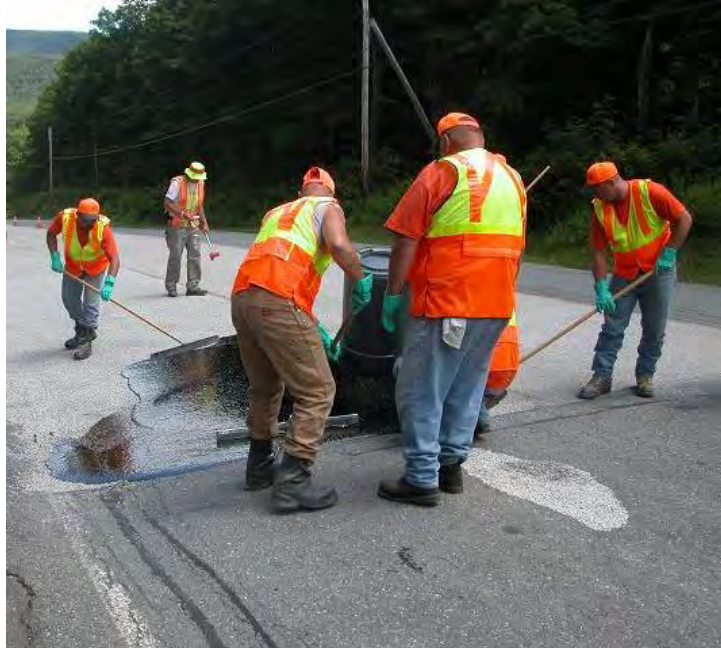
In preparation for the second lift, the area was swept twice with the mechanical sweeper, blown with leaf blowers and the air compressor to rid of any excess aggregate. It was once again delineated with duct tape. The section edges were taped again over the edge of the first lift to create a space to form a level joint between the adjacent lanes. This was important to provide for a smoother transition upon entering the overlay from the non-treated roadway for all roadway users. To ensure the overlay area was uniform in thickness, larger epoxy mixtures were used to ensure that the entire surface was coated with the two-part mixture. The batches applied were between 9.7 and 18.4 gallons. The epoxy was spread using flat-bladed squeegees as shown in figure 8. Once consistency was evident, the aggregate was spread over the epoxy. After the crew completed the second layer and allowed it to cure, it was once again swept and blown with an air compressor to rid the surface of any excess aggregate. On the final day of installation, the same process was used for the travel lane except that duct tape was only used to delineate the upper and lower widths of the section, not along its length on either side. The completed surface is shown in Figure 9. The completed surface texture is shown in Figure 10, and the texture after a year of service is shown in Figure 10.

Figure 8 Placement of the second lift.

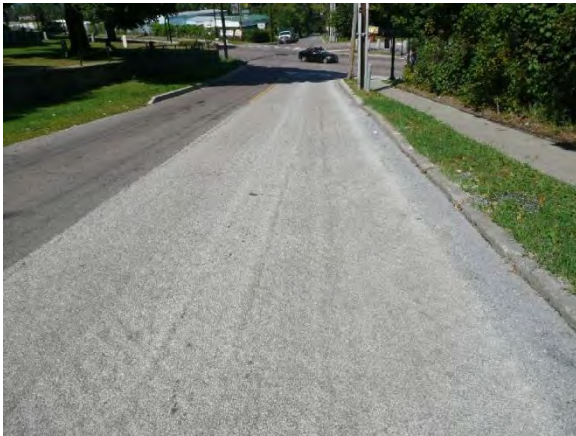
Figure 15 Overlay after application in 2008

apply the overlay. The first day involved milling the existing pavement to ensure the overlay would be flush with the surrounding pavement after completion. In the night after the milling process, a passing truck leaked oil onto the milled surface. As a result, the surface required shot blasting to ensure that the surface was clean in preparation of applying the overlay. Though the surface was properly prepared for the application of the material, the supplemental blasting left a ripple pattern on the surface of the overlay. Although the finish was not smooth and flat, the overlay was noted as being in good condition after placement. The site was visited periodically over the next 4 years. A considerable amount of cracking was noted in the last visit in March of 2012. No crashes or incidents have been reported between placement and the summer of 2012.

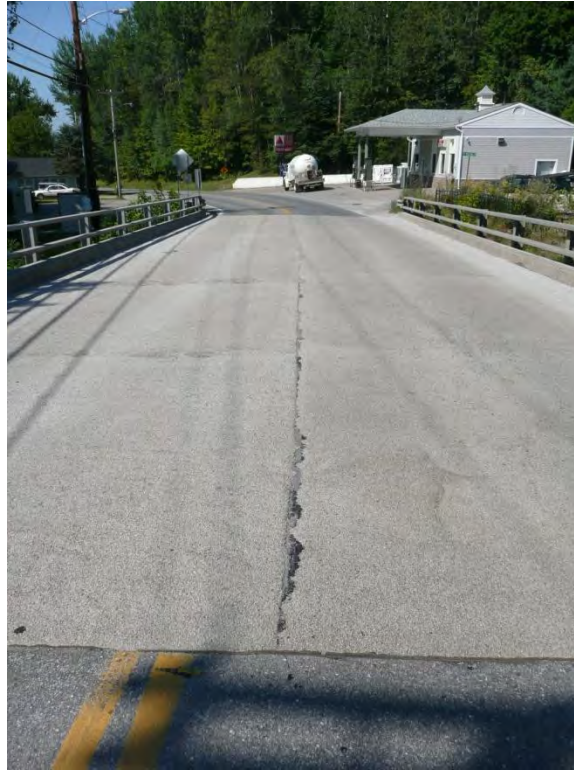
Figure 17 Application after installation in 2008

The application was also completed by Parent Construction. As with the North Prospect Street site, this site was visited periodically by Research personnel. Figure 17 shows the completed application in 2008. In August 2010, two years after installation Research personnel

noted that the wheelpaths of the overlay were slippery. The surface was damp due to precipitation during morning hours. Upon furtherer examination, it was noted that within the wheelpaths, little aggregate remained on the surface of the experimental overlay. Instead, as shown in Figure 18, exposed epoxy was present in the majority of the surface of the overlay.
