Agency of Transportation

Report on Spring 2006 Evaluation of Detectable Warning products installed 2003- 2005

July 12, 2006

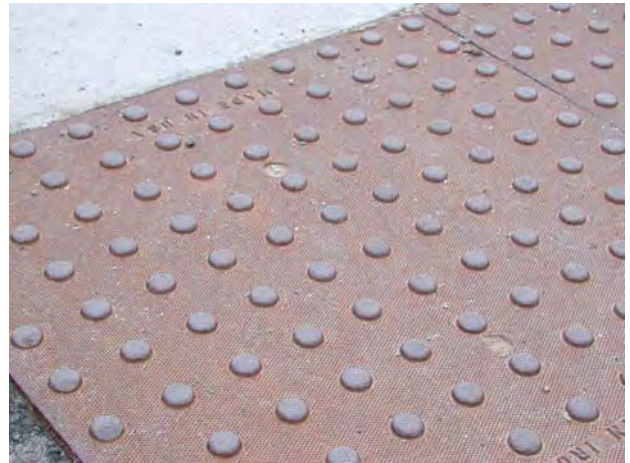
These panels showed virtually no damage and all domes were intact. There was good color contrast to the surrounding concrete. Some minor bleeding of rust onto the adjacent concrete was observed.

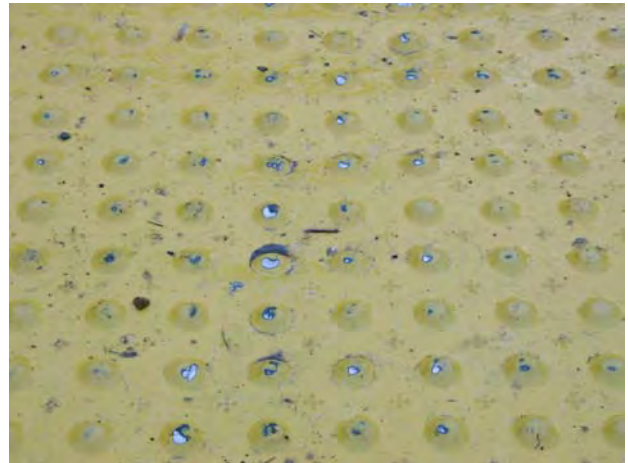
The removal of surface coating was noted on some internal domes, not just the leading edge.
