Reinforced Earth[®]
Mechanically Stabilized Earth Abutment Walls
Initial Report 1998-3
April, 1998

Reporting on Work Plan 94-S-21

State of Vermont
Agency of Transportation
Materials and Research

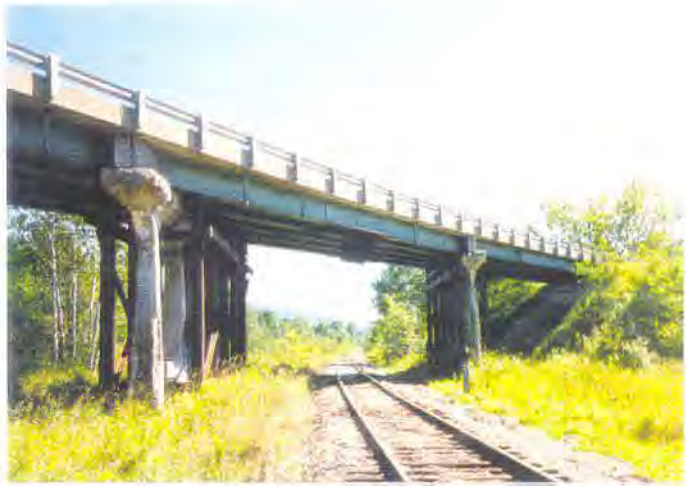
Figure 1. I-Beam Bridge, Constructed 1937

In 1996 the Vermont Agency of Transportation constructed its first mechanically stabilized earth (MSE) abutment wall. Located in the Town of Wallingford, the project consisted of replacing a badly deteriorated steel I-beam bridge (Figure 1) by realigning U.S. Route 7 and constructing a 100 foot simple span steel girder bridge over the Vermont Railway. Design of the new bridge was complicated by the 30° skew in the roadway over the railway and the height needed to accommodate the rail line. In addition to these constraints, it was necessary to maintain traffic on the existing roadway during construction, creating a confined area in which to erect the structure.
