PAVEMENT MARKING COMPARISON STUDY – US ROUTE 302 BIKE LANE MARKINGS

Ian Anderson, Research Engineer
Vermont Agency of Transportation
Research Section

November 2018

Final Report 2018-03

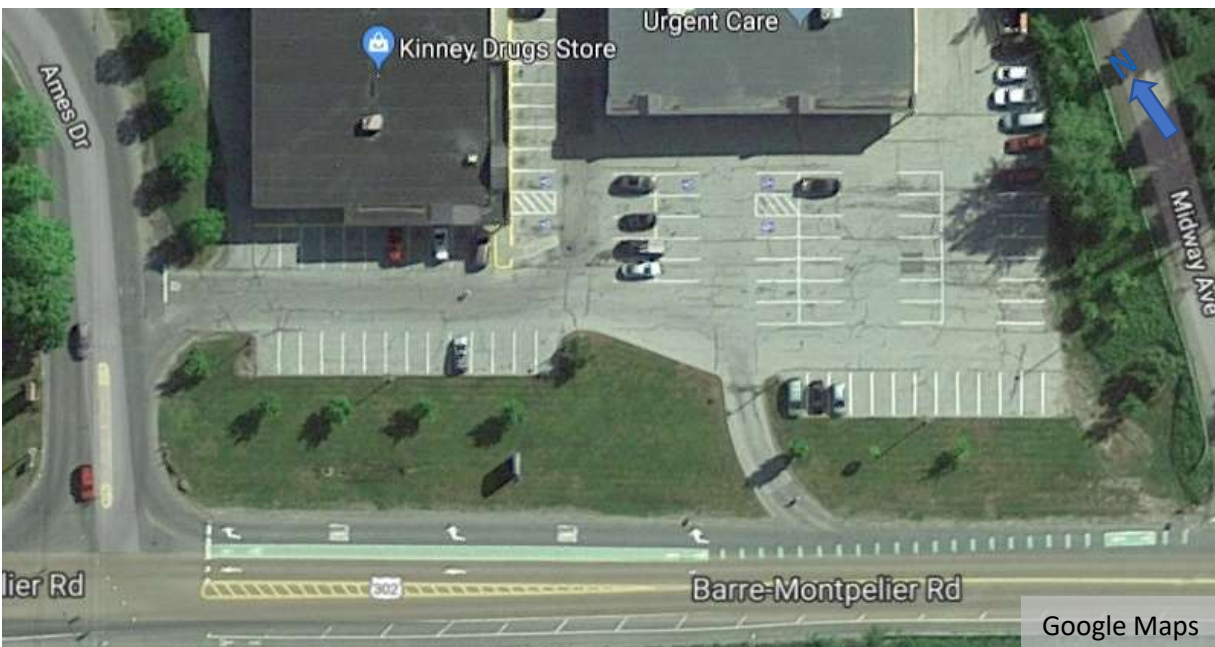
Figure 1: PreMark Location 1

PreMark preformed thermoplastic was installed on Aug 26-27, 2016, with ambient temperatures of 80°F. PreMark was used in three locations throughout the test. The first was between a straight and a turn lane on the North/West bound travel lanes leading to the Ames Ave, as seen in Figure 1. Cars both entering the driveway prior, and making right turns onto Ames Dr will cross over the skip marks. Traffic counts show a peak hourly count of 77 vehicles turning right onto Ames Dr, but the counts do not include the driveway use. This installation includes 22 skip marks in the convergence zone, and two solid blocks, a small block at the start of the lane, and a large block that extends the full length of the right turn lane.

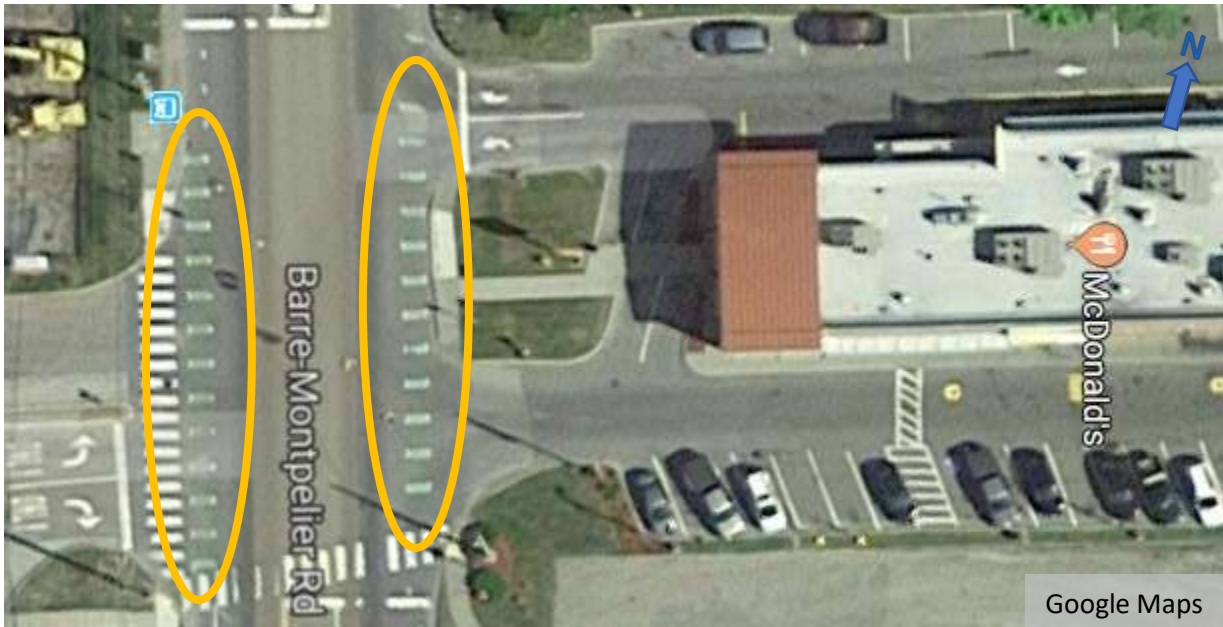
Figure 2: PreMark Locations 2 and 3, and CycleGripMMAX Location 2.

The second test site is at the entrance to the McDonalds, on the North/West bound side, and includes 14 skip marks across the entrance and exit of the restaurant. Traffic counts indicate a peak hourly count of 140 vehicles entering and 120 exiting across the intersection markings. The final site contains one skip mark (furthest east) on the opposite side of the intersection from the second site, on the South/East bound travel lane, across the driveway for the Burger King and adjacent office/medical complex. Traffic counts indicate a peak of 6 cars per hour making right turns, and likely to cross this final skip marks. The second and third PreMark sites can be seen in Figure 2.

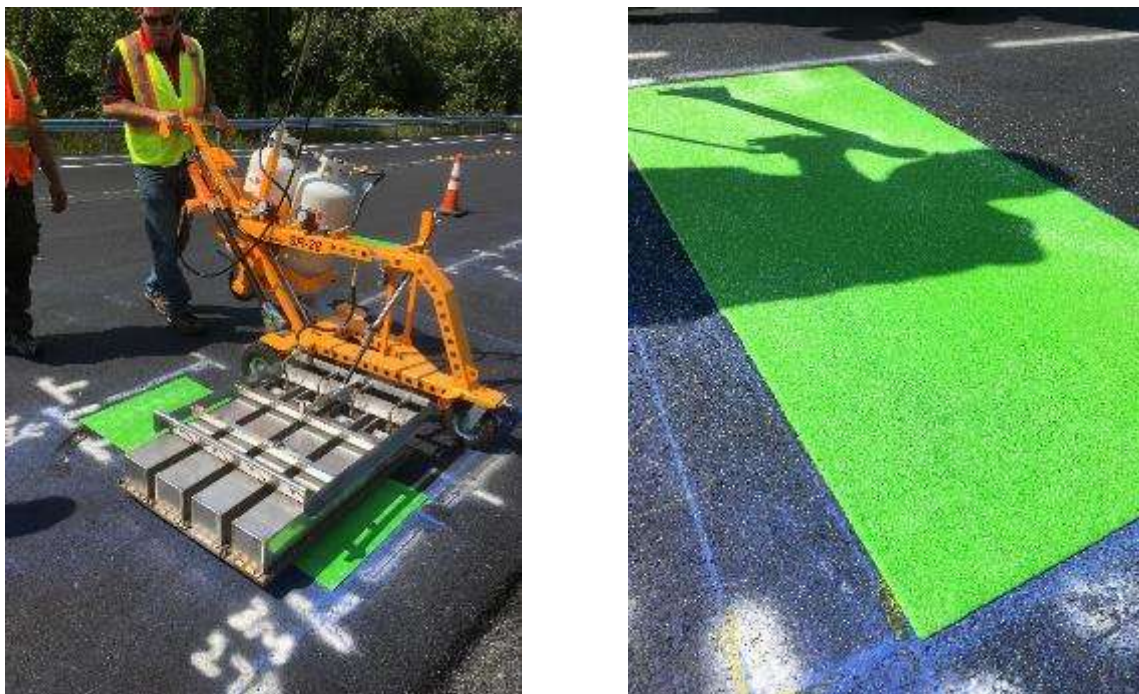
Figure 3: PreMark Installation

Jeremy Crow, the Ennis-Flint representative, was instructing the L & D crew how to properly install the PreMark thermoplastic material. Installation included: brushing and blowing off the asphalt surface, applying an approved two-part sealer to remove unwanted moisture from the asphalt surface, and heating the symbols into place. When torch applying the material, he recommended slow and steady passes of the torch. The torch should be at a low to medium heat range, at approximately 4 to 8 inches above the material. Installation of the PreMark sections can be seen in Figure 3. If the torch is too hot or too close to the material surface, the material may burn, as seen in Figure 4. Skid resistance material, Corundum (Aluminum Oxide) was added to the PreMark, and settles into the material during heating. The PreMark thermoplastic material reaches the proper installation temperature when the heat indicators disappear. Both the skid resistance and heat indicator tabs can be seen in Figure 5. Jeremy emphasized that the edges of the material when properly installed should be rounded. For further installation instructions read the PreMark Application Instructions [6].

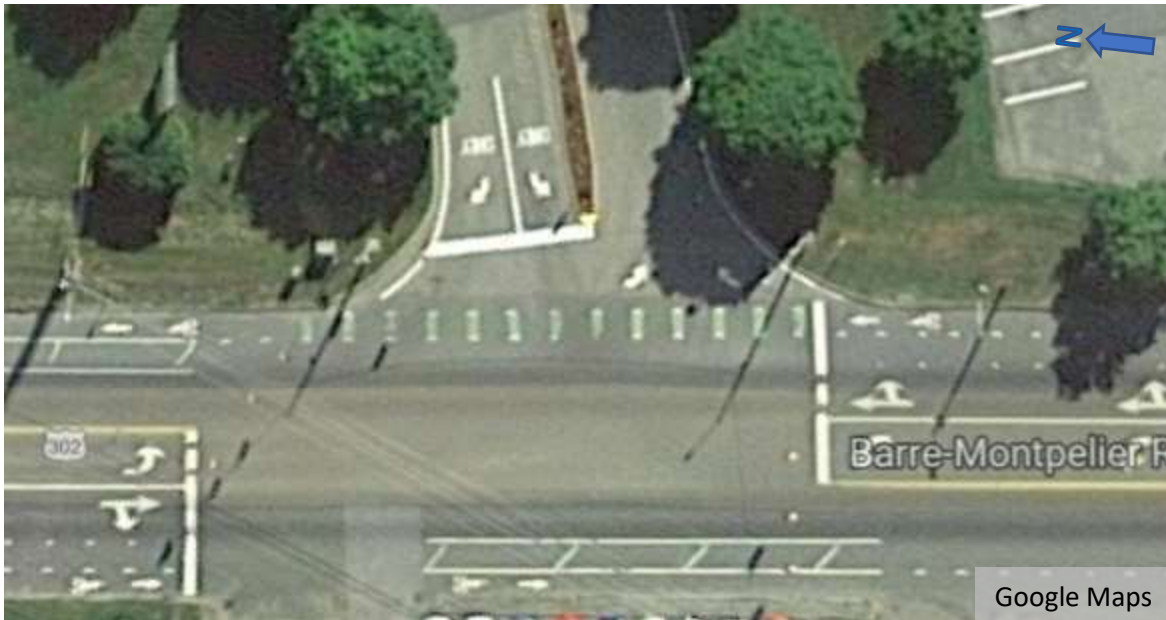
Figure 6: CycleGripMMA Location 1

CycleGripMMAX was installed September 30, 2016, with an ambient temperature of 60°F. CycleGripMMAX was used in two locations in this study. The first installation contains 13 skip marks at the entrance and exit ways of the Vermont Shopping Center, as seen in Figure 6. Traffic studies show peak hourly counts of 165 entering and 105 exiting the shopping center. The second site coincides with the third installation of PreMark, with CycleGripMMAX constituting the other 12 skip marks, as show in Figure 2. Traffic studies show peak hourly counts of 54 vehicles entering and 51 exiting across the intersection skip markings.

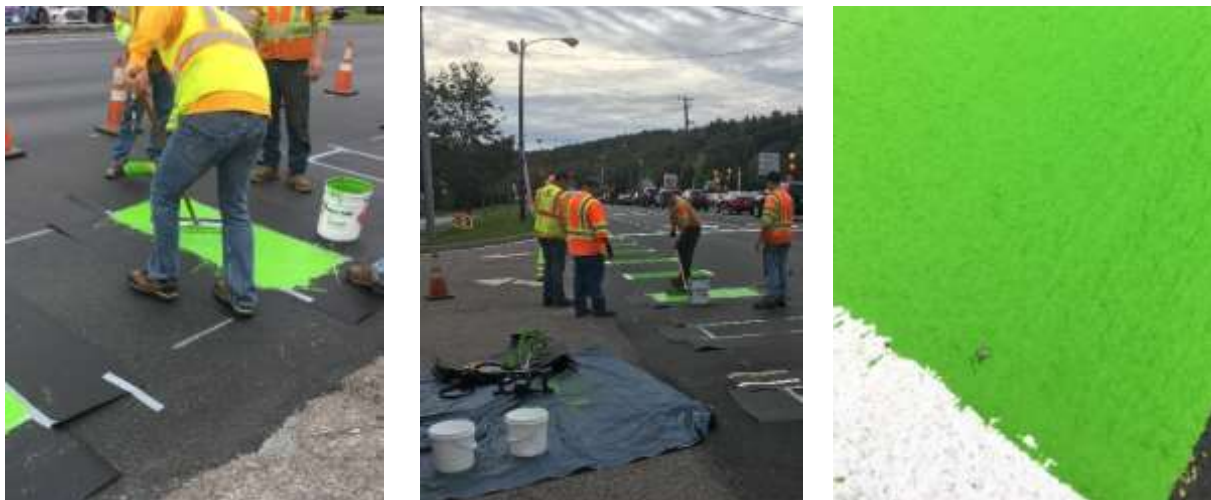
Figure 7: CycleGripMMA Installation

CycleGripMMA was installed after the specified 30-day waiting period following new paving. Prep work included masking the inlaid pavement marking tape, marking out the bike lane blocks and mixing the MMA compounds, catalyst and aggregate. MMA is applied with a squeegee, then back rolled with a coarse paint roller to add texture. Recommended mixing instructions and proportioning of the catalyst agent can be found in the manufacturer application instructions [7]. Ideal cure times for the CycleGripMMA product is between 20 – 60 minutes depending on the ambient temperature and moisture. The material cured at the Vermont Shopping Center intersection within 45 – 60 minutes, as it was cloudy, cool and the moisture was relatively high since it rained earlier in the morning. CycleGripMMA was mixed in 5-gallon kits, producing 50 ft² of finished product each, enough for five 2'x5' bike skips. Three 5-gallon kits were used to complete the 13 bike lane blocks at the Vermont Shopping Center Intersection. For the second site, the crews stretched the remaining two kits to cover 12 skip blocks, resulting in a need for Pre-Mark to be used on the remaining, 13th skip box. Figure 2 shows the second CycleGripMMA location along with the Pre-Mark 13th box. Photos from the installation of the CycleGripMMA can be seen in Figure 7.

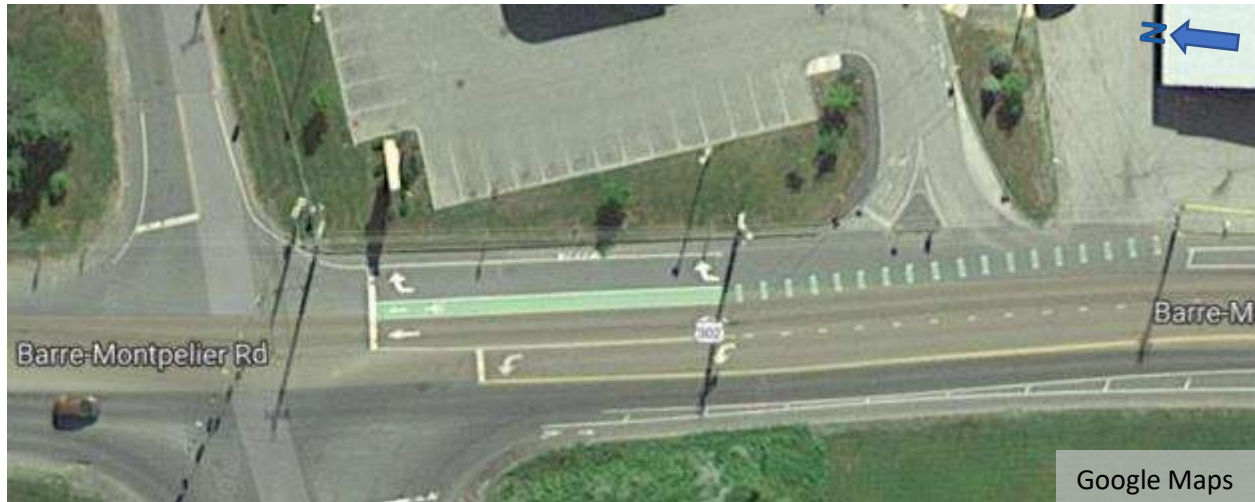
Figure 8: Color-Safe Location 1

Transpo Color-Safe MMA was installed on Oct 5, 2016, with an ambient temperature of 67 degrees. Color-Safe was used in two locations, the first being between the straight and turn lane of the North/West bound travel lane at Partridge Farm Rd, as seen in Figure 8, made up of 18 skips and a large block. Traffic studies show a peak hourly count of 20 vehicles

turning onto Partridge Farm Rd. This section includes vehicles entering the CVS Pharmacy and exiting the gas station and Sears Home Store, but are not captured in the traffic counts.

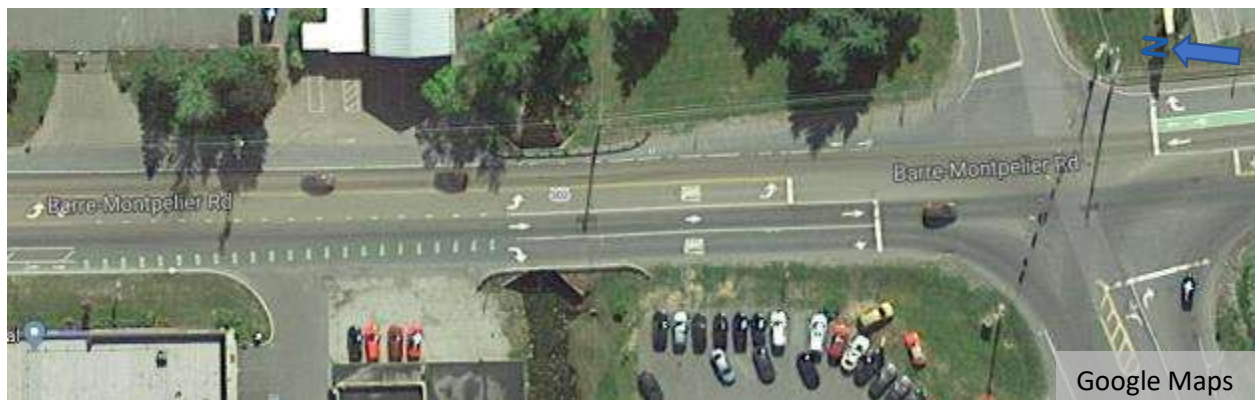
Figure 9: Color-Safe Location 2

The second location separates the turn and straight lanes of the South/East bound lane as it approaches Berlin State Hwy, shown in Figure 9. Berlin State Hwy is a heavily trafficked road, as it is the connection to I-89, and sees a large number of cars making a right turn, and crossing the bike skips frequently. Traffic studies show a peak hourly count of 193 vehicles turning right onto Berlin State Hwy. This section also includes driveways for local business offices and a car dealership lot, which are not included in the traffic counts.

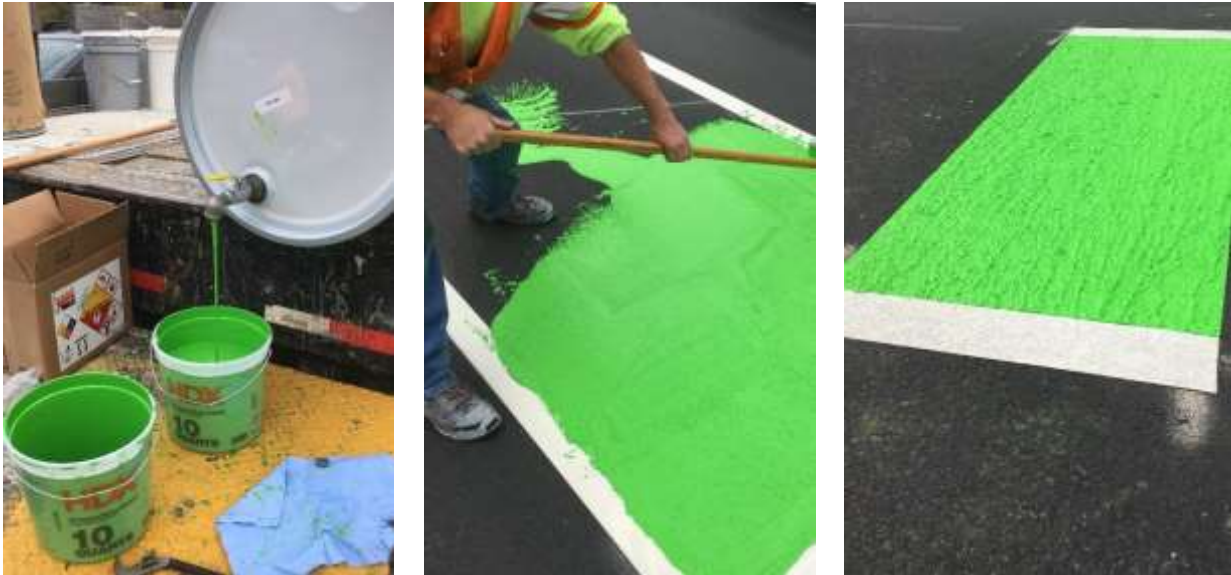
Figure 10: Color-Safe Installation

It took approximately 45 to 60 minutes for the Color-Safe product to cure in this location. This was due to the ambient temperature and the lack of direct sunlight. Aggregate clumps arose on two of the bike lane blocks as a result of premature curing, and were identified and removed with a chisel after curing. Installation of Color-Safe can be seen in Figure 10.
