ASSESSMENT OF THE 40" WIDE PAVING SKID BOX FOR PREVENTATIVE MAINTENANCE

Ian Anderson, Research Engineer
Vermont Agency of Transportation
Research Section

Experimental Feature
Reporting on Work Plan 2012-R-03

Final Report 2018-06

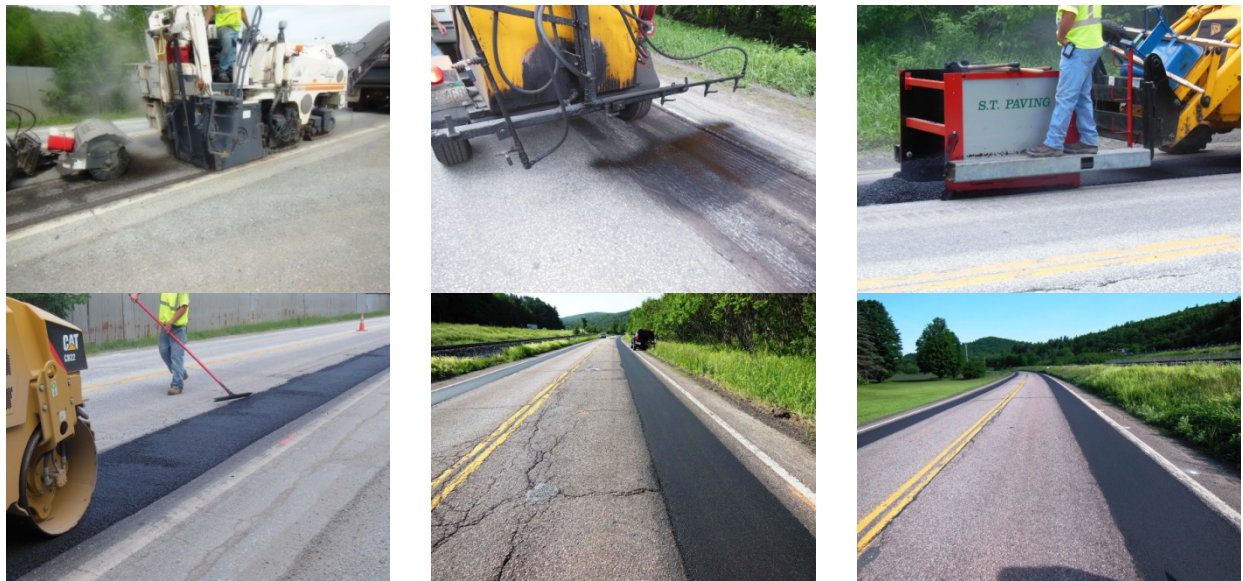
Figure 1: Construction

The pavement used in this study was Type IV 50 Blow Marshall Bituminous Concrete Pavement. The binder used was PG 52-34. Construction can be seen in Figure 1. The pavement was applied through a five-step process. The first; cold planning at variable depths at a width of 40", second; sweeping before the application of the emulsion tack coat. The third step; applying the emulsion tack coat, which was a rapid setting (RS-1(h)). The fourth step; paving at variable depths using the 40" skid box. Lastly, the pavement was then rolled for compaction.

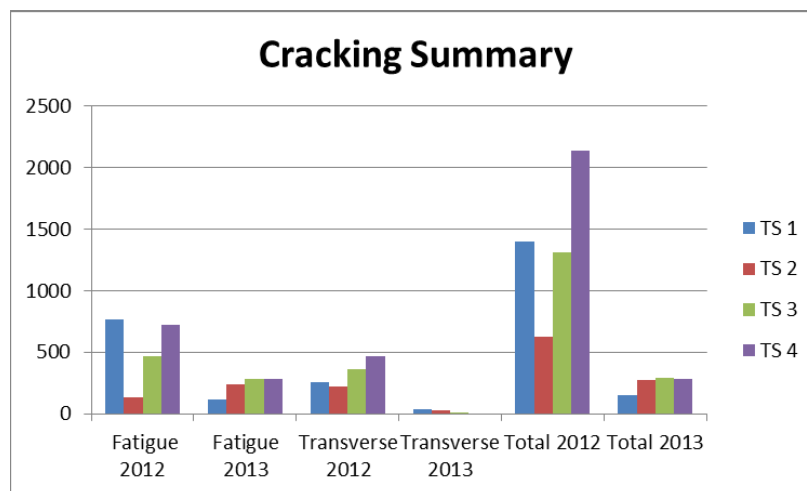
Figure 5: Cracking Summary

The purpose of this study was to examine and evaluate the constructability, overall performance and cost effectiveness of using this repair method. Research personnel assessed the existing pavement condition prior to construction to document all distresses, construction practices, and visited the sites annually to document any failures. Overall, the performance of the skid box (repaving only under the right wheel path) was effective in reducing cracking as well as repairing rutting. The data from this project suggest that using the 40" skid box to repair distressed sections is a viable alternative to repairing and repaving an entire section of road. Rutting was significantly reduced and remained so for the entirety of the project, as well the total cracking within the repaved project sections was reduced as well for the period of this study.
