ASSESSMENT OF JAHN PERMEABLE MORTAR SYSTEM IN A HISTORIC BRIDGE ABUTMENT APPLICATION

Ian Anderson, Research Engineer
Vermont Agency of Transportation
Research Section

January 2019

Final Report 2019-01

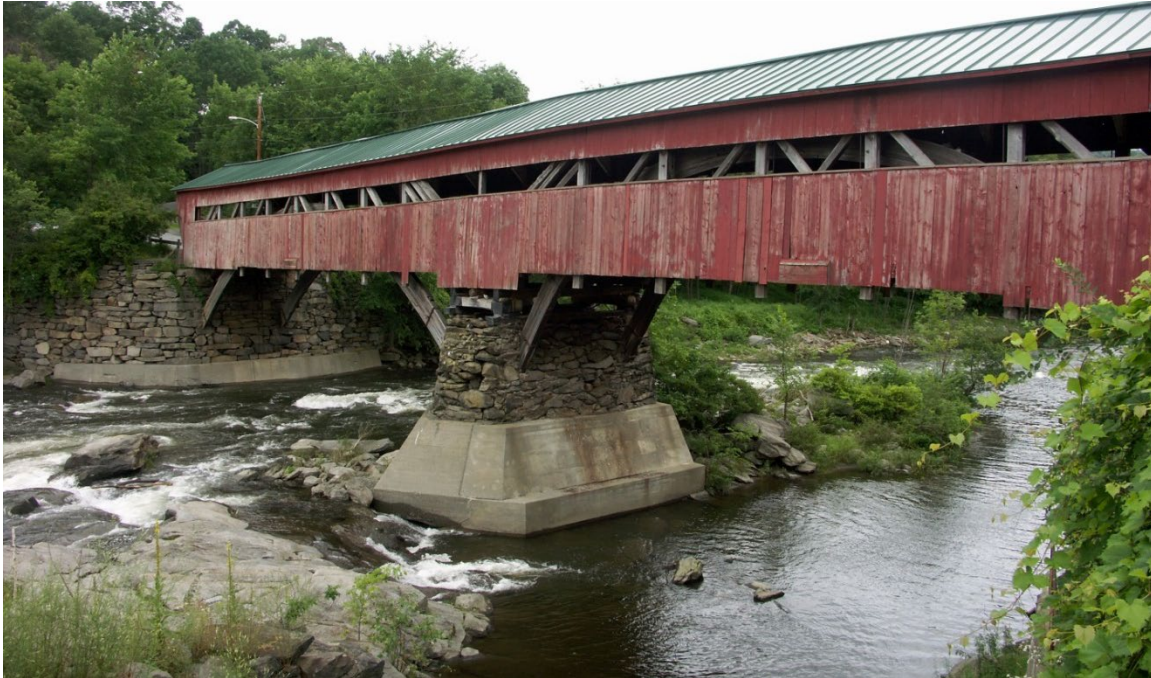
This study focused on the repair of the substructure. The existing stone and concrete masonry components of the substructure were intact (Figure 2) with the exception of the western abutment. The western abutment was reconstructed with stone-faced reinforced concrete, while the two surviving substructure components were identified for preservation. Typically, this type of preservation is accomplished by removing and replacing the deteriorated mortar with new pointing mortars and grouts to fill in the gaps and void spaces between stones in the wall. During design and construction, it is vital to account for lateral forces that build up behind the wall from rain events, frost penetration and groundwater. In the case of piers and abutments, consideration must also include vertical forces applied by the superstructure's weight and applied live loads. Preservation considerations were centered on maintaining the visual appearance of the surviving pier and abutment. All structural enhancements were hidden from the sight for that reason. The repaired bridge in 2012 can be seen in Figure 3.

Figure 2: The Taftsville Covered Bridge in 2006 showing the Pier and Abutment that were preserved

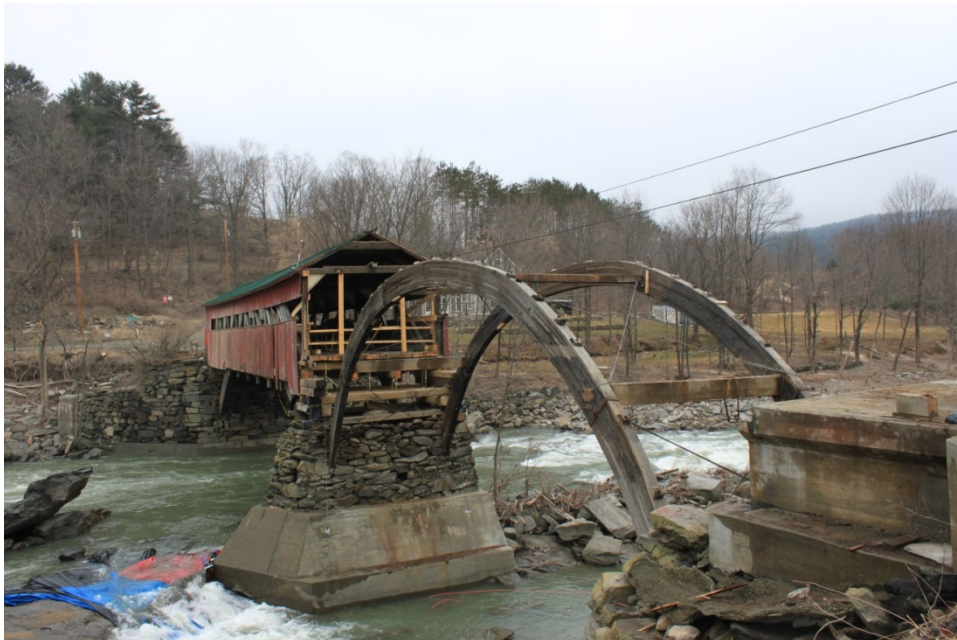
Figure 10: Western span dismantled leaving only the arches

According to McFarland Johnson, the engineering firm hired to design and specify the rehabilitation work for the covered bridge, the dry-laid stone abutments and pier have flaws and weaknesses. The pier comprises of dry-laid stone down to the riverbed. The pier and abutments have a concrete skirt encasing the stone pier placed after the original construction, which can be seen in Figure 10.
