## Appendix 1: Site Descriptions

## I-89 NORTH (1)

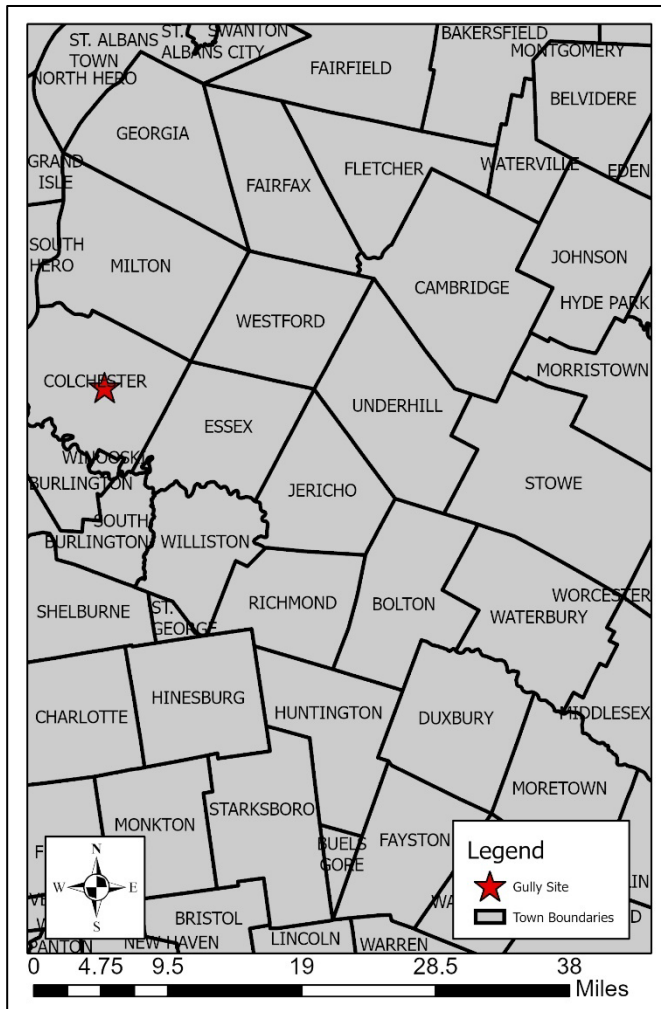
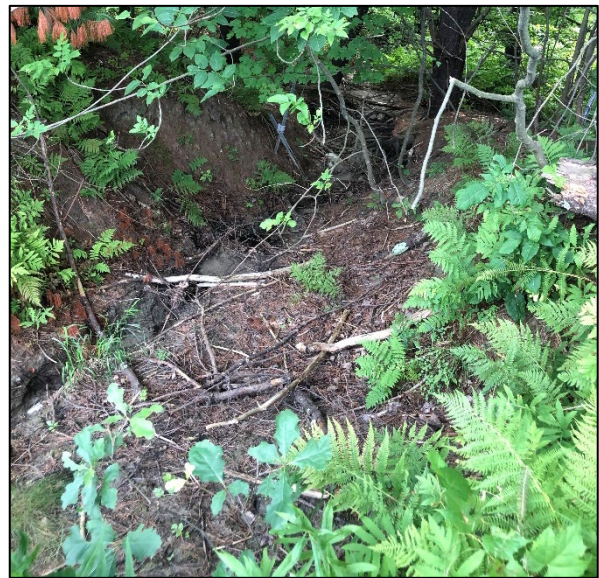
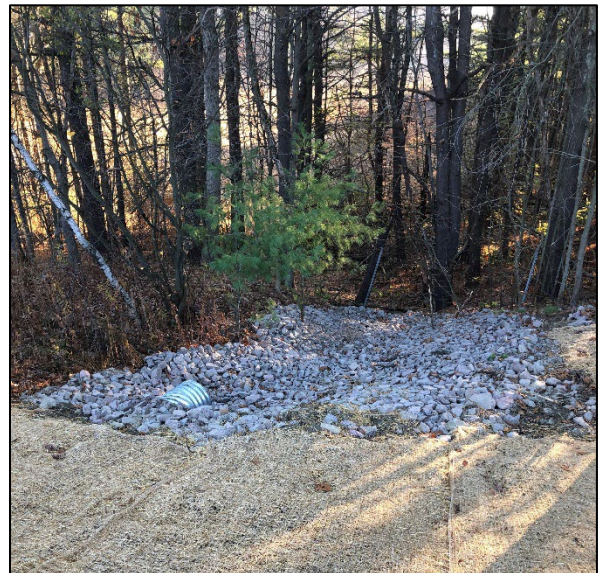
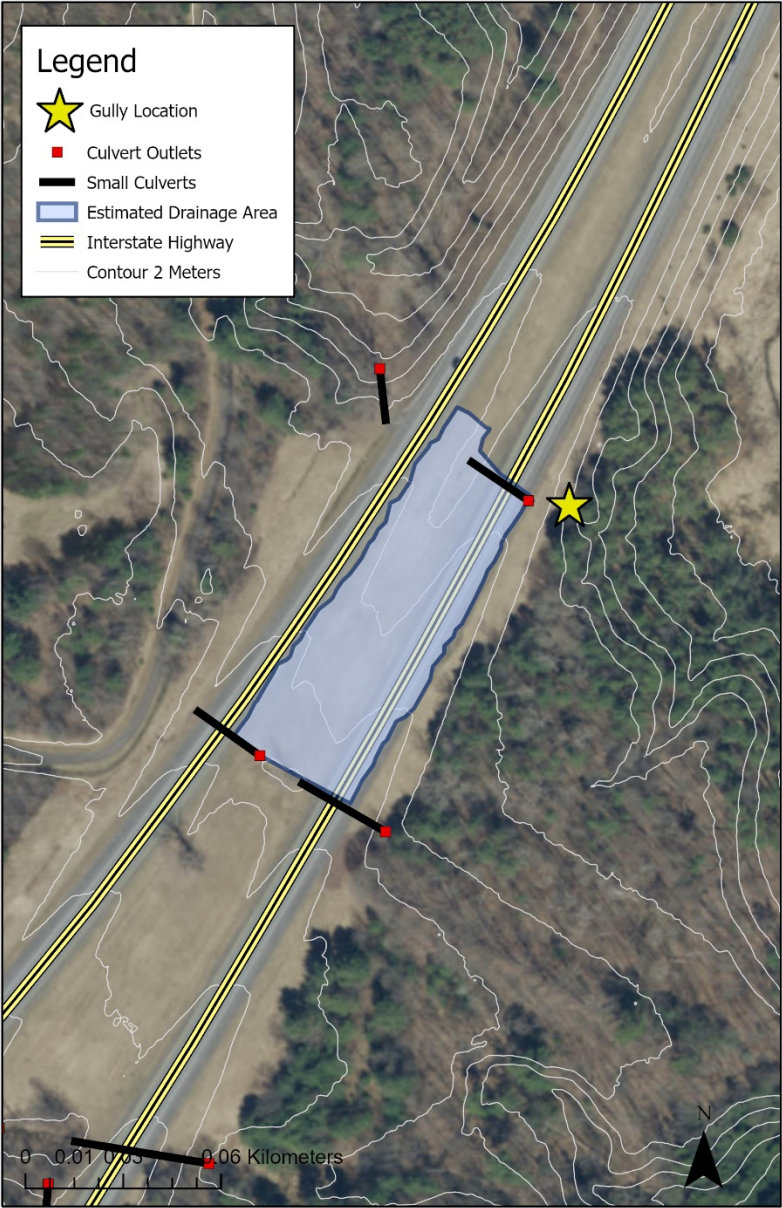
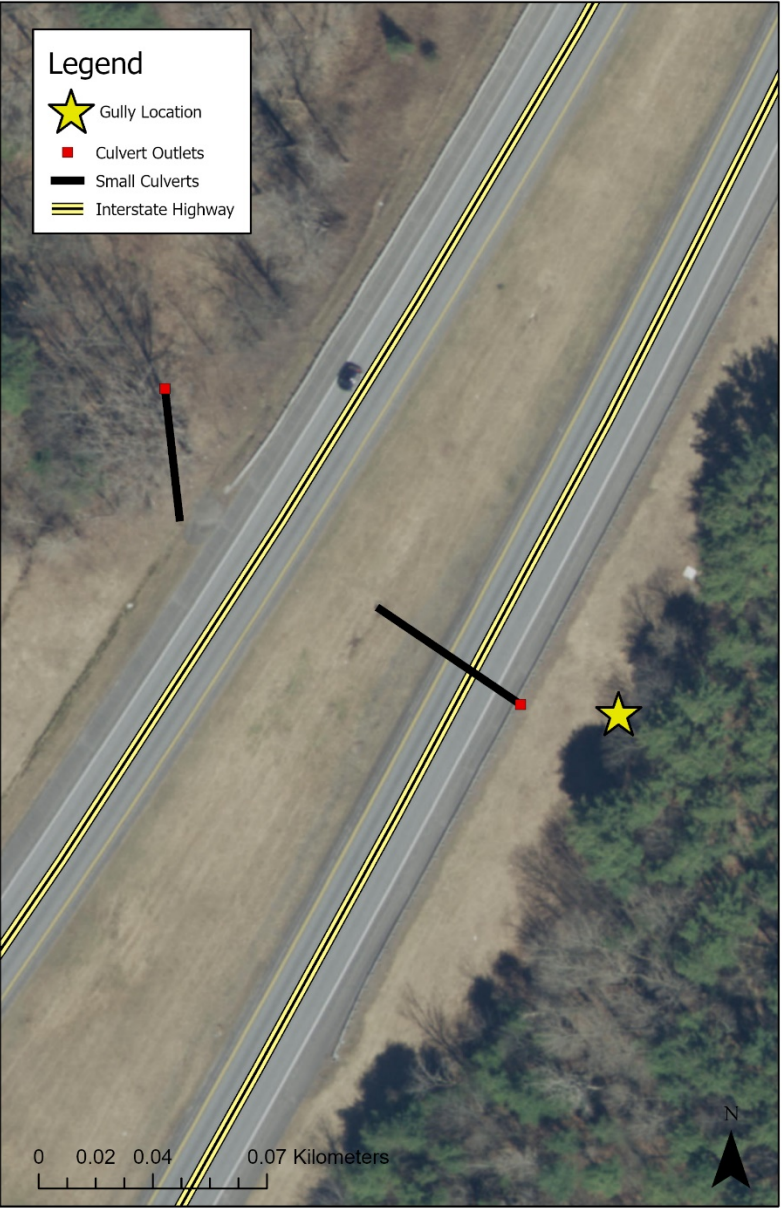
This gully at the north direction on Interstate 89 is located at mile marker 95.05 north in the town of Colchester, Vermont. This road is a one lane Interstate Highway that is maintained by the Vermont Agency of Transportation District 5. The culvert monitored is part of the Small Culvert Inventory database with an ID of 50194. The culvert was a metal material and 18 inches in diameter and 73 feet in length. The system type of the culvert is a single pipe. The drainage area for this culvert was estimated to be 4,352 meters<sup>2</sup> (derived from 0.7-meter DEM). The road length draining to this culvert was estimated at 154.4 meters and an average width of 17.5 meters. The slope steepness at outlet was estimated as 31.2% (derived from 10-meter DEM). The soil type at the culvert outlet is Belgrade and Eldridge with a soil texture of coarse silt loam. Repeated surveys on this site took place from May 14<sup>th</sup>, 2020 to May 12, 2021 with a total of 4 surveys. Erosion mitigation was installed late October 2020.

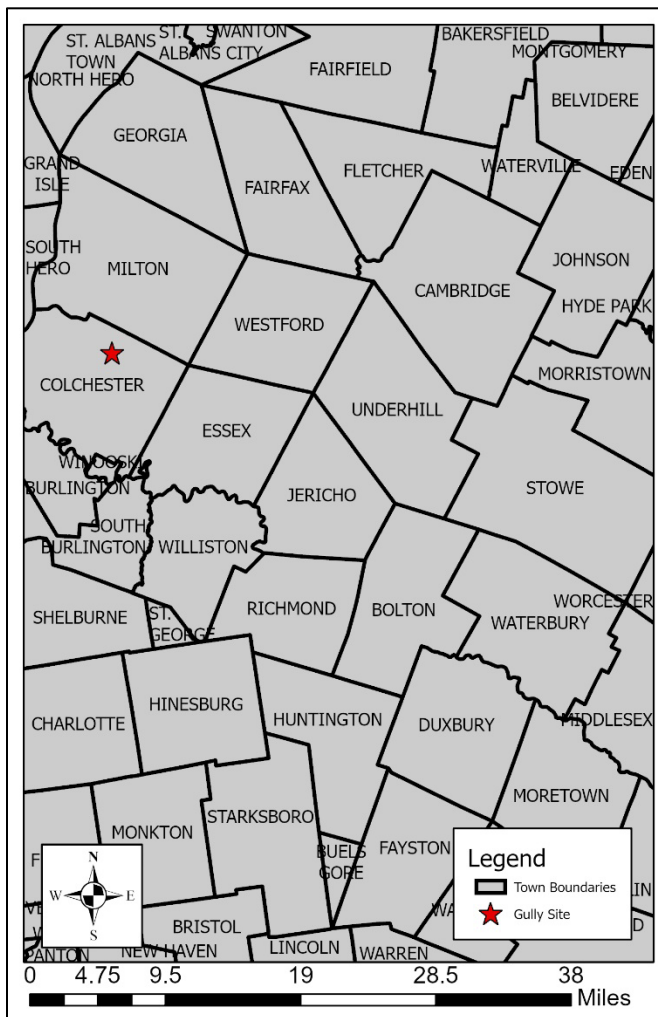
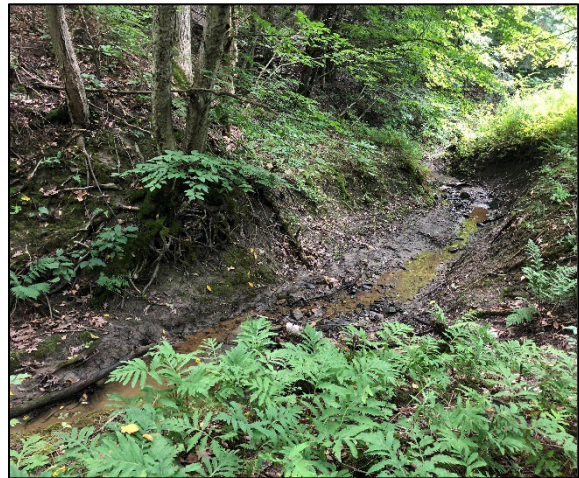
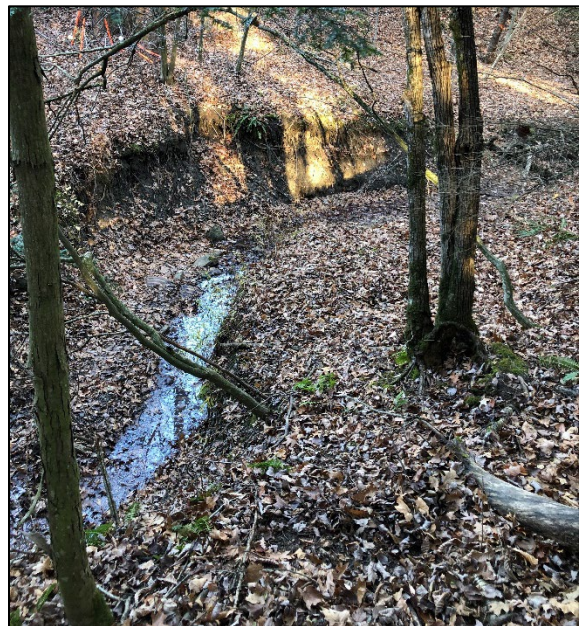
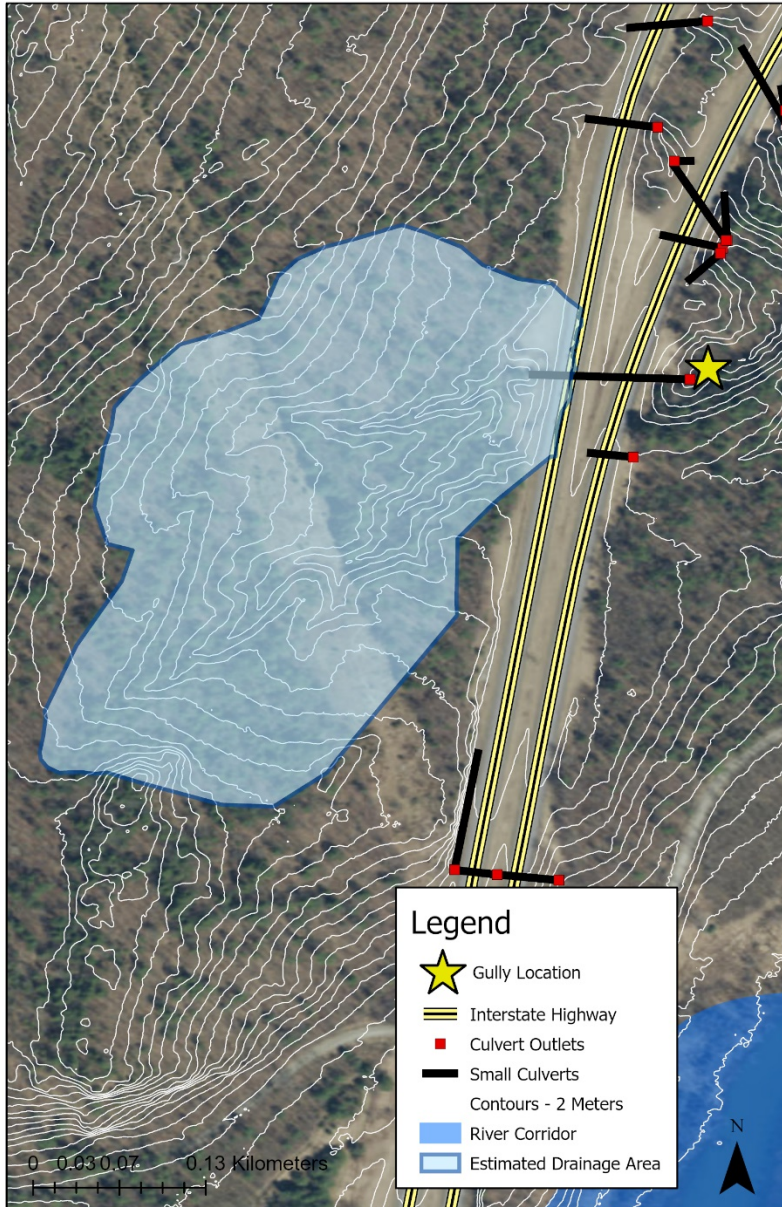
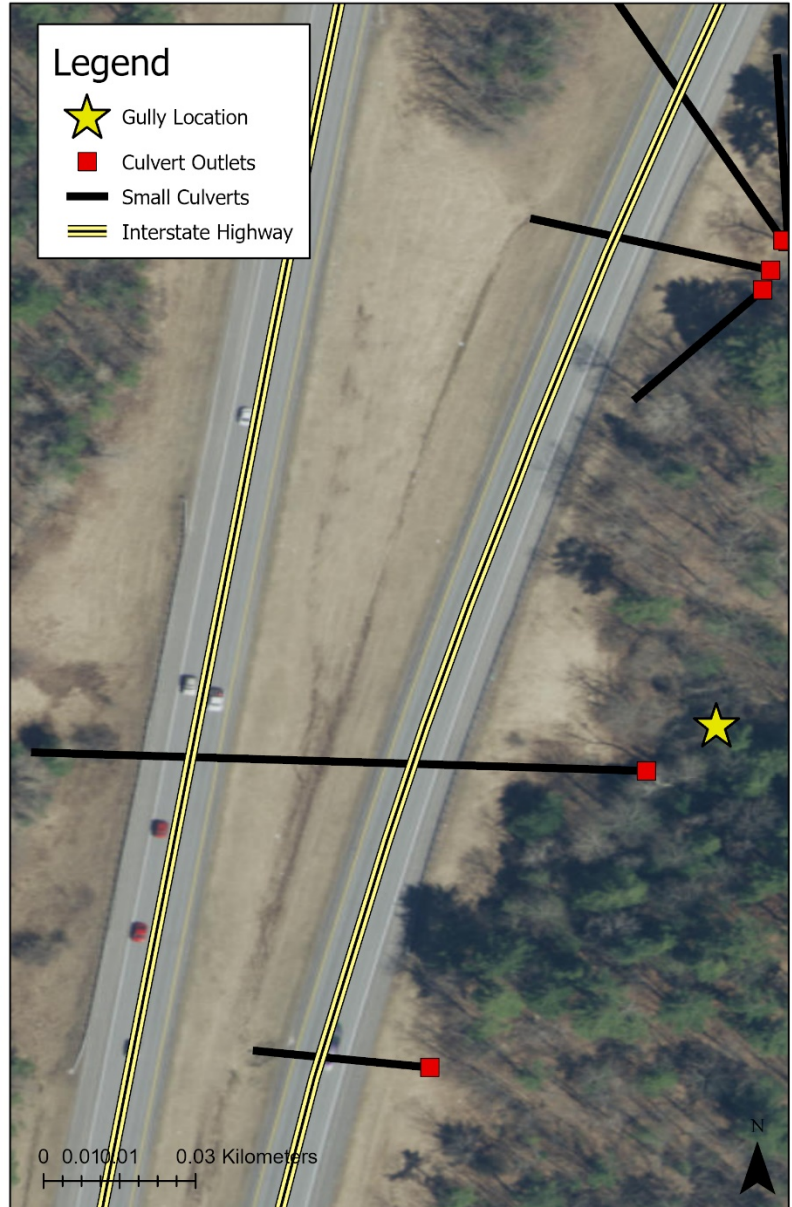
## I-89 NORTH (2)

This gully is at the north direction on Interstate 89 and is located at mile marker 97.05 north in the town of Colchester, Vermont. This road is a one lane Interstate Highway that is maintained by the Vermont Agency of Transportation District 5. The culvert monitored is part of the Small Culvert Inventory database with an ID of 58013. The culvert was a metal material and 36 inches in diameter and 285 feet in length. The system type of the culvert is a single pipe. The drainage area for this culvert was estimated to be 78,077 meters<sup>2</sup> (derived from 0.7-meter DEM). The road length draining to this culvert was estimated at 322.8 meters and an average width of 17.5 meters. The slope steepness at outlet was estimated as 7.7% (derived from 10-meter DEM). The soil type at the culvert outlet is Terrace Escarpments with a soil texture of silty clay. Repeated surveys on this site took place from October 25<sup>th</sup>, 2019 to May 12, 2021 with a total of 5 surveys. Erosion mitigation was not installed at this site.

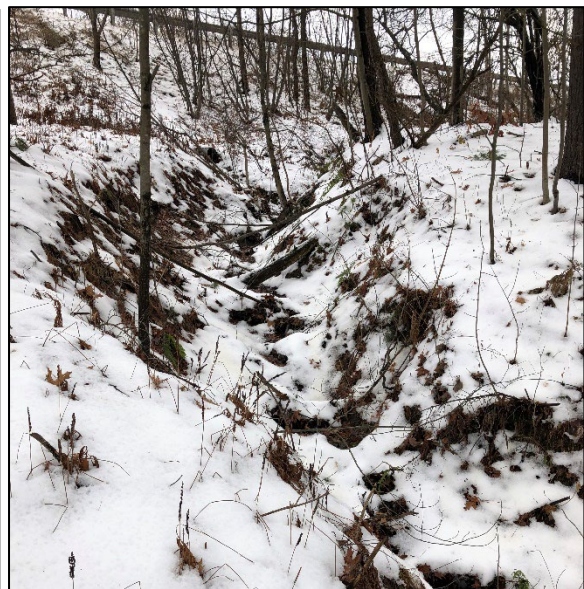
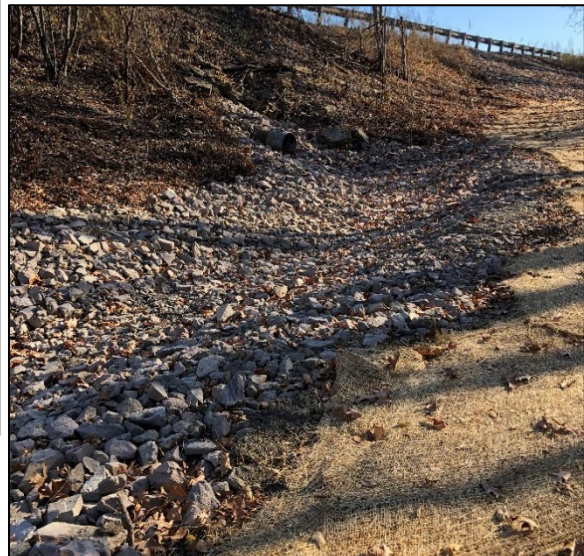
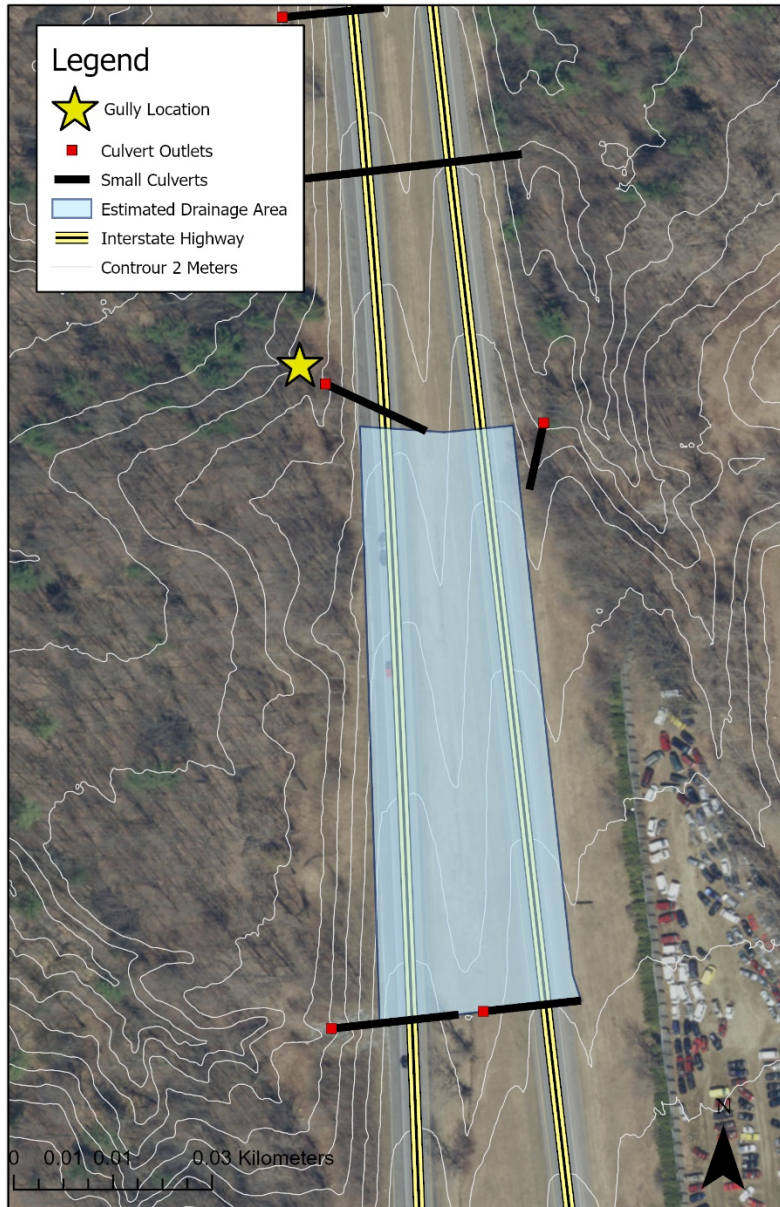
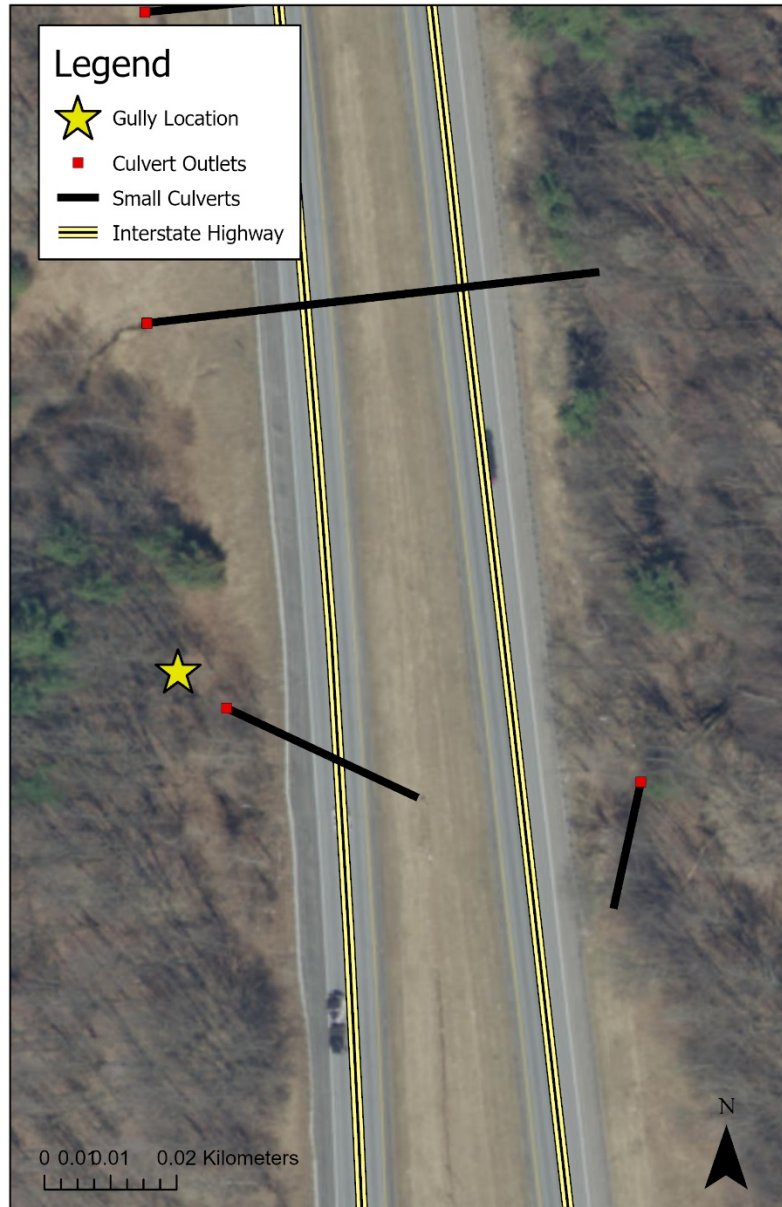
### I-89 SOUTH (3)

This gully is at the south direction on Interstate 89 and is located at mile marker 92.4 south in the town of Colchester, Vermont. This road is a one lane Interstate Highway that is maintained by the Vermont Agency of Transportation District 5. The culvert monitored is part of the Small Culvert Inventory database with an ID of 50151. The culvert was a metal material and 18 inches in diameter and 105 feet in length. The system type of the culvert is a closed system. The drainage area for this culvert was estimated to be 8,458 meters<sup>2</sup> (derived from 0.7-meter DEM). The road length draining to this culvert was estimated at 168.5 meters and an average width of 17.5 meters. The slope steepness at outlet was estimated as 24.4% (derived from 10-meter DEM). The soil type at the culvert outlet is Adam and Windsor with a soil texture of loamy sand. Repeated surveys on this site took place from October 21<sup>st</sup>, 2019 to May 12, 2021 with a total of 5 surveys. Erosion mitigation was installed late October 2020.

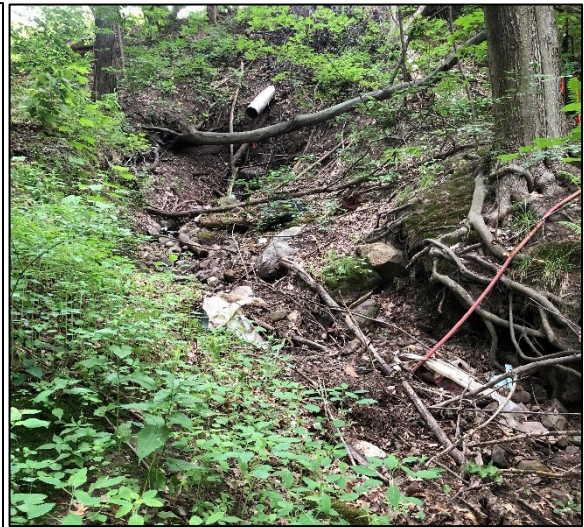
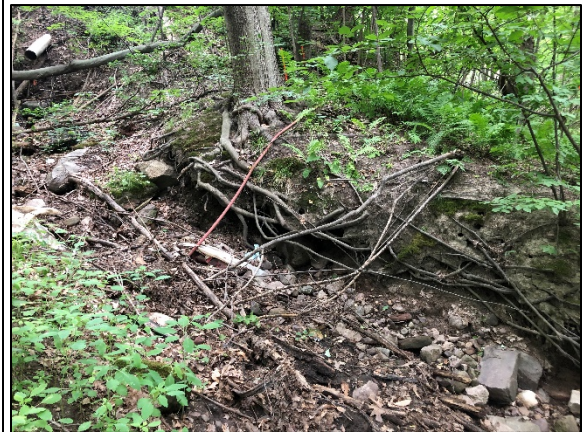
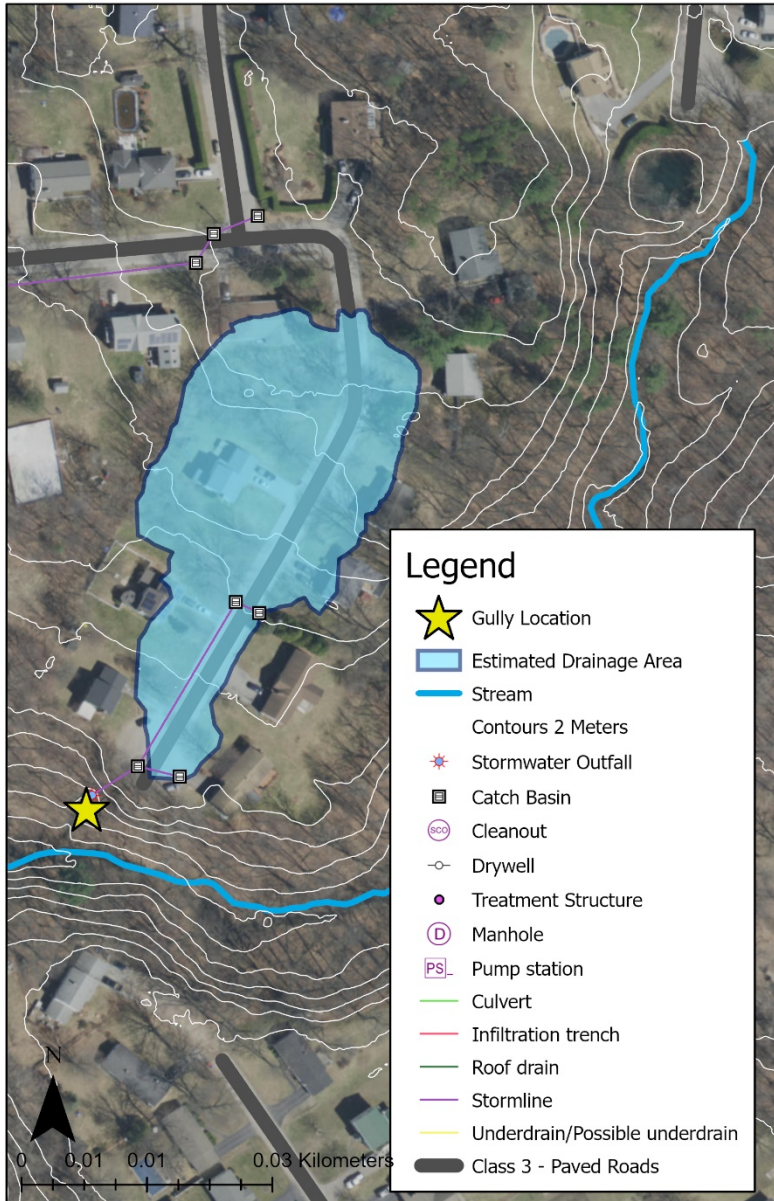
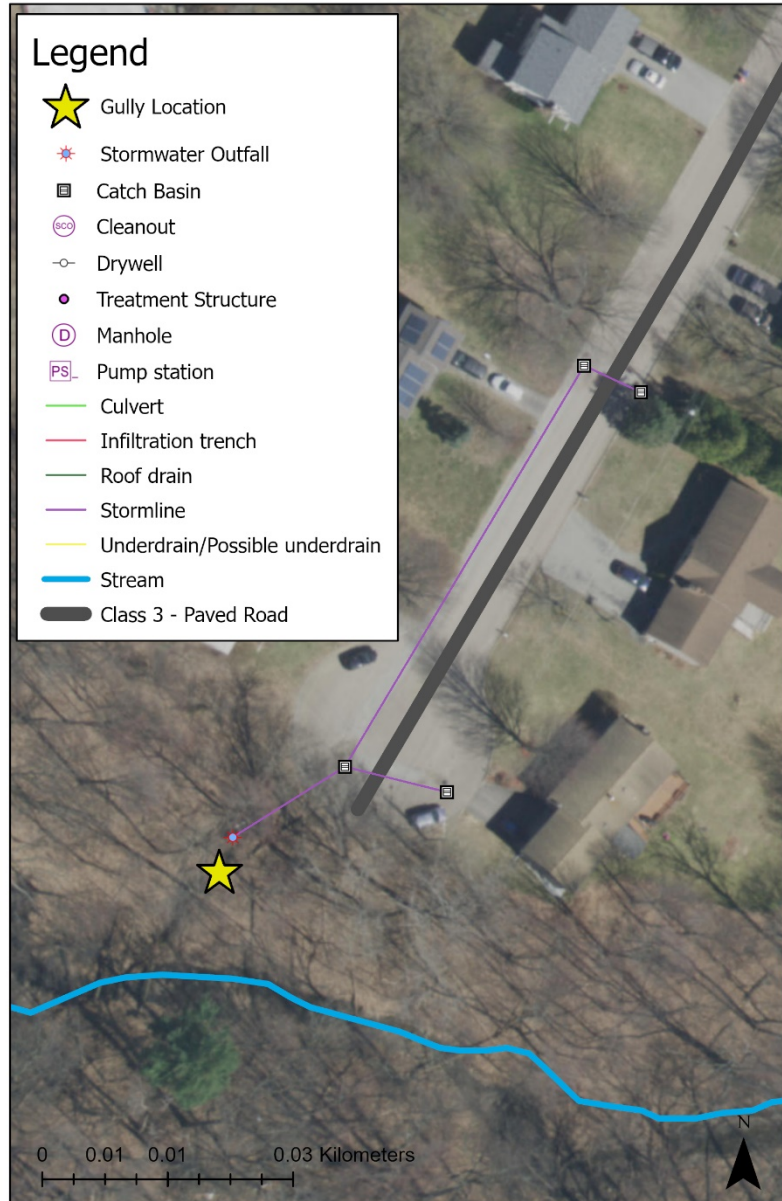
## YOUNG STREET (10)

This gully is located at the end of Young Street in the town of Colchester, Vermont. This road is a class 3 paved road that is residential. The culvert monitored is part of the town of Colchester culvert database. The culvert was a metal material and 12 inches in diameter and 52 feet in length. The system type of the culvert is a closed drainage system. The drainage area for this culvert was estimated to be 6,428 meters<sup>2</sup> (derived from 0.7-meter DEM). The road length draining to this culvert was estimated at 56.5 meters and an average width of 11.8 meters. The slope steepness at outlet was estimated as 35.9% (derived from 10-meter DEM). The soil type at the culvert outlet is Adam and Windsor with a soil texture of loamy sand. Repeated surveys on this site took place from October 4<sup>th</sup>, 2019 to May 11, 2021 with a total of 7 surveys. Erosion mitigation was not installed at this site.

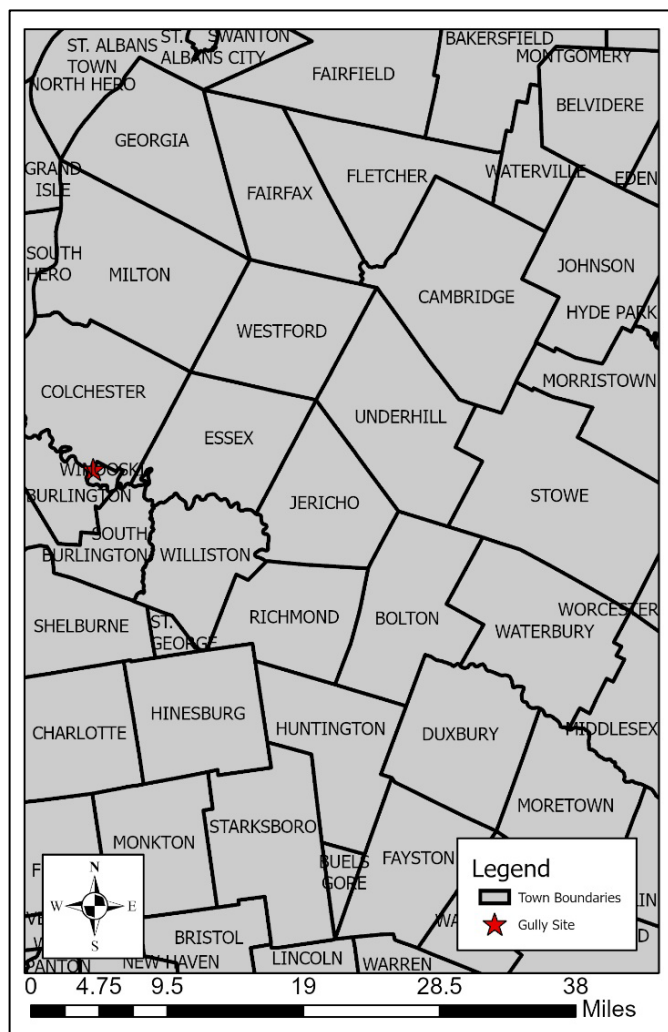
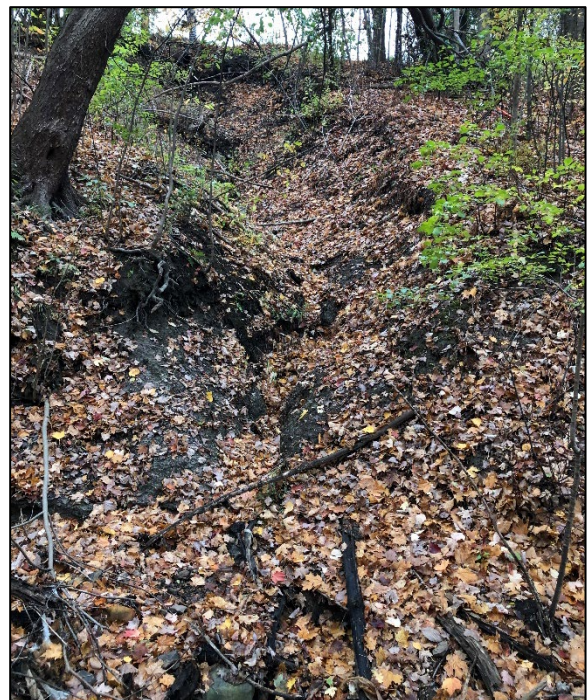
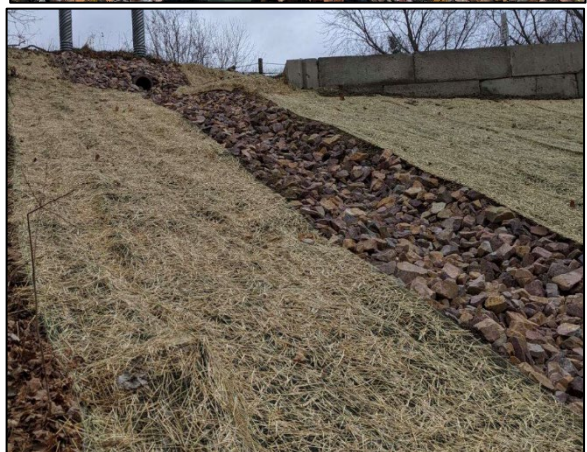
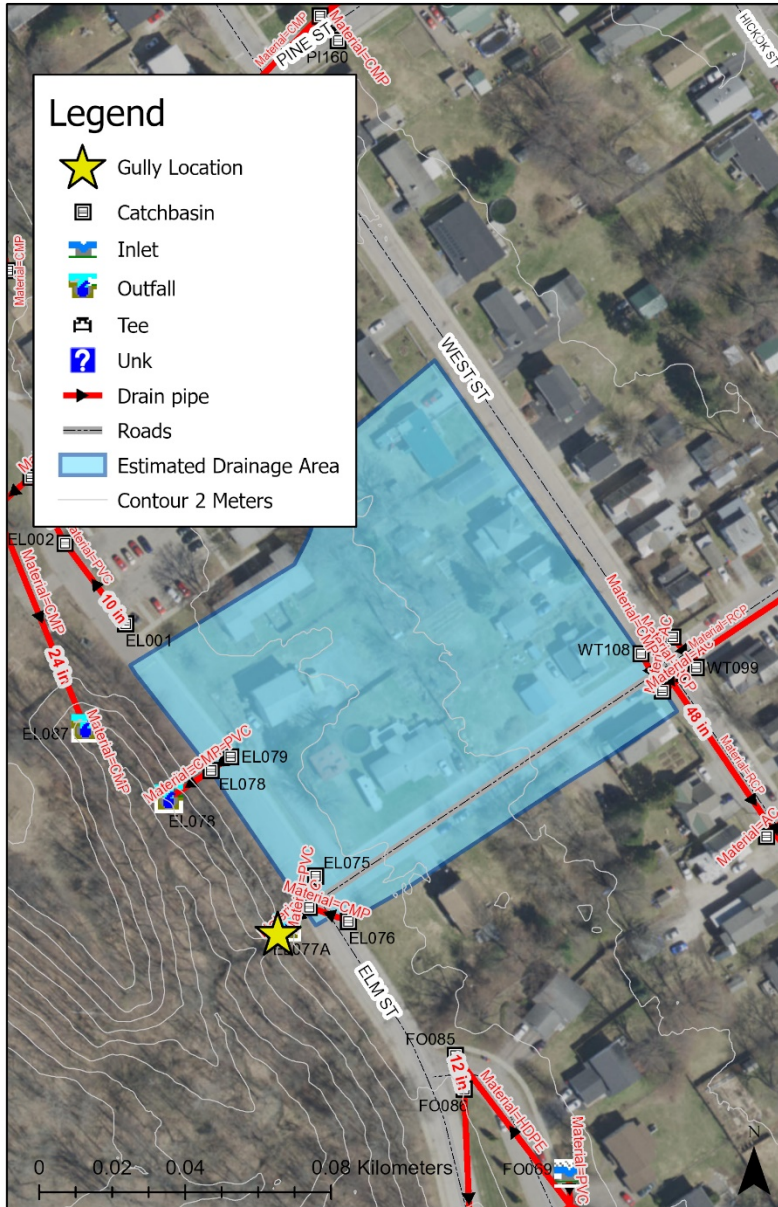
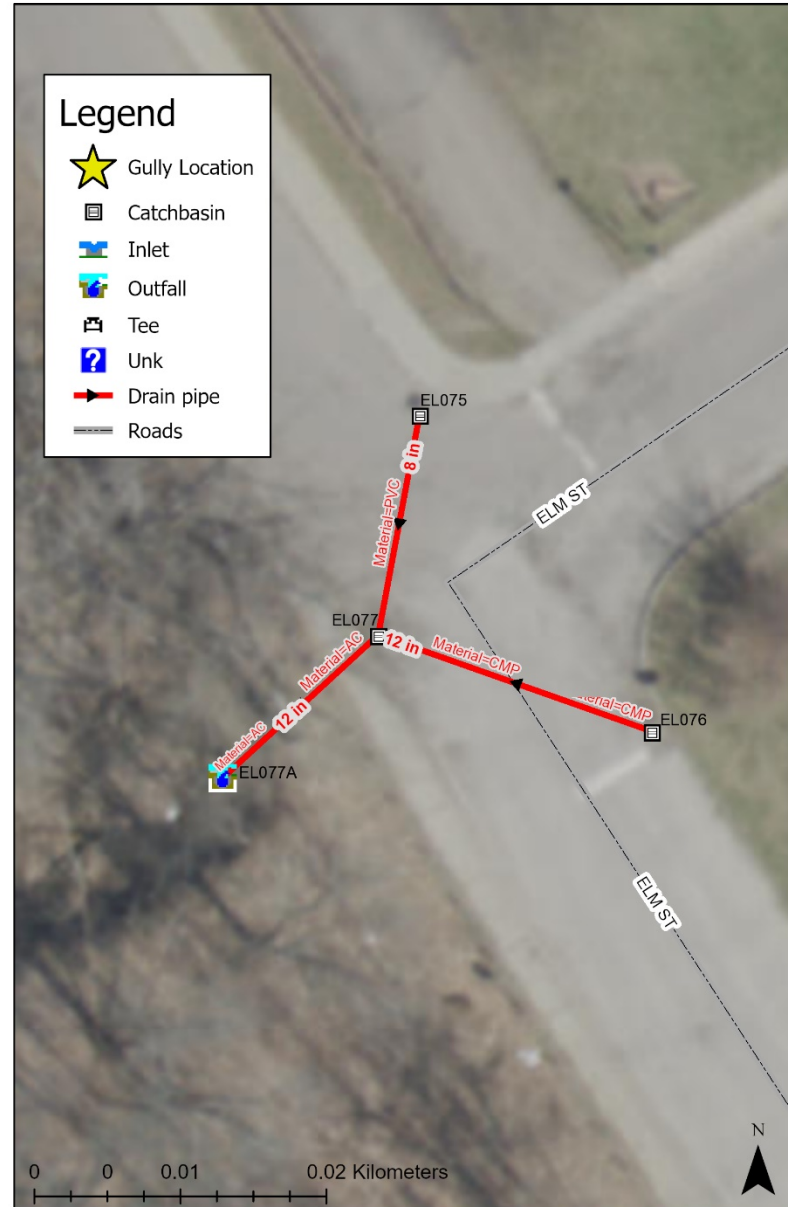
## ELM STREET (11)

This gully is located at the intersection of Elm Street and Forrest Street in the town of Winooski, Vermont, and drains a closed system. The gully was specifically located just behind the “River Works” sign. This road is a class 3 paved road that is residential. The culvert monitored is part of the town of Winooski culvert database. The culvert was a metal material, and the diameter and length of the culvert is unknown (not visible at the ground surface). The drainage area for this culvert was estimated to be 11,574 meters<sup>2</sup>. The road length draining to this culvert was estimated at 201 meters and an average width of 6.5 meters. The slope steepness at outlet was estimated as 36.2% (derived from 10-meter DEM). The soil type at the culvert outlet is Colton and Stetson with a soil texture of loamy sand. Repeated surveys on this site took place from October 3<sup>rd</sup>, 2019 to May 11, 2021 with a total of 7 surveys. Erosion mitigation was installed at this site in November 2020.

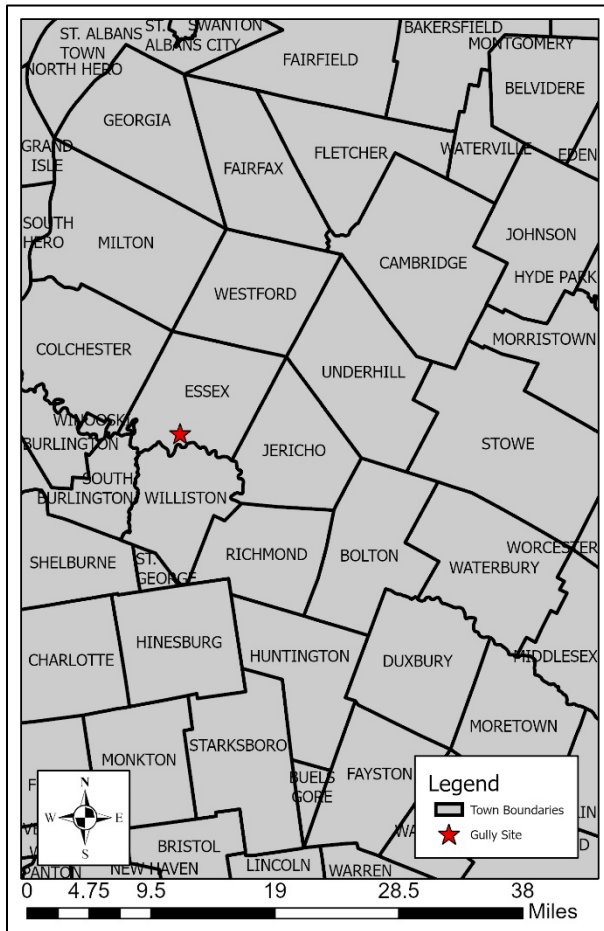
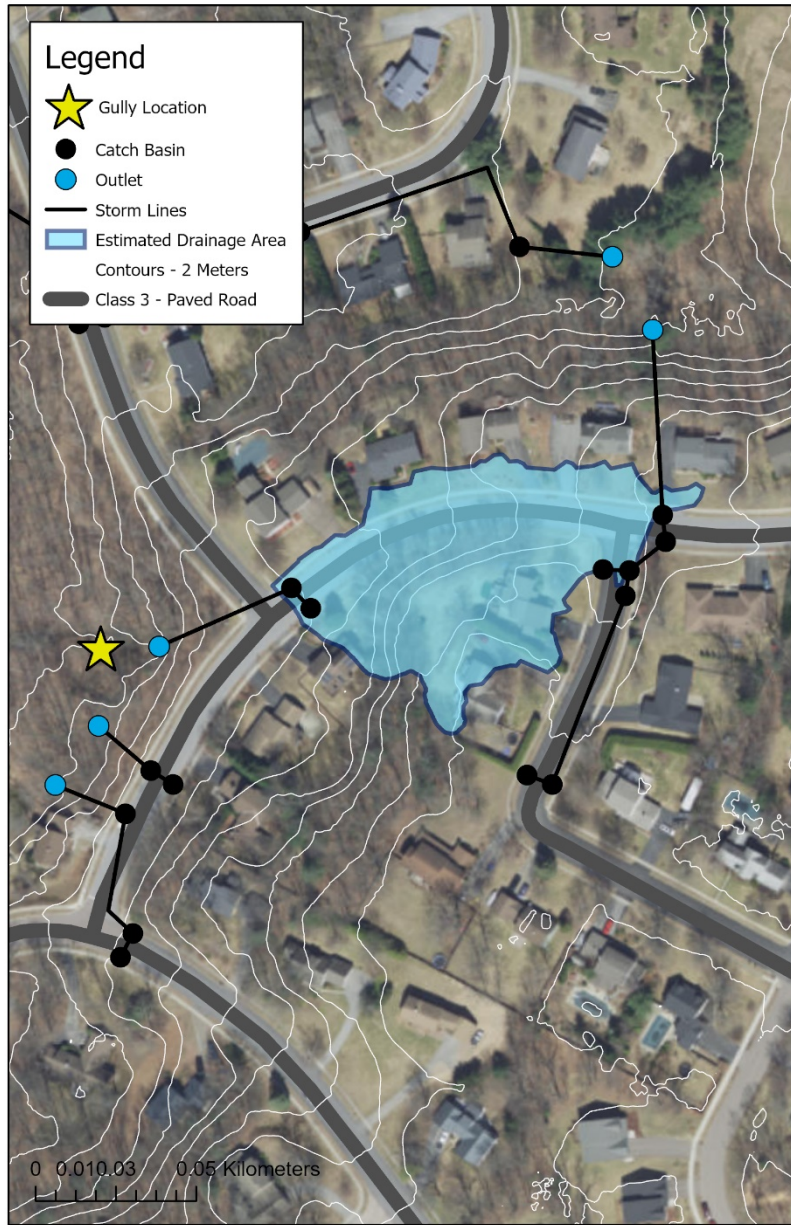
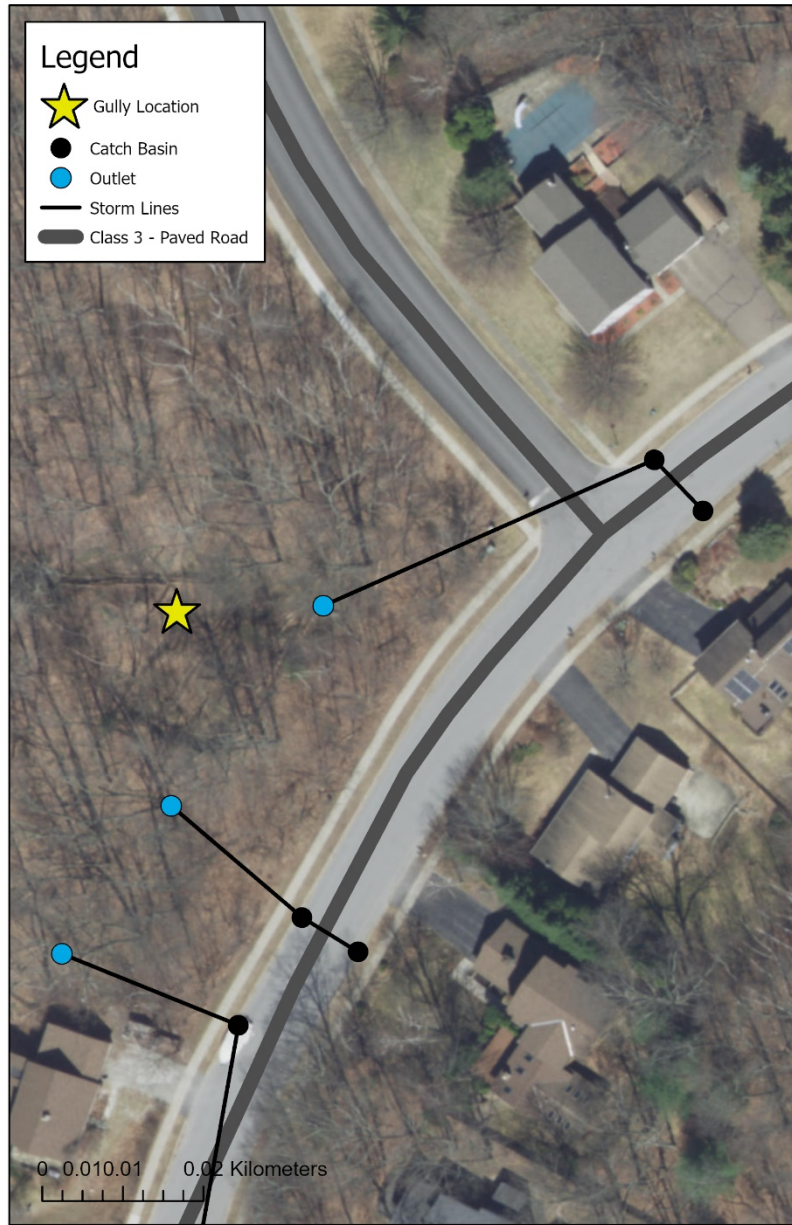
## CORDUROY ROAD (13)

This gully is in a valley between Corduroy Road, Brickyard Road, and Briar Lane in the town of Essex, Vermont. The access to this gully is specifically on Brickyard Road, near the intersection of Corduroy Road. This road is a class 3 paved road that is residential. The culvert monitored is part of the town of Essex culvert database. The culvert diameter is 15 inches and is a closed drainage system. The drainage area for this culvert was estimated to be 5,768 meters<sup>2</sup>. The road length draining to this culvert was estimated at 127 meters and an average width of 9.2 meters. The slope steepness at outlet was estimated as 29.5% (derived from 10-meter DEM). The soil type at the culvert outlet is Duane and Deerfield with a soil texture of loamy sand. Repeated surveys on this site took place from October 10<sup>th</sup>, 2019 to May 11, 2021 with a total of 5 surveys. Erosion mitigation was installed at this site by the Village of Essex Junction before July 2019 when this study was initiated.

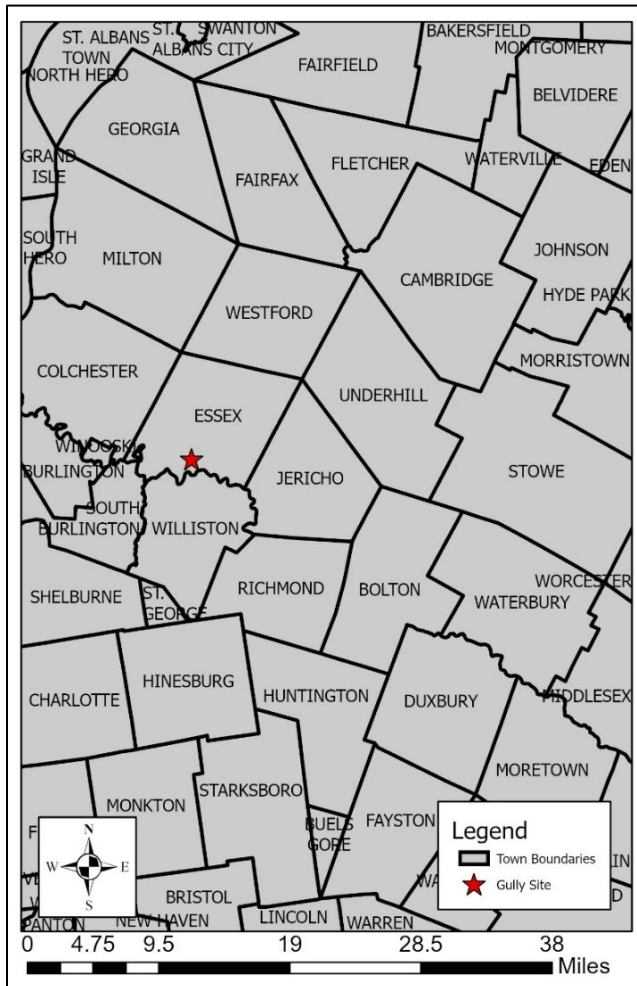
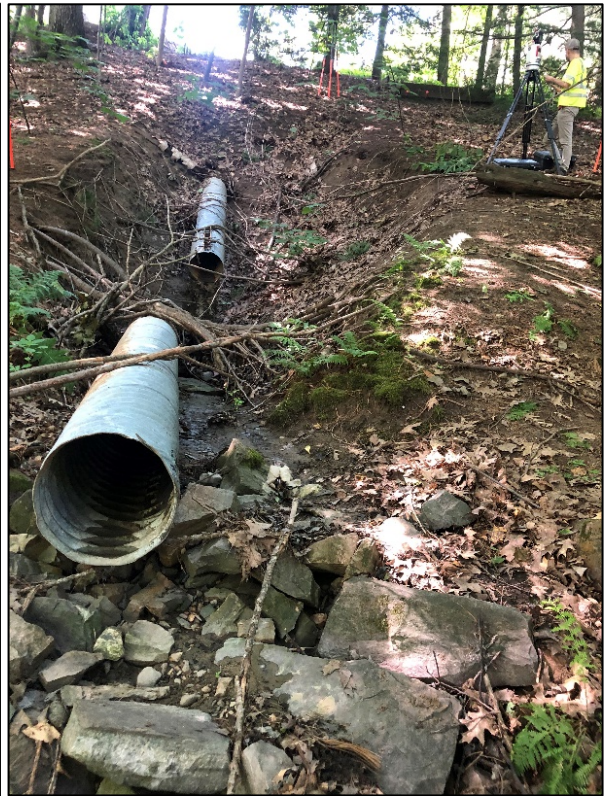
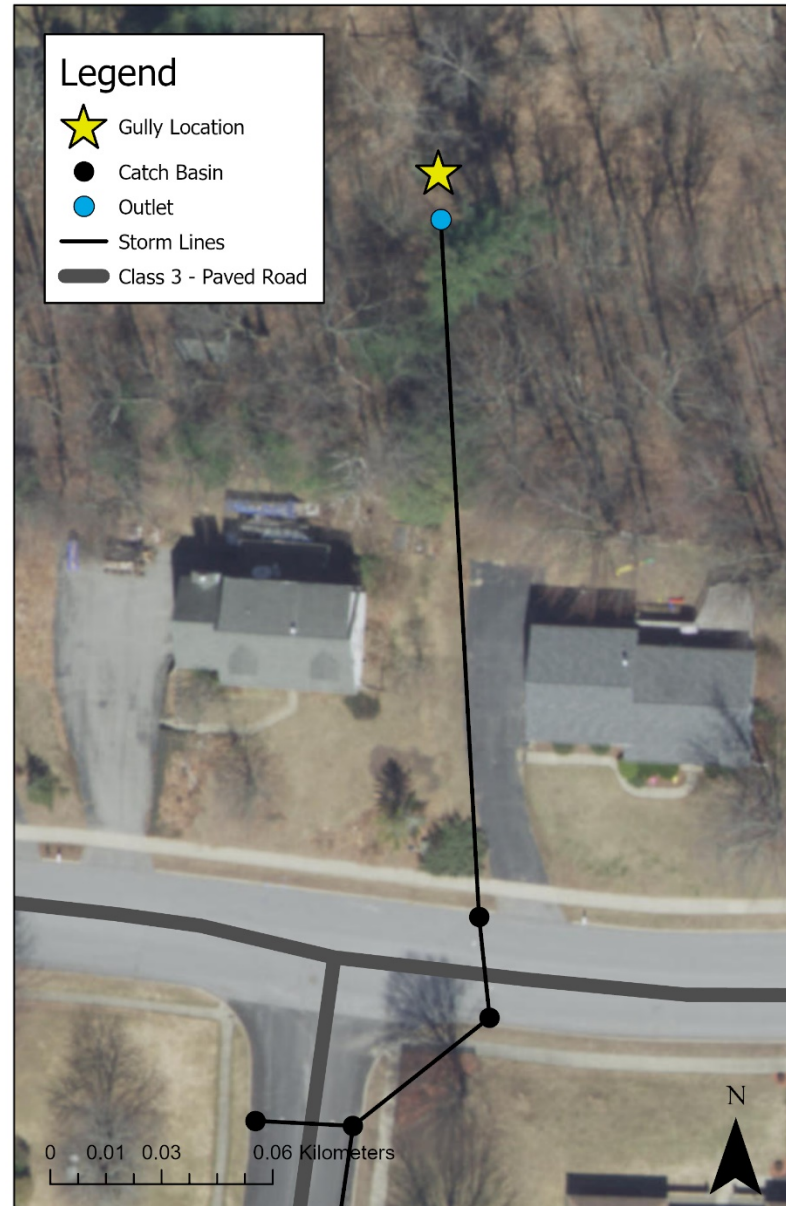
## VALE DRIVE (15)

This gully is located between Vale Drive and Corduroy Road in the town of Essex, Vermont. The access to this gully was specifically on Vale Drive where field technicians had landowner permission to access gully behind their house. This road is a class 3 paved road that is residential. The culvert monitored is part of the town of Essex culvert database. The culvert diameter is 15 inches and is a closed drainage system. The drainage area for this culvert was estimated to be 7,910 meters<sup>2</sup>. The road length draining to this culvert was estimated at 212.9 meters and an average width of 9.2 meters. The slope steepness at outlet was estimated as 35.2% (derived from 10-meter DEM). The soil type at the culvert outlet is Agawam with a soil texture of fine sandy loam. Repeated surveys on this site took place from September 27<sup>th</sup>, 2019 to September 9<sup>th</sup>, 2020 with a total of 4 surveys. Due to landowner restrictions, surveying at this was terminated after September 9<sup>th</sup>, 2020. Erosion mitigation was not installed at this site.
