## Appendix 1: Site Descriptions

## I-89 NORTH (1)

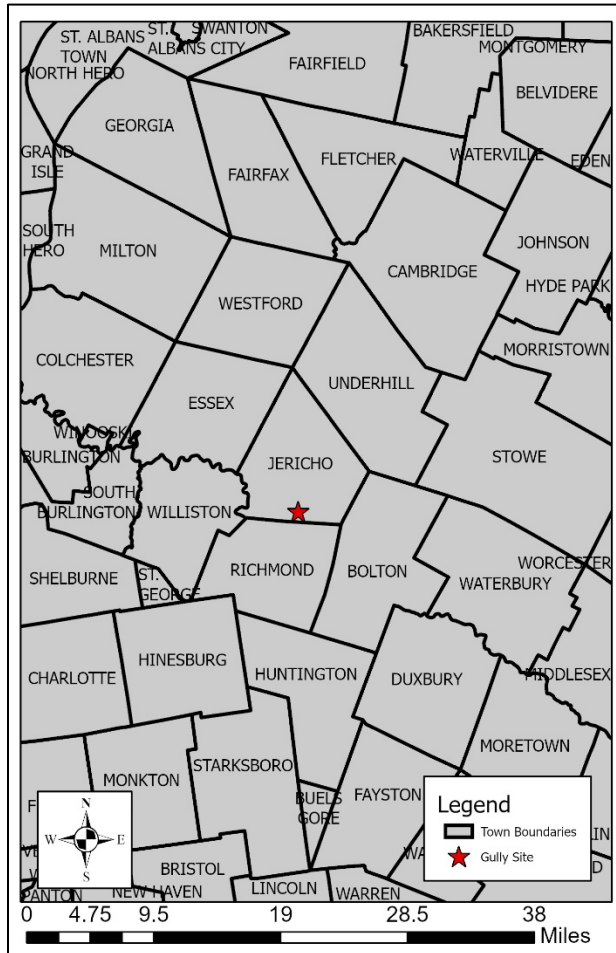
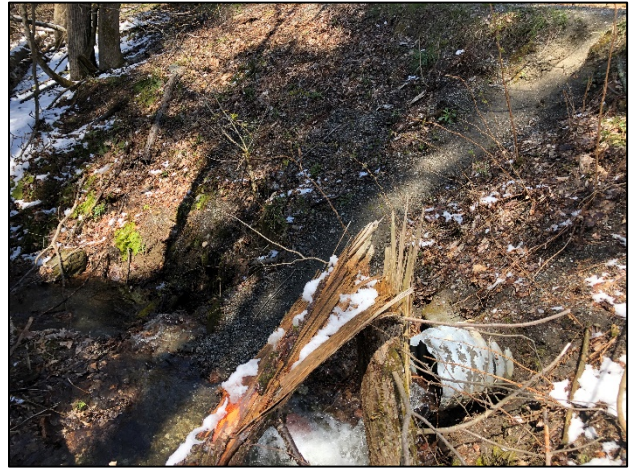
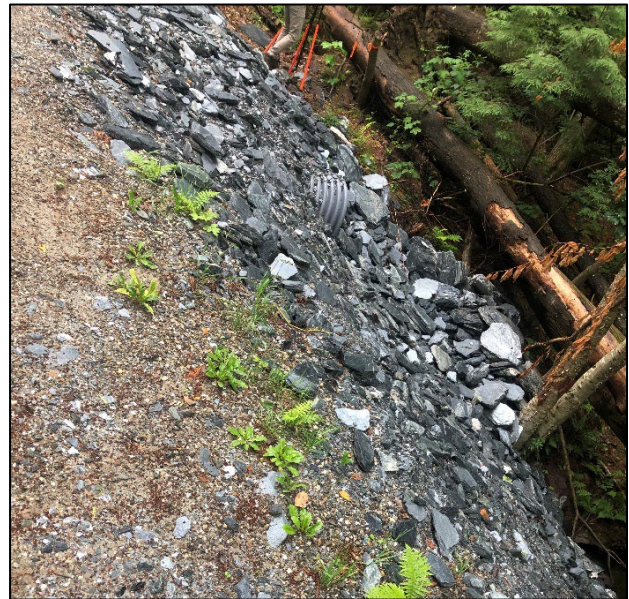
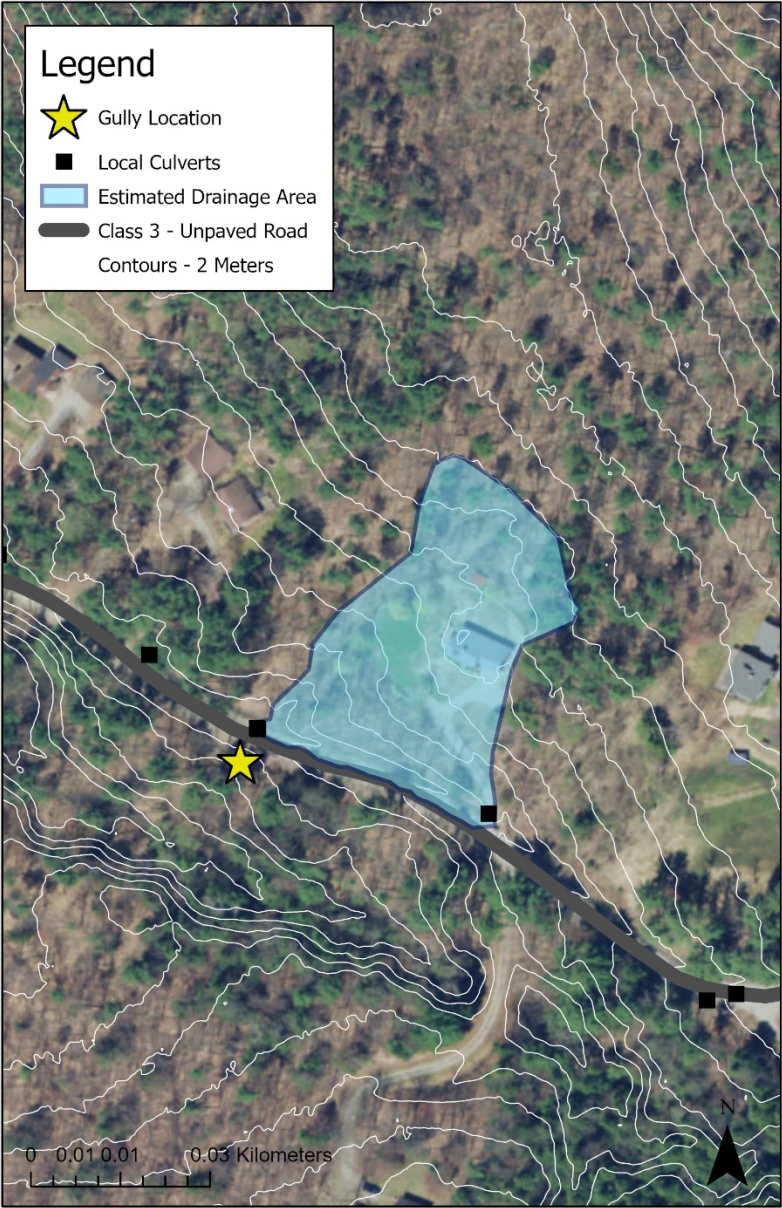
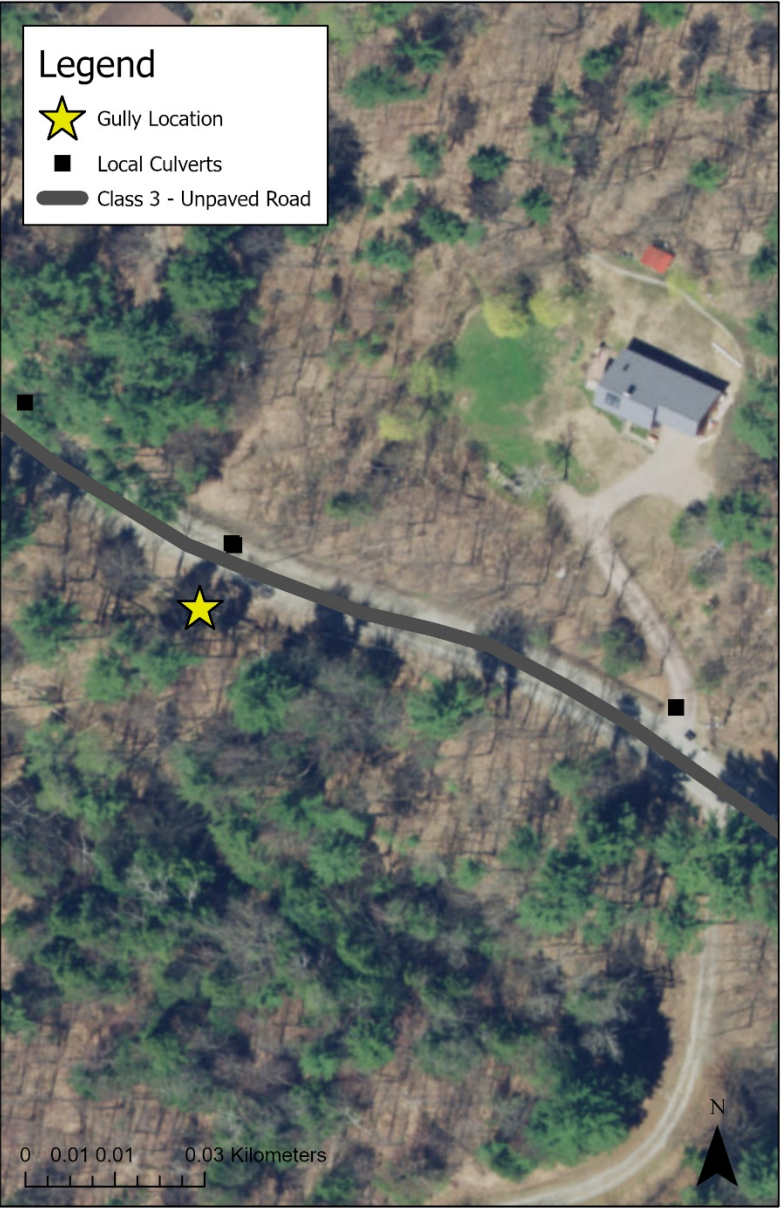
## MILO WHITE ROAD (16)

This gully is located off Milo White Road in the town of Jericho, Vermont. This road is a class 3 unpaved road that is residential. Specifically, the gully is located 1.12 kilometers from the intersection of Brown's Trace Road on the right. The culvert monitored is part of the town of VTCulverts database. The culvert diameter is 24 inches and 35 feet in length. This culvert is a single pipe part of an open drainage network. The drainage area for this culvert was estimated to be 6,147 meters<sup>2</sup>. The road length draining to this culvert was estimated at 169.2 meters and an average width of 9.5 meters. The slope steepness at outlet was estimated as 13.7% (derived from 10-meter DEM). The soil type at the culvert outlet is Peru with a soil texture of fine sandy loam. Repeated surveys on this site took place from May 12<sup>th</sup>, 2020 to May 13, 2021 with a total of 5 surveys. Erosion mitigation was installed at this site in early July 2020.

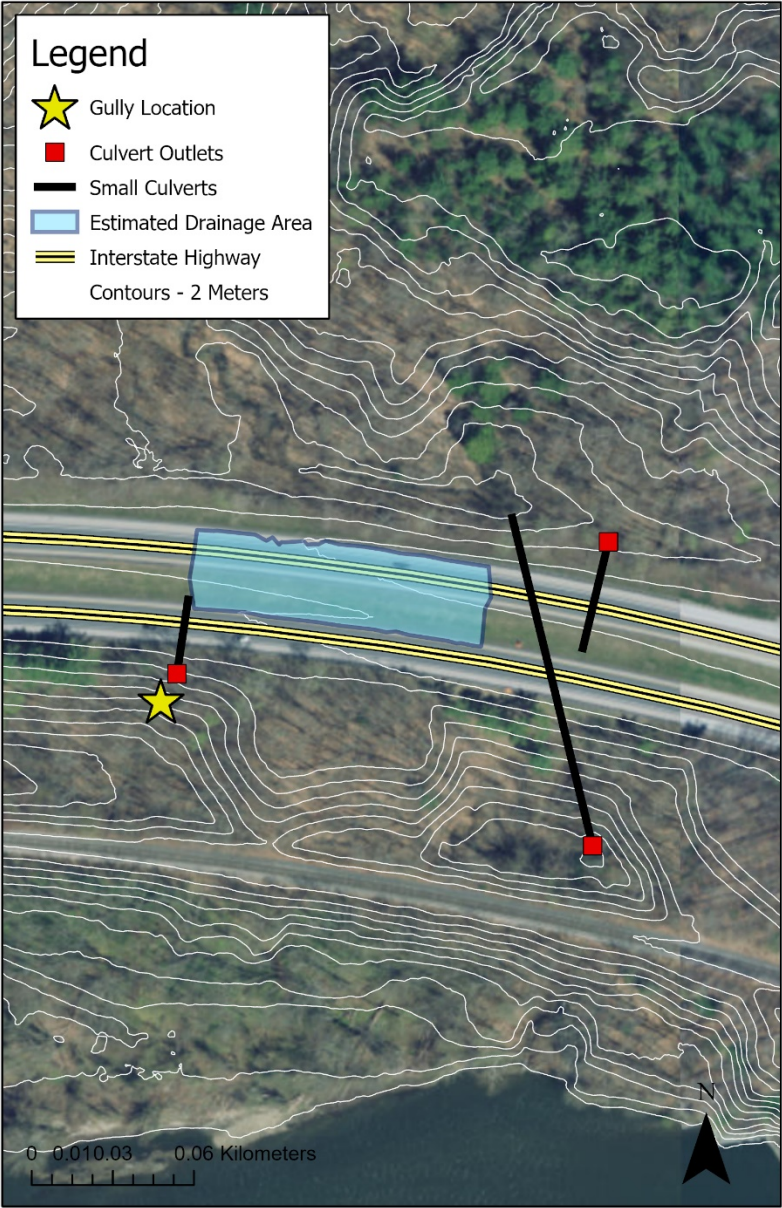
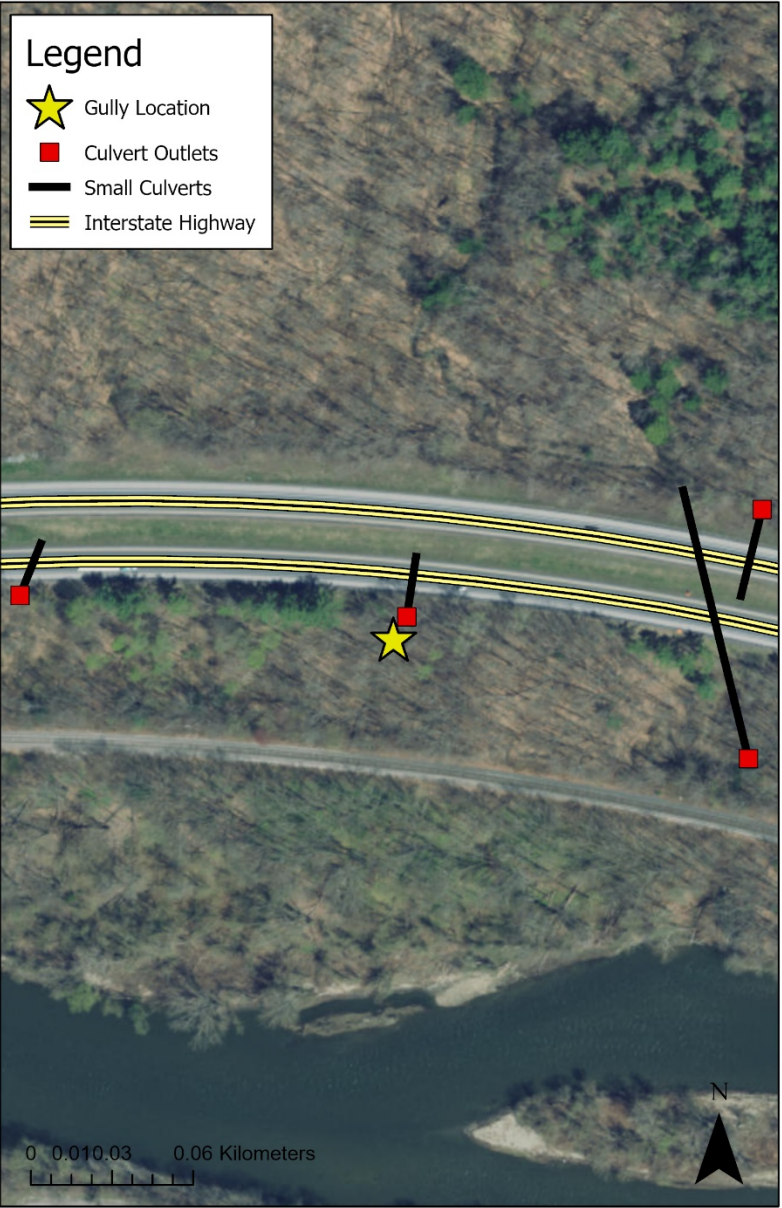
## I-89 MIDDLESEX

This gully is at the south direction on Interstate 89 and is located 5.7 kilometers past the Montpelier on ramp in the town of Middlesex, Vermont. This road is a one lane Interstate Highway that is maintained by the Vermont Agency of Transportation District 5. The culvert monitored is part of the Small Culvert Inventory database with an ID of 60855. The culvert was a concrete material and 18 inches in diameter and 79 feet in length. The system type of the culvert is a single pipe. The drainage area for this culvert was estimated to be 2,164 meters<sup>2</sup> (derived from 0.7-meter DEM). The road length draining to this culvert was estimated at 90.9 meters and an average width of 14 meters. The slope steepness at outlet was estimated as 48.1% (derived from 10-meter DEM). The soil type at the culvert outlet is Tunbridge-Lyman Complex with a soil texture of fine sandy loam. Repeated surveys on this site took place from May 12<sup>th</sup>, 2020 to May 13, 2021 with a total of 5 surveys. Erosion mitigation was not installed at this site.

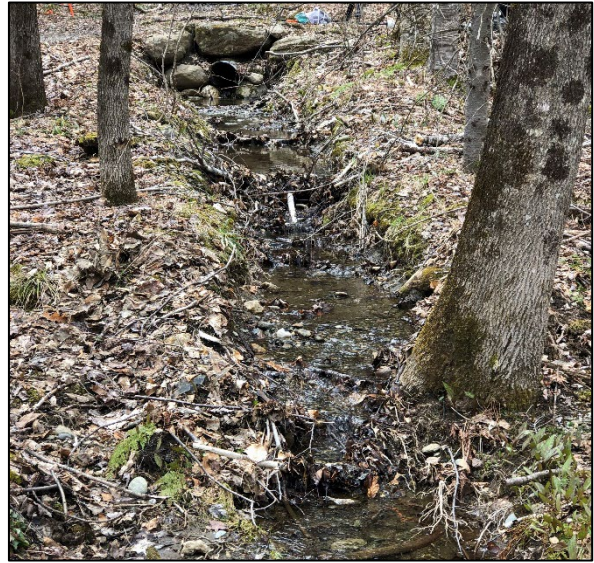
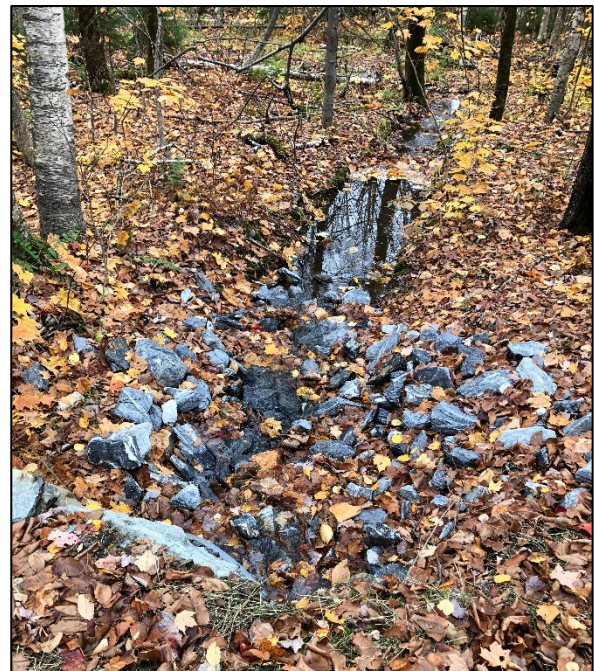
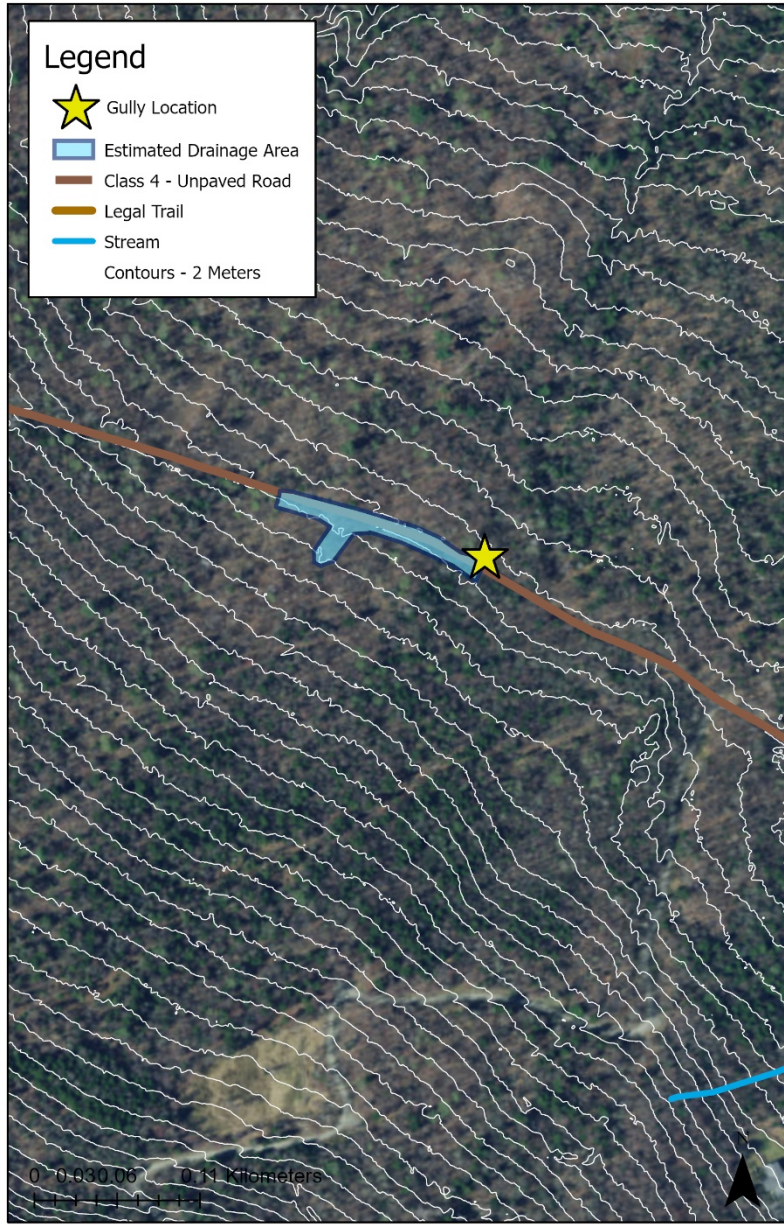
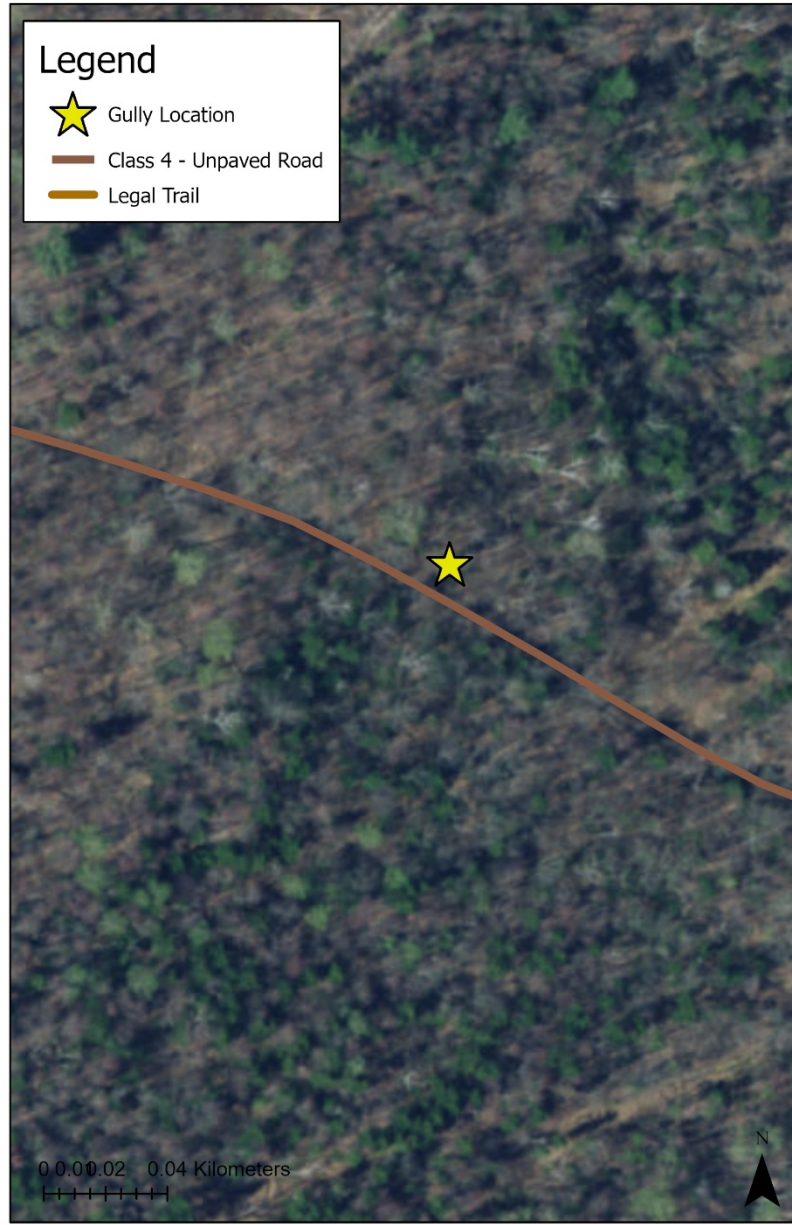
## MAPLE RUN LANE (30)

This gully is located off Maple Run Lane in the town of Stowe, Vermont. This road is a class 4 unpaved road and located 0.18 kilometers from a pull off on Maple Run Lane (access to site is on foot). The culvert monitored is not part of any database. This culvert is a single pipe part of an open drainage network. The drainage area for this culvert was estimated to be 2,294 meters<sup>2</sup>. The road length draining to this culvert was estimated at 145.3 meters and an average width of 4.5 meters. The slope steepness at outlet was estimated as 7.7% (derived from 10-meter DEM). The soil type at the culvert outlet is Berkshire with a soil texture of fine sandy loam. Repeated surveys on this site took place from November 2<sup>nd</sup>, 2019 to May 17, 2021 with a total of 6 surveys. Erosion mitigation was installed at this site in October 2020.

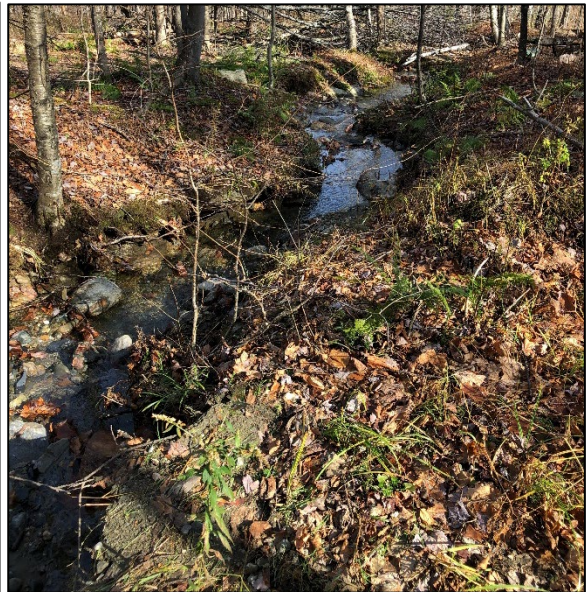
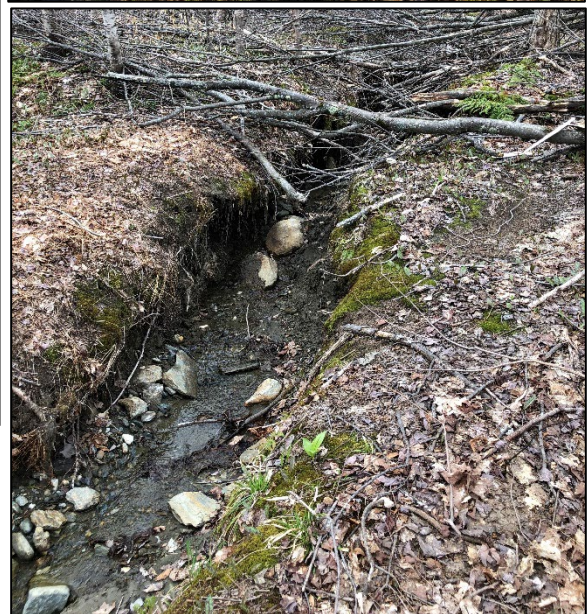
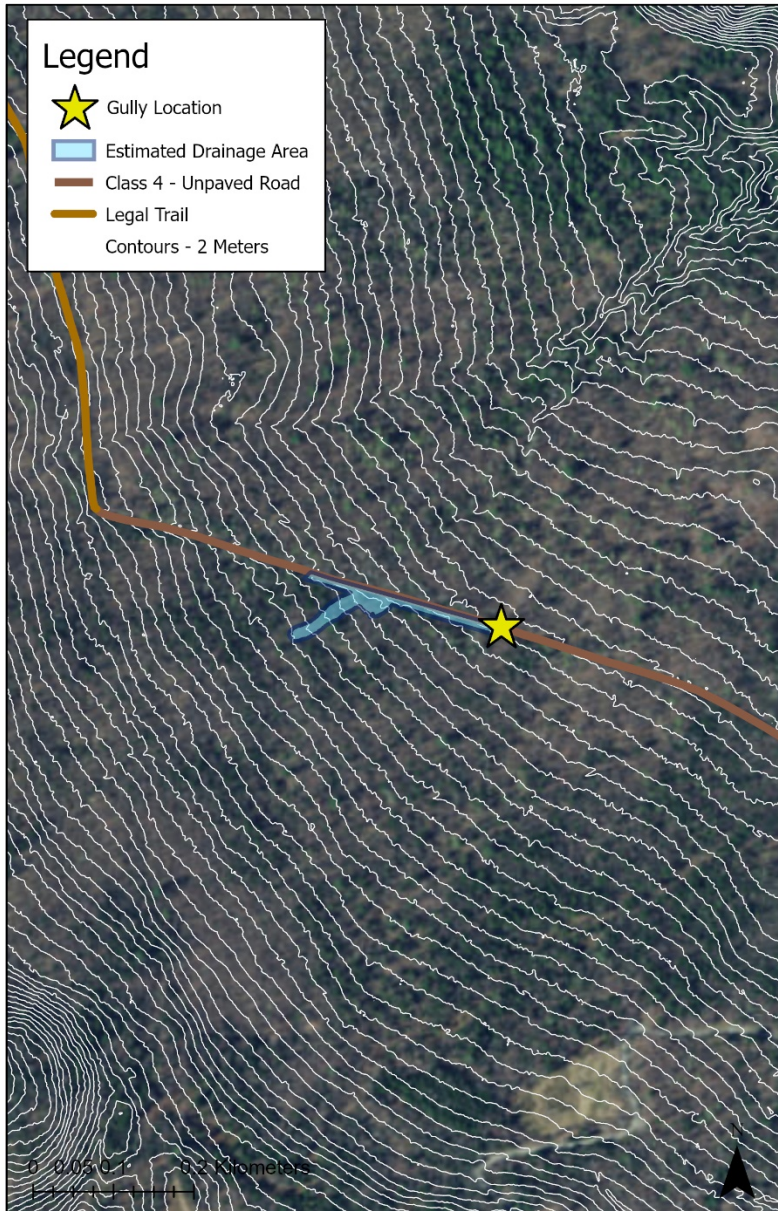
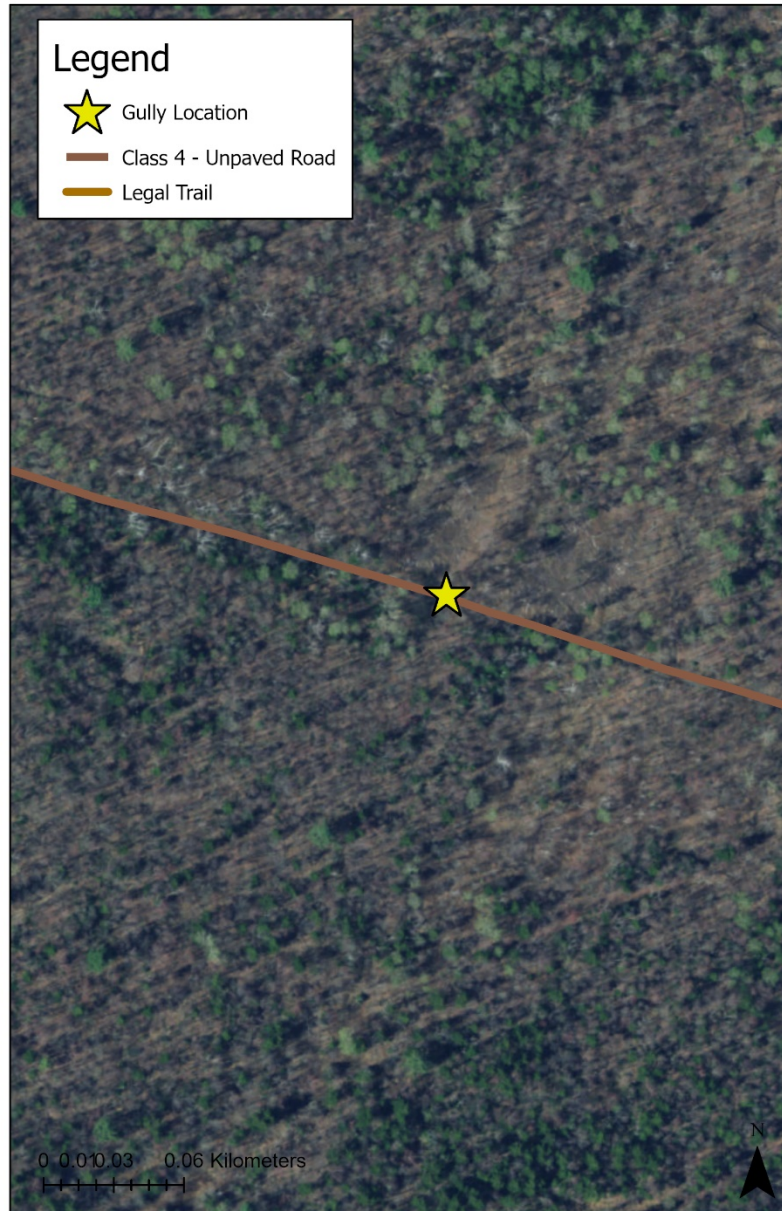
## MAPLE RUN LANE (31)

This gully is located off Maple Run Lane in the town of Stowe, Vermont. This road is a class 4 unpaved road and located 0.40 kilometers from a pull off on Maple Run Lane (access to site is on foot). The culvert monitored is not part of any database. This culvert is a single pipe part of an open drainage network. The drainage area for this culvert was estimated to be 2,698 meters<sup>2</sup>. The road length draining to this culvert was estimated at 180.6 meters and an average width of 4.5 meters. The slope steepness at outlet was estimated as 7.5% (derived from 10-meter DEM). The soil type at the culvert outlet is Berkshire with a soil texture of fine sandy loam. Repeated surveys on this site took place from November 2<sup>nd</sup>, 2019 to May 17, 2021 with a total of 5 surveys. Erosion mitigation was not installed at this site.

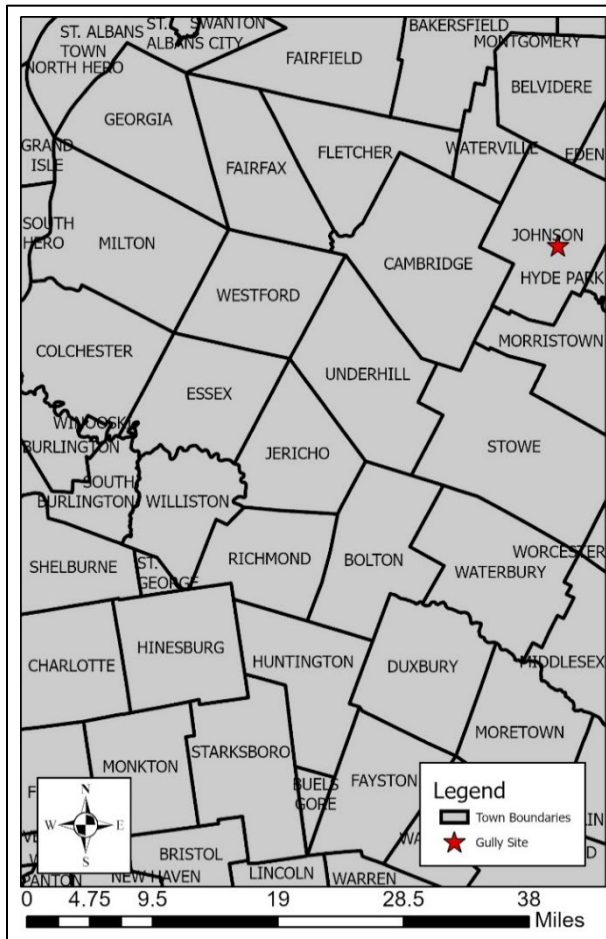
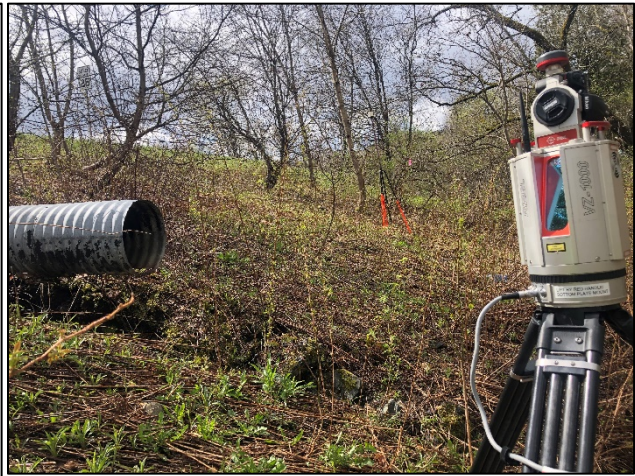
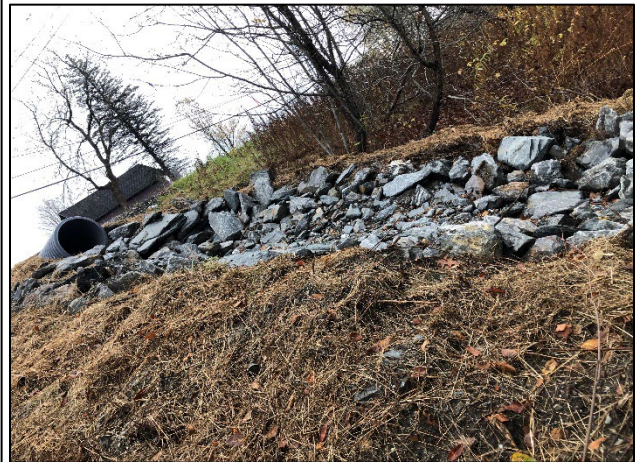
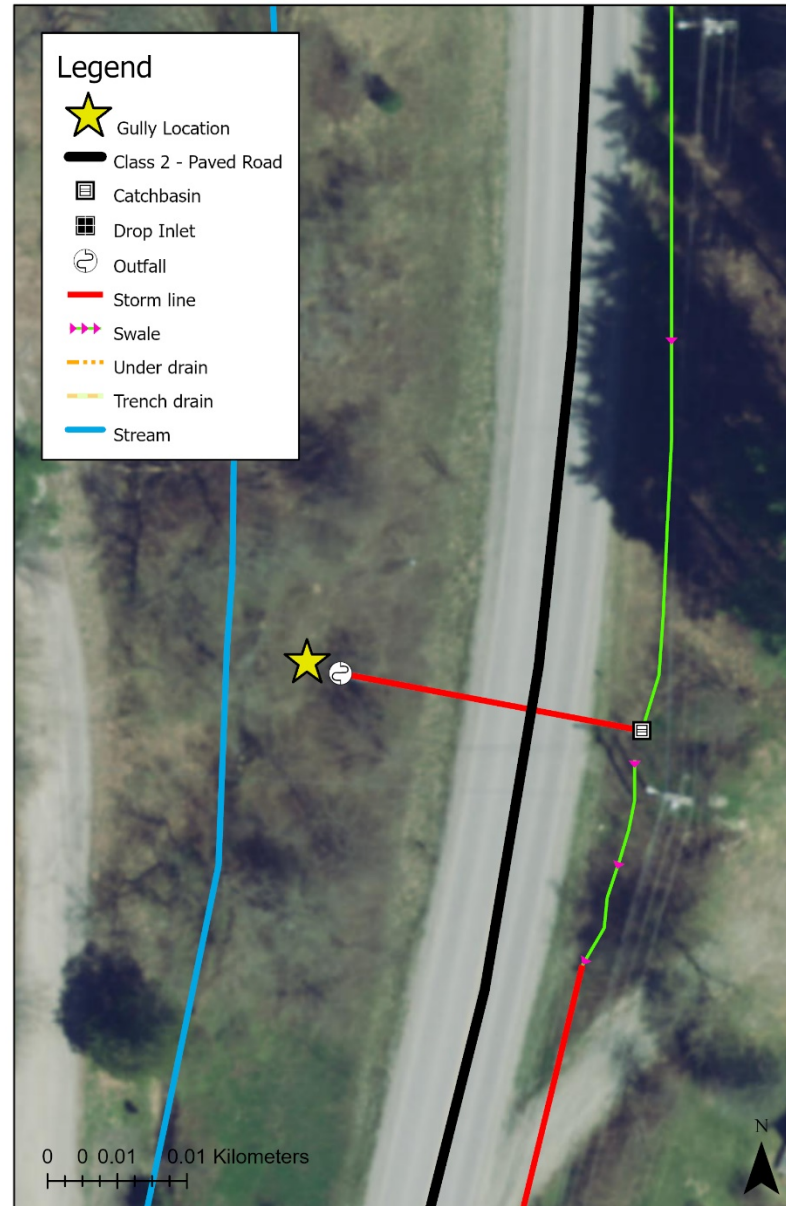
## CLAY HILL ROAD (32)

This gully is located off Clay Hill Road in the town of Johnson, Vermont. This road is a class 3 paved road and located on the left 0.4 kilometers from the intersection of Lower Main Street and Pearl Street (Pearl Street turns into Clay Hill Road at the intersection of School Street). The culvert monitored is part of the town of an Agency of Natural Resources database that included supplementary information on the drainage and hydrologic network. The metal culvert diameter is 18 inches in width and 60 feet in length. This culvert is a single pipe part of an open drainage network. The drainage area for this culvert was estimated to be 1,490 meters<sup>2</sup>. The road length draining to this culvert was estimated at 79.7 meters and an average width of 7.8 meters. The slope steepness at outlet was estimated as 14.7% (derived from 10-meter DEM). The soil type at the culvert outlet is Salmon Variant with a soil texture of very fine sandy loam. Repeated surveys on this site took place from May 8<sup>th</sup>, 2020 to May 18, 2021 with a total of 4 surveys. Erosion mitigation was installed at this site in October 2020.

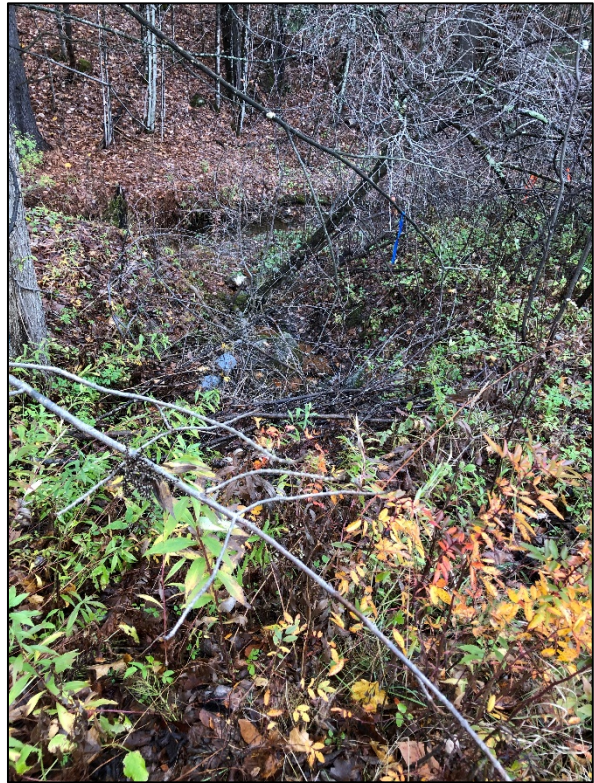
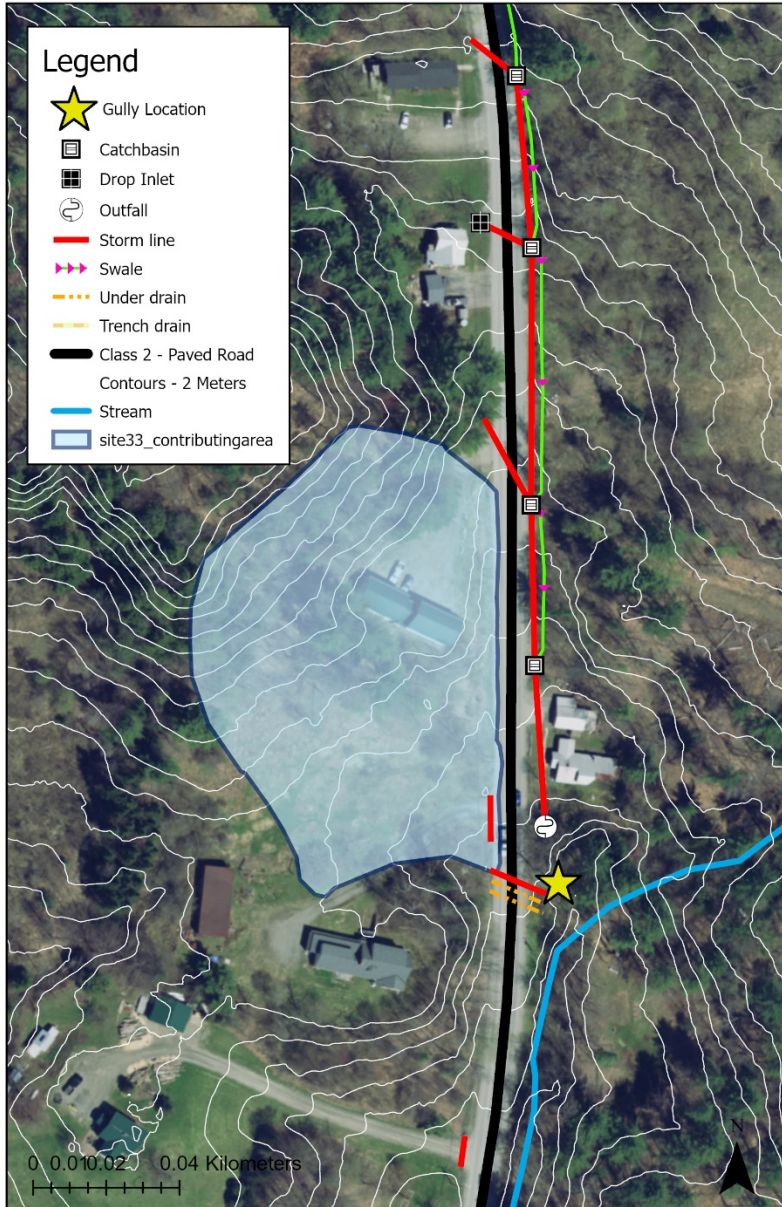
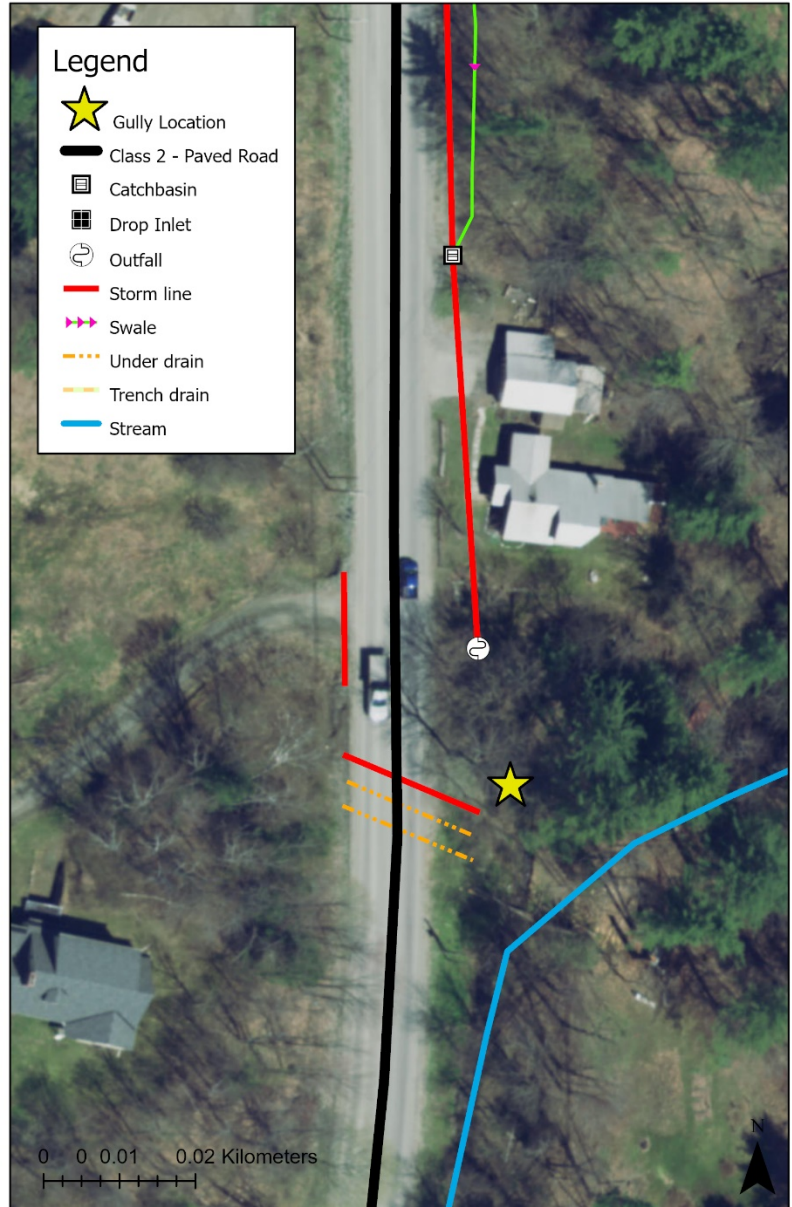
## CLAY HILL ROAD (33)

This is located off Clay Hill Road in the town of Johnson, Vermont. This road is a class 3 paved road and located on the right 0.77 kilometers from the intersection of Lower Main Street and Pearl Street (Pearl Street turns into Clay Hill Road at the intersection of School Street). The culvert monitored is part of the town of an Agency of Natural Resources database that included supplementary information on the drainage and hydrologic network. The metal culvert is 18 inches in diameter and 48 feet in length. This culvert is a single pipe part of an open drainage network. The drainage area for this culvert was estimated to be 8,341 meters<sup>2</sup>. The road length draining to this culvert was estimated at 103.8 meters and an average width of 7.8 meters. The slope steepness at outlet was estimated as 20.8% (derived from 10-meter DEM). The soil type at the culvert outlet is Salmon Variant with a soil texture of very fine sandy loam. Repeated surveys on this site took place from May 8<sup>th</sup>, 2020 to May 18, 2021 with a total of 4 surveys. Erosion mitigation was not installed at this site.

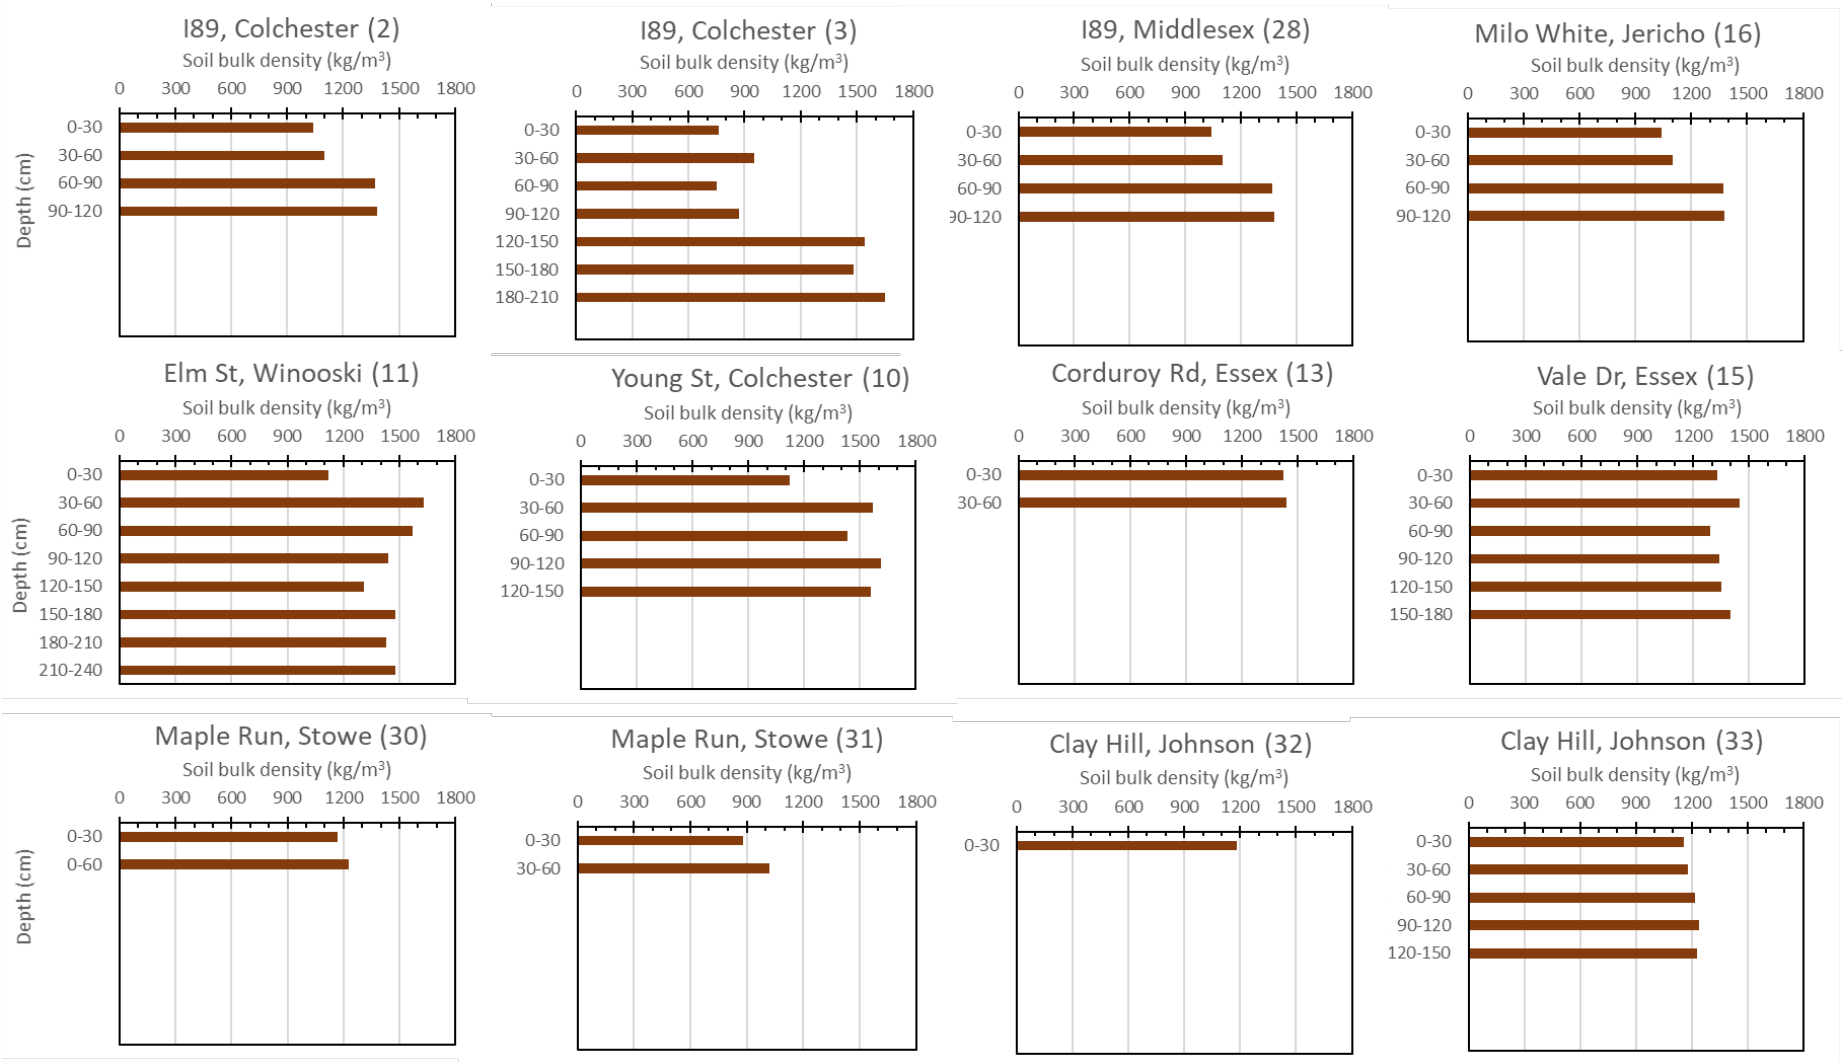
## A. Soil Bulk Density

## Appendix 2: Soil bulk density and phosphorus concentrations from sampled gullies

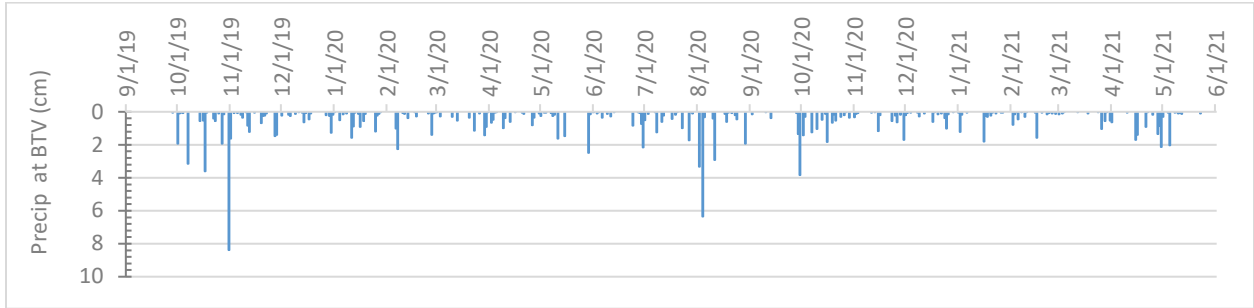
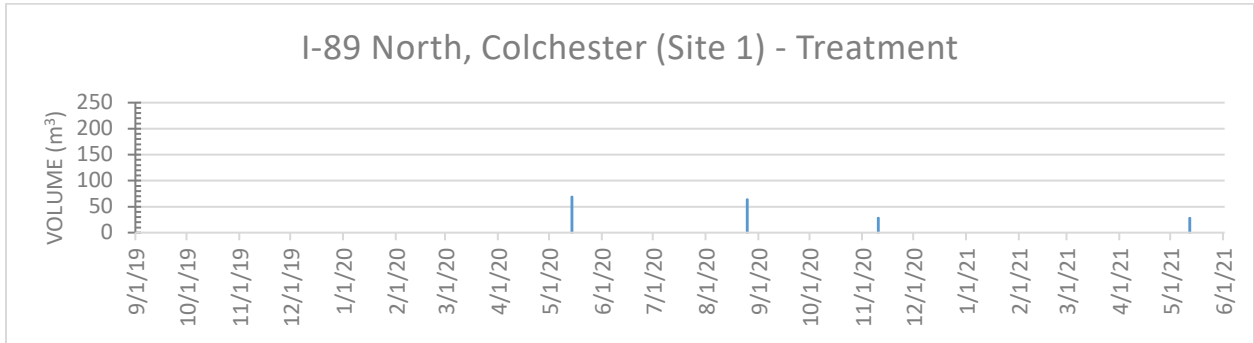
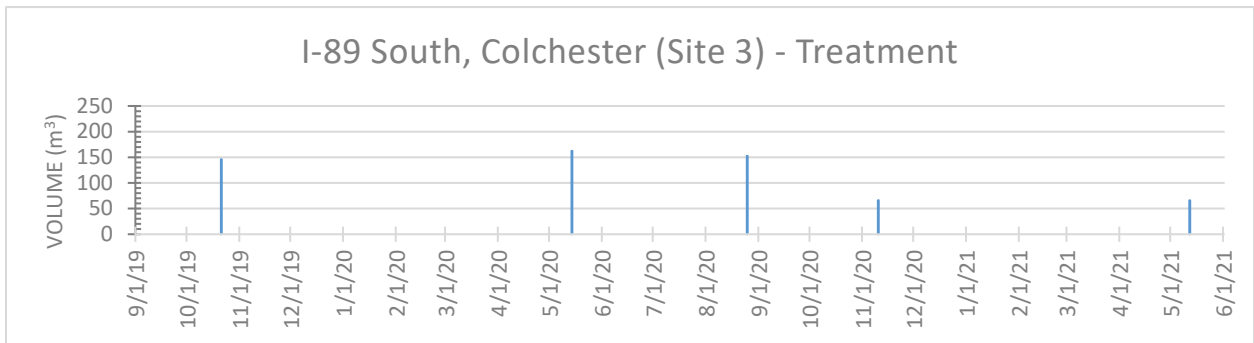
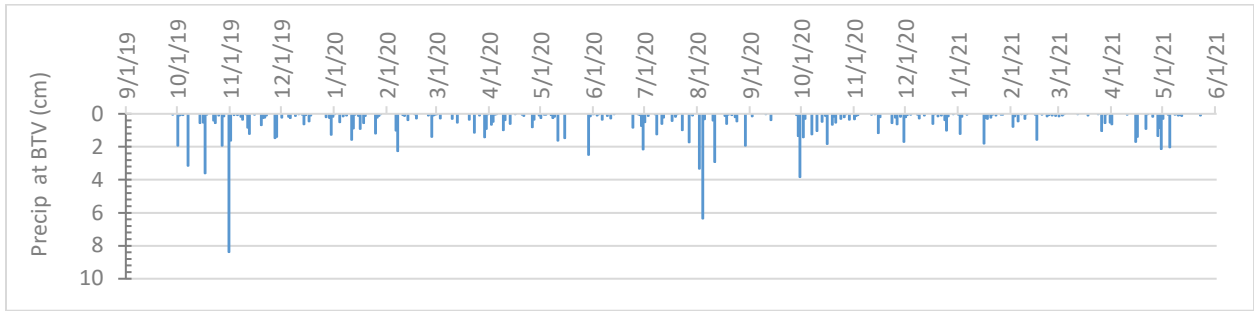
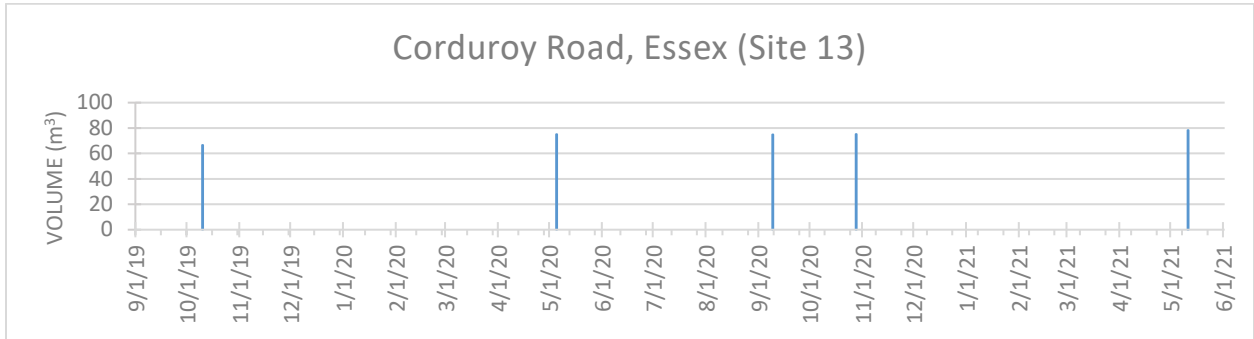
## Appendix 3: Time series plots of gully volumes

Note: Plots presented in this Appendix are for data collected over the term of this project. Precipitation data are daily totals for Burlington International Airport (BTV) and Morrisville Airport (MVL). Y-axis scales for precipitation and gully volume differ among plots displayed. Site pairs are plotted on common y-axis scale to aid in visual comparison of gully volumes.

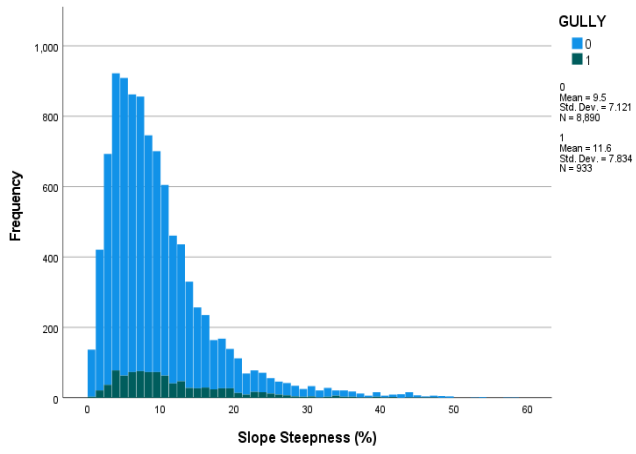
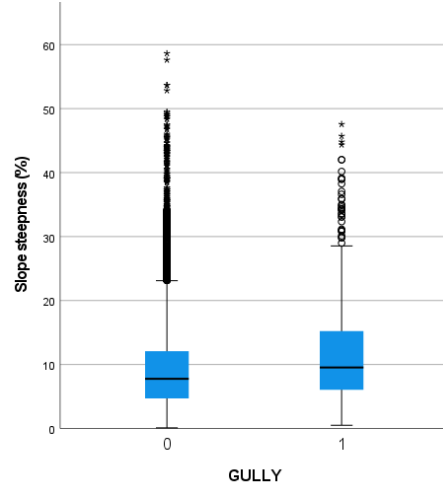
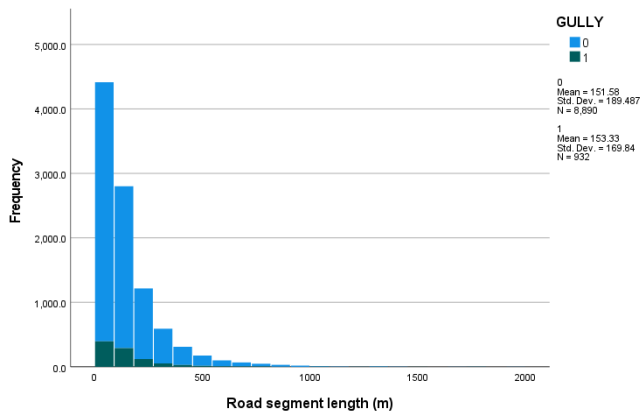
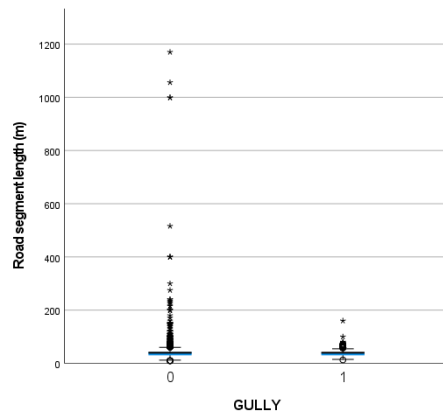
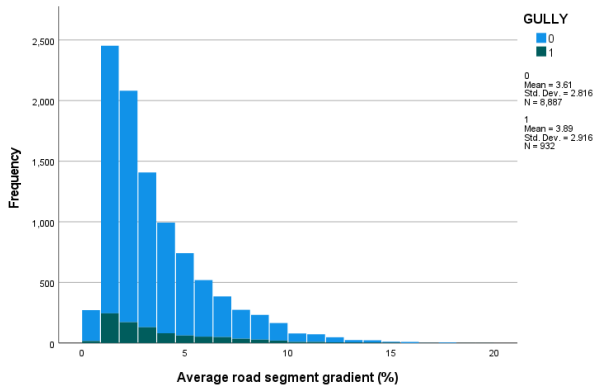
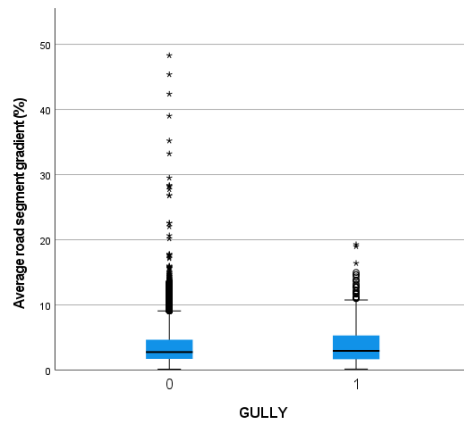
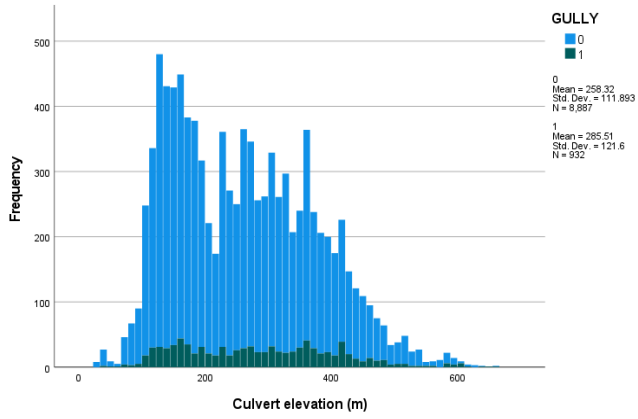
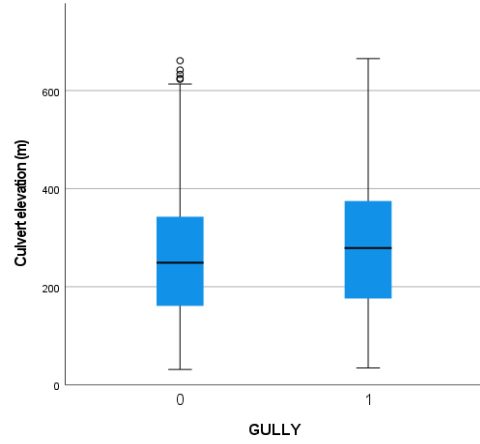
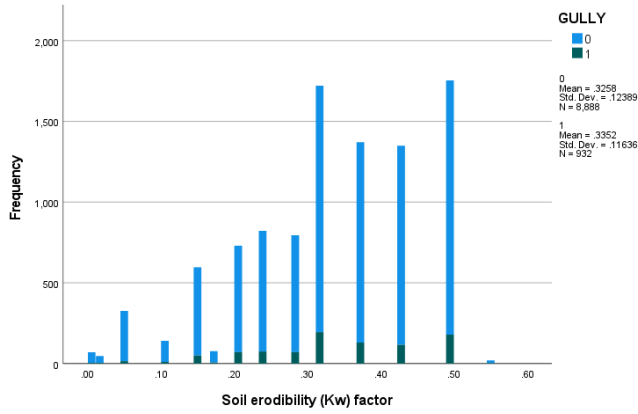
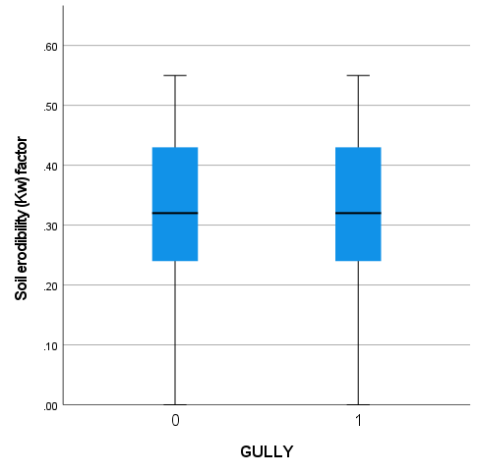
This appendix contains plots for the dataset of gullies identified on airborne lidar data. The graphs on the following pages visualize gully occurrence against the set of continuous variables assessed (in both histogram form and as error bar plots). Tables summarize counts of culverts with (gully = 1) and without (gully = 0) against categorical explanatory variables.
