## Appendix 1: Site Descriptions

## I-89 NORTH (1)

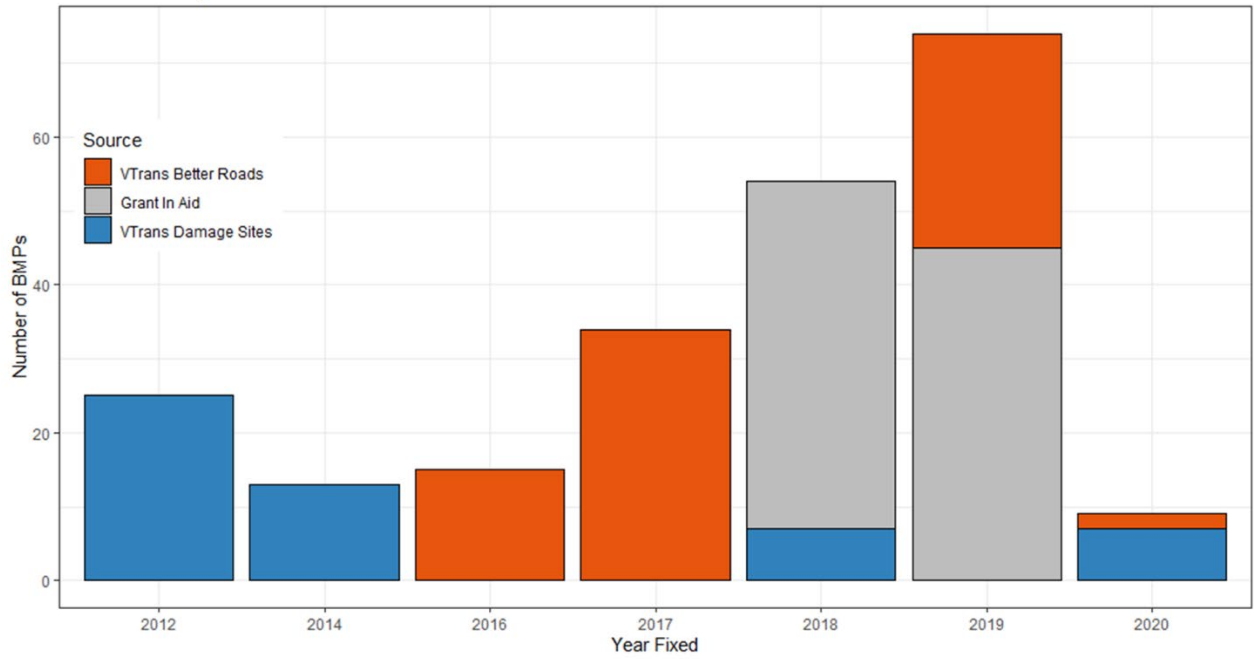
Source of Site by Year Fixed

The graphs on the following pages visualize the sites assessed against variables of interest, including year practice was installed, assessed condition of the practice, age of practice (assumed to be 2020 minus year recorded in the database), and slope steepness on which the erosion remediation project (or BMP) was installed.
