Prepared in cooperation with the Vermont Agency of Transportation

Effects of Highway Road Salting on the Water Quality of Selected Streams in Chittenden County, Vermont, November 2005–2007

Scientific Investigations Report 2009–5236

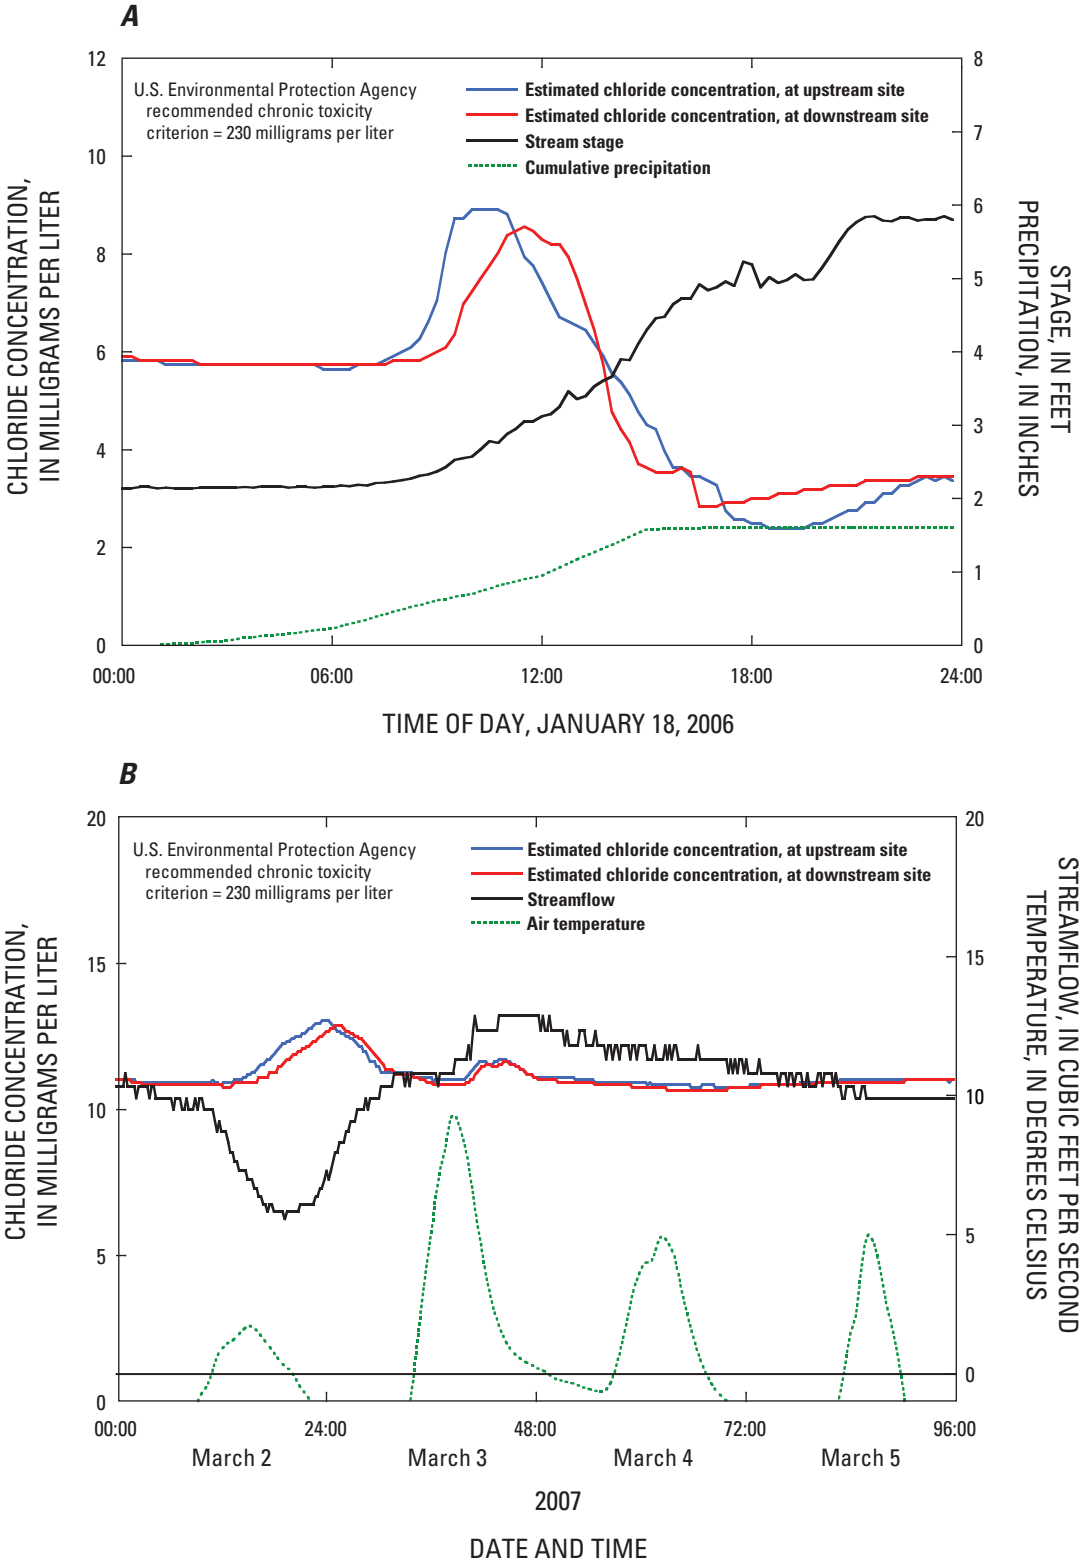
Figure 5. Relation of estimated chloride concentration to (A) stream stage during a rain-on-snow event (January 18, 2006) and (B) streamflow during a snowmelt event (March 2007) at Mill Brook at VT 117 near Essex Junction, VT, stations 04289880 and 04289881.

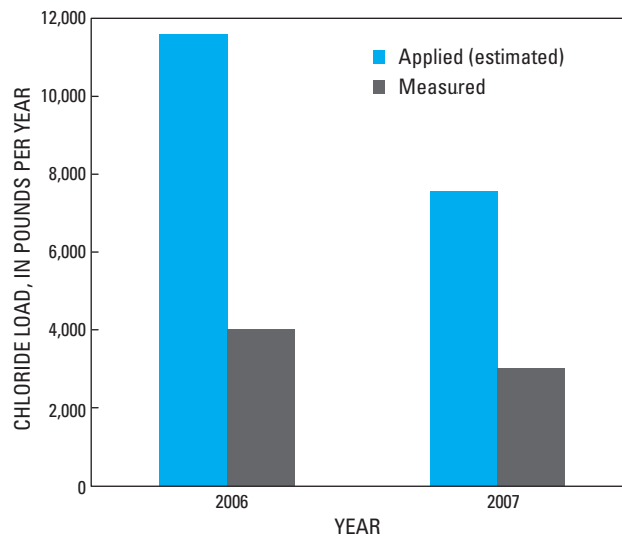
Figure 6. Estimated applied road deicing and measured chloride load for Mill Brook at VT 117 near Essex Junction, VT, station 04289881.

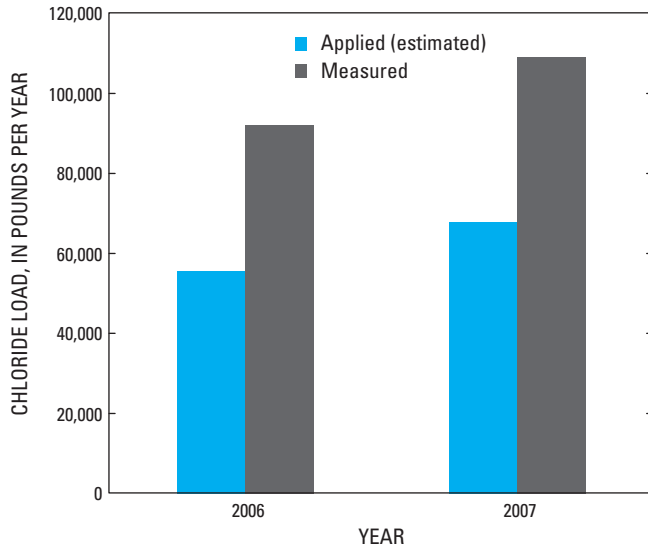
Figure 11. Estimated applied road deicing and measured chloride load for Alder Brook at VT 289 near Essex Junction, VT, station 04290161.

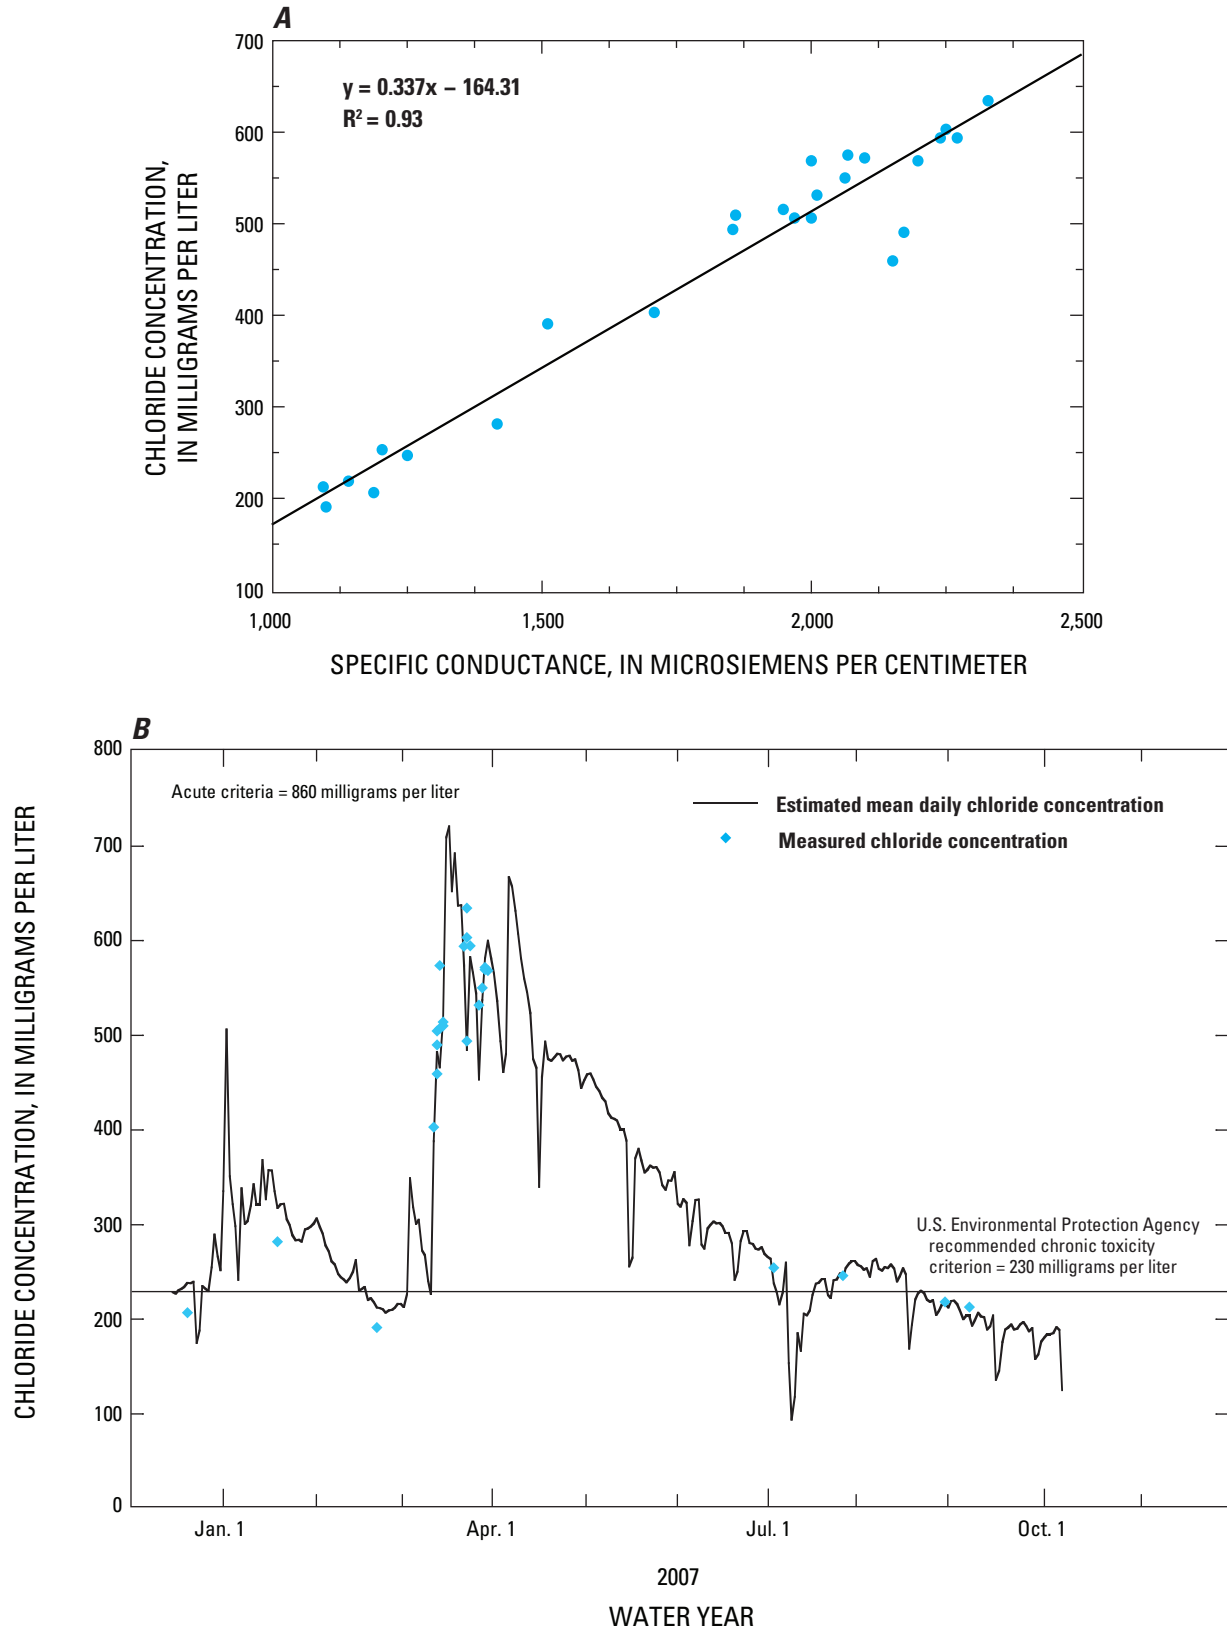
Figure 13. (A) Relation between specific conductance and chloride concentration in the routine water-quality samples and (B) estimated daily mean chloride concentrations and chloride concentration in routine water-quality samples for the study period at Alder Brook tributary at mouth near Essex Junction, VT, station 042901608.

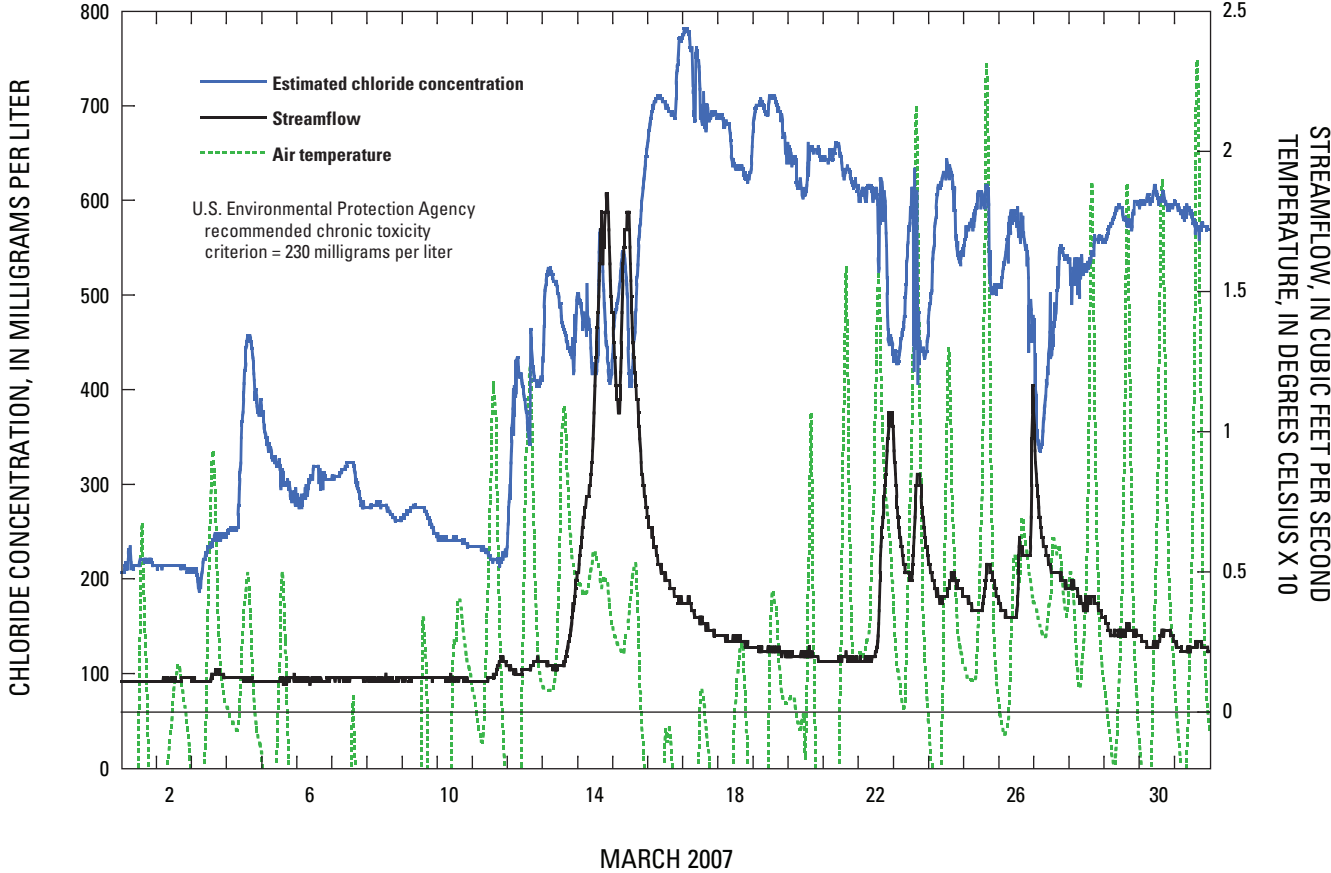
Figure 14. Relation of estimated chloride concentration to streamflow during a snowmelt event (March 2007) at Alder Brook tributary at mouth near Essex Junction, VT, station 042901608.

Samples collected in March 2007 were used to describe the effects of snowmelt on Cl concentrations in the tributary (fig. 14). An increase in the estimated Cl concentration at Alder Brook tributary was observed on March 4. The estimated maximum instantaneous Cl concentration during this event was 460 mg/L (fig. 14). During the period of March 15–22 instantaneous Cl concentrations were greater than 600 mg/L with a maximum instantaneous concentration of nearly 800 mg/L. The dominant source of Cl was most likely from highway runoff and other sources in the drainage area. The USEPA recommended chronic toxicity criterion of 230 mg/L was exceeded during the event and for the remainder of the month of March and the snowmelt period (fig. 14).

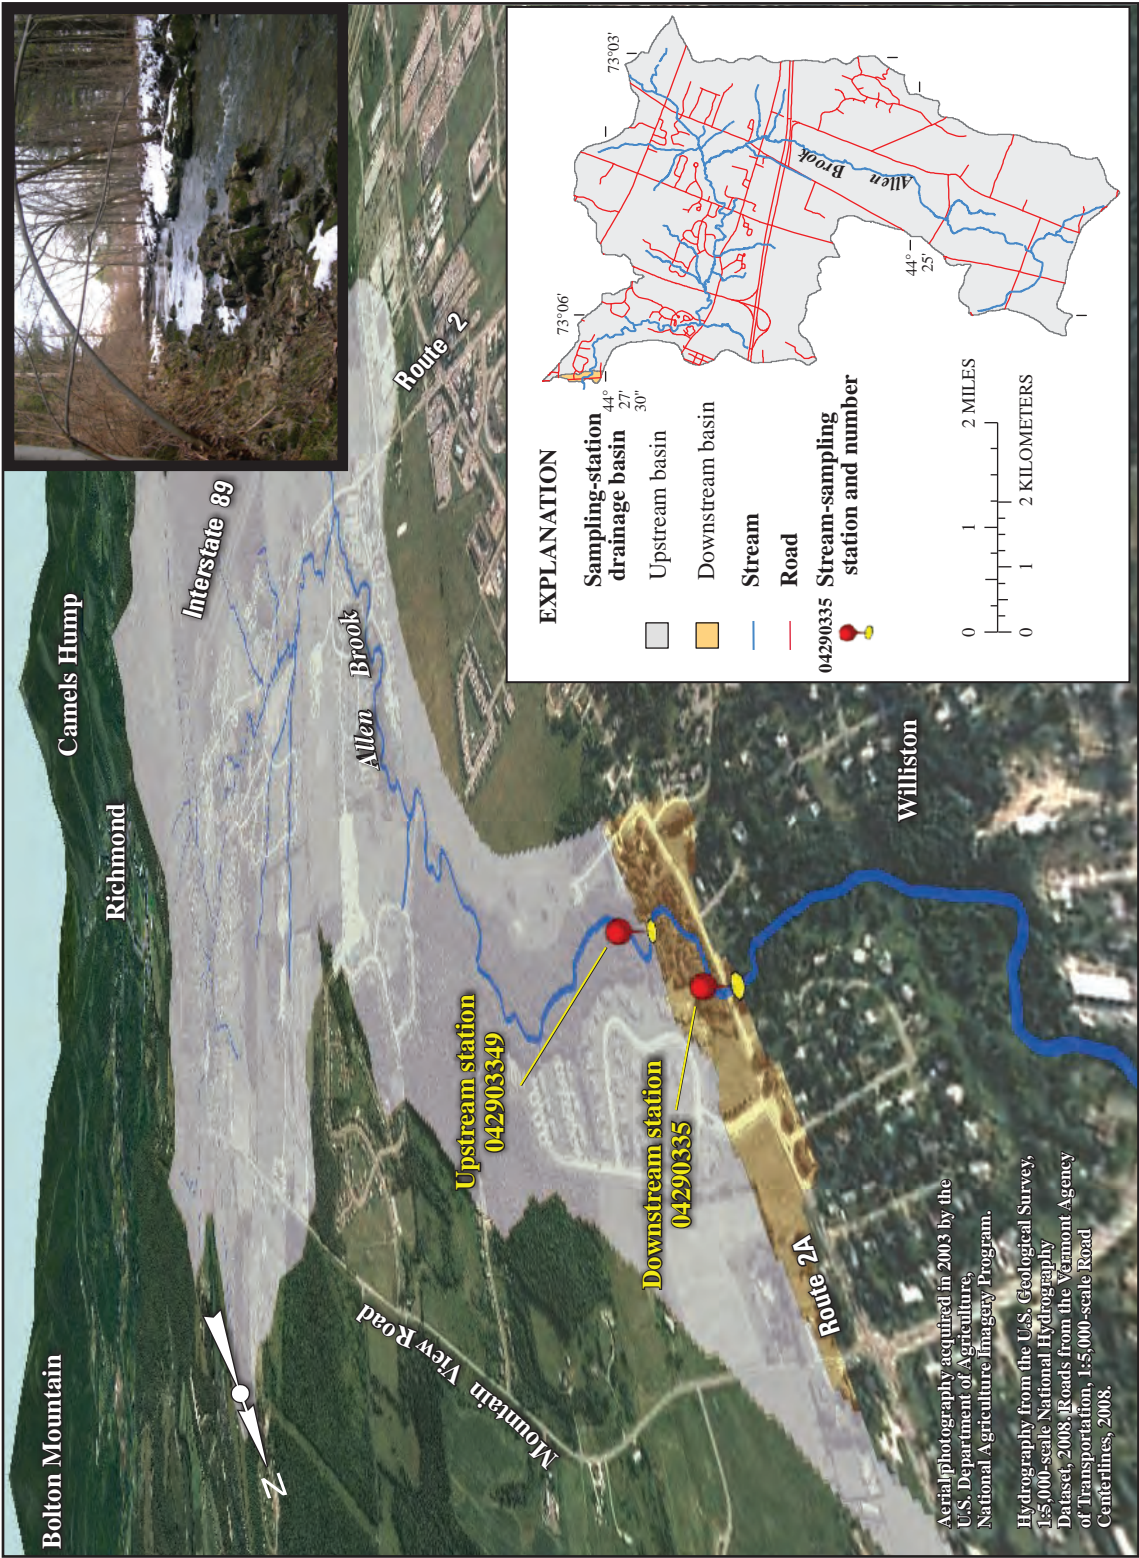
Figure 15. Location of upstream- and downstream-sampling stations, basin delineations, state road network, and photograph of the downstream-sampling station for Allen Brook at VT 2A near Essex Junction, VT, stations 042903349 and 04290335 (Refer to table 1 and figure 1 for additional site information).

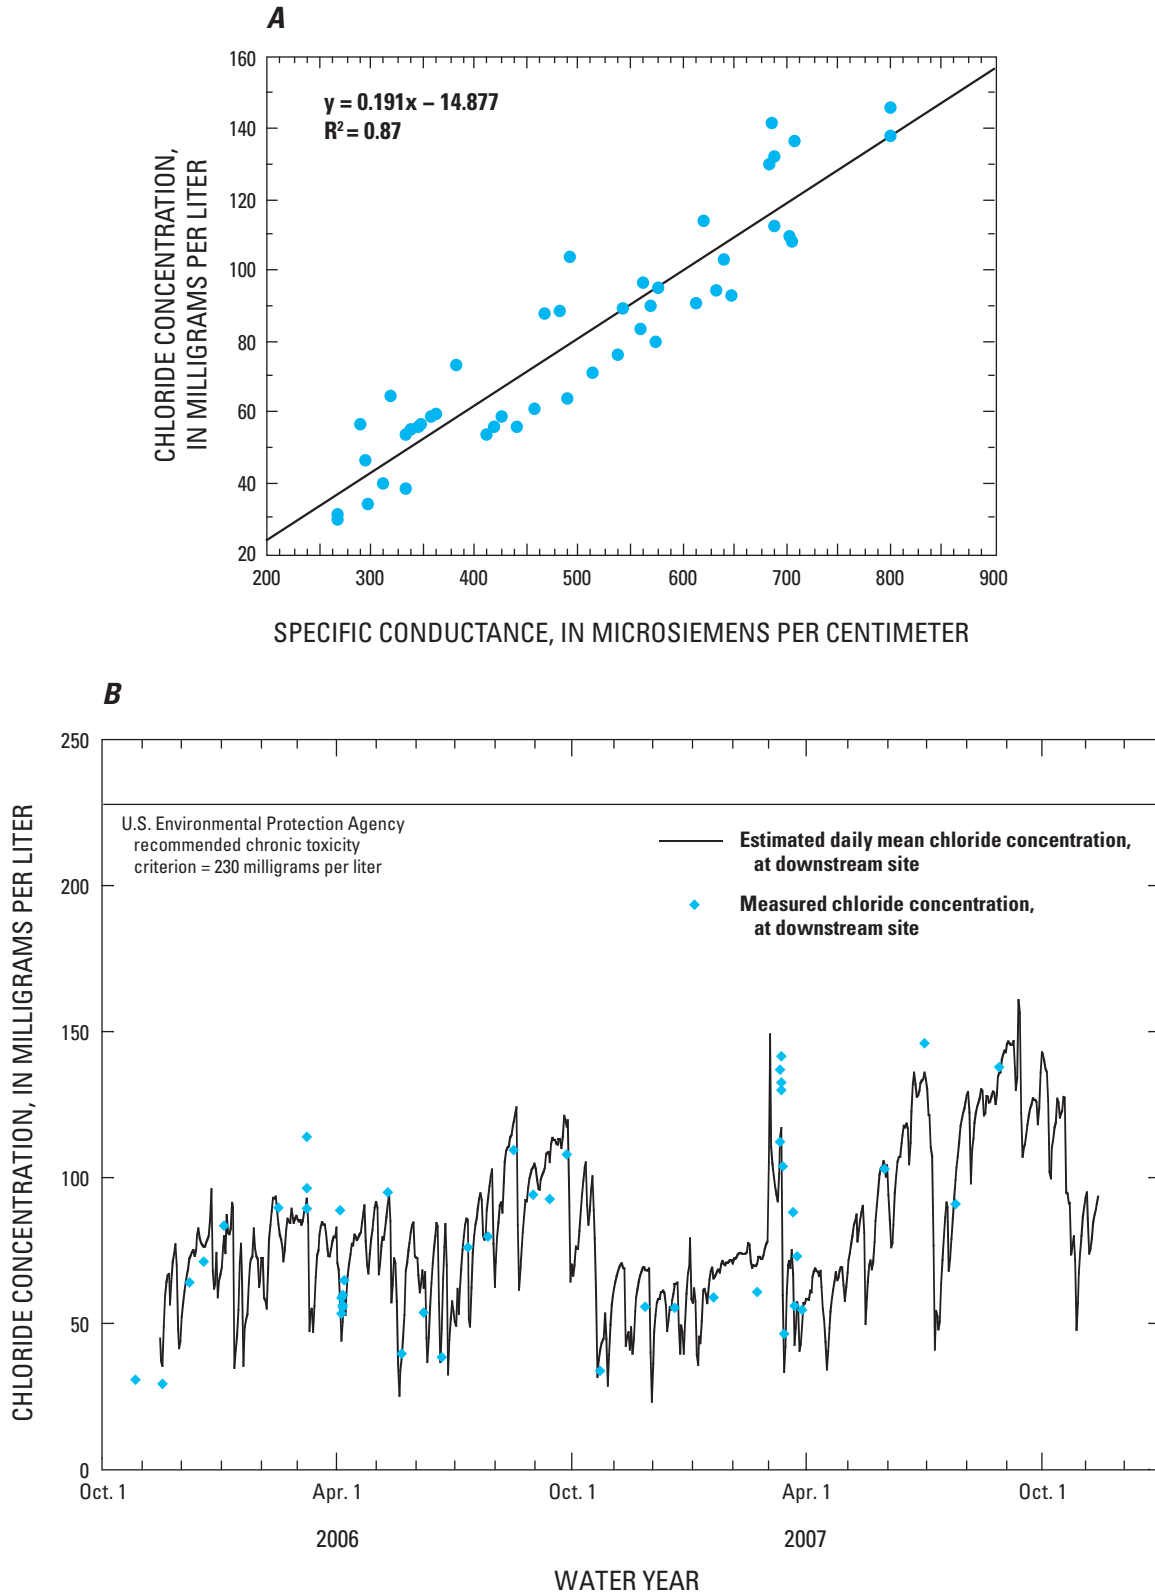
Figure 17. (A) Relation between specific conductance values and chloride concentration in routine water-quality samples and (B) estimated daily mean chloride concentrations and chloride concentration in routine water-quality samples for the study period at Allen Brook at VT 2A near Essex Junction, VT, station 04290335.

The highest estimated daily mean Cl concentration in 2007 at the downstream station was 161 mg/L during a period of summer low flow (fig. 17B). Summer base flow was lower in 2007 than in 2006 because rainfall was lower. In contrast, the lowest daily mean Cl concentrations at the downstream station (25.0 and 23.3 mg/L) occurred following rainstorms in May 2006 and December 2007, respectively. None of the Cl concentrations in the routine water-quality samples or the estimated daily mean Cl concentrations at the downstream station exceeded the USEPA recommended chronic toxicity criterion of 230 mg/L or the acute toxicity criterion of 860 mg/L (fig. 17B; tables 11 and 12).

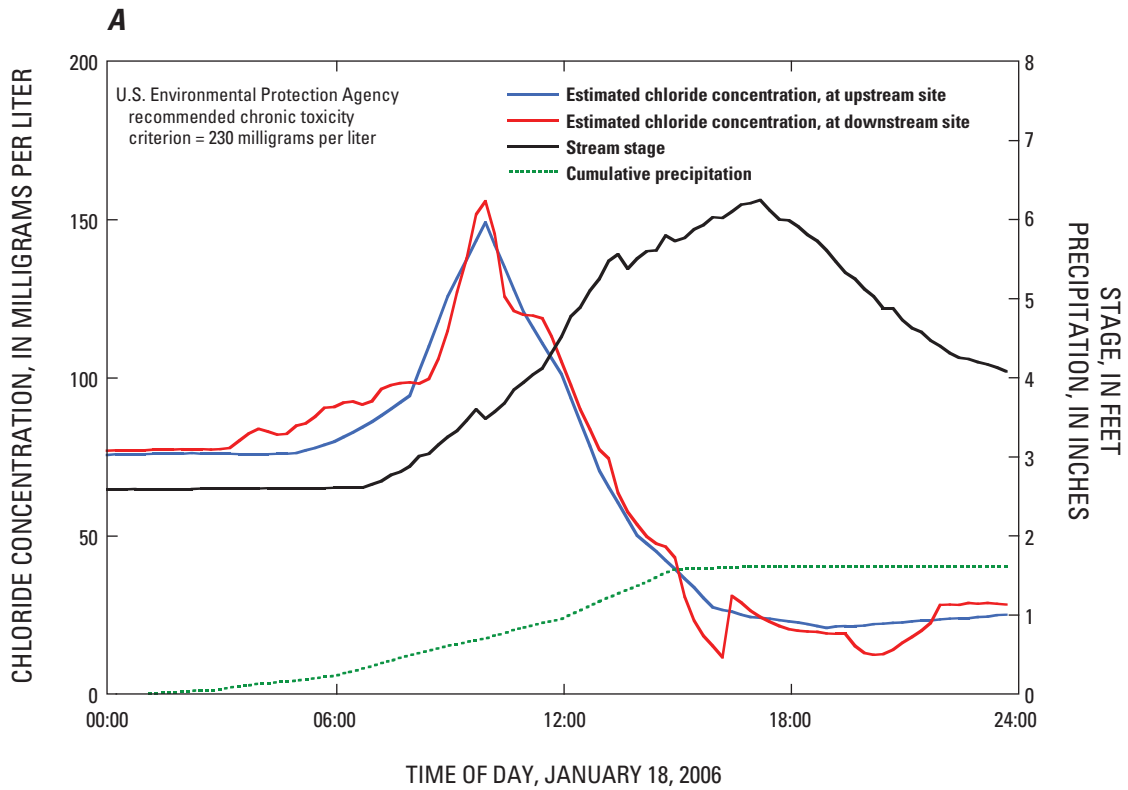
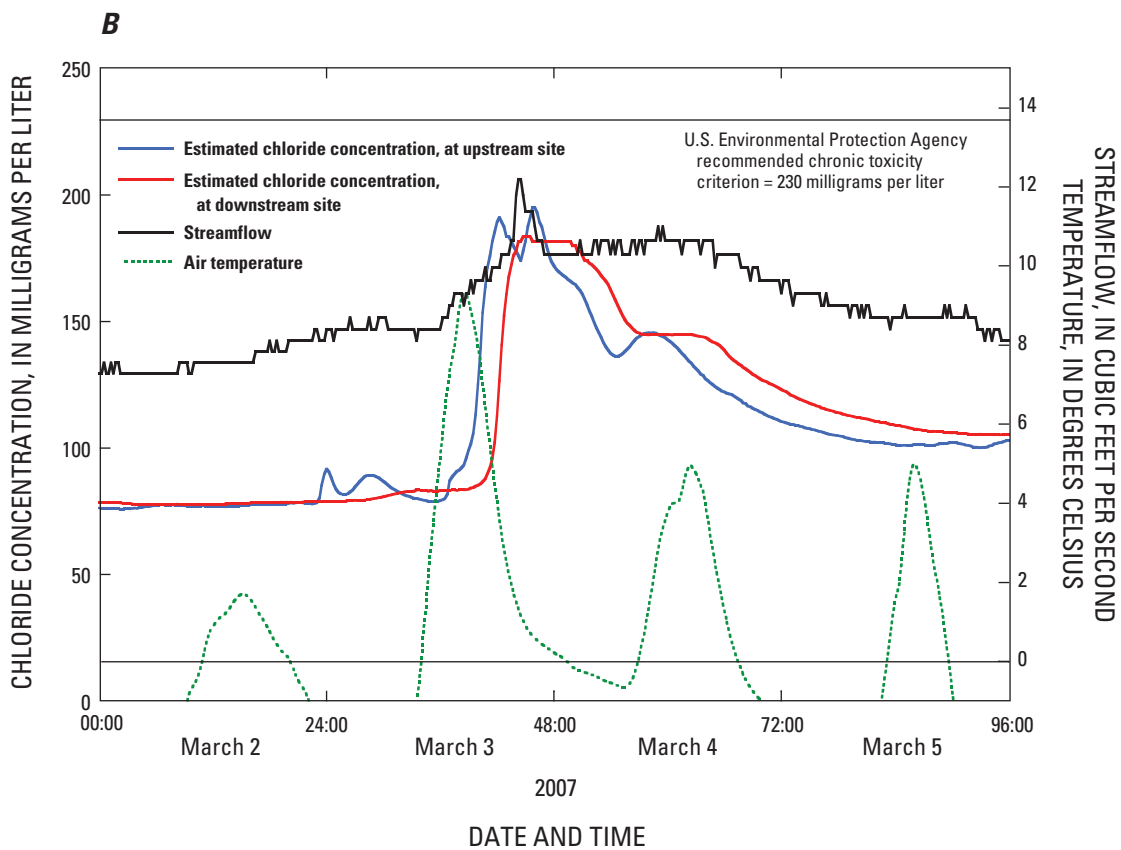
Figure 18. Relation of estimated chloride concentration to (A) stream stage during a rain-on-snow event (January 18, 2006) and (B) streamflow during a snowmelt event (March 2007) at Allen Brook at VT 2A near Essex Junction, VT, stations 042903349 and 04290335.

The January 2006 rain-on-snow event and its effects on instantaneous concentrations of Cl in relation to stream stage are shown in figure 18A. Stream stage was used as a surrogate for discharge, in this case, because the stream was ice-affected. Estimated Cl concentrations at the downstream station increased prior to an increase in the Cl concentration at the upstream station. This initial increase in Cl concentration at the downstream station is likely the result of direct runoff of salt from the bridge and roadway. However, Cl concentrations at both monitoring stations eventually increased with a gradual increase in stage (fig. 18A) indicating other watershed sources of Cl were contributing to the observed Cl concentrations. Estimated maximum instantaneous Cl concentrations during this event were 149 mg/L at the upstream station and 156 mg/L at the downstream station (fig. 18A). Cl concentrations decreased sharply as streamflow increased. Maximum streamflow occurred about 8 hours after the maximum Cl concentration was observed. Instantaneous Cl concentrations did not exceed the USEPA recommended chronic toxicity criterion of 230 mg/L during this event.

The March 2007 snowmelt event and its effects on instantaneous concentrations of Cl in relation to streamflow from March 2 to 5 are shown in figure 18B. A slight increase in Cl concentration was observed on March 2. Because this increase occurred long after the daily maximum air temperature was reached, it is likely that the Cl concentration increased in response to Cl sources upstream. The estimated maximum instantaneous Cl concentrations were 195 mg/L at the upstream station and 184 mg/L at the downstream station on March 3 (fig. 18B). Instantaneous Cl concentrations did not exceed the USEPA recommended chronic toxicity criterion of 230 mg/L during this event.

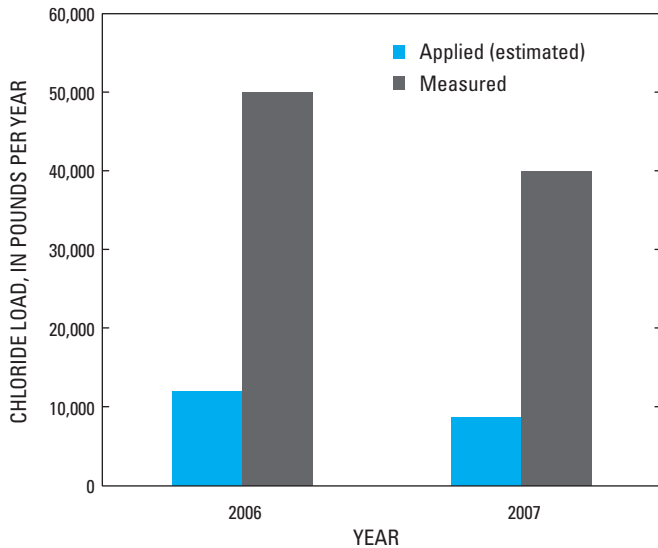
Figure 19. Estimated applied road deicing and measured chloride load for Allen Brook at VT 2A near Essex Junction, VT, station 042903349.

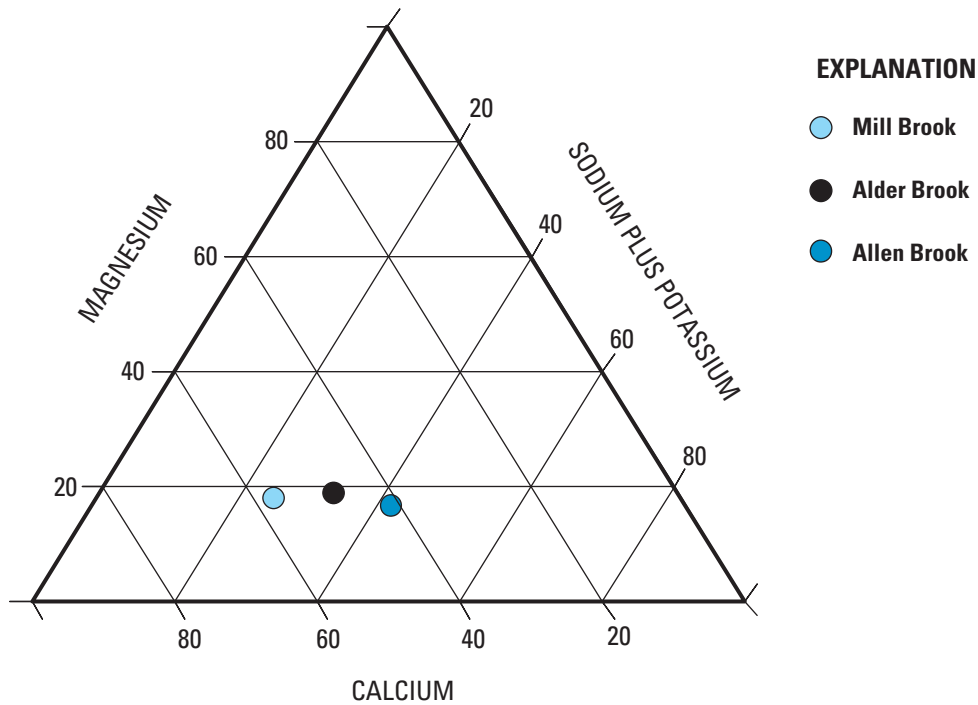
Figure 20. General cation composition (in percent) for Mill Brook at VT 117, Alder Brook at VT 289, and Allen Brook at VT 2A near Essex Junction, VT.

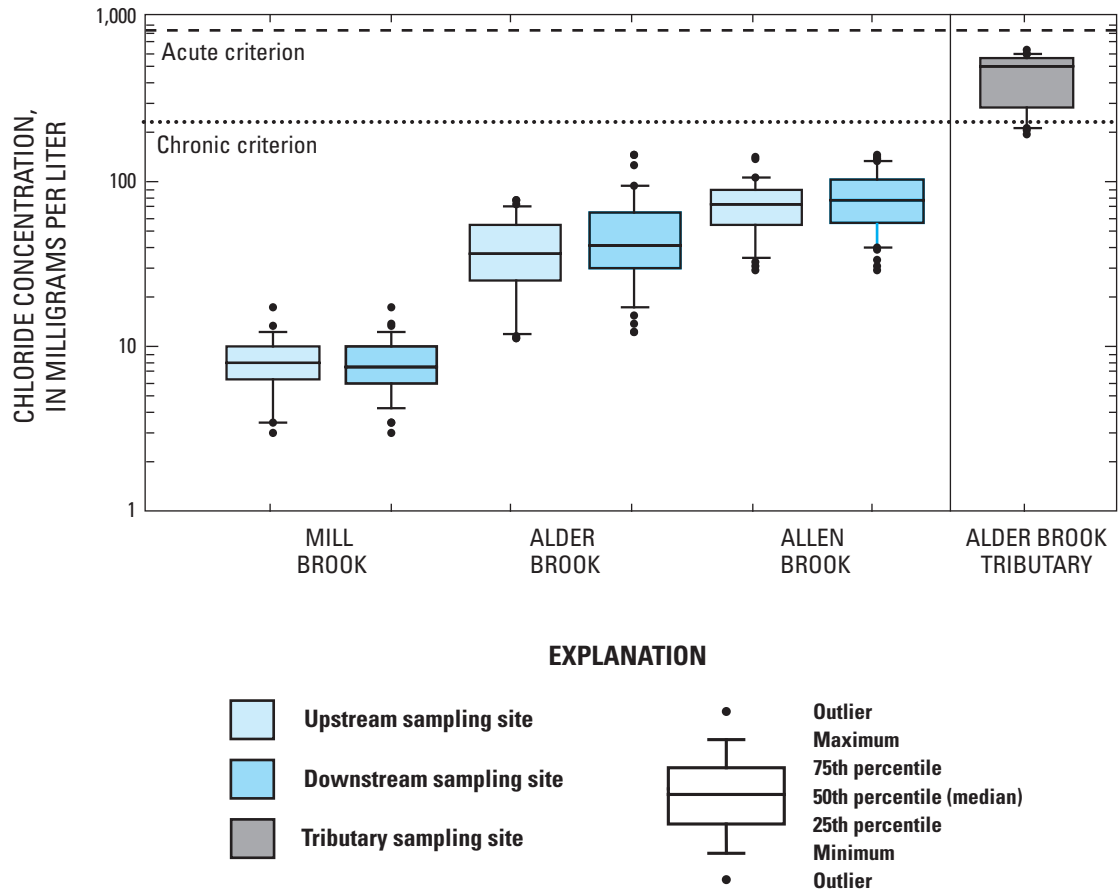
Figure 21. The range in chloride concentrations in the routine water-quality samples for the paired sampling stations at Mill Brook at VT 117, Allen Brook at VT 2A, Alder Brook at VT 289, and Alder Brook tributary at mouth near Essex Junction, VT.
