Structures Engineering Instructions (SEI)

Subject: Northeast Extreme Tee Beams

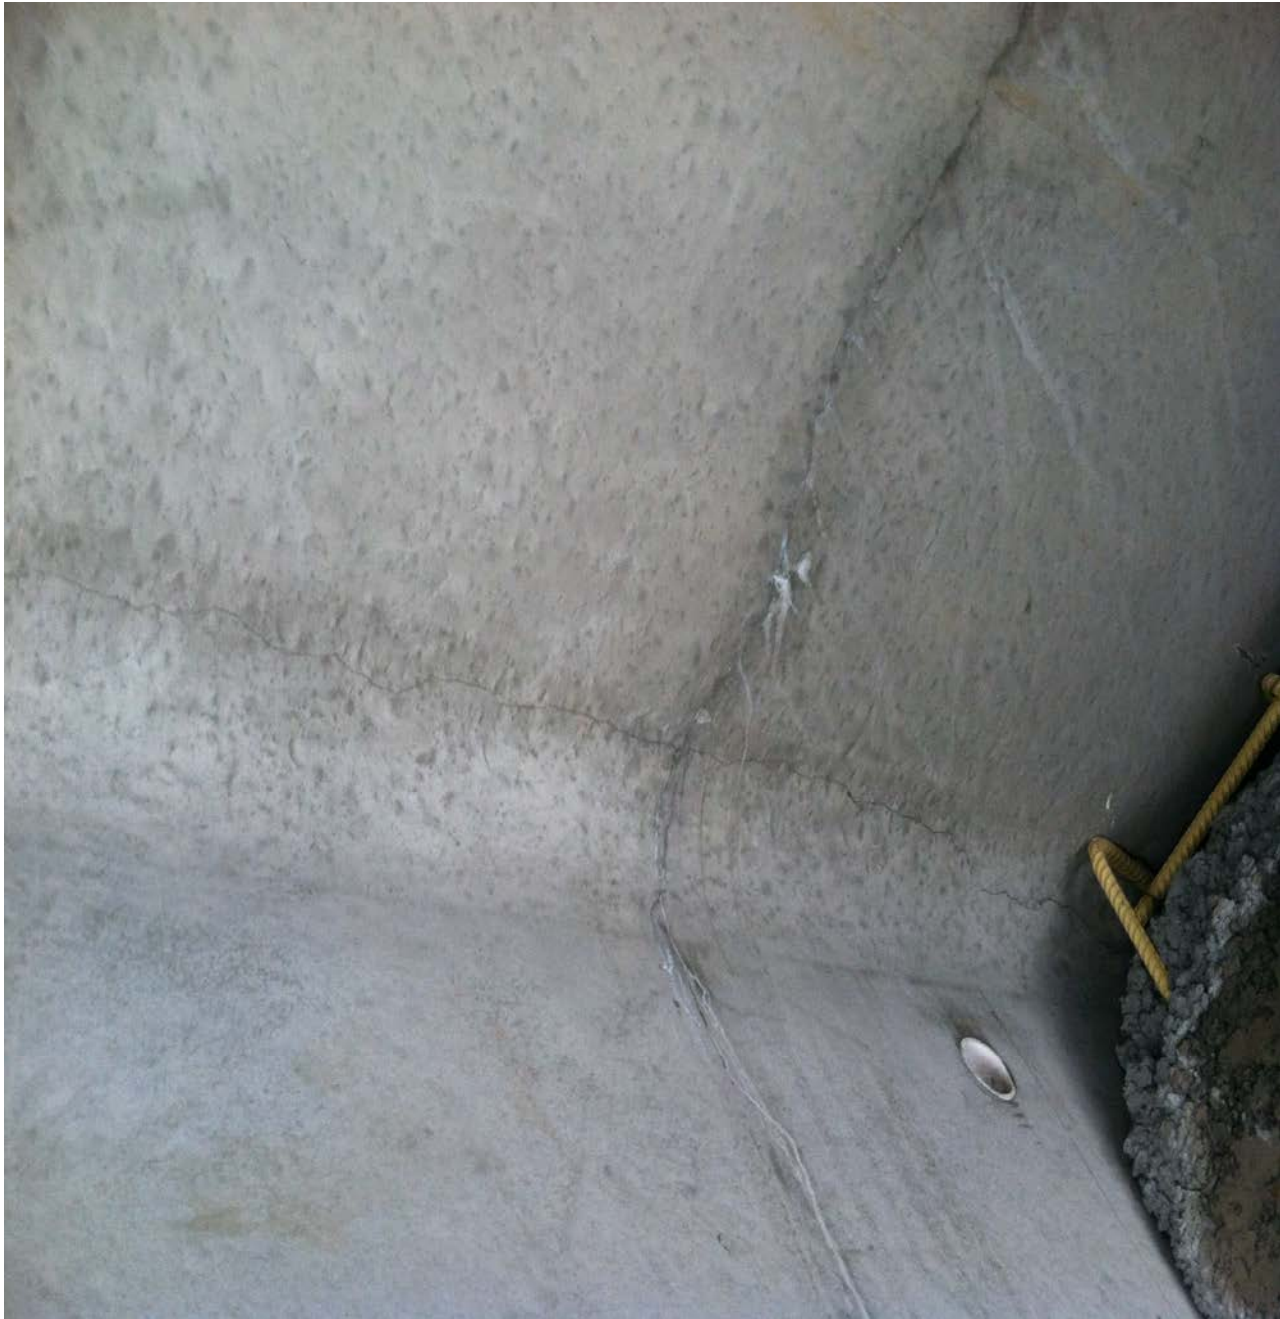
Cracking in flange and web section of NEXT F Beams

Pending the completion of the research, prestressed NEXT F Beams and NEXT E Beams shall not be specified for VTrans bridge projects under design.

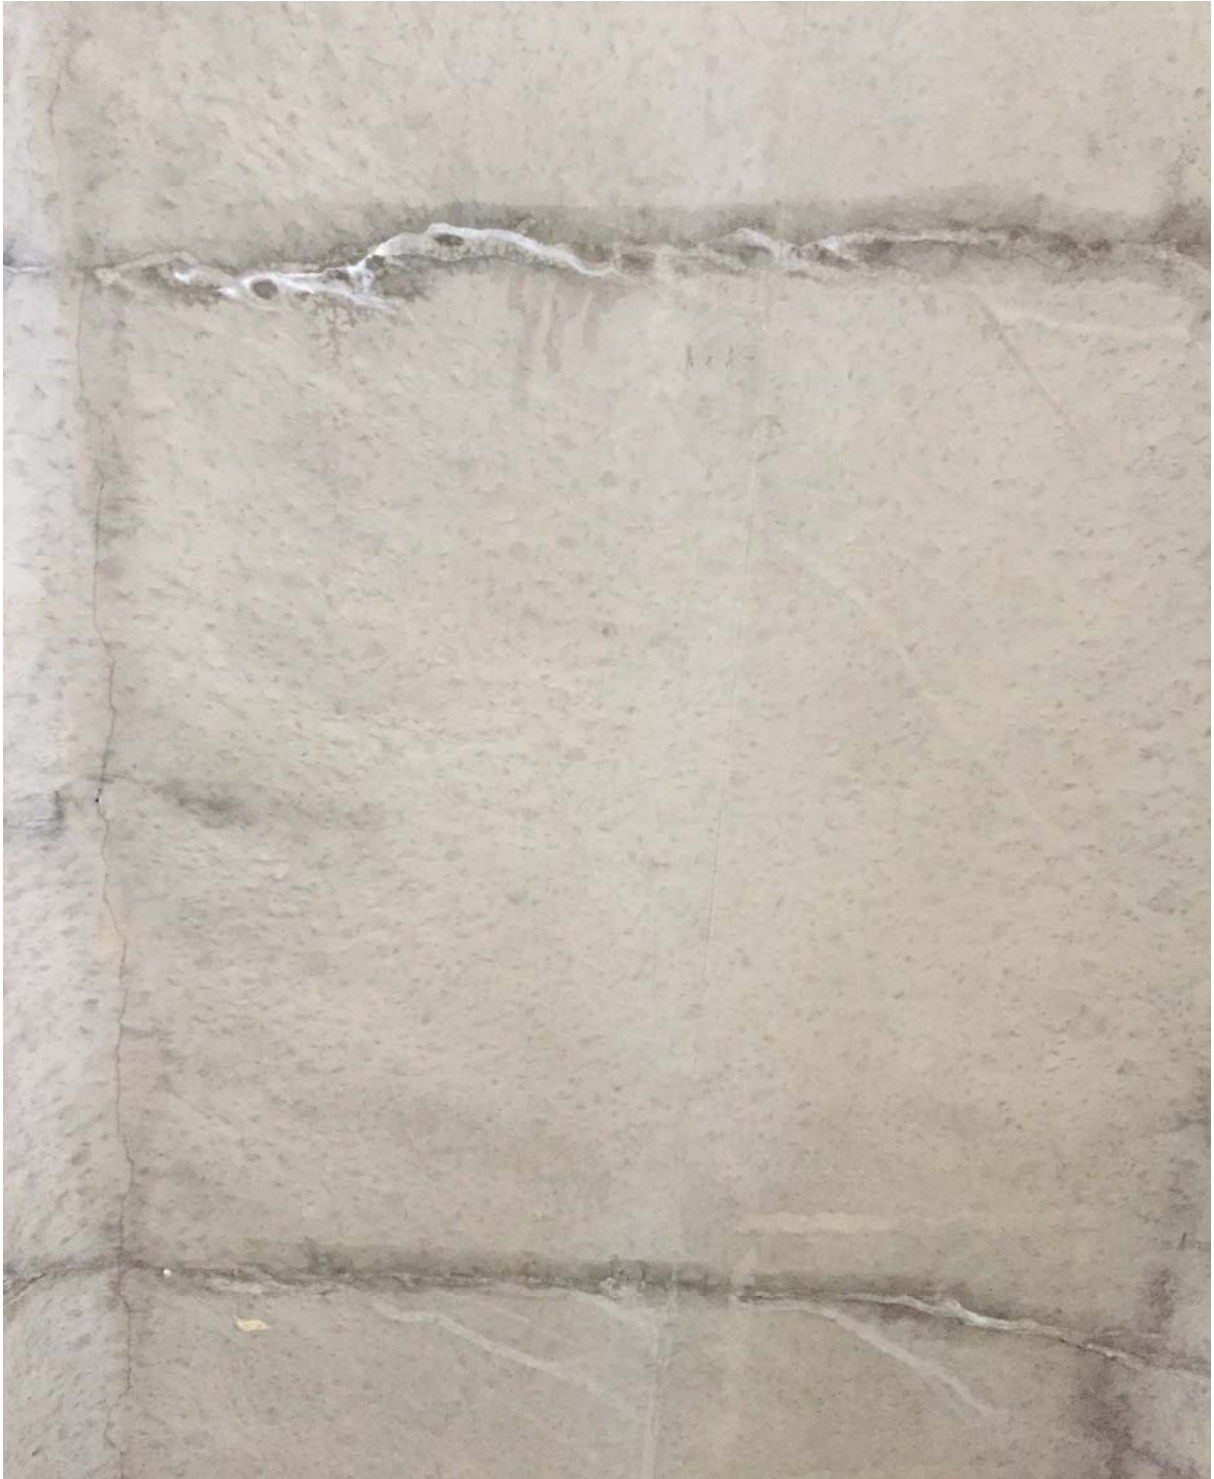
Transverse cracking in NEXT F flange and cracking along the flange to web transition.

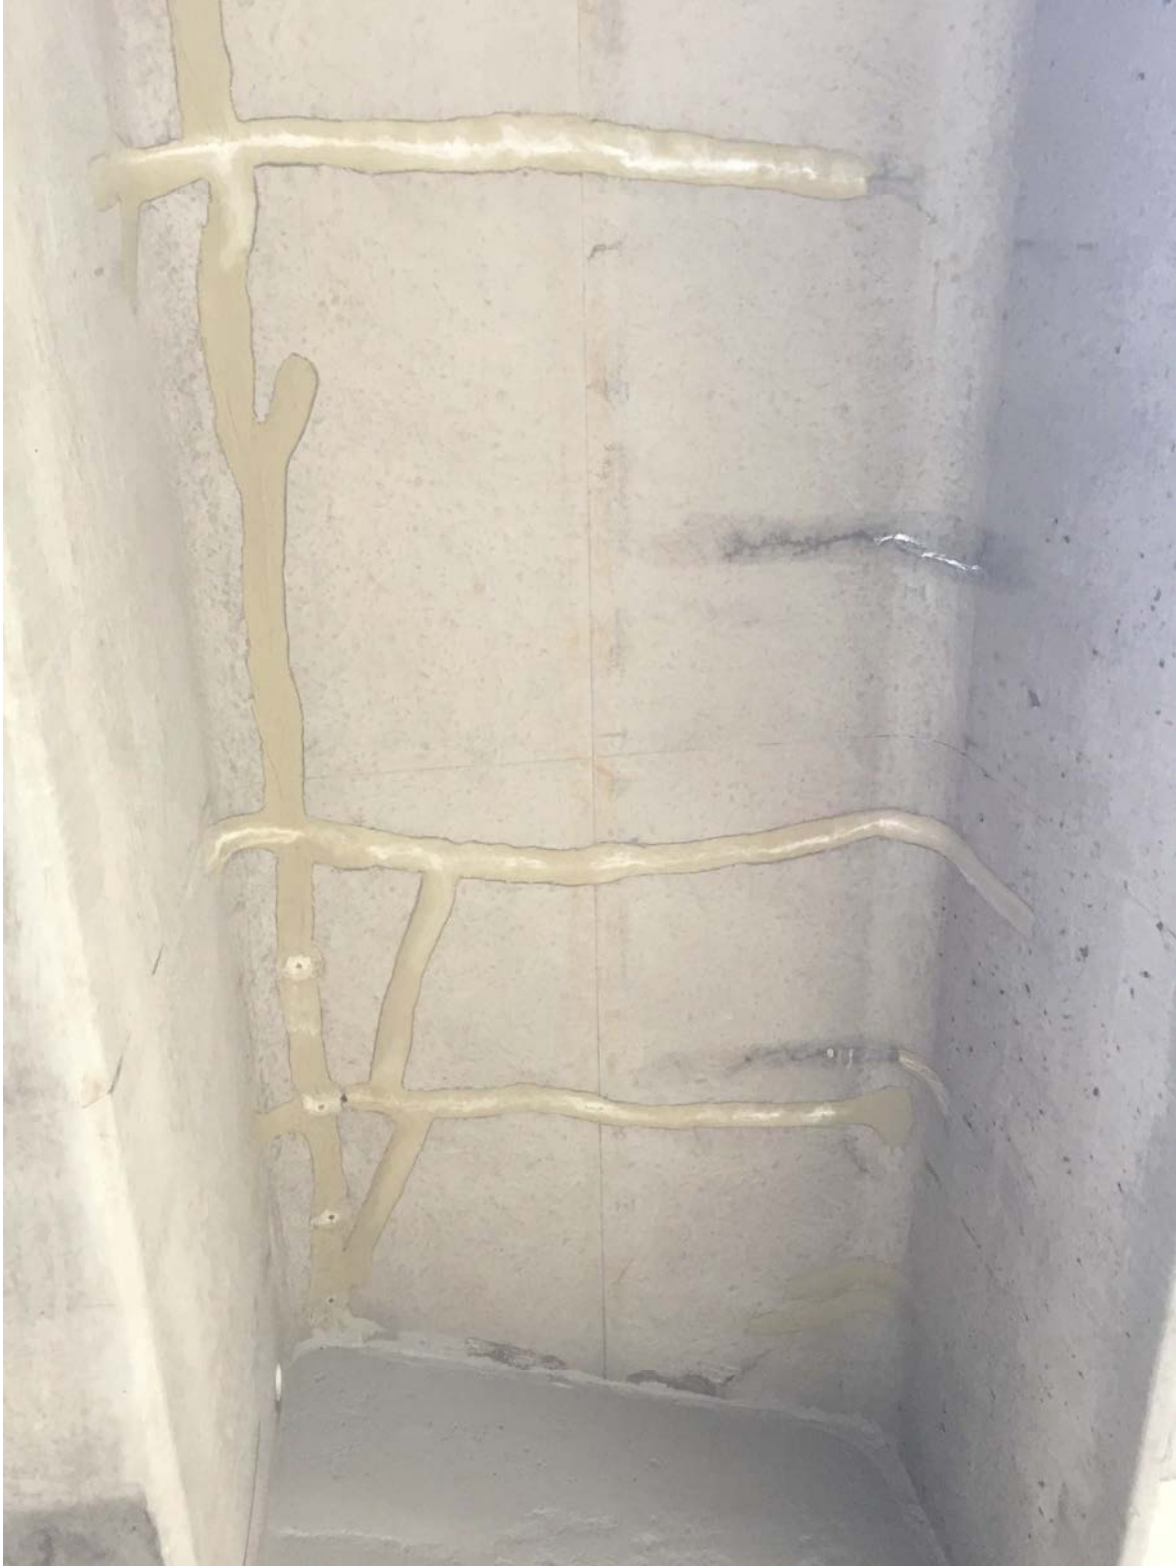
Cracking in NEXT F Section that was repaired at the Fabrication Plant but has opened back up.

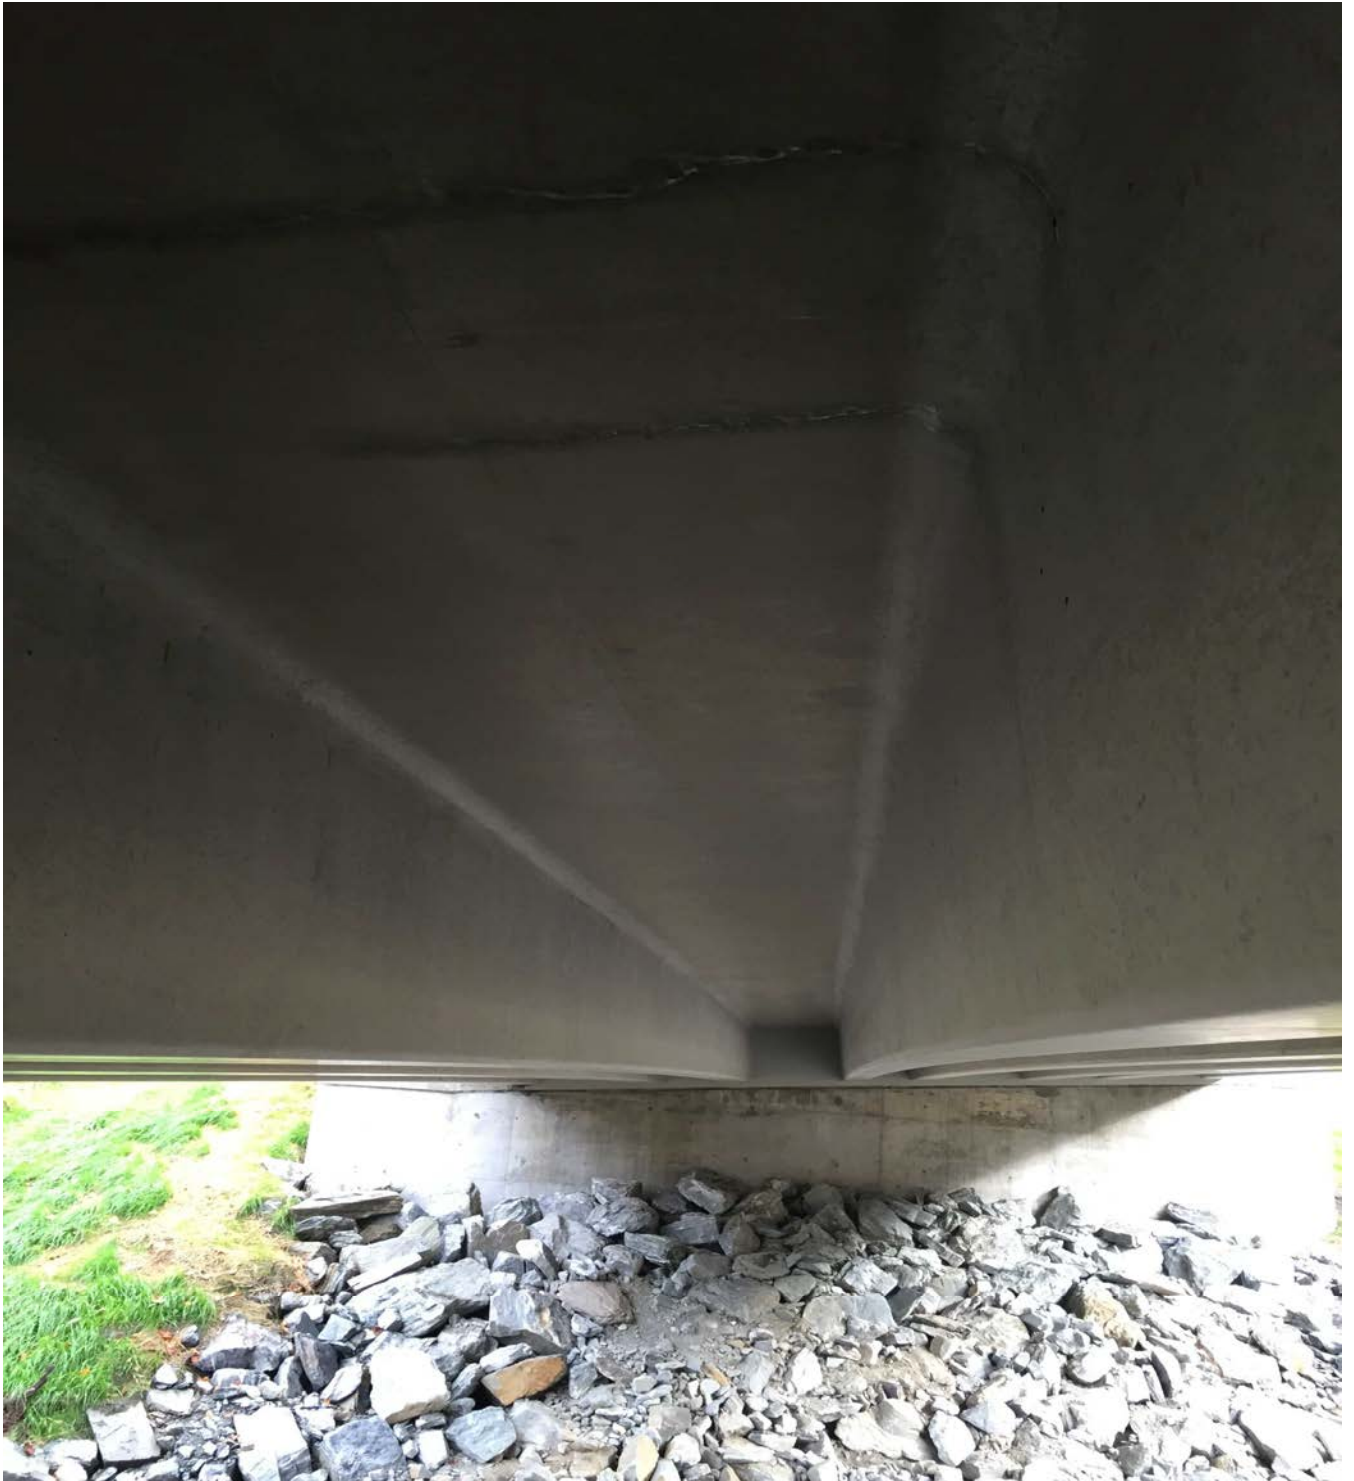
Cracking in flange and web section of NEXT F Beams
